## SUTTONS BEACH PAVILIONS – STRUCTURAL INVESTIGATION REPORT

SUTTONS BEACH  
50 MARINE PARADE, REDCLIFFE

MORETON BAY REGIONAL COUNCIL

REF: RG/RG/27747RPT- ISSUE A

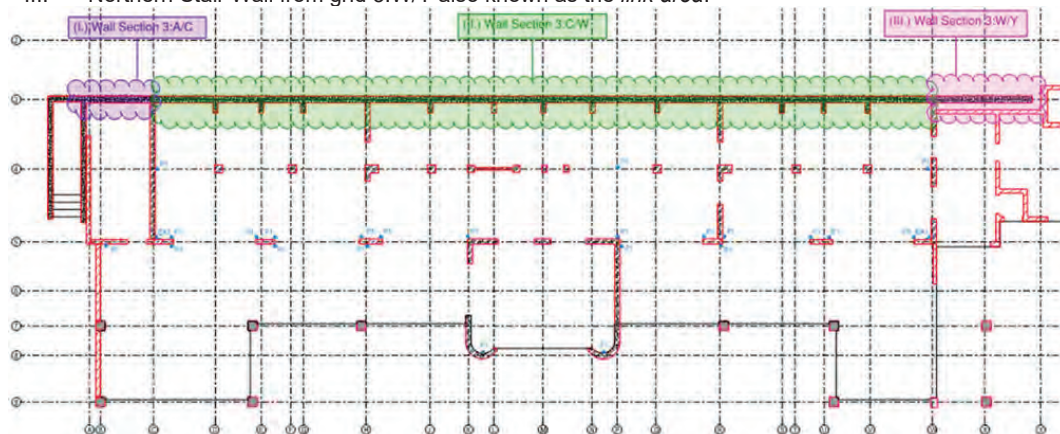
Figure 1: Retaining wall section references.

Wall section (I.) in toilet area has lots of cracking, water ingress, is carbonated, has chloride ingress and is in poor condition.

Wall section (II.) has cracking on internal face, water ingress at a previous crack repair, water ingress through the upper wall penetrations due to external ground height being above the openings in places, carbonation to reinforcement. Despite this the breakouts in this section of wall at random locations showed the reinforcement had no signs of corrosion.

Wall section (II.) is structurally inadequate for current design loads and requires strengthening and/or reduction of applied loads (that is relief from surface and subsurface water). Similarly for Wall section (I.)

Wall section (III.) no longer has lateral supports from the stair walls hence it is structurally inadequate for current design loads.

Wall section (I.) is in poor condition and at the end of its service life. It requires remedial work.

Wall section (II.) reinforcement was in good condition, but cannot be left as is due to the carbonation depth and chloride ingress. *On this basis the wall is considered to be at the end of its service life and intervention is required to extend the life of the wall.* But remedial options are more diverse.

Wall section (III.) is expected to be further along the corrosion path than section (II) due to exposure and its exposed reinforcement is already corroding. Hence at best this section of wall should be treated like section (I.)

An adequate drainage system behind the wall is required to relieve pressure and get water away. Waterproofing to the positive side of the wall is recommended.

Wall section (II.) Since the onset of corrosion of reinforcement has not yet occurred, hence there are more options for remedial intervention. Anti-carbonation coating is the most appropriate method and is expected to have a design life of up to 20 years (depending on the product manufacturers warranty etc.) alternatively sacrificial anodes can be used or replacement is also an option (see report in Appendix H).

Wall sections (I.) and (III.) both require breaking back of all chloride contaminated concrete to the reinforcement and if it is not corroded then sacrificial anodes can be installed and the removed concrete reinstated. Else if corrosion has begun the concrete must be take back to 30mm beyond the steel reinforcement. Clean and coat reinforcement and replacing any that have suffered sectional loss (reduced in size). Followed by installing new concrete and applying protective anti-carbonation coatings.
