JOINT REPORT
GROUND FLOOR BRICK WALLS AND COLUMNS

PAVILION 1, 50 MARINE PARADE, REDCLIFFE

COVEY ASSOCIATES & ACOR CONSULTANTS

PROJECT NO: 223164
REF: RG/RG/102205RPT – A
22 DECEMBER 2022

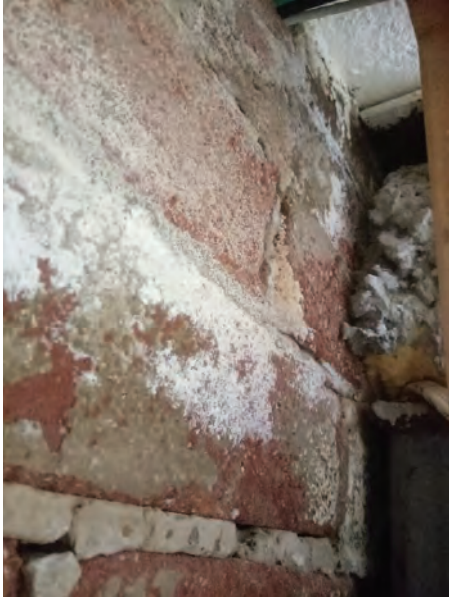
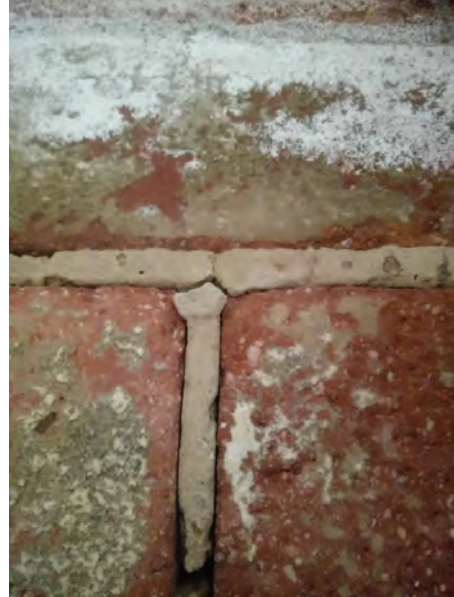
Photo 3

Images show close up of white powdery substance on bricks, pitted / worn / oxidised brick surface and mortar with localised failures in a few locations. Taken after cladding removed.

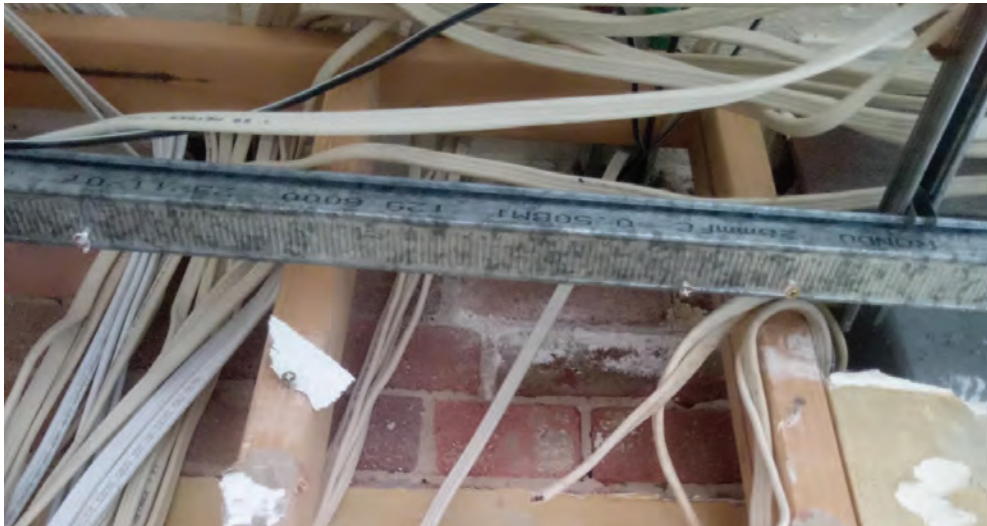
Photo 5: Efflorescence at 5-K/L

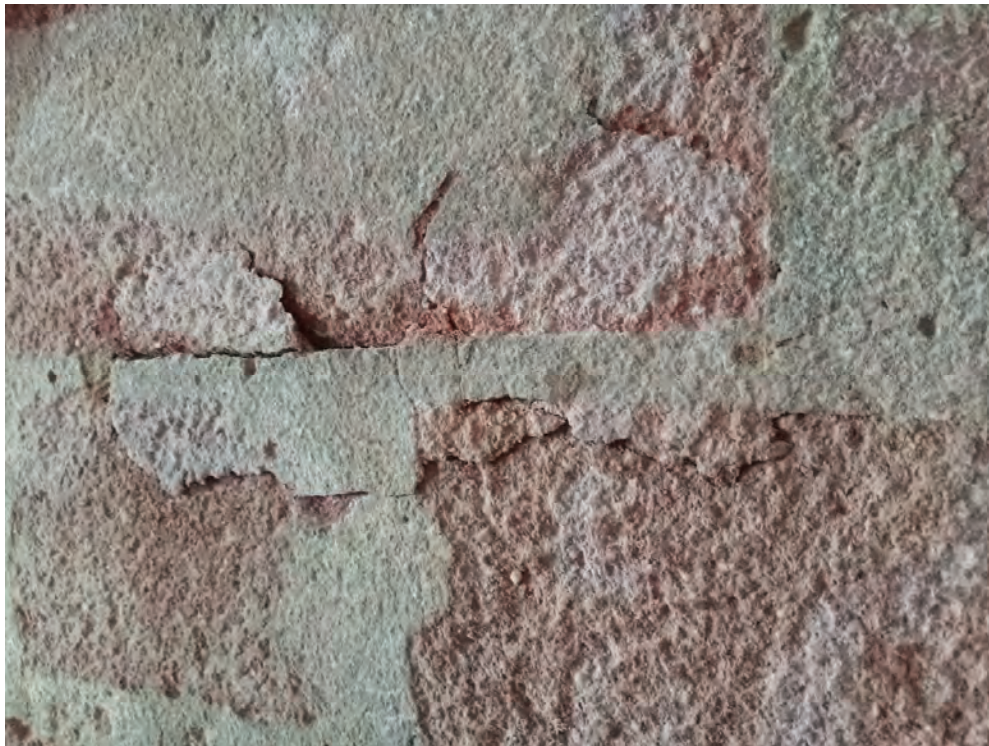
Photo 6: Example of spalling of brick and grout surface.

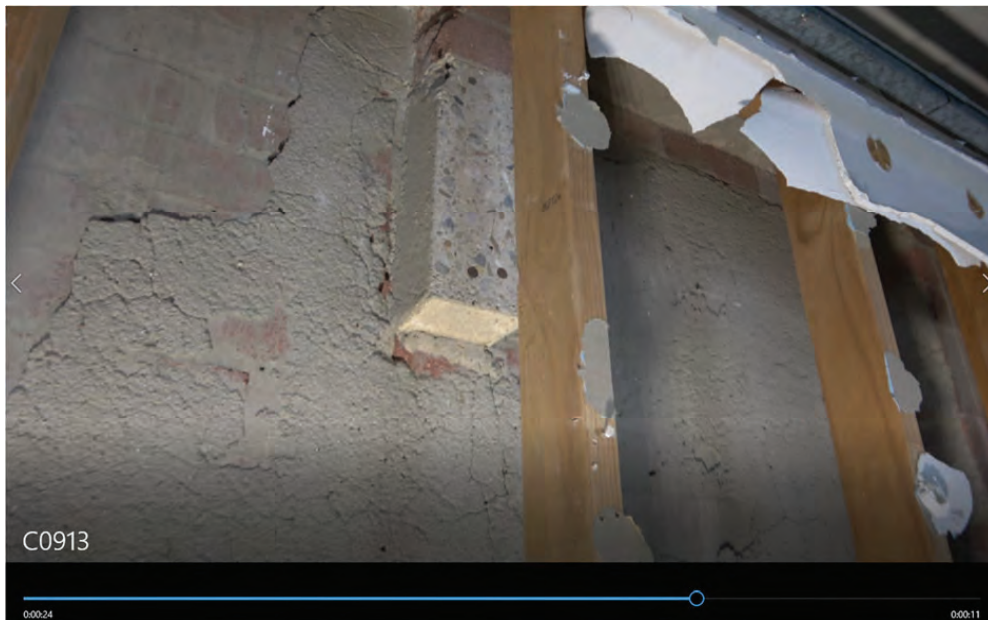
Photo 7: Cut lintel beam with exposed reinforcement at 4-K/M. Typical. Original render is cracked and has fallen off in many places.

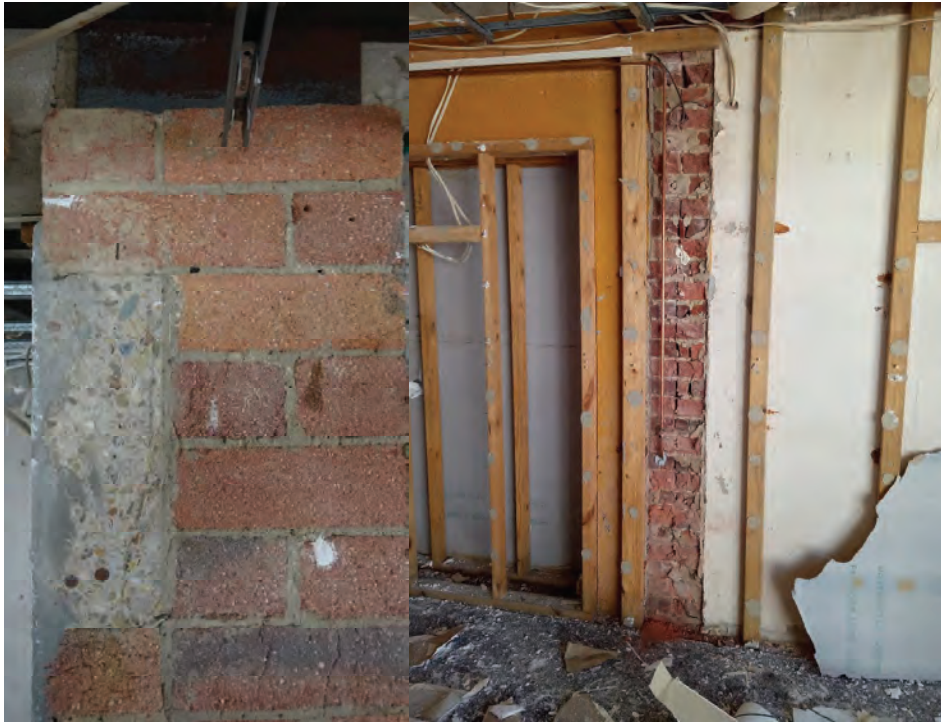
Photo 8: Another cut Concrete lintel

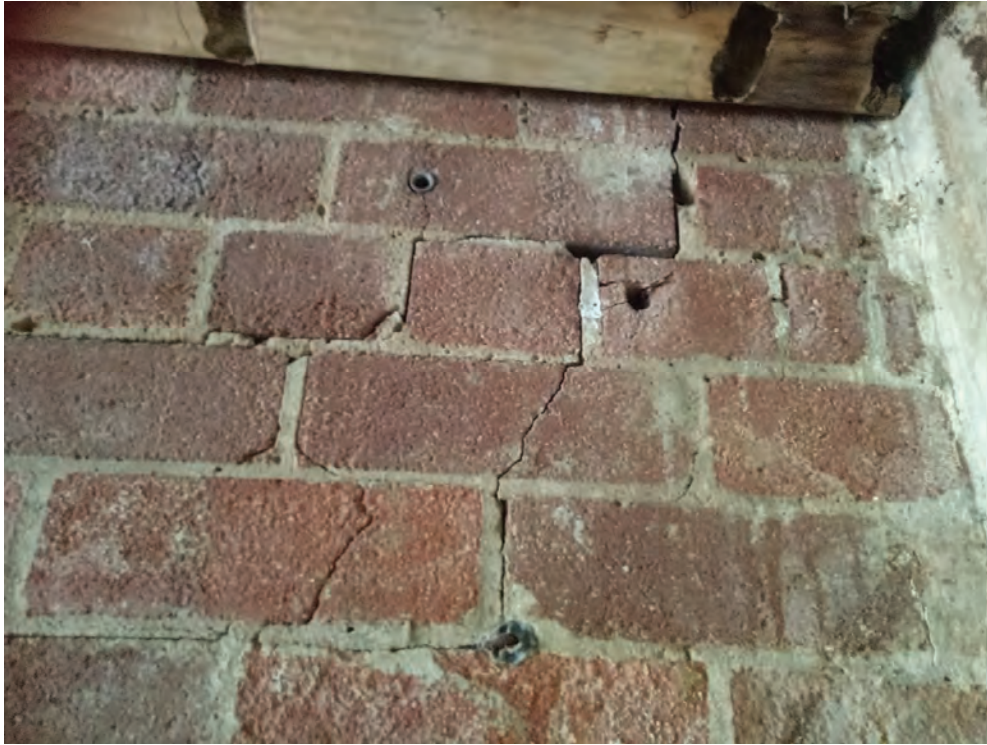
Photo 10: C/4 Brick wall cracks stepping down from rear retaining wall on northern side of wall. Note discoloration and decay of some brick surfaces as well as some efflorescence. Also note the water damaged timber ceiling batten at the top.

Note the cracking in wall C-3/4, 3-C/D and buttress/nib at 3-D suggest settlement of the rear retaining wall footing in this area. In addition to unknown/inadequate drainage behind the rear retaining wall, the cracked stormwater pipe could be providing a water source to flush fines away and consolidate foundation soils allowing this corner to settle. Causing the cracks and gaps visible today. See other sections of the report for more details including *Foundations* and/or *Leaks and Water Ingress*.

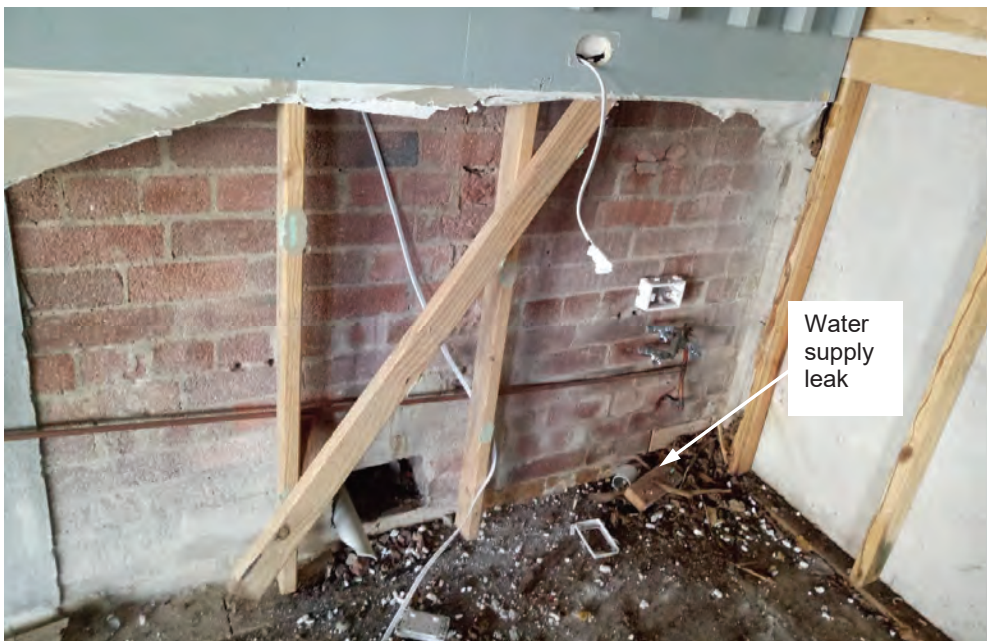
Photo 11: Image shows the wall C-3/4 during strip out. Note termite and water damage to non-load bearing stud framing attached directly to brick wall and rear concrete retaining wall.

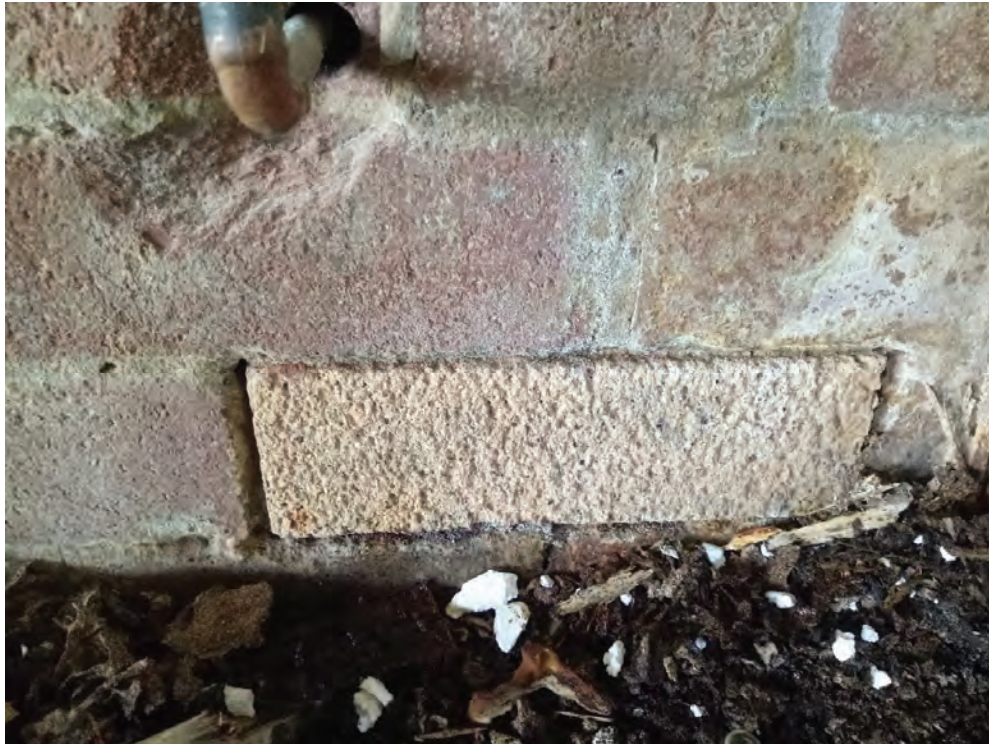
Photo 12: C-3/4 during strip out. Timber frame wall linings were damp with termite and water damage.

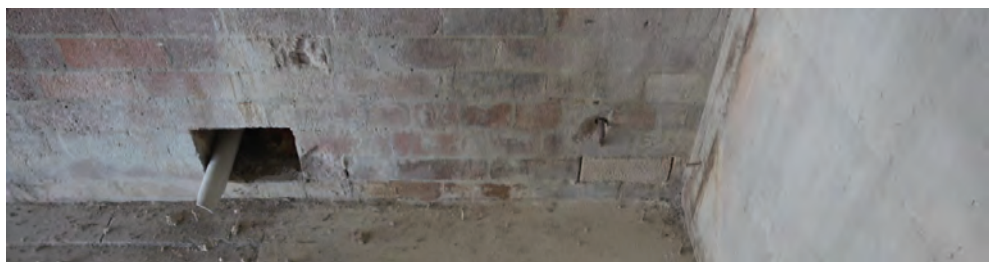
Photo 13: C-3/4 Image shows white powdery mould on brick surface after cladding removed.

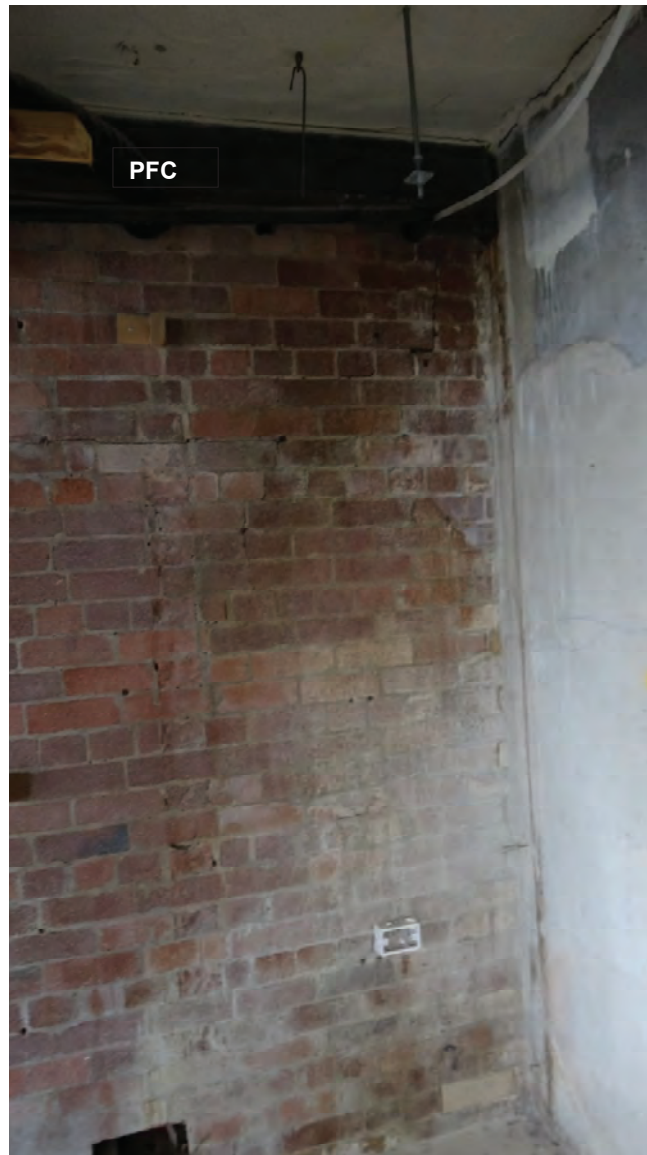
Photo 14: C-3/4 Brick wall. Note stepped cracks at top. And cracks at joint to suspended slab.

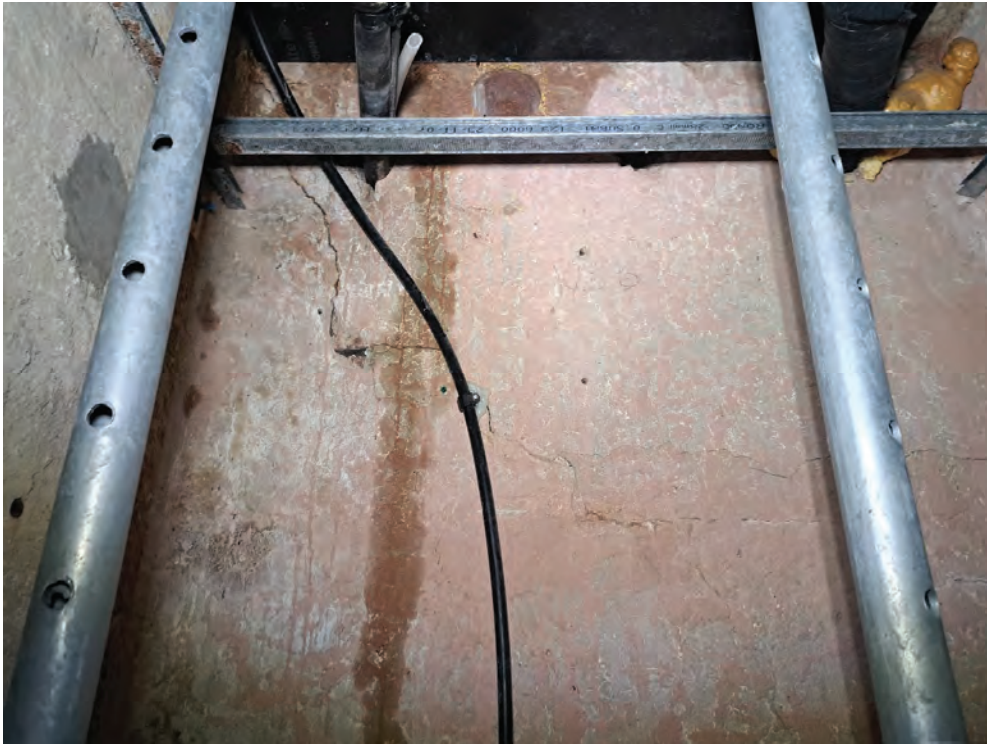
Photo 15 : Other side of Wall C-3/4 shows cracks stepping down from the rear retaining wall is reflected to this face of the wall too. Also note water ingress.

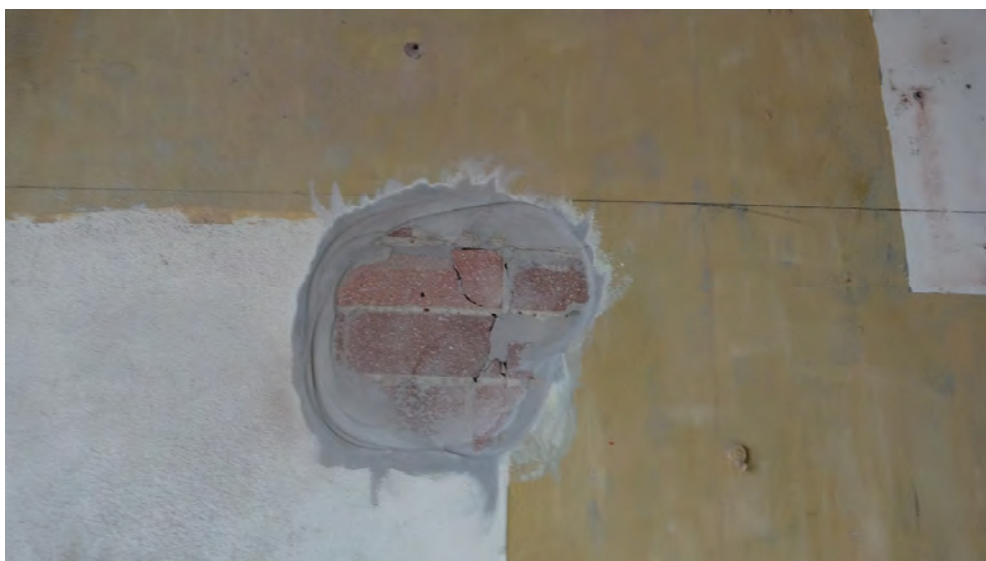
Photo 17: Modern render ground off to expose crack at top of wall through bricks.
Also shows previous grout repairs beneath modern render.

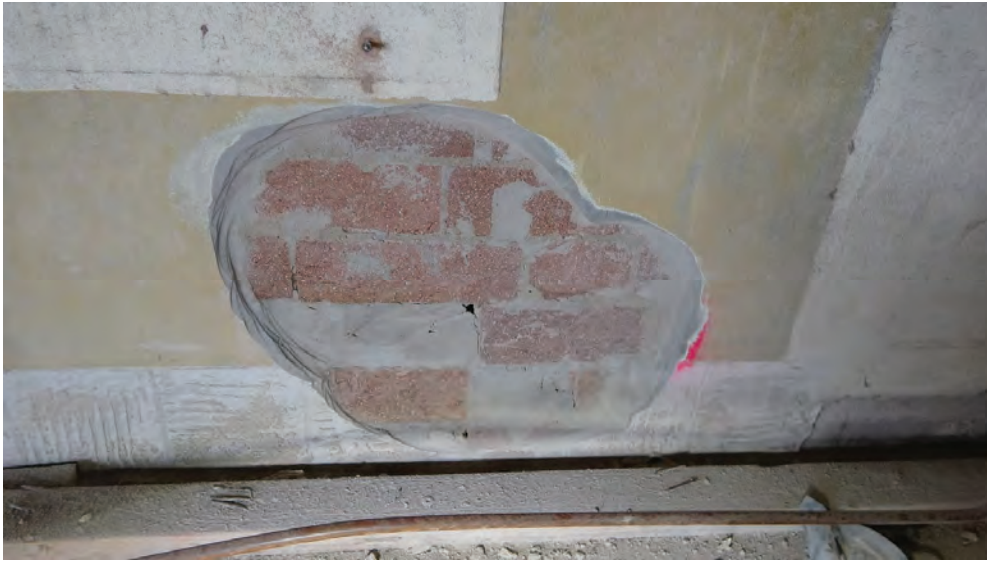
Photo 18: Crack at base of wall much finer. Also shows gout patching beneath modern render.

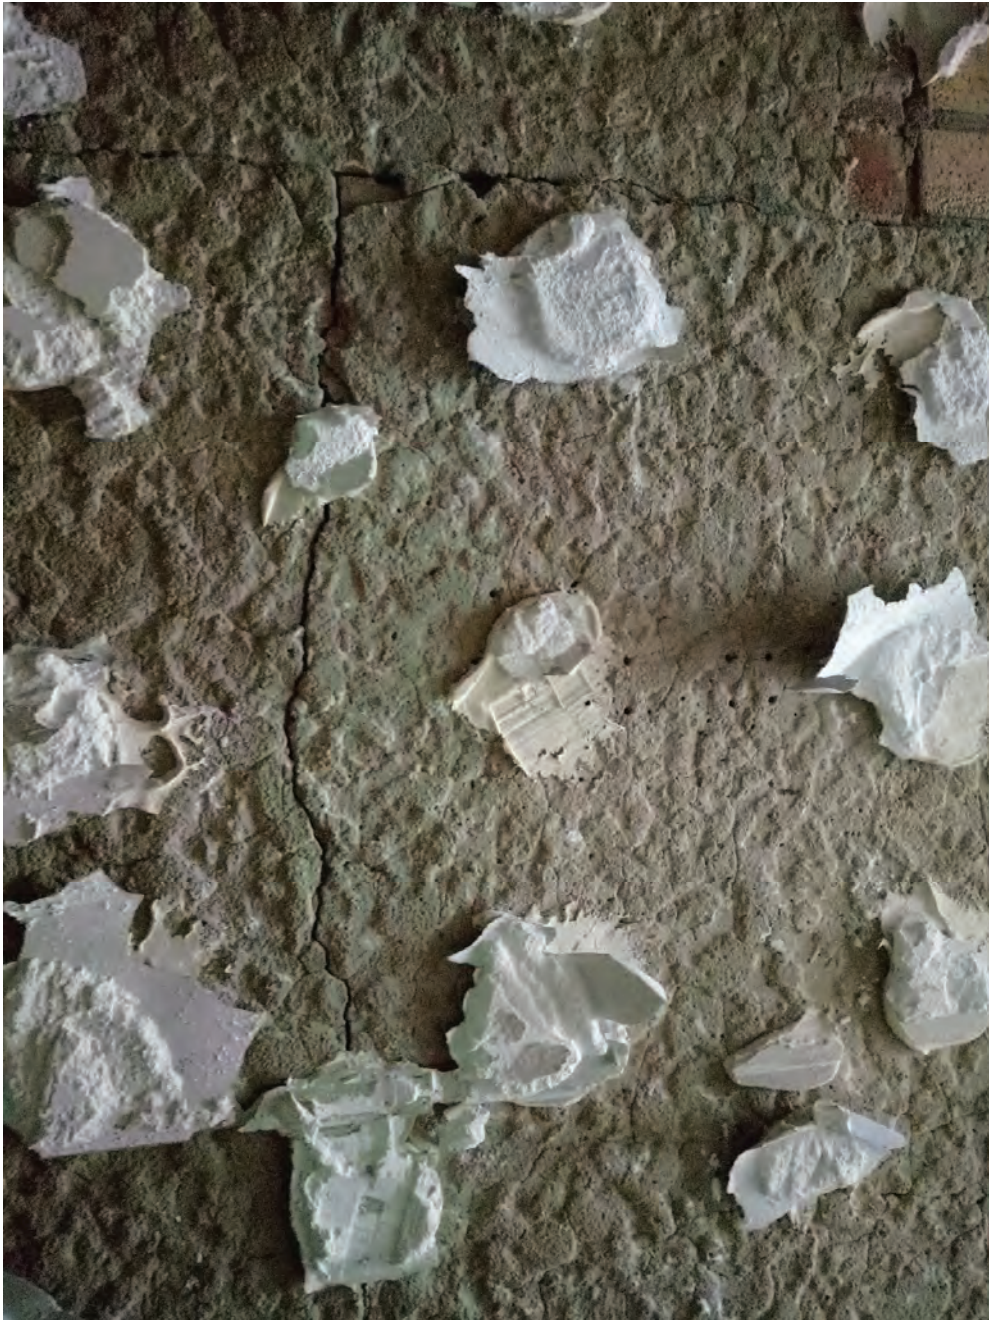
Photo 19: Opposite side of the wall – shows original render with cracks through bricks and mortar that do line up on the inside face – see above pictures where the newer grout was ground back.

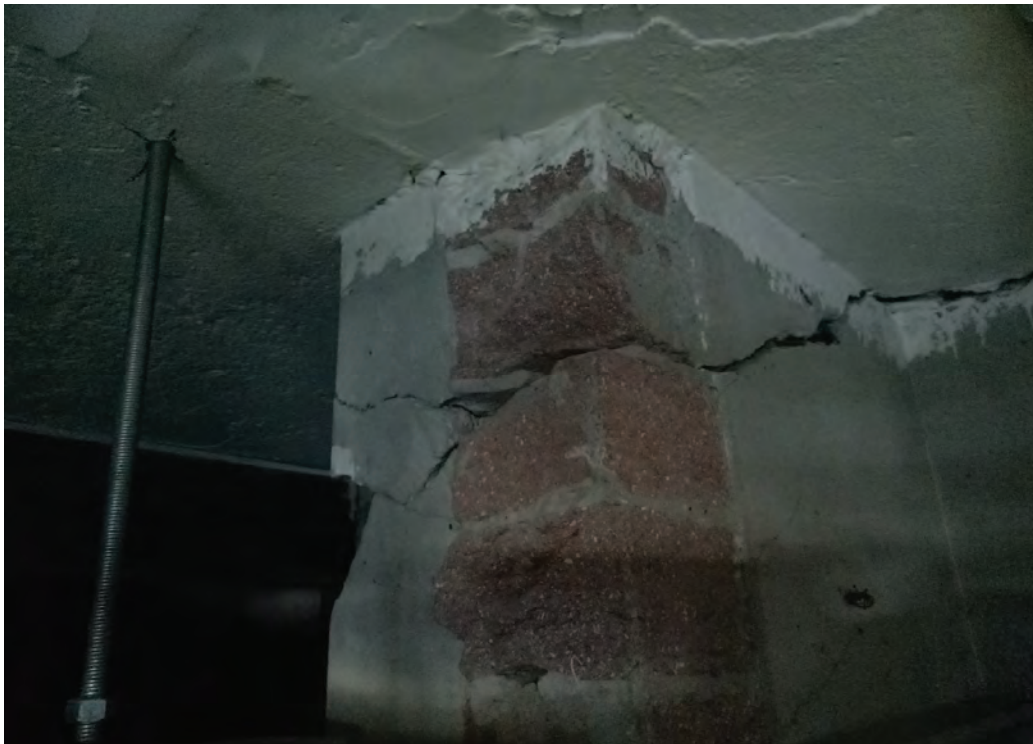
Photo 21: At top of Butress column/wall at grids 3:D. Northern Face. The column is mostly concrete with a brick corner that used to be a continuous brick wall along D:3-4 but was removed.

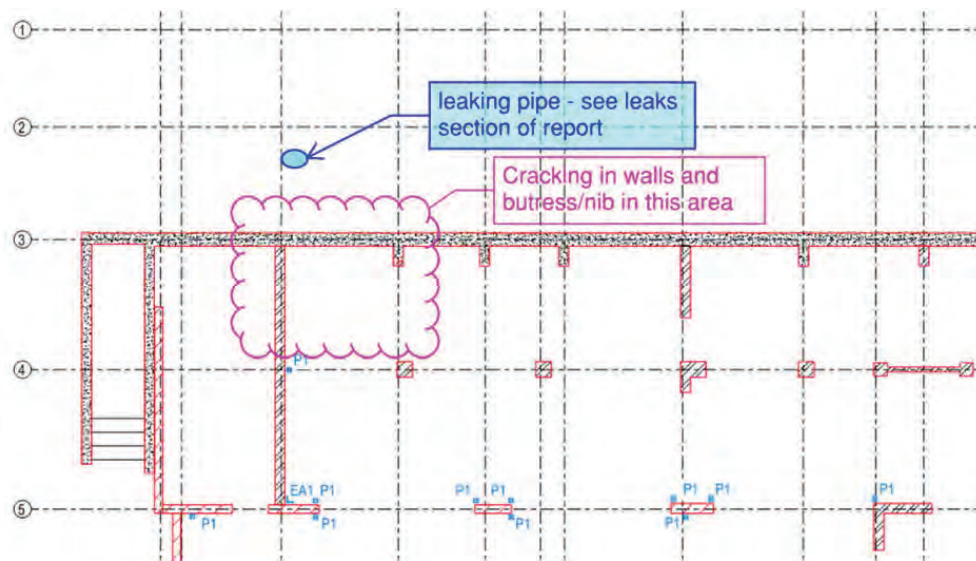
Figure 7: Plan excerpt showing cracking in corner and proximity of leaking pipe.

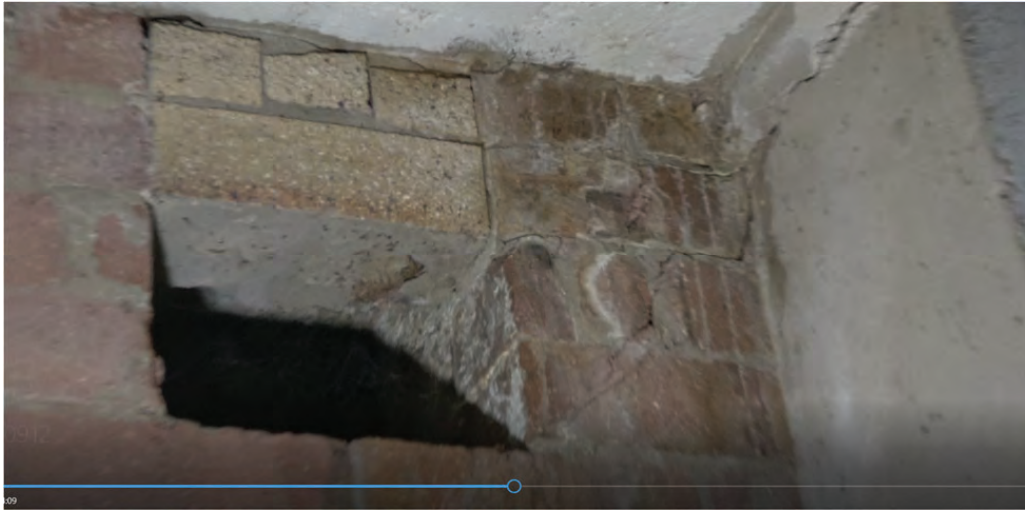
Photo 23: Close up of cracked bricks at wall section H-3/4

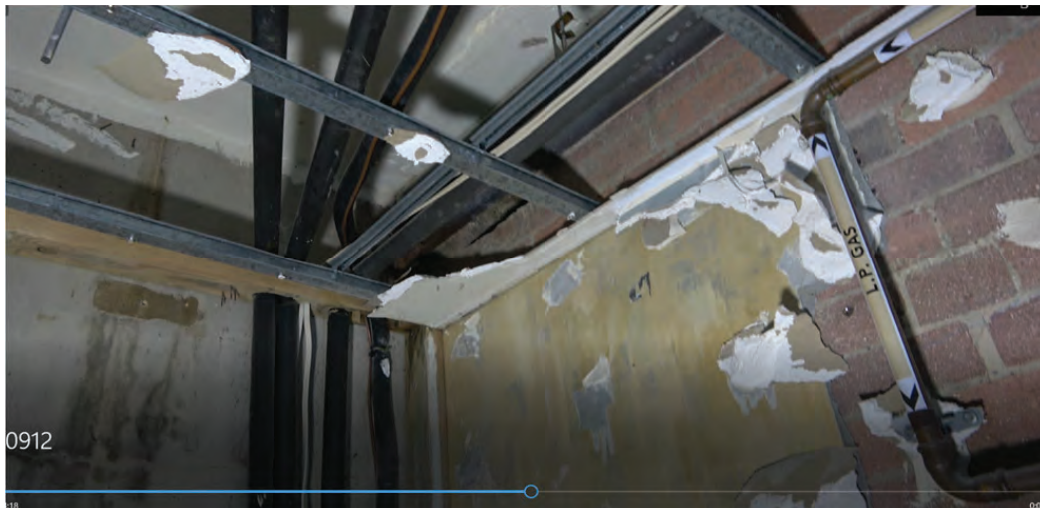
Photo 24: Other side of wall above. Note some wall linings glued on in patches other render and tiles glued to wall.

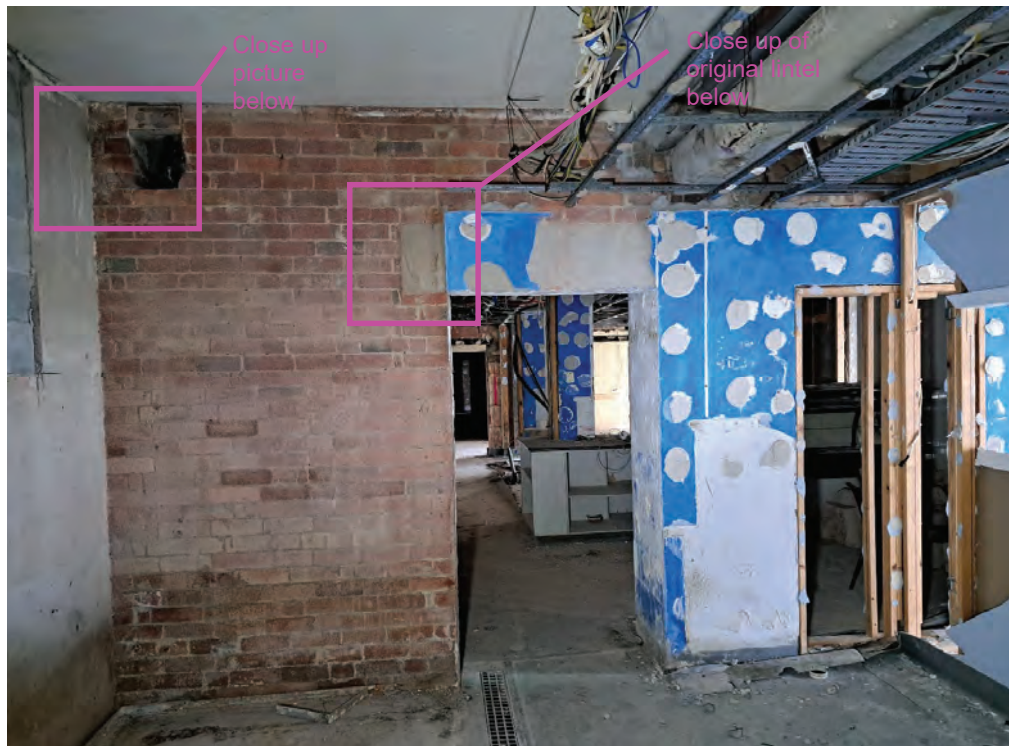
Photo 26: Wall with timber cladding removed – has no glue/render on this side – original bricks appear worn with some decay. There was some white efflorescence on the wall when cladding removed, but after being left open for weeks this has reduced somewhat with better ventilation. Note the opening with original lintel still in place. Also note discolouration of wall at the base.

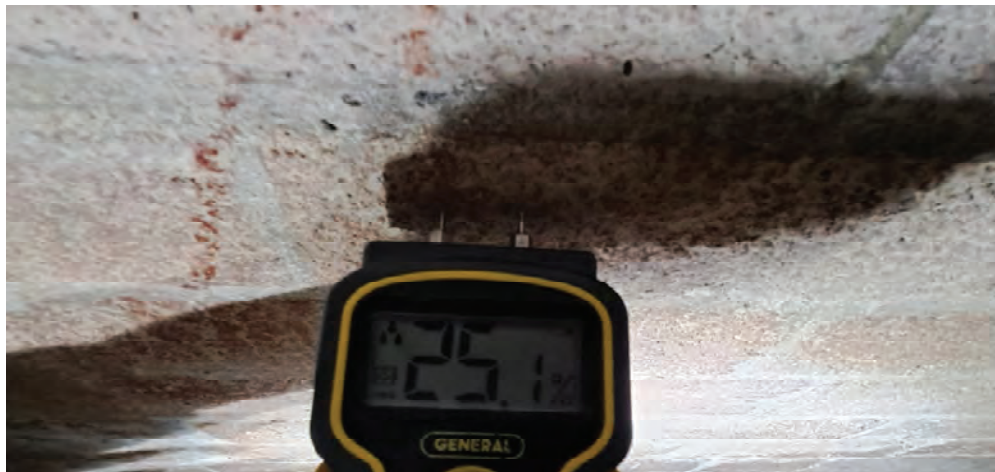
Photo 27: Moisture Content near base of wall above.

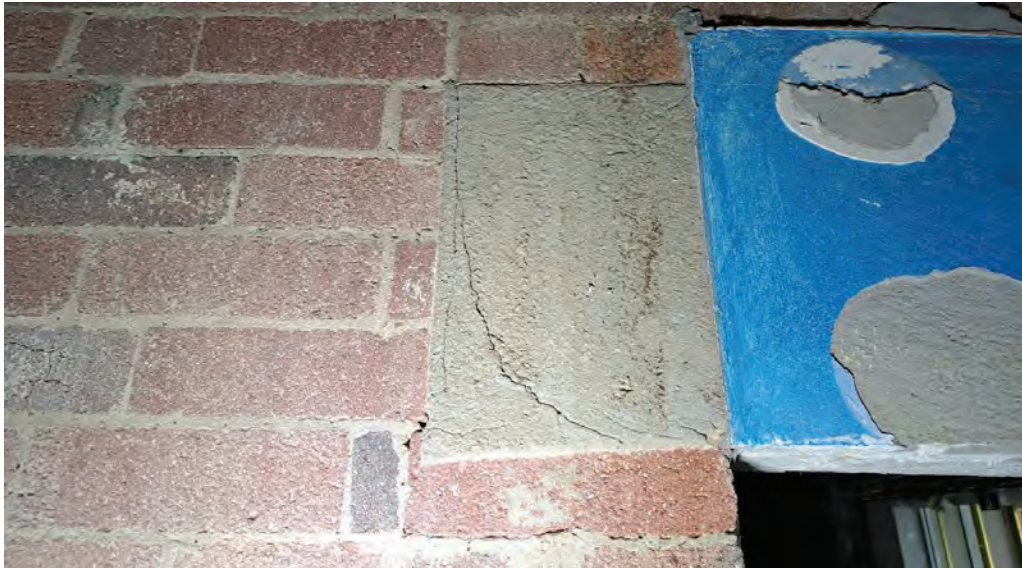
Photo 28: Cracking in render over original concrete lintel above. Also note cracking and gaps in mortar

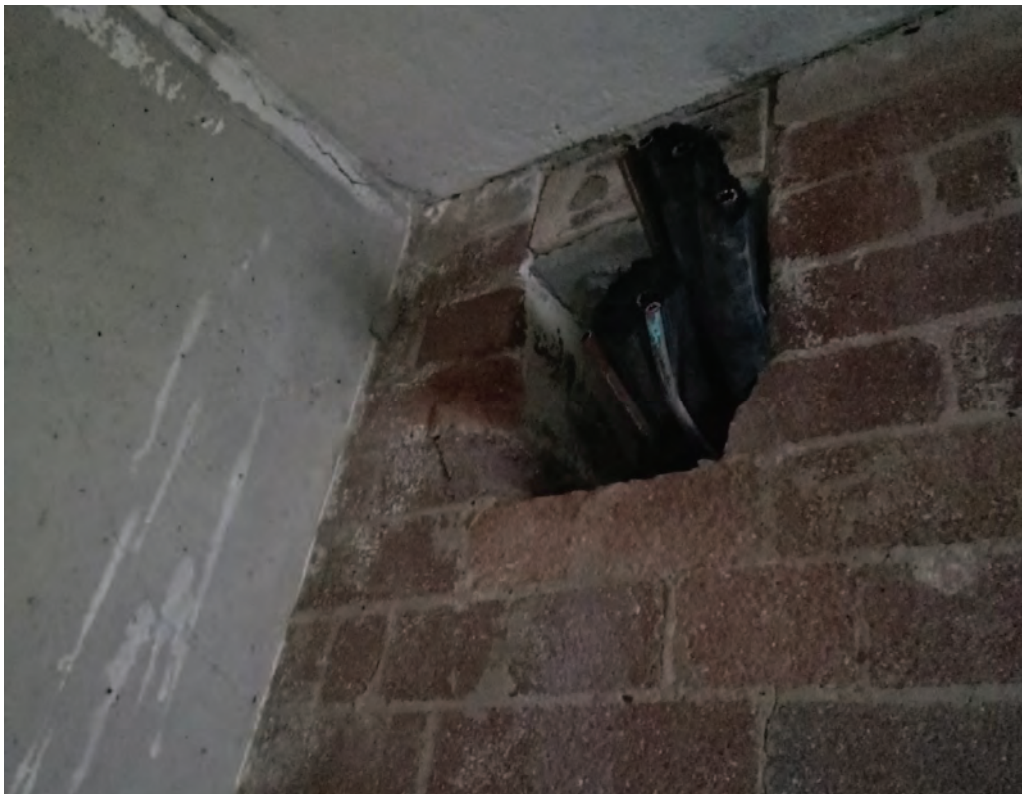
Photo 29: Note surface of bricks appears pitted and worn with some cracks in mortar extending through the bricks.

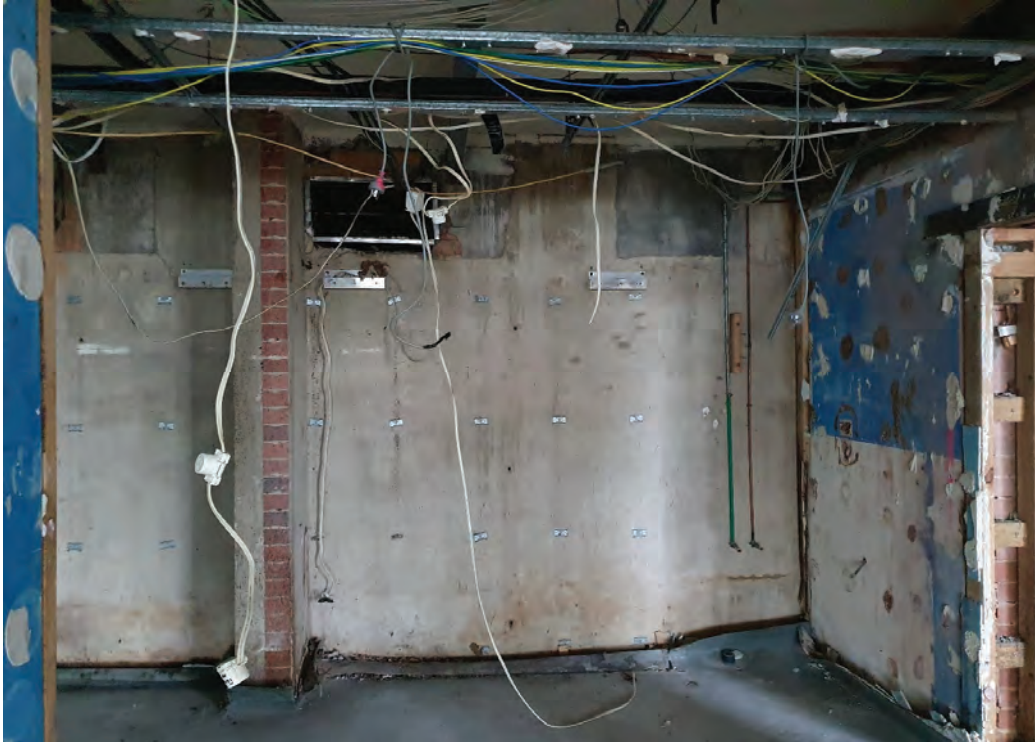
Photo 30: Wall W-3/4 on far right mostly clad with a with brick corner – this is all that remains of a single skin brick wall along grid V that was removed.

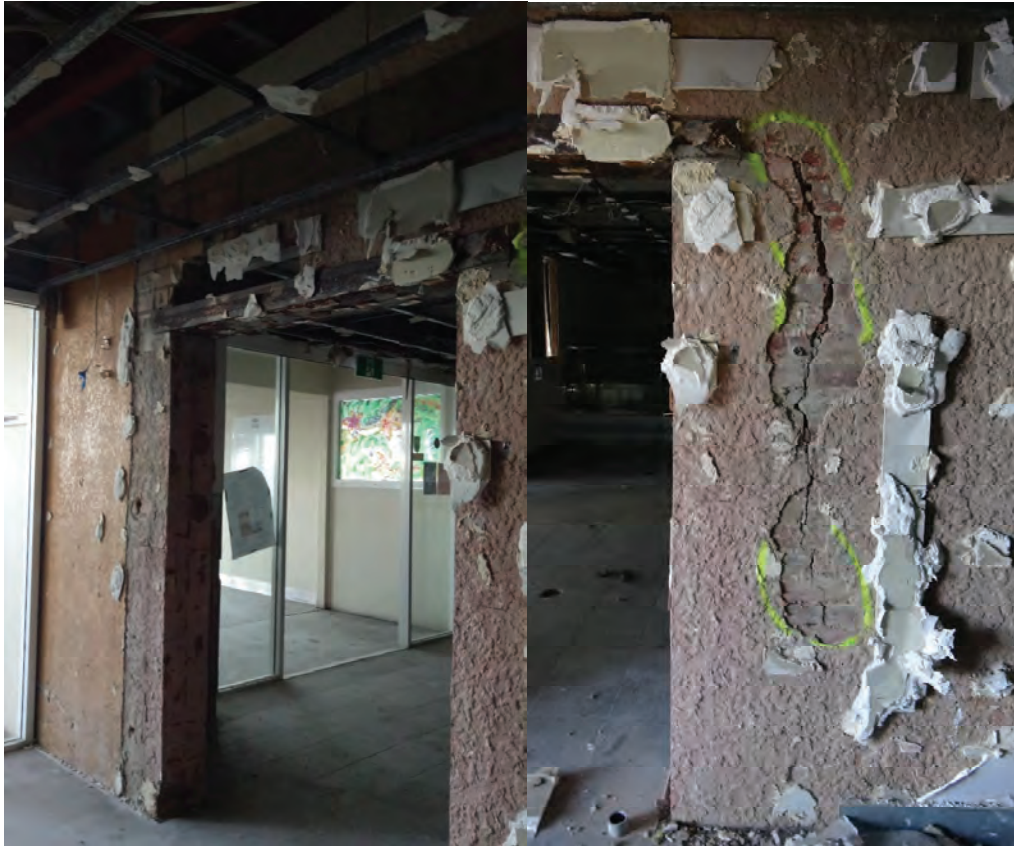
Photo 32: Section of wall at W-4/5
Also lintel between W-4/5 and W-4.

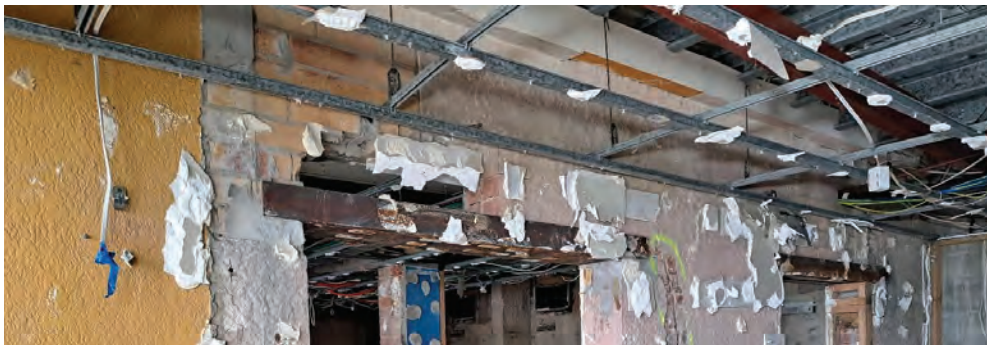
Photo 34: Steel Lintel between wall segments W-4/5 and W-4. Missing bricks over and newer bricks over also installed. Brick work cracked through at W-4.

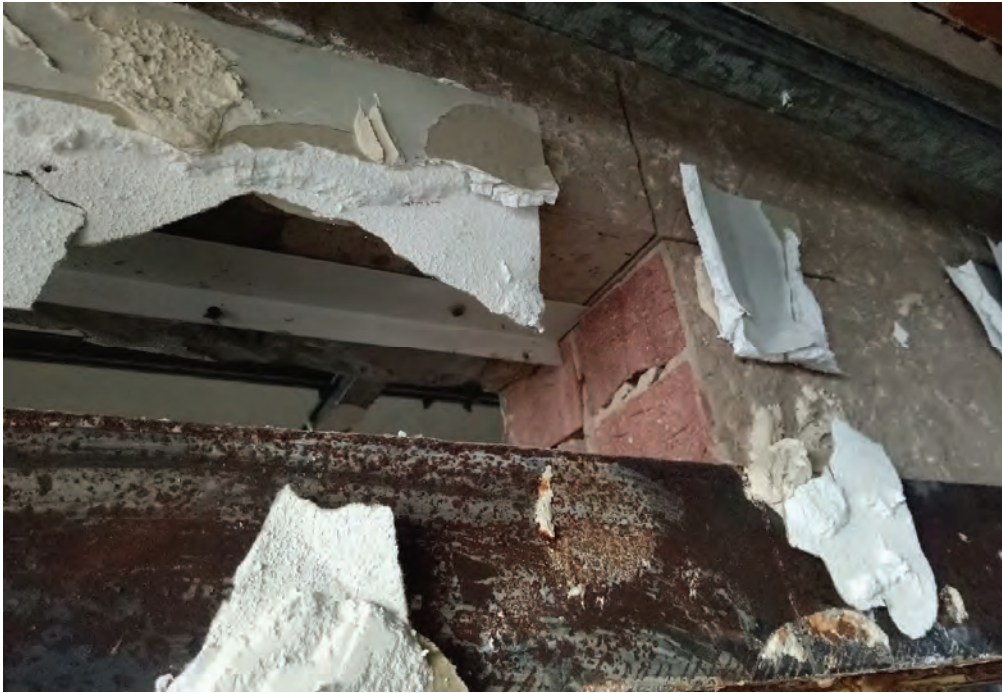
Photo 35: Close up of missing bricks above lintel.

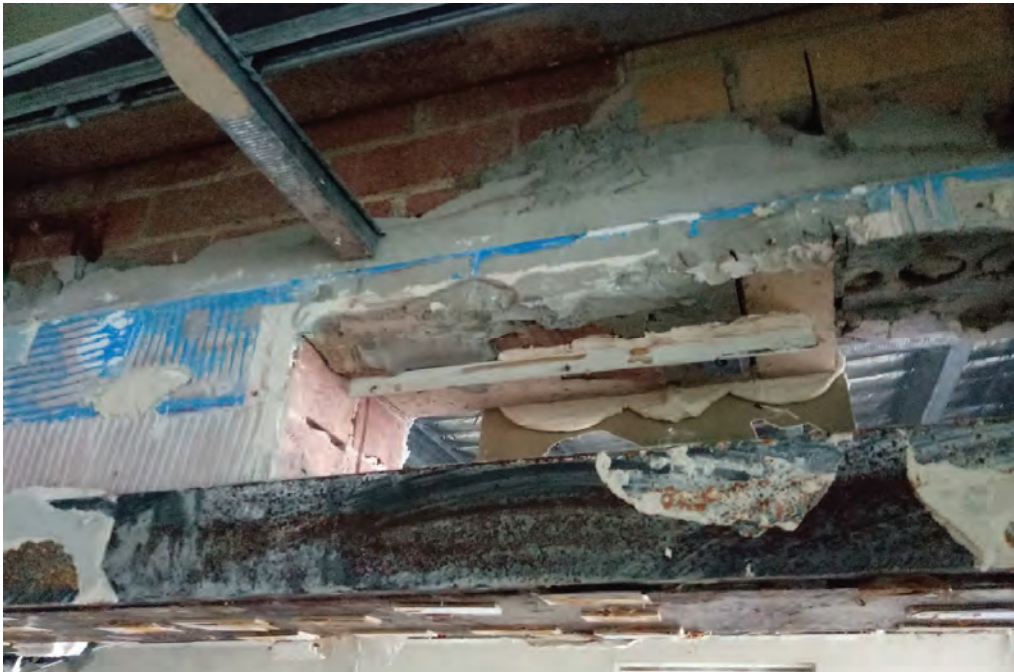
Photo 36: View from other side of lintel in above photo. Note missing bricks, new bricks. Surface rust on steel angle

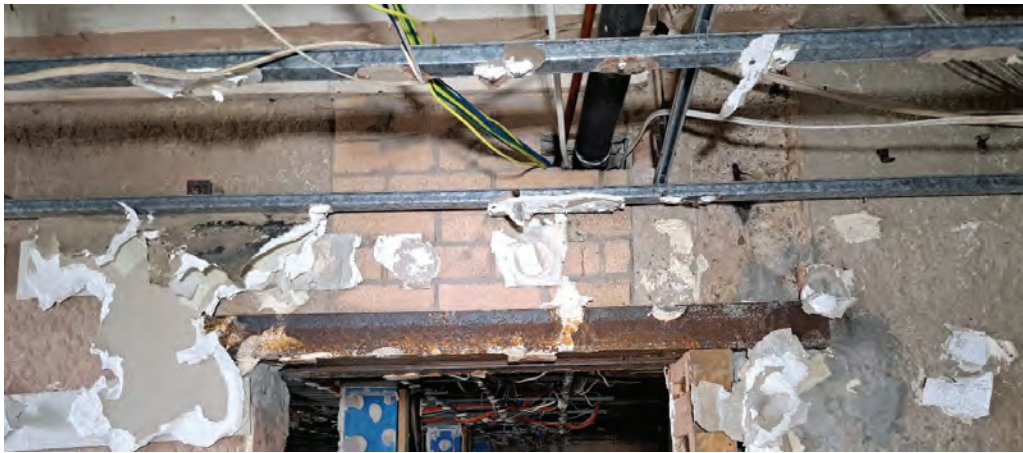
Photo 37: Lintel between W-3/4 and W-4. Note infill with modern bricks and grouted patch repairs

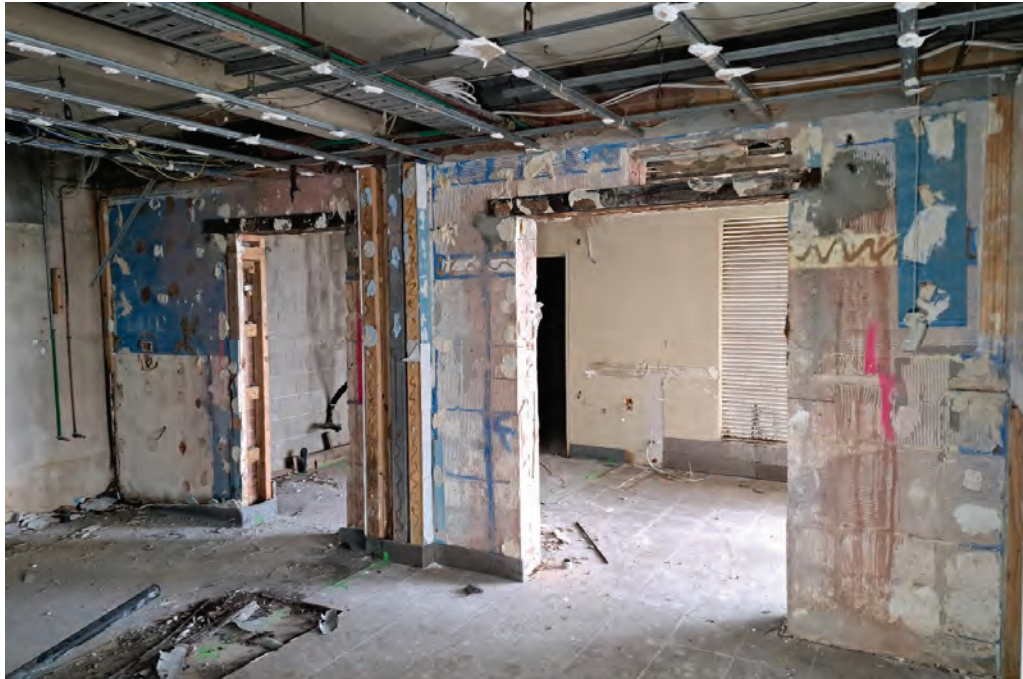
Photo 38: View of other side of wall along Grid W. Note the tile glue, patches and other render

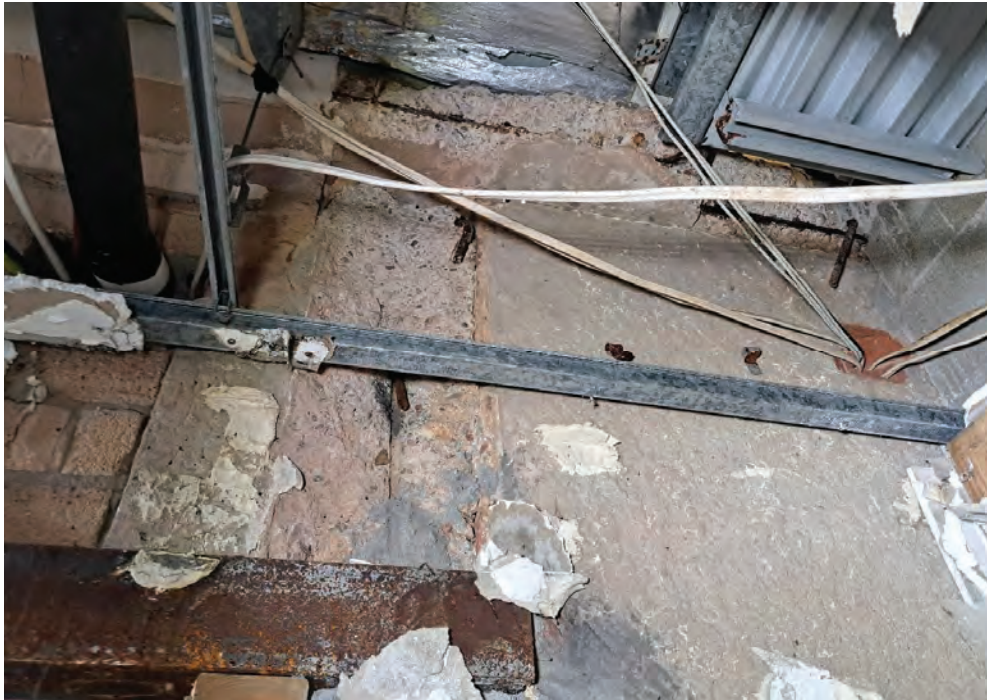
Photo 39: Top of brick wall at W:3/4 where northern stair has been removed

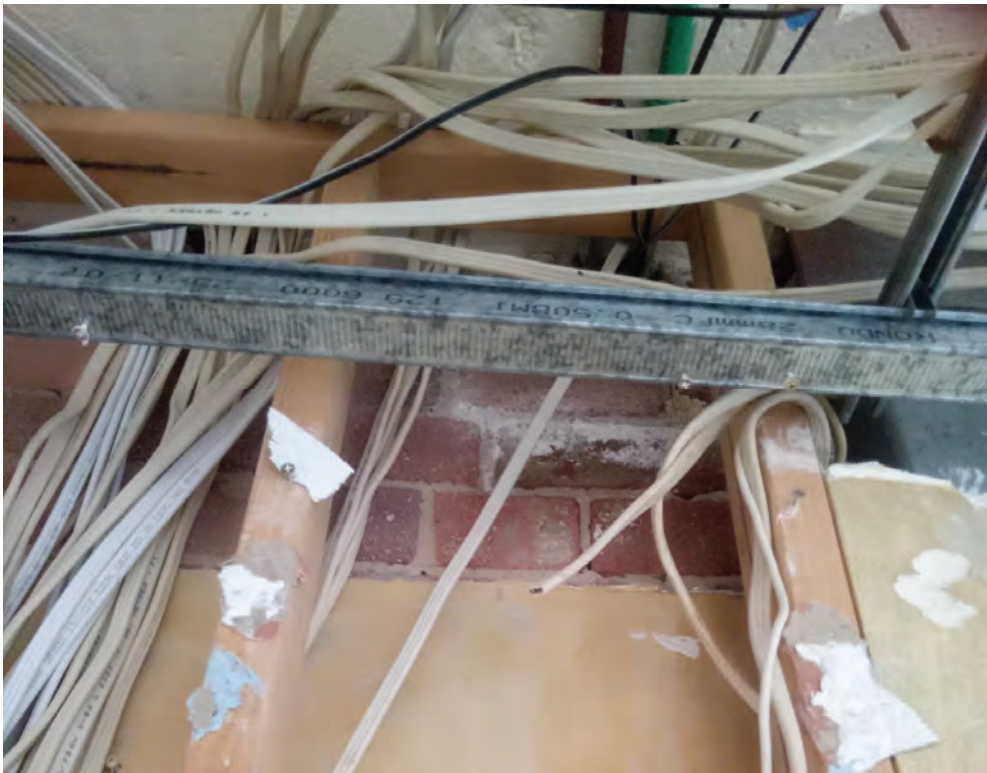
Photo 41: Efflorescence at 5-K/L

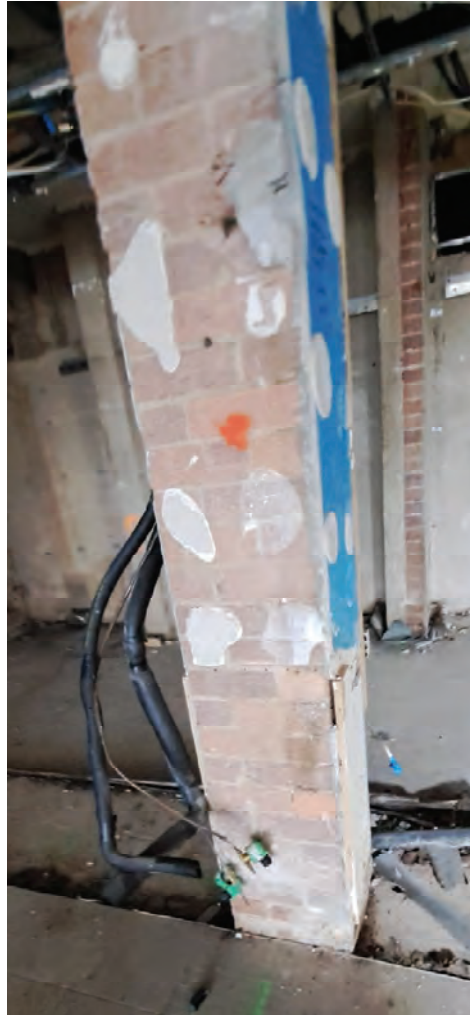
Photo 43: Brick column at V-4

Note discolouration of bricks at base of column and the moisture reading taken at V-4 below:

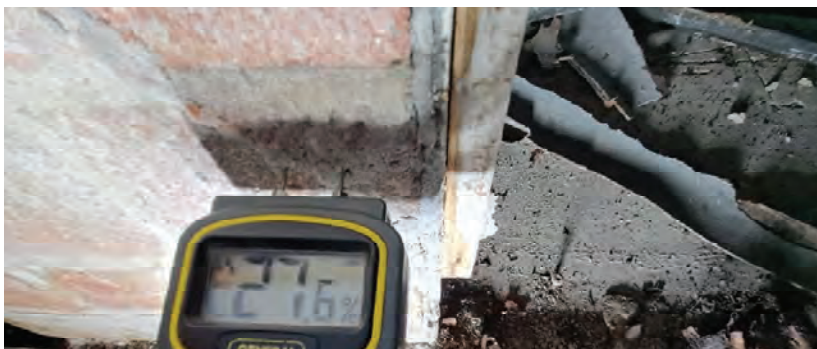
Photo 44: Moisture reading near bottom of brick column at V-4

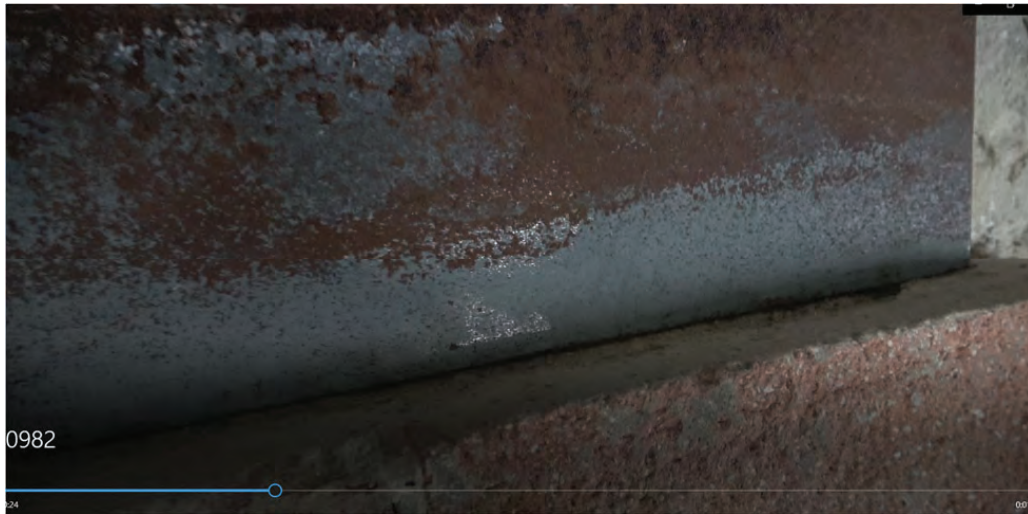
Photo 45: Concrete beam CB-2 metal side plate bearing on brick column at D:4, Note that these metal side plates are above every brick column along Grid 4 and some of the side plates are in contact with (bearing) on the top of the brick column and others have a small gap.
