JOINT REPORT
GROUND FLOOR BRICK WALLS AND COLUMNS

PAVILION 1, 50 MARINE PARADE, REDCLIFFE

COVEY ASSOCIATES & ACOR CONSULTANTS

PROJECT NO: 223164
REF: RG/RG/102205RPT – A
22 DECEMBER 2022

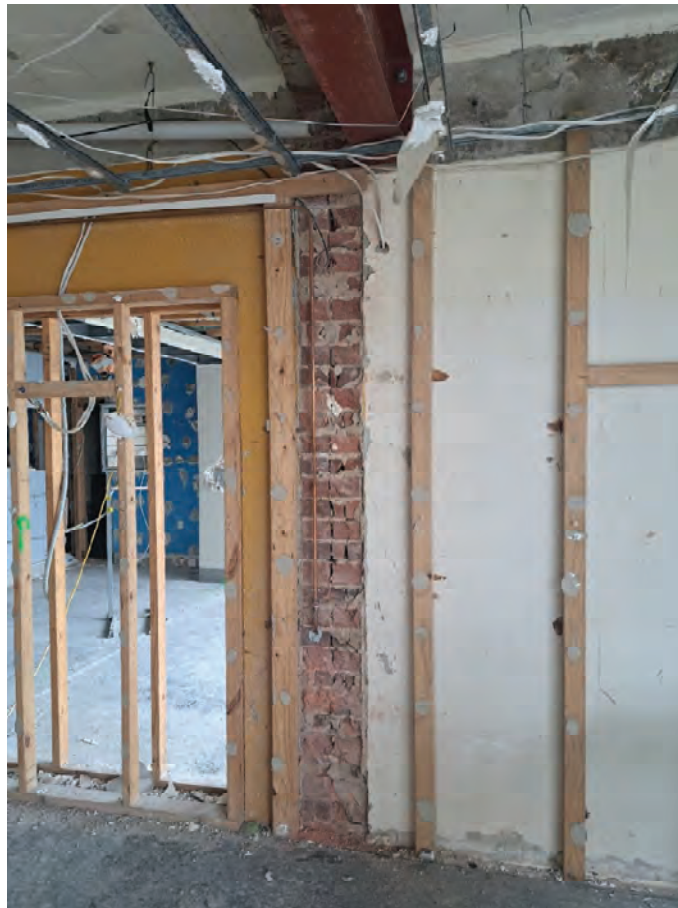
Photo 47: Beam to wall connection at 6:P

This occurs in the side of the wall at P:6 and in the end of the wall near K:7. The load path is eccentric to the brick wall. The brick wall is inadequate. It does not have enough capacity in bending. Also there is potential issue with the effectiveness of the anchors in the brickwork.

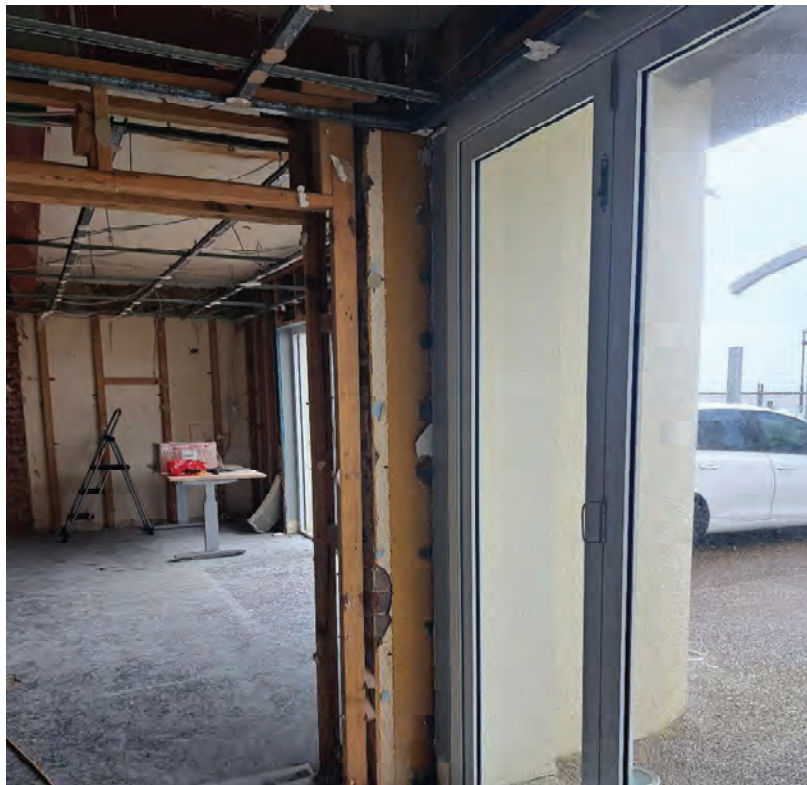
Photo 50: Remaining brick wall at 7:K Supporting steel beam B1-2

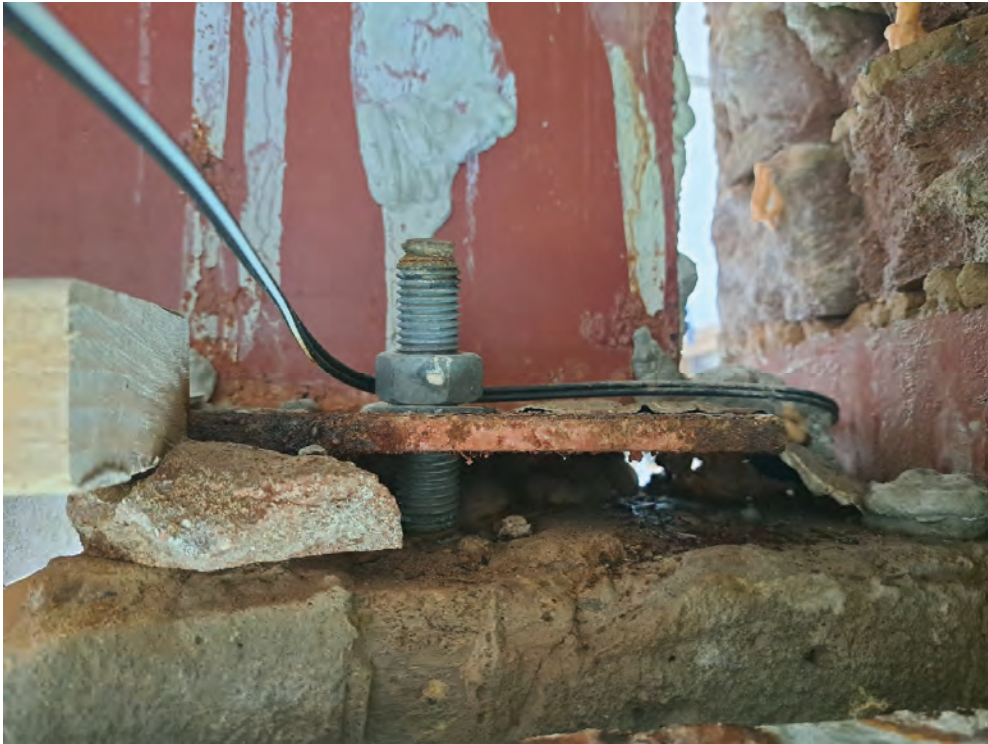
Photo 51: Beam B1-2 near Grids K:7. Note gap between steel beam and top of original brick wall.

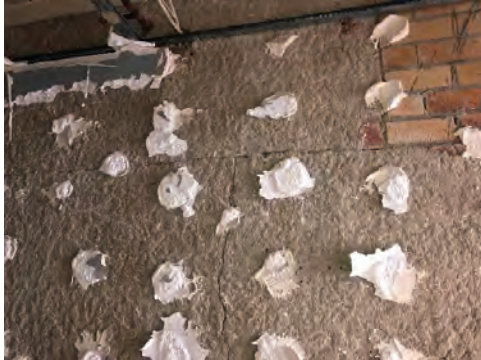
Photo 12 – Masonry wall panel

Referring to photo 12, we note that there is some evidence of cracking in the brickwork substrate here. It is not heavily reflected in the second skin of brick, as discovered when the render was removed from the other side of the wall. Only hair line cracks in brick and grout. We suggest that crack repair (as discussed earlier) and, if necessary, brick replacement, will suffice.

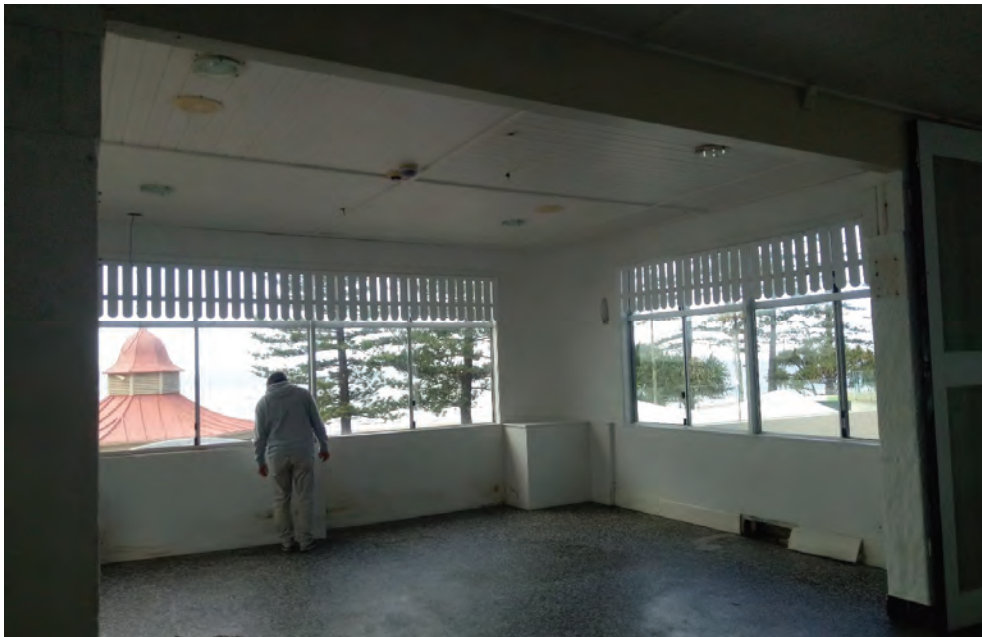
Photo 3: Parapet enclosed prior to strip out – note the water damage and watermarks along the bottom third of the parapet.

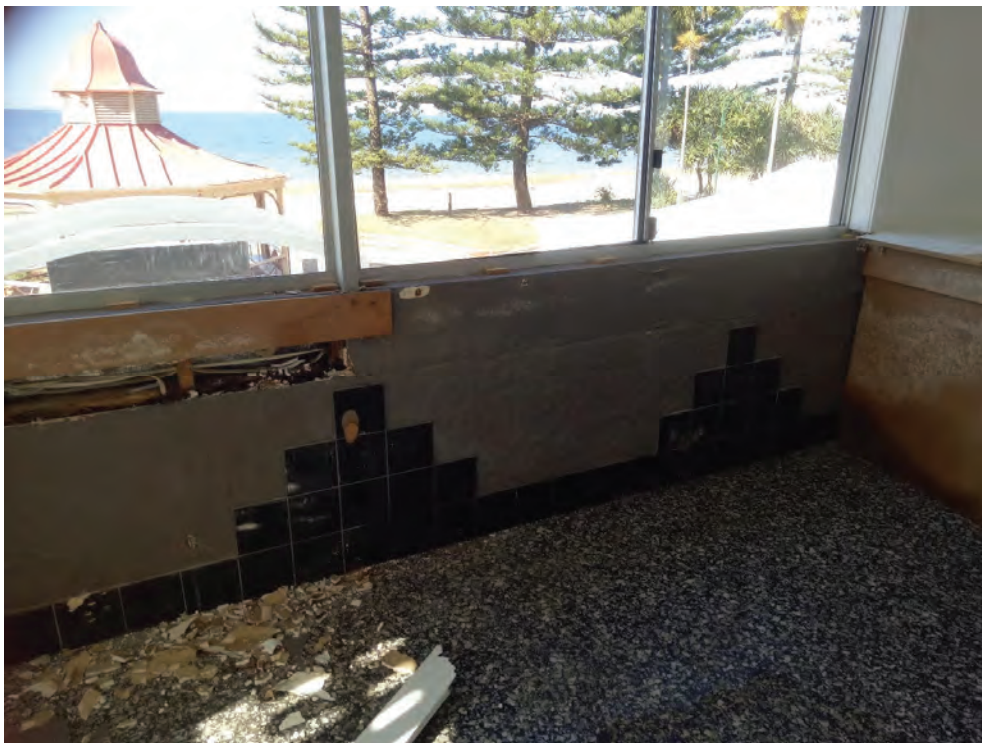
Photo 4: Note mould on removed cladding, grey lining bubbled with water damage.

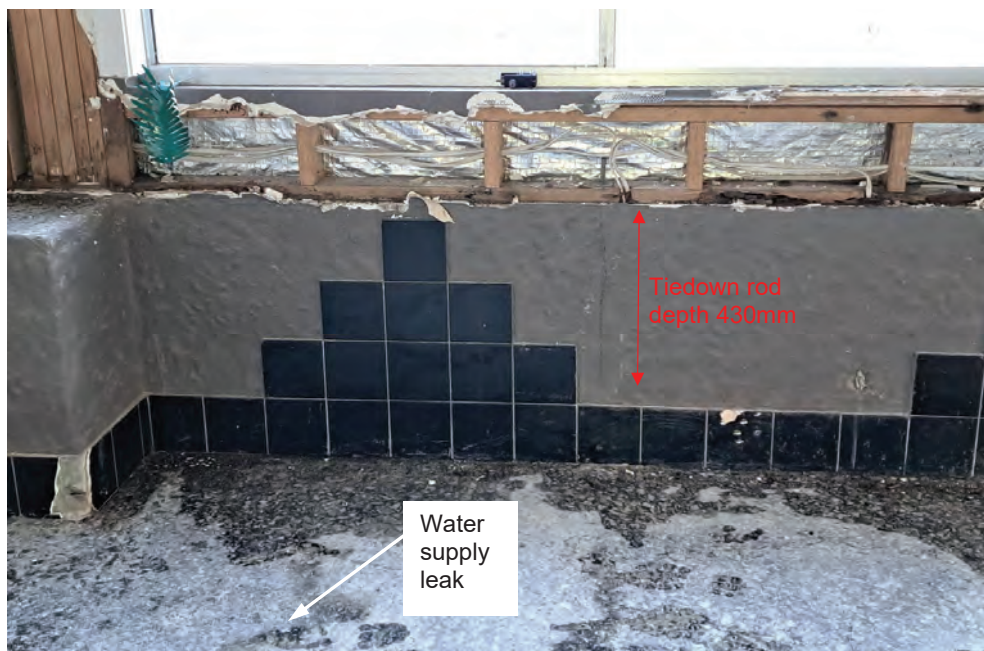
Photo 5: rendered brick parapet with tiles glued on – note water on floor indicates water ingress at front windows/roof. Timber studs and framing above parapet had termite and water damage. Note bottom plate tiedown rod underneath window framing extends approximately 430mm into bricks. Tiedown rod is drilled directly into the inner skin brick. It is not in the cavity and it does not appear to be anchored in the suspended slab.

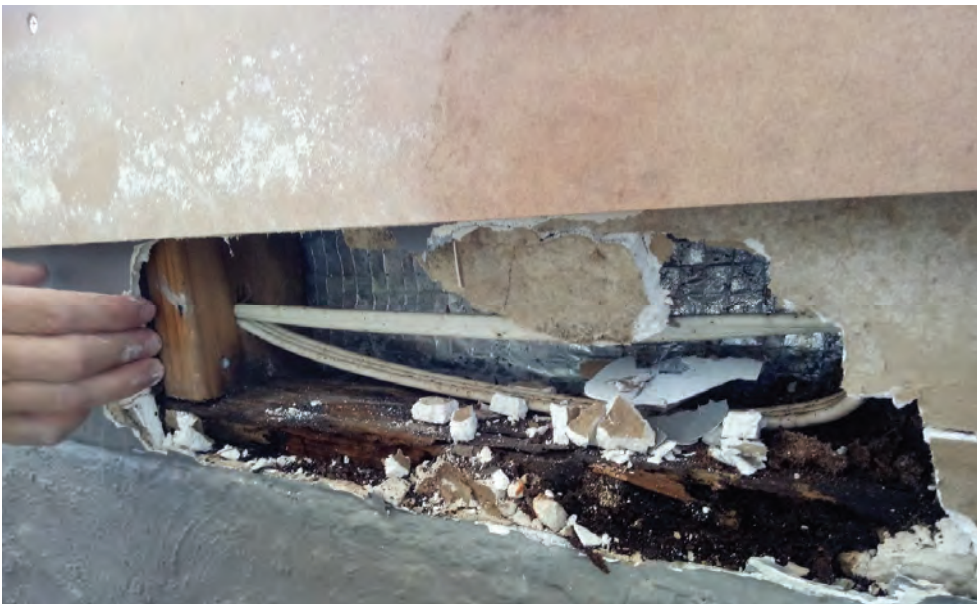
Photo 10: Note termite and water damage to timber frame.

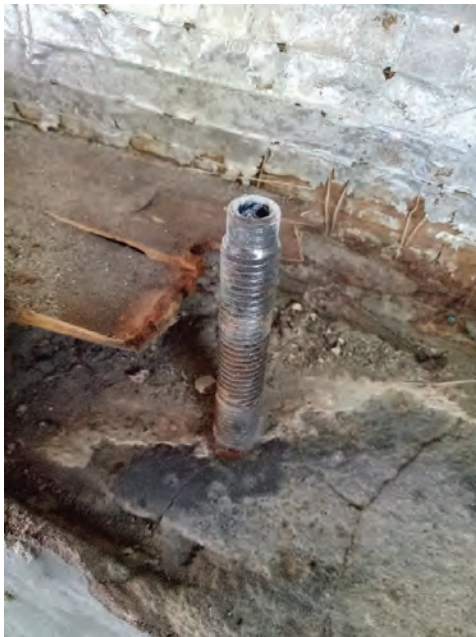
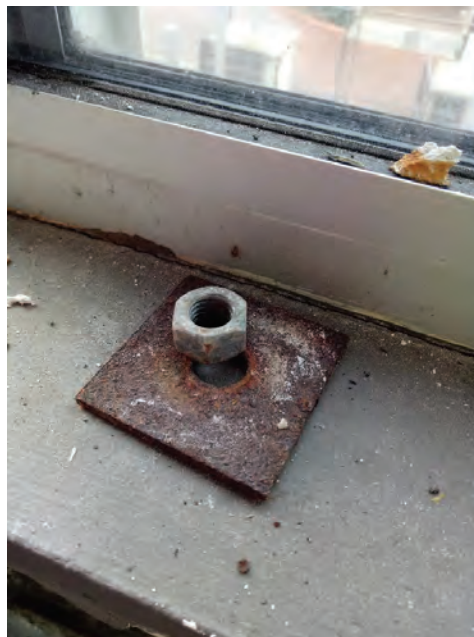
Photo 11: Rotten timber base plate removed. Photo 12: Hold down washer rusted. Note cracks in brick render.

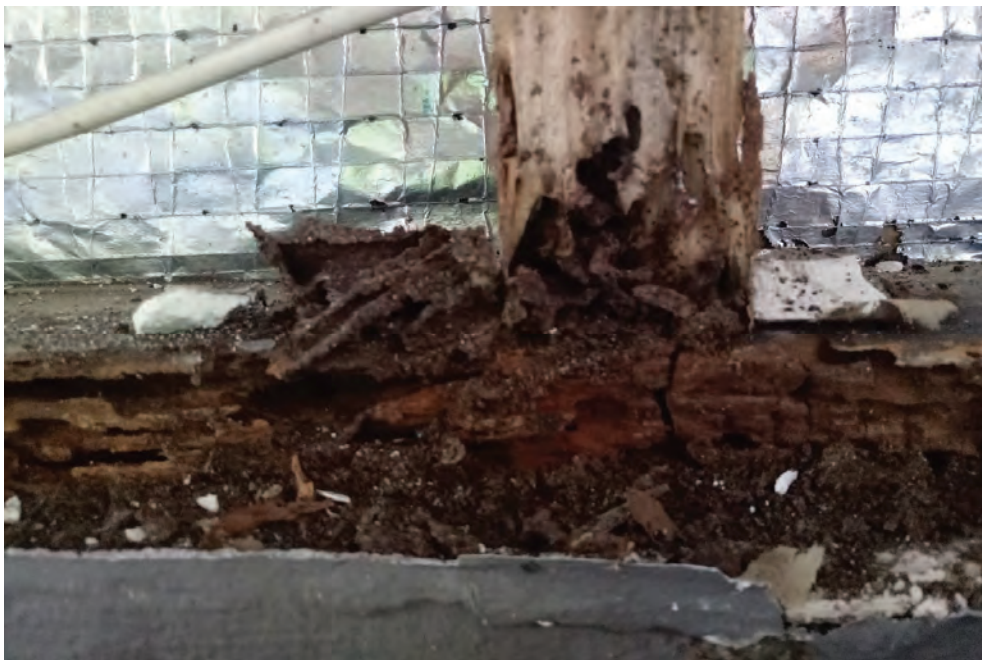
Photo 13: Termite and water damage to timber frame above brick parapet.

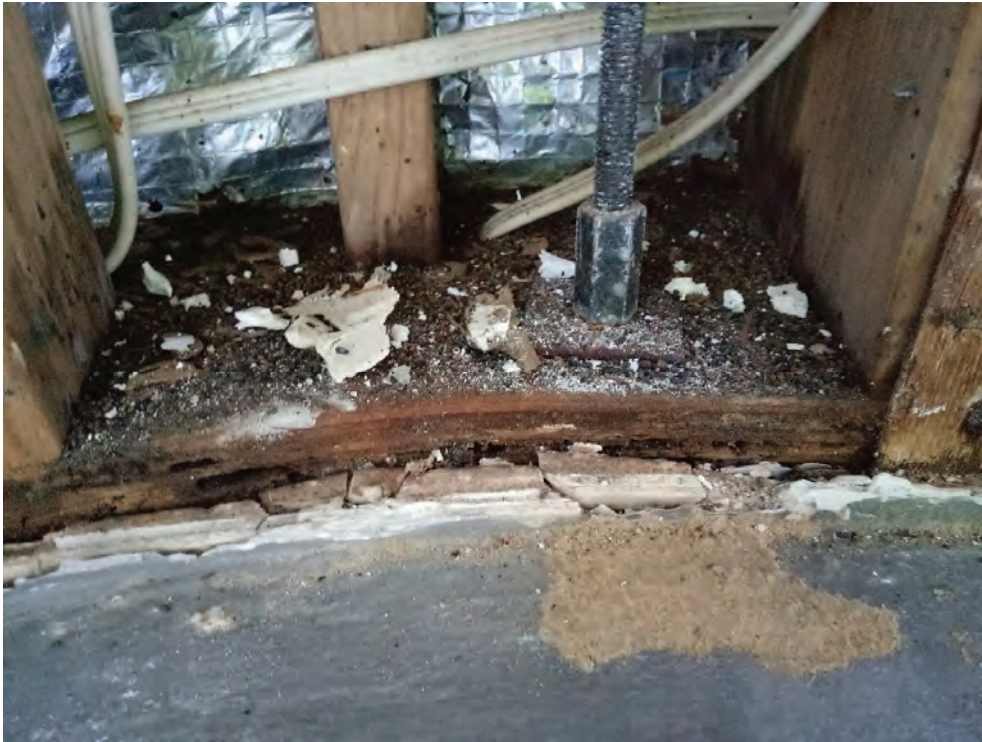
Photo 14: More water ingress and termite damage – Note rusted washer and cracking render.

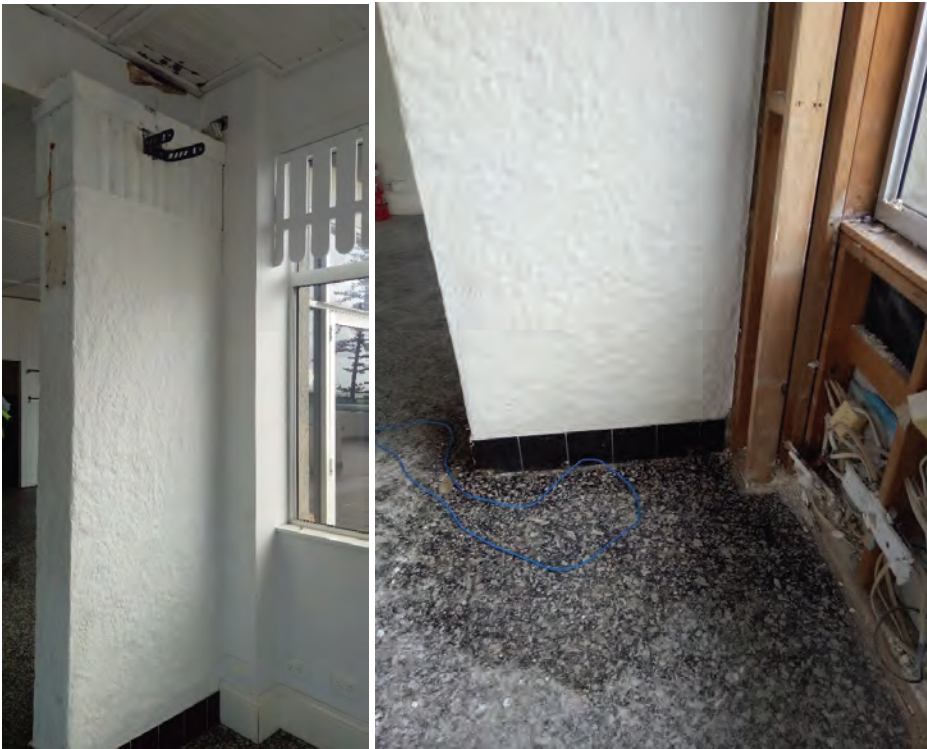
Photo 19: Original rendered brick column at U-5-N Note leak at ceiling.

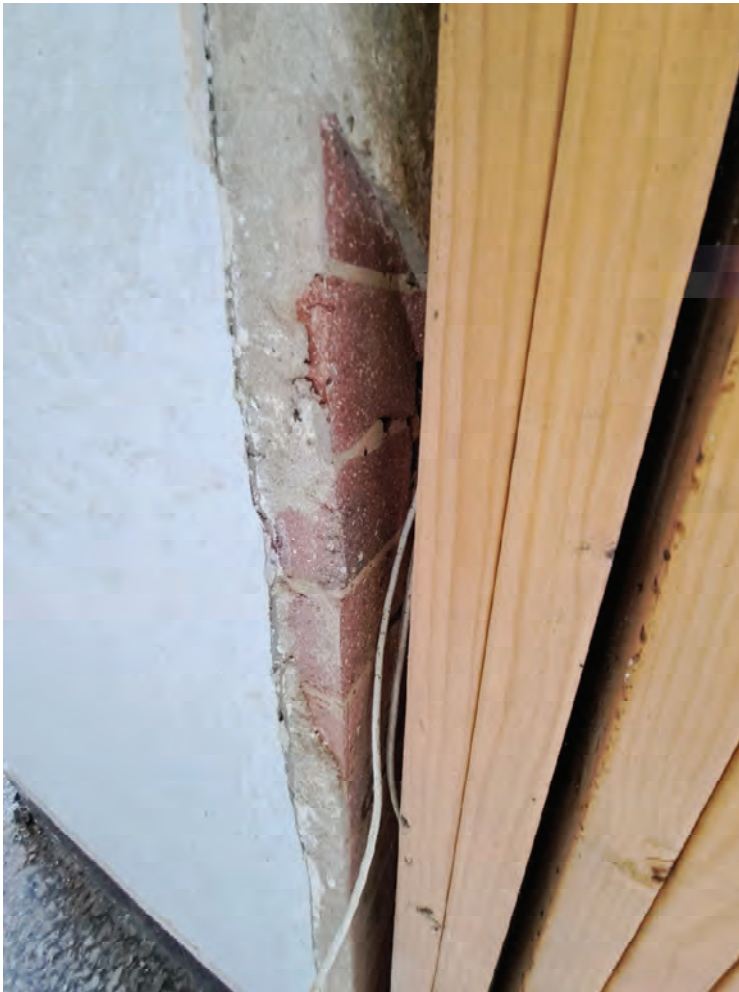
Photo 21: Edge of column where exposed bricks are. Note render removed and some bricks cut back.

The render on these bricks appears to be in good condition even though the roof leaks and they have been exposed to water ingress.

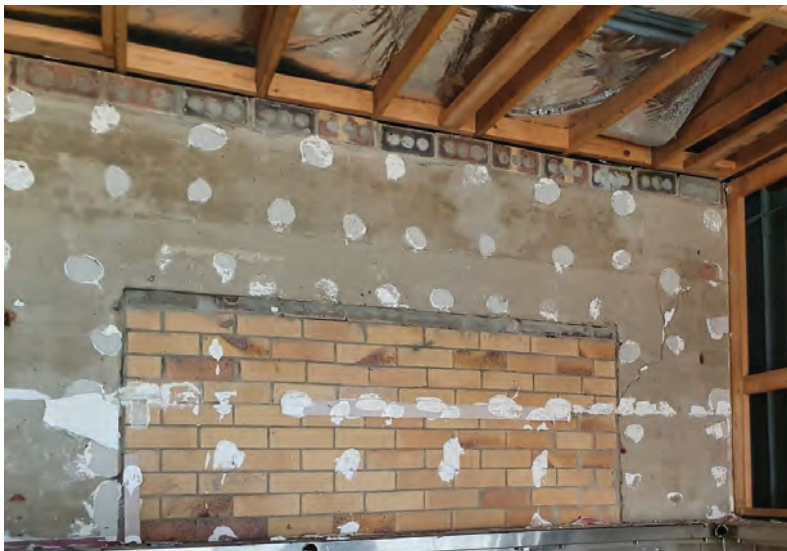
Photo 23: Close up of above – Note diagonal crack through render and bricks on RHS.

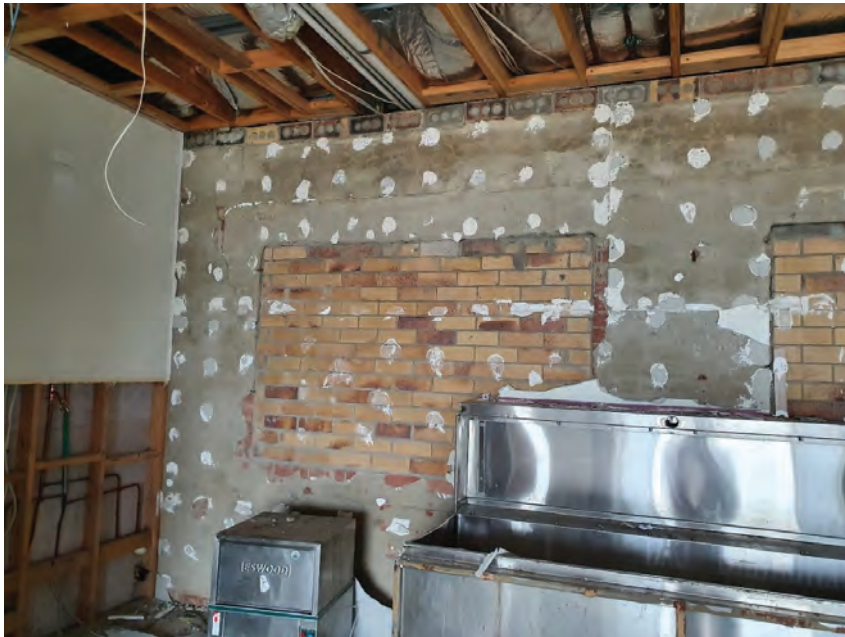
Photo 24: Wall at 2:N-Q. Diagonal cracks through render and bricks at the edge of the concrete lintel.

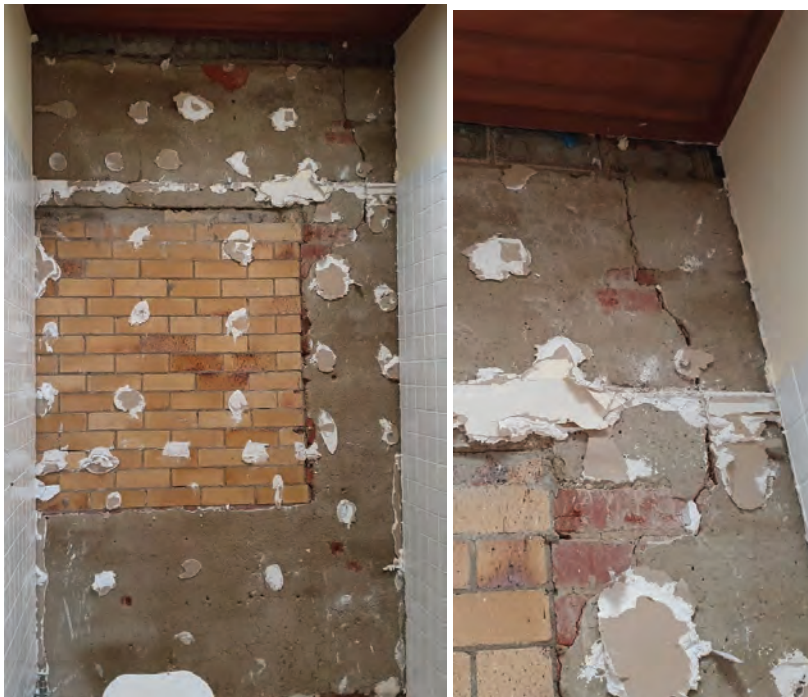
Photo 25: Wall at 2:L

Photo 26: Close up of crack through render and brick at edge of concrete lintel.

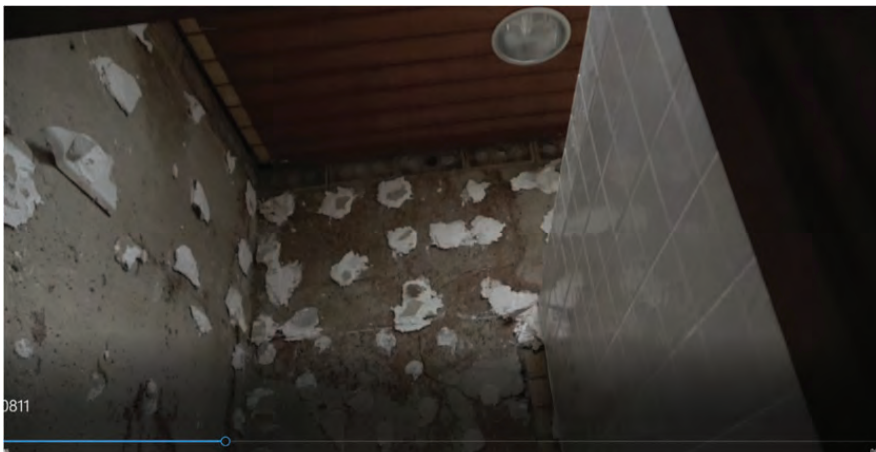
Photo 28: Cracks around the edge of the concrete lintel again at U-2-J end cubicle.

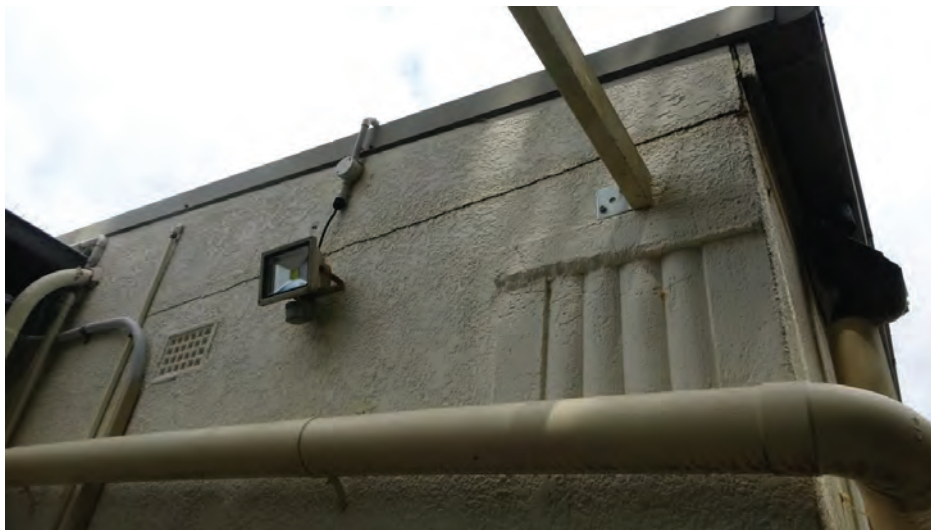
Photo 35: Outside wall U-R-2/3 Note the smaller portal frame is on the inside of this wall. Also note the horizontal crack along the top of the wall and lighter cracks in the vertical tile section.

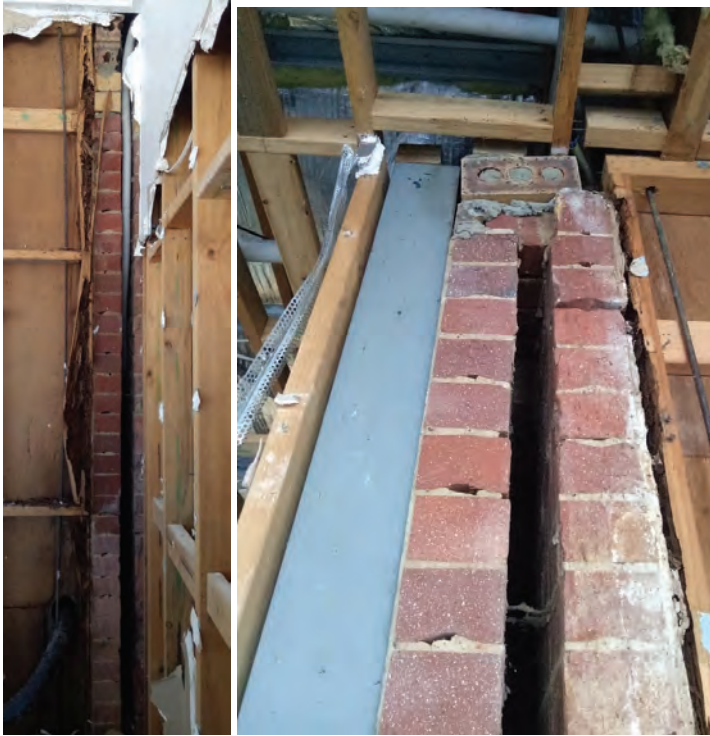
Photo 36: End view of Wall U-C-3/4

Photo 37: View of cut end of brick wall U-R-3/4. Note rusted brick tie and steel portal frame adjacent wall.

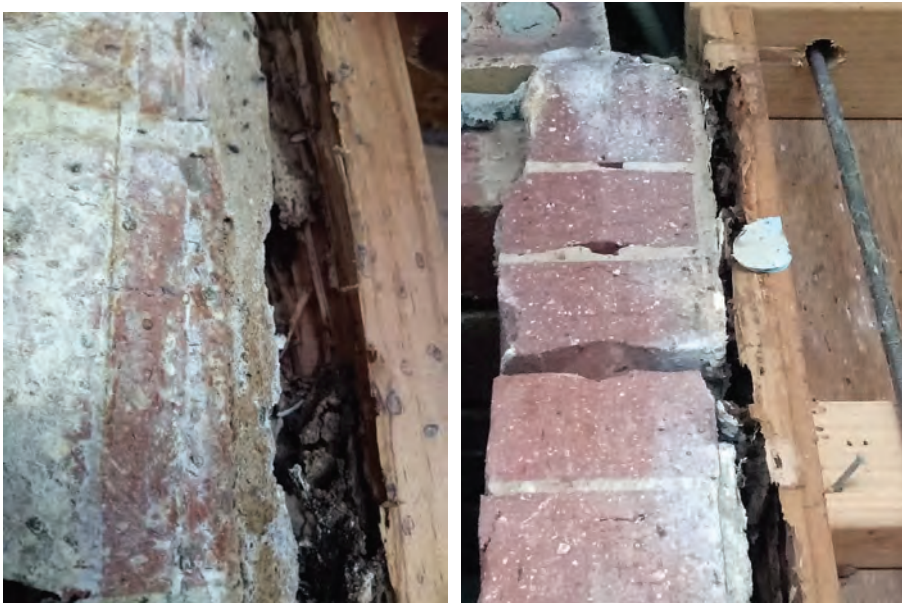
Photo 38 / 39: Close up of above view of the above cut wall edge half way and at top. Note discolouration and water stains on bricks and render and initial stages of decay. Also note cracks and gaps.

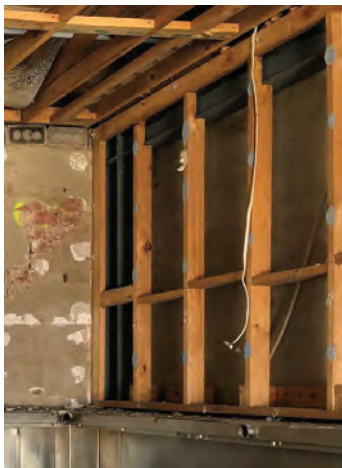
Photo 46 – portal framed bracing wall

Noted – a UB structural steel portal frame has been incorporated into the timber framing, immediately adjacent to these two (2) walls.

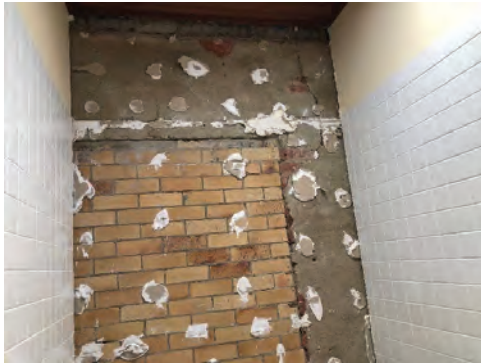
Photo 47: Item 4 – back wall

Condition - Brick work remains in serviceable condition.
