JOINT REPORT ORIGINAL SUSPENDED SLAB

PAVILION 1, 50 MARINE PARADE, REDCLIFFE

COVEY ASSOCIATES AND ACOR CONSULTANTS

PROJECT NO: 223164
REF: RG/RG/37300RPT – ISSUE A
22 DECEMBER 2022

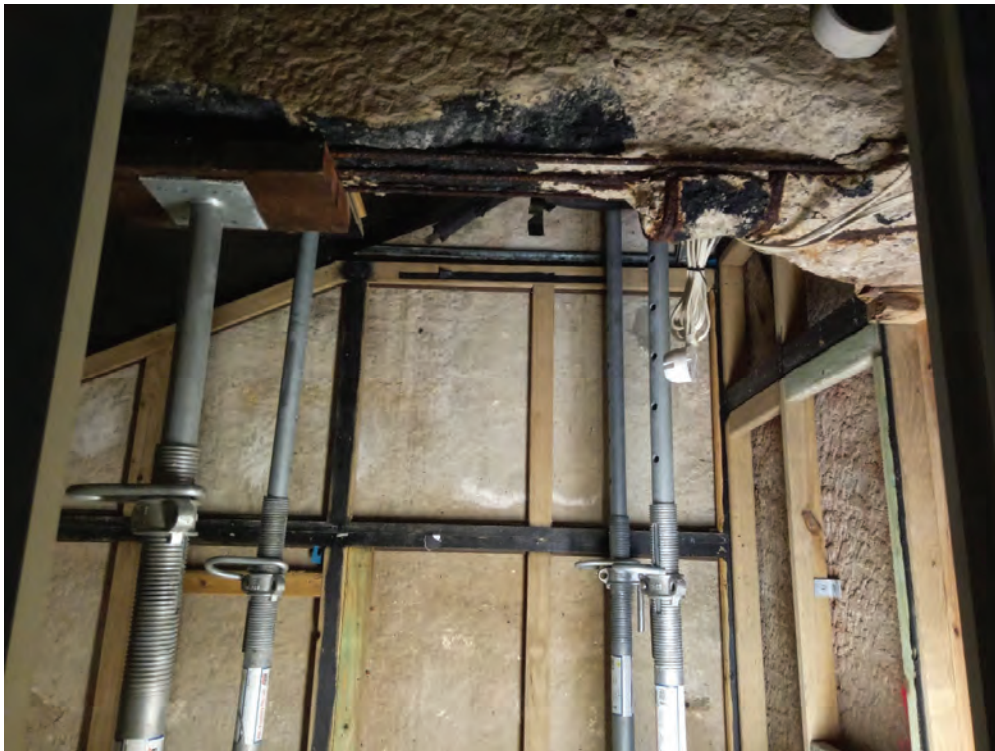
The supporting concrete beam CB-1 has spalled, exposed and rusted reinforcement with significant section loss. See Photos.

Photo 1 - Shows suspended stair and landing soffit all propped.

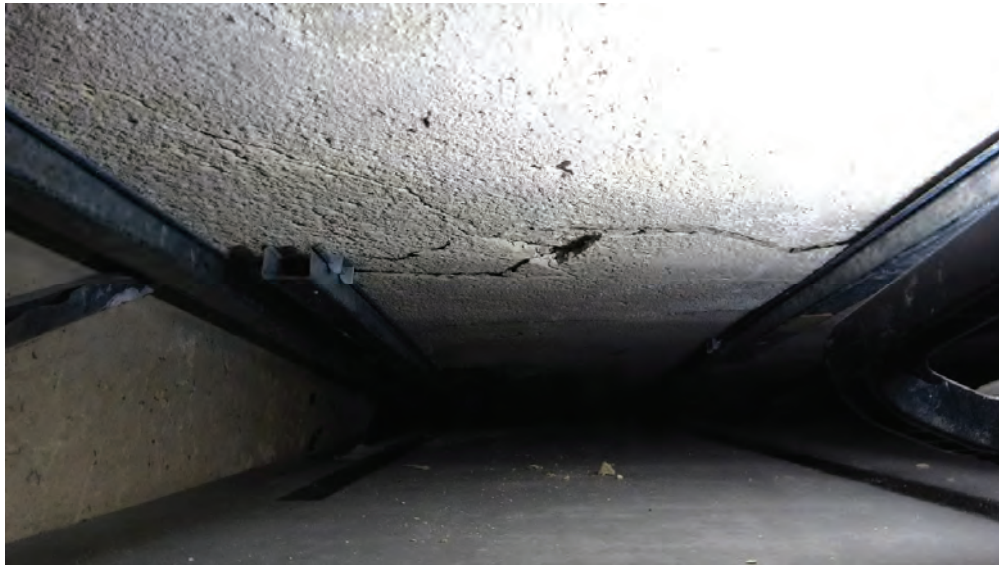
Photo 2 - Shows cracked and delaminating suspended stair slab soffit.

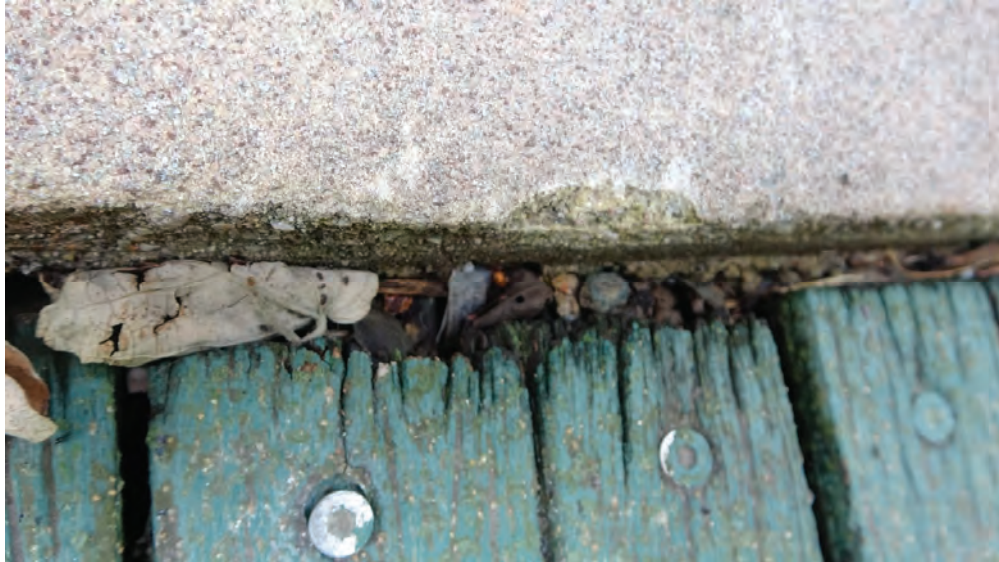
Externally the overhang is cracked, spalling and delaminating. The render is cracking off and there are holes in concrete substrate. The timber decking and support members are right up against the concrete.

Photo 3 – Externally at joint between slab overhang and timber deck at approximately 3:B-D. Note the timber is against the slab or the small gap is full of debris.

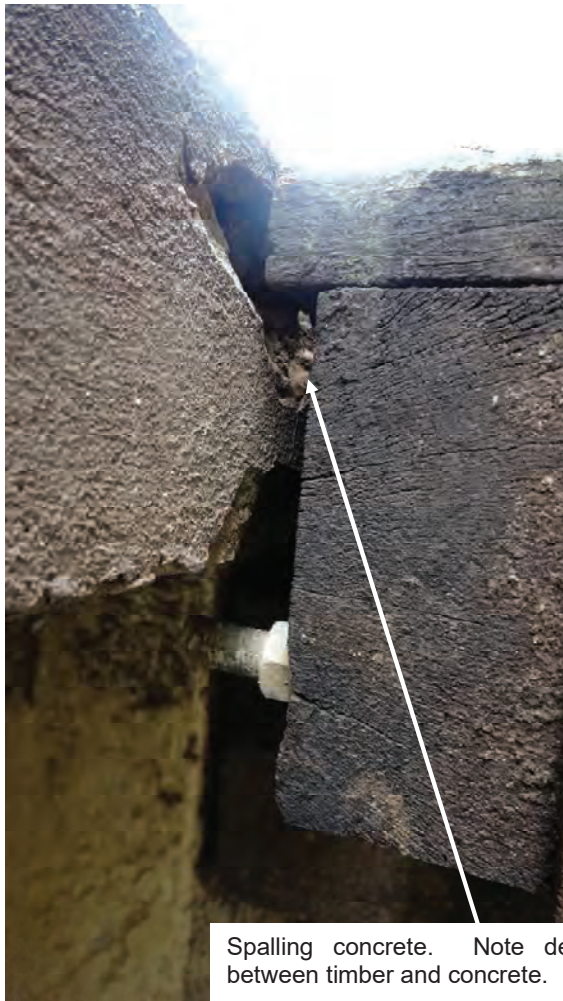
Spalling concrete. Note debris between timber and concrete.

Photo 5 – Suspended slab edge at southern end next to timber walkway. Note concrete has spalled and is against timber.

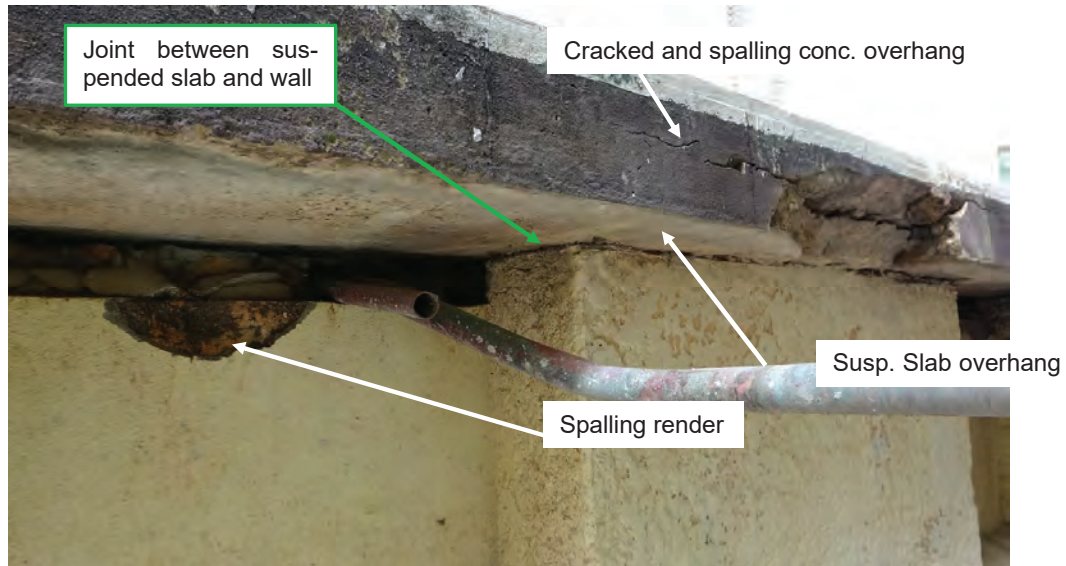
Rear retaining wall section 3-D/C/B

Photo 6 - Rear retaining wall at approx. 3-D. Note gaps above window infills, spalling of concrete overhang, joint between suspended slab and wall.

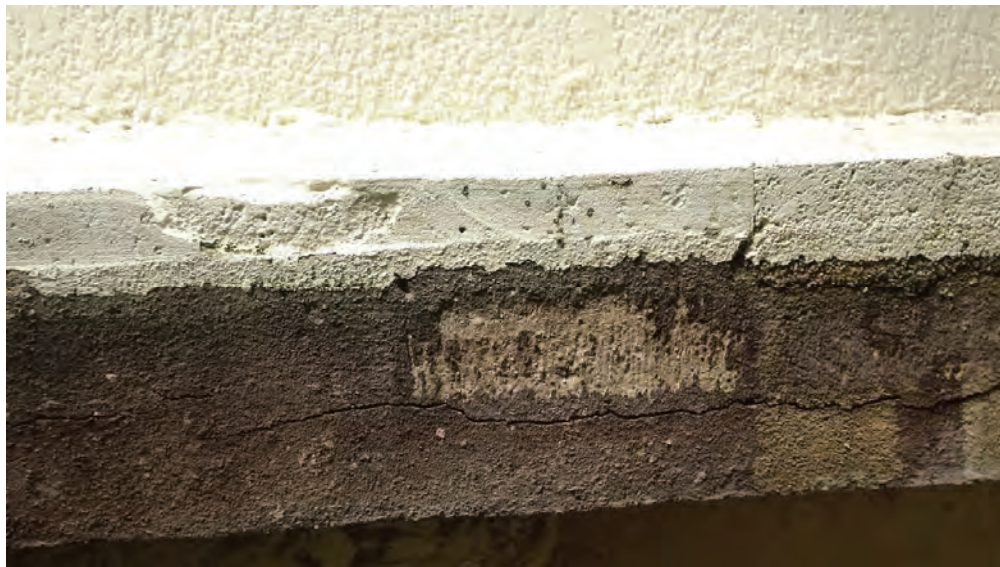
Photo 7 – Edge of suspended slab overhang cracked on southern end.

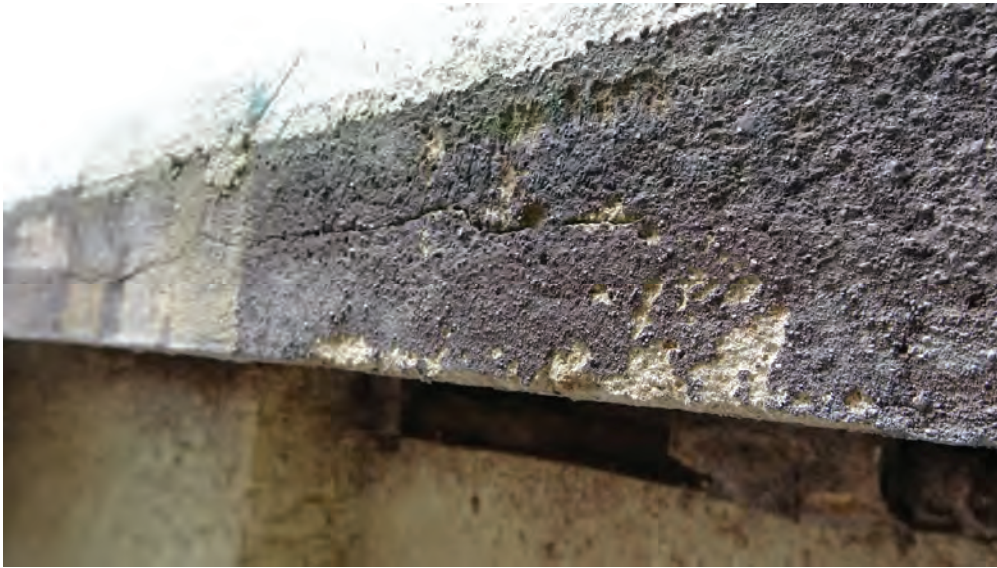
Photo 8 - More cracks in overhang edge and notice gap above window infill.

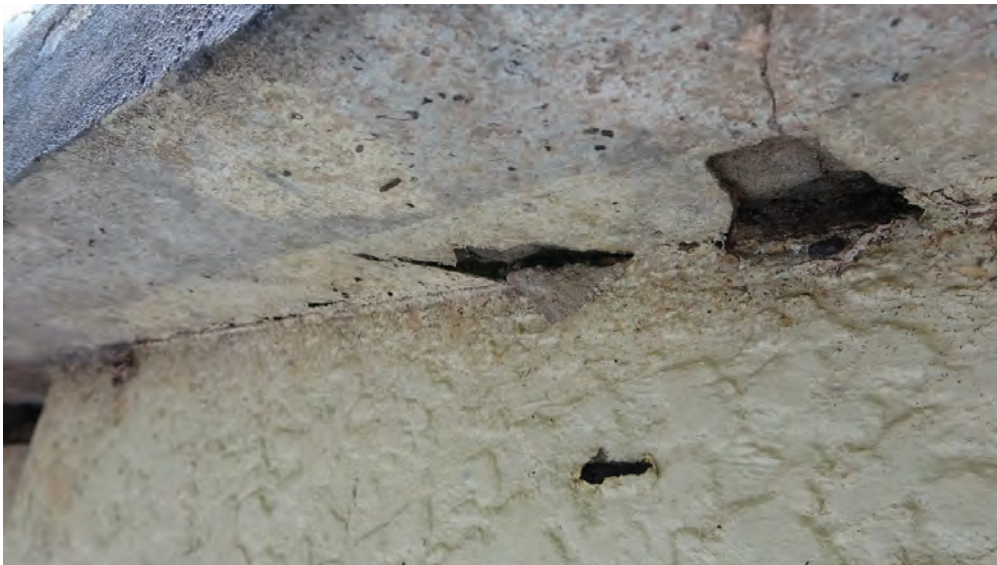
Photo 9 – Cracked soffit of overhang, spalling render and concrete.

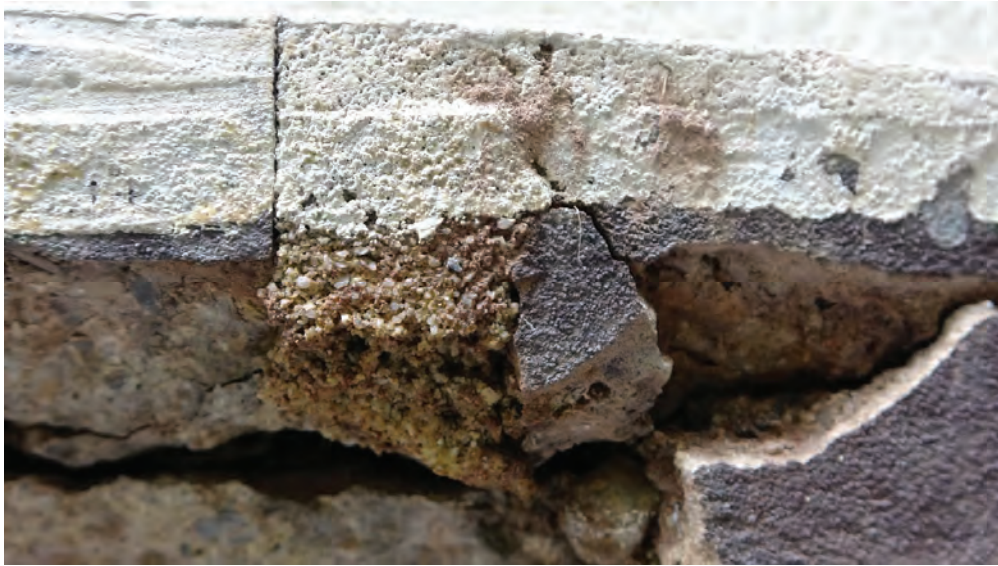
Photo 10 – cracking and spalling concrete at edge of overhang of suspended slab.

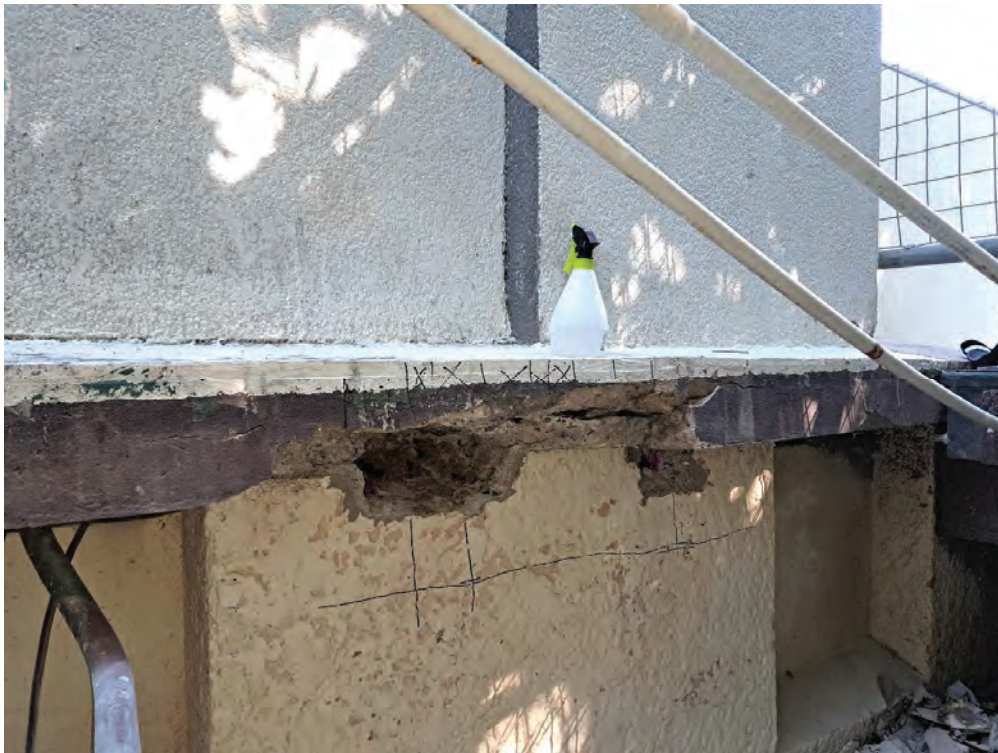
- Breakout was carried out to search for steel reinforcement tying the suspended concrete slab to the rear retaining wall. – None was found. Vertical bars exposed during breakouts had hooks finishing within the wall. See Photos in *Rear Retaining wall report* No. 37304.

Photo 11 - Shows the breakouts searching for ties to slab – none were found.

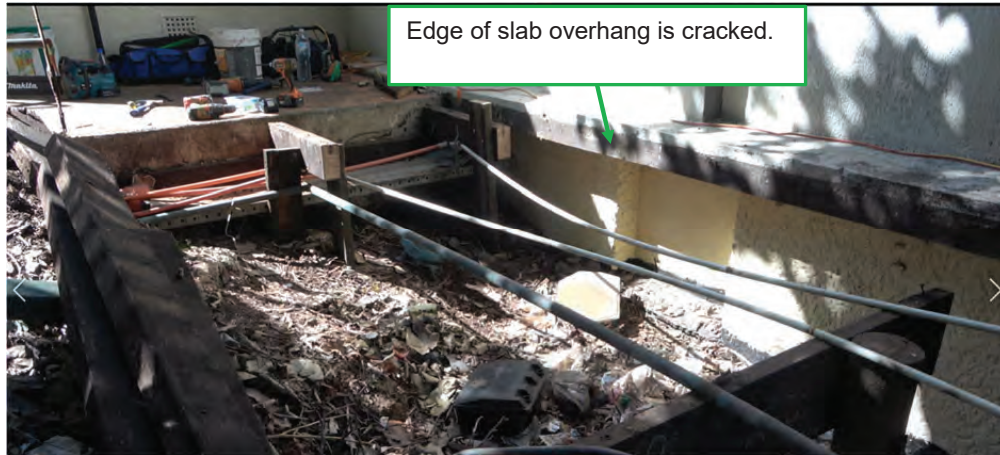
Photo 12 - Rear retaining wall section 3-D to H.

Externally the edge of the suspended slab overhang is cracked most of the way along this section, with spalling and delamination in some places. The soffit of this overhang also has some of the render missing. See photos.

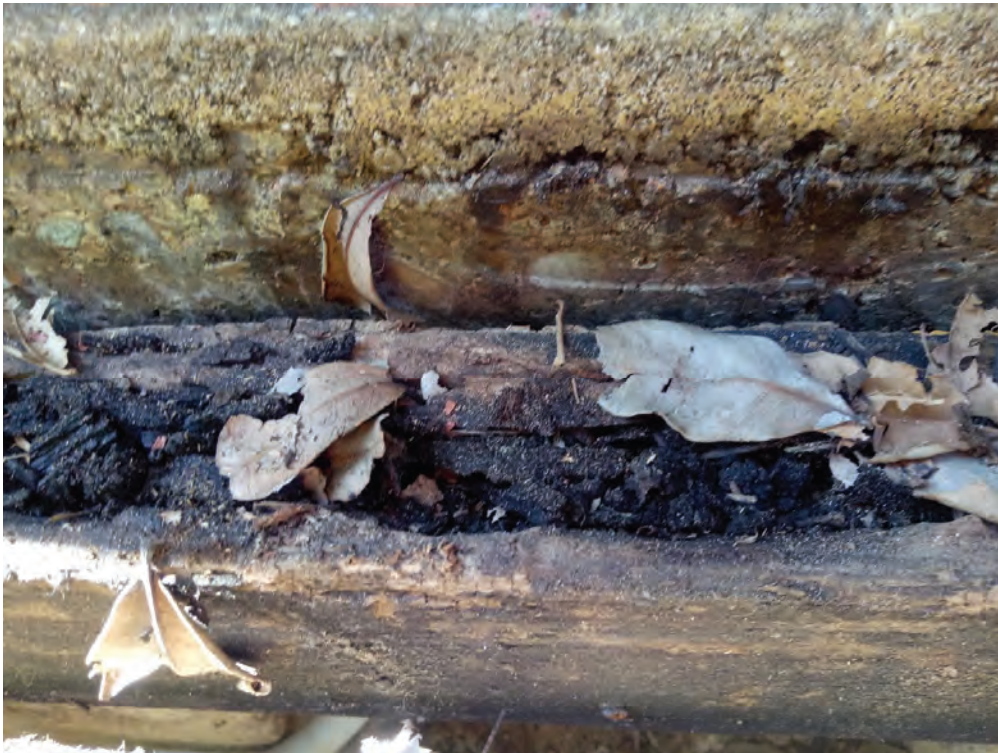
Photo 18 - Image shows rot in joist, joist adjacent concrete, decking boards above would have been touching the cut concrete slab edge. Note exposed reinforcement rusted and expanding to form a crack in the slab.

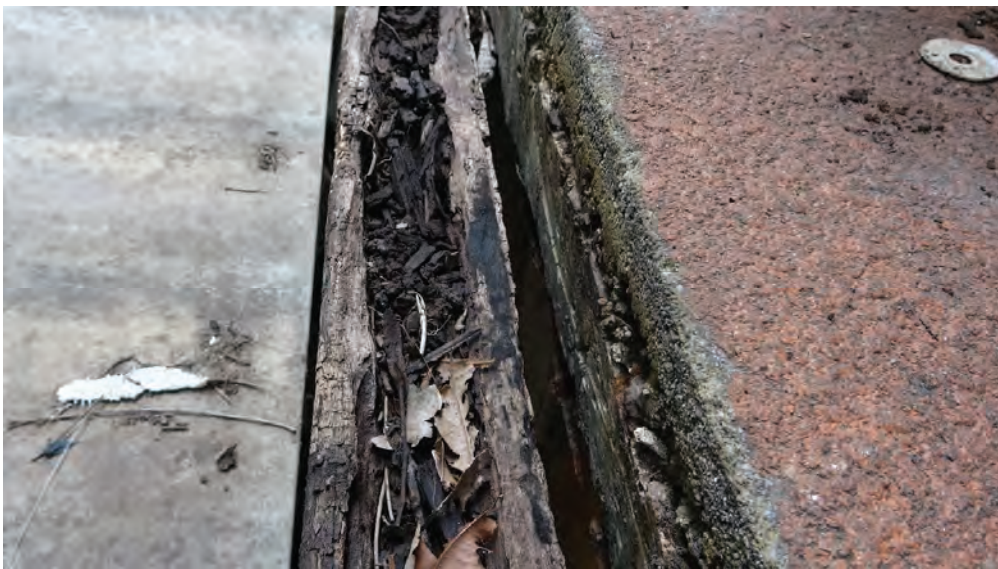
Photo 19 - Another view of edge.

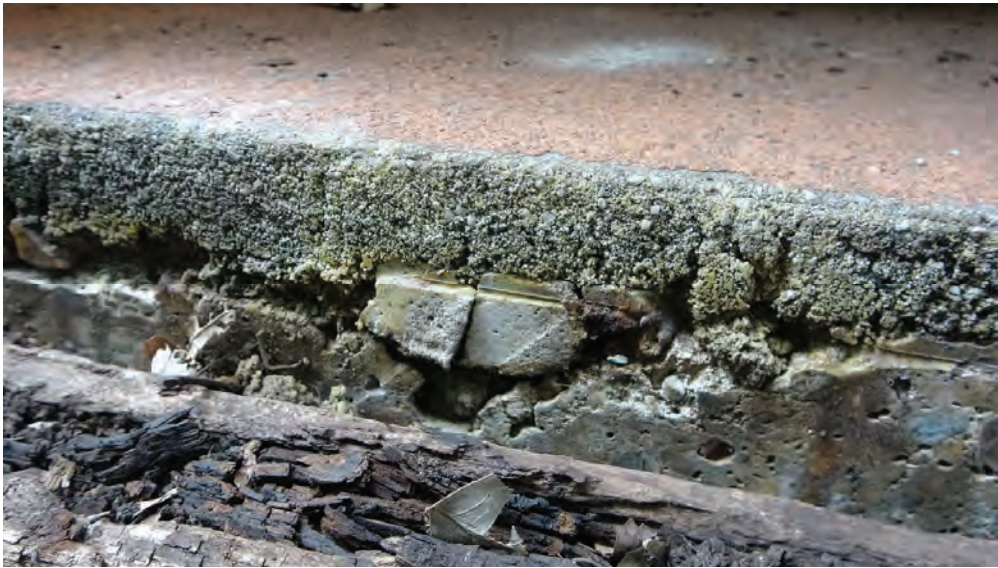
Photo 20 - Cut edge of concrete. Exposed reo rusted, delaminating.

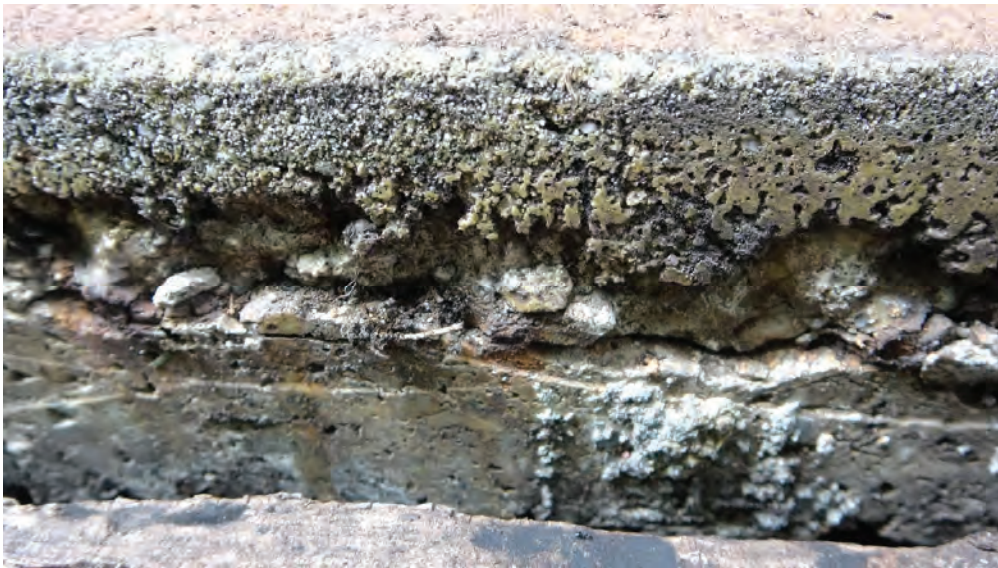
Photo 21 – Cut slab edge showing corrosion to reinforcement, expansion of reinforcement caused by delamination, cracking and spalling of concrete.

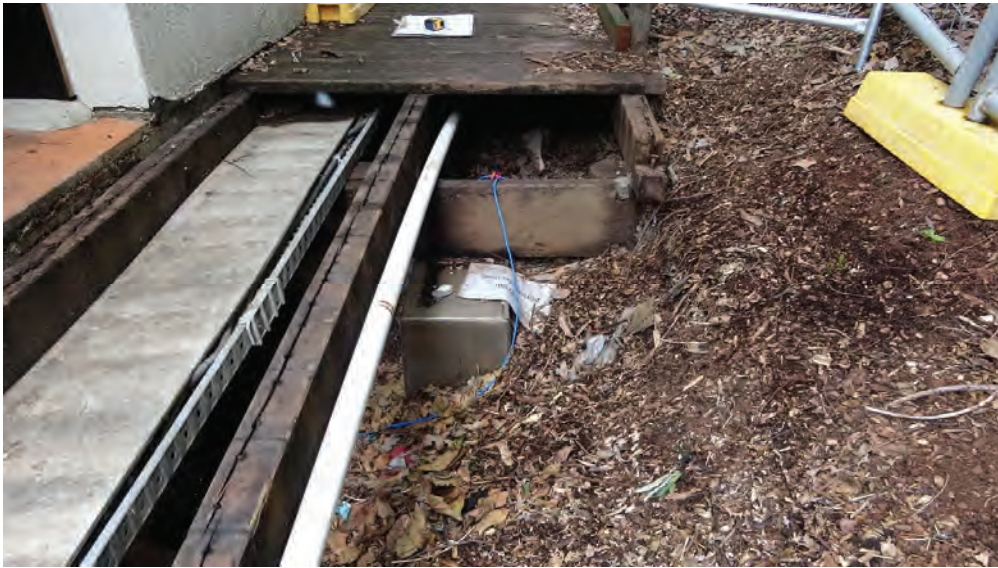
Photo 22 - View from North to South behind grid 3:W/V showing ground level above vents and timber walkway in direct contact with the ground.

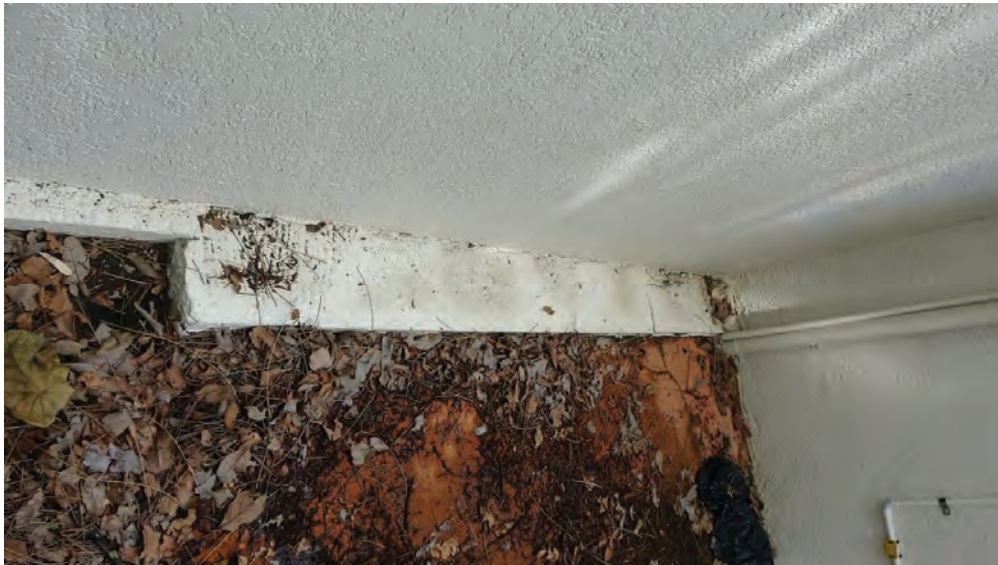
Photo 26 – start of cut at suspended slab overhang and crack in overhang – see close up below.

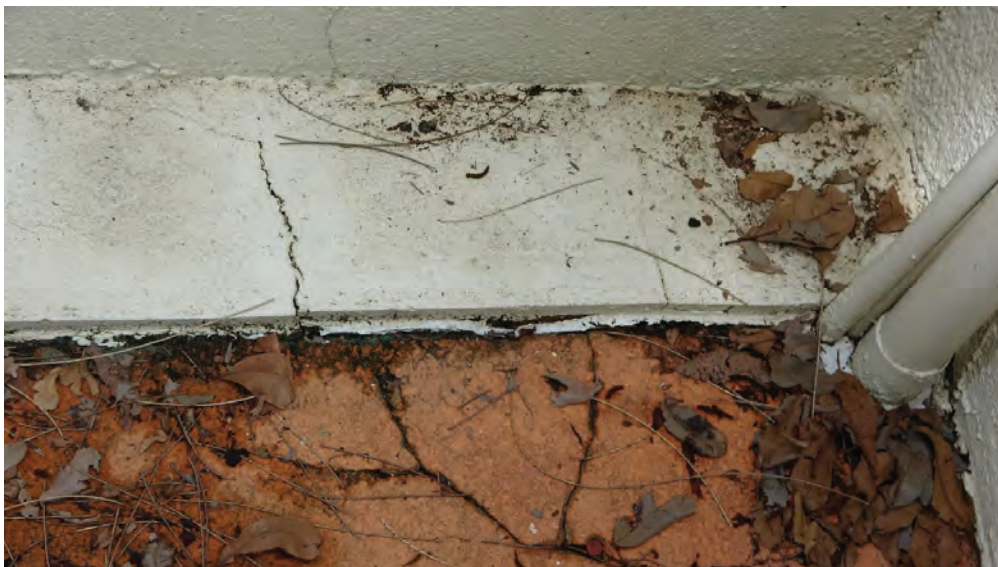
Photo 27 – Close up of above crack.

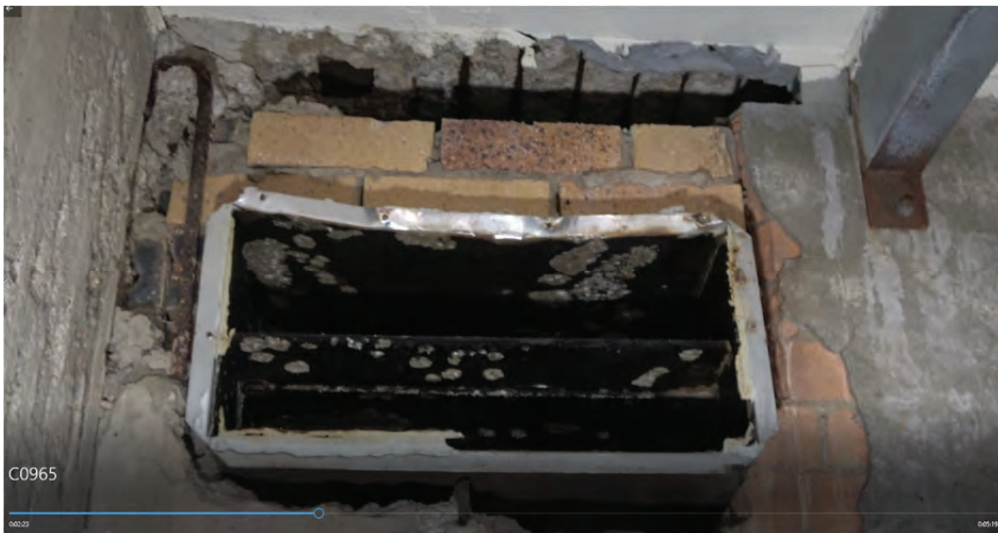
This section of slab has similar issues to the above-mentioned sections. The slab soffit fell down when the top row of bricks were removed during the strip out, exposing corroded and delaminating bottom steel reinforcement, which was also visible from outside under the timber decking.

Photo 31: Photo of rear retaining wall between grids U and V. Note the vertical bar on the left cogs over below the slab level. Also note the exposed slab reinforcement due to the slab soffit falling down when the layer of bricks directly beneath it was removed.

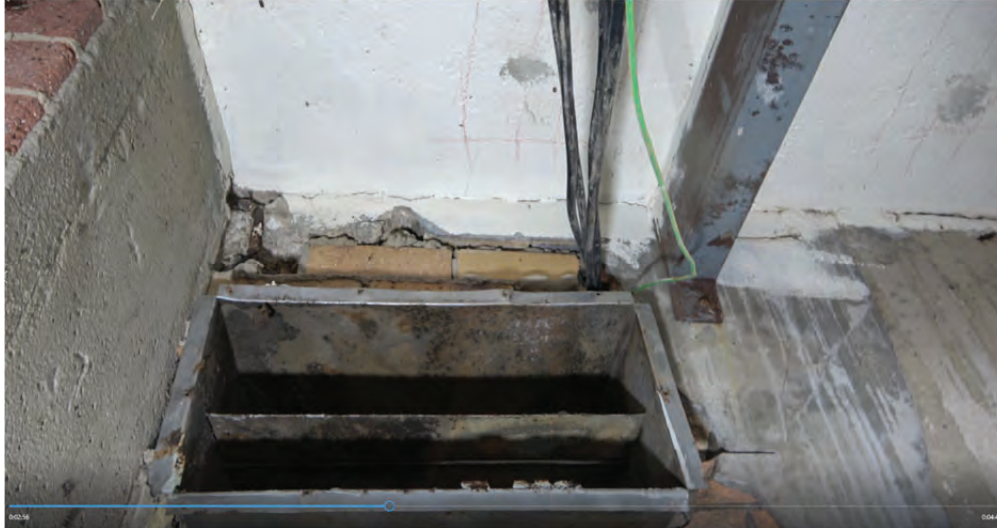
Photo 32 - Close up of the above vent penetration in rear retaining wall between grids V and W. Note the vertical bar at buttress column corner is hooked and does not extend into the slab.

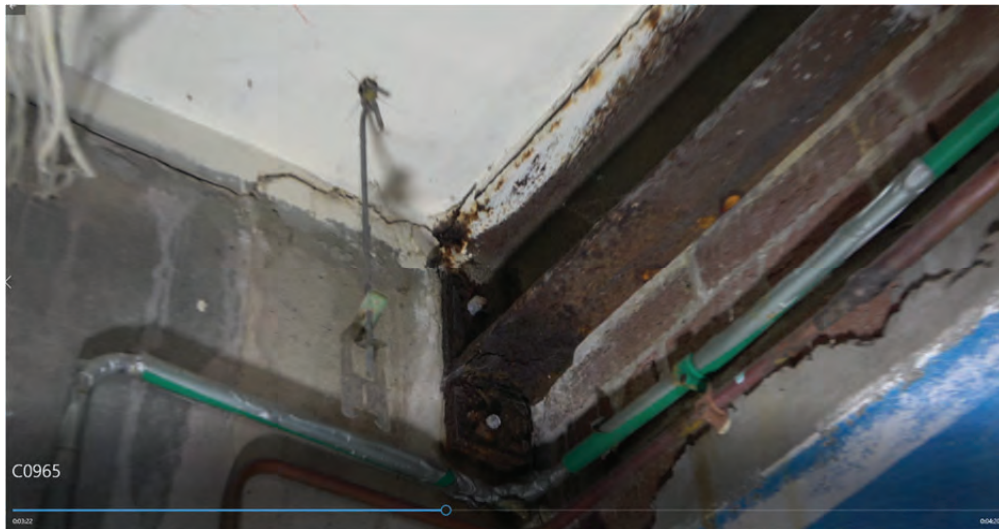
Photo 36 - The slab is supported on a number of steel beams which appear to be in reasonable condition with some surface rust in places and only a few areas of significant corrosion: as shown in this photo at 3:V/W.

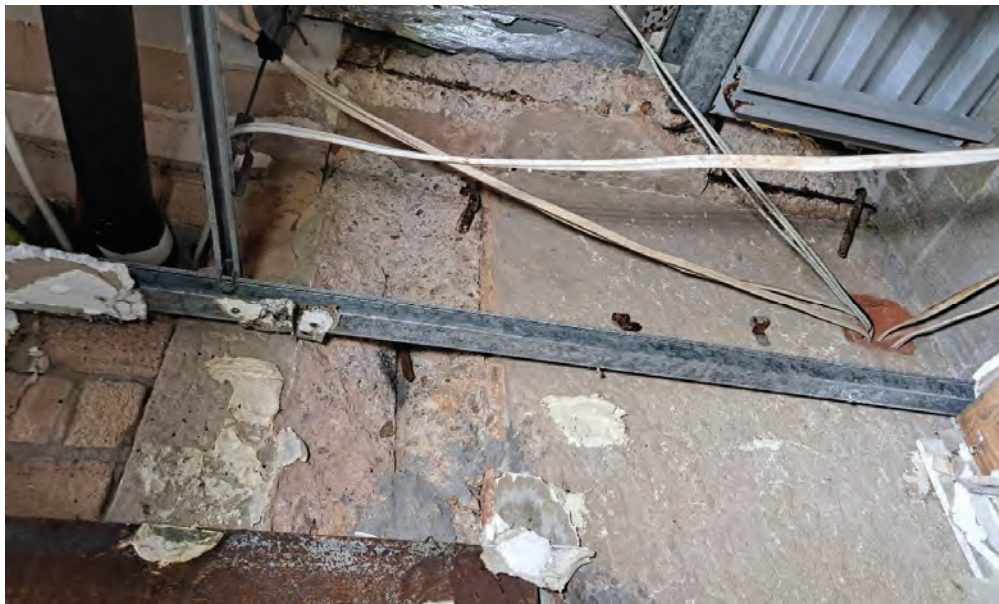
Photo 34 – Reinforcement bars left hanging out of wall and stair beam where original Northern stairs were cut off at Grid 3:W.

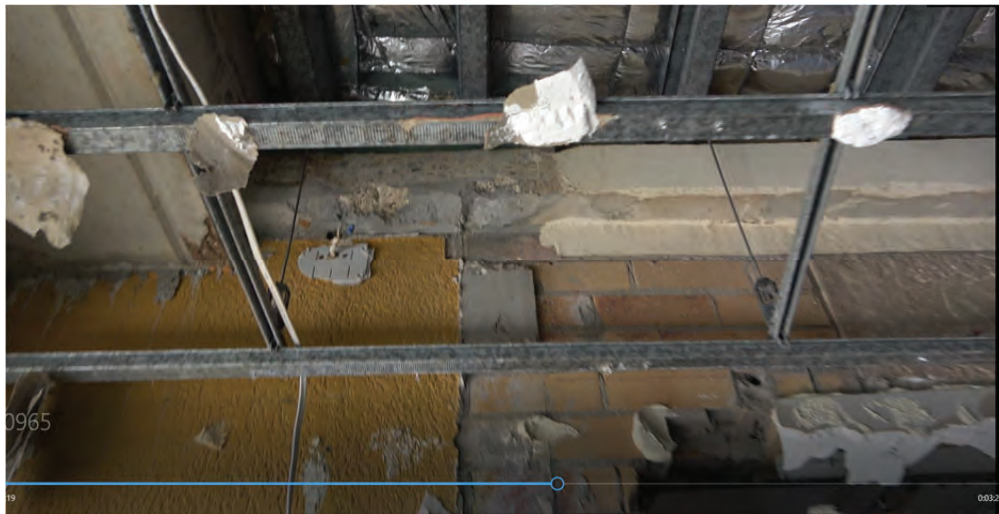
Photo 37 - Slab edge at W-4/5. Note patches, cut concrete, spalled concrete, rendered concrete.

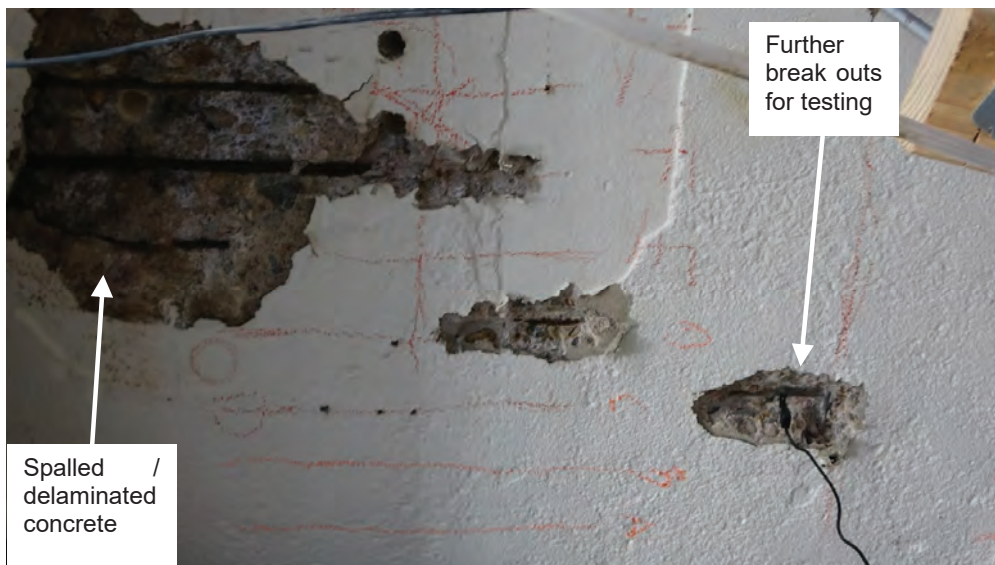
Photo 38 - 20mm diameter core was taken at Grid L:2-3 through the crack. It was very crumbly and fell apart, aggregate was loose and not well compacted. There was a sandy section at the top of the slab core.

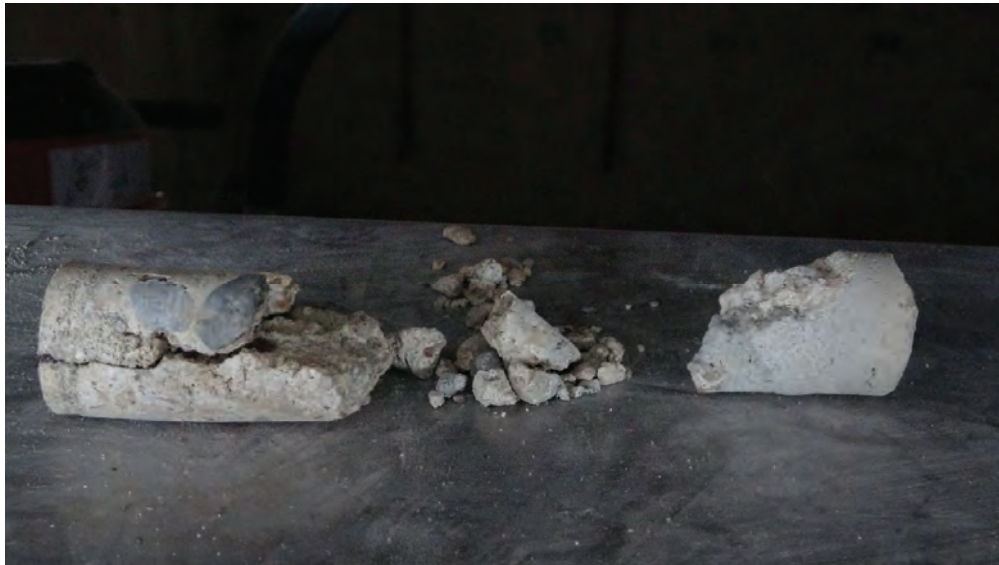
Photo 39 – Boney and poorly compacted concrete core sample take at grid L:3/4.

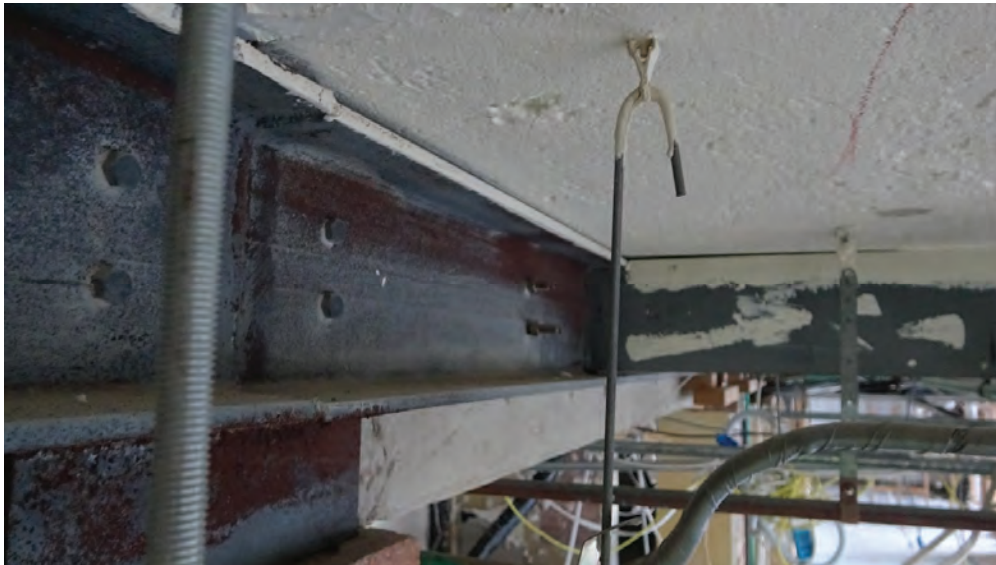
Generally, the steel framing is in reasonable condition with minor surface rust and pitting. There are a few localised areas where the corrosion is more significant. A number of steel beams are connected directly to the face of brickwork which is unable to support any eccentric load when checked to current standards.

Photo 41 - Rusty steel support beams.

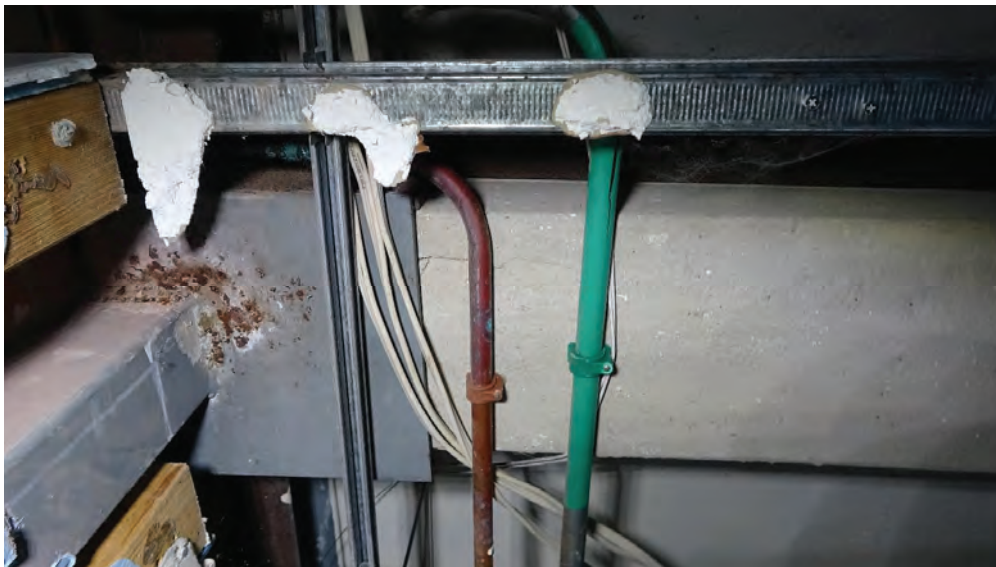
Photo 42 - Rusty and pitted steel column and cap plate.

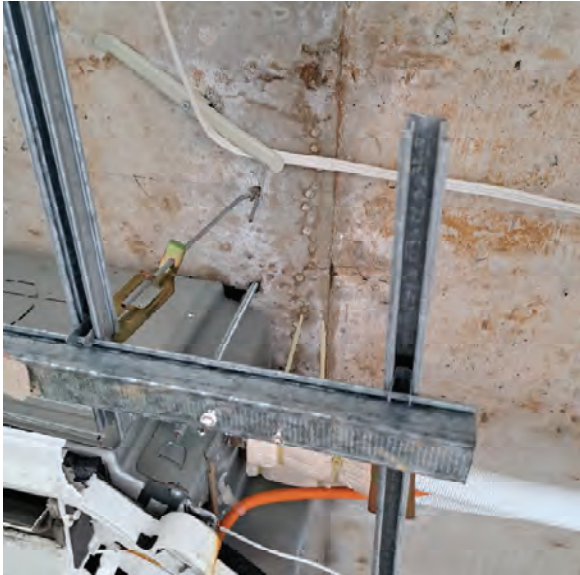
Photo - 43
Cracking with water ingress in new slab

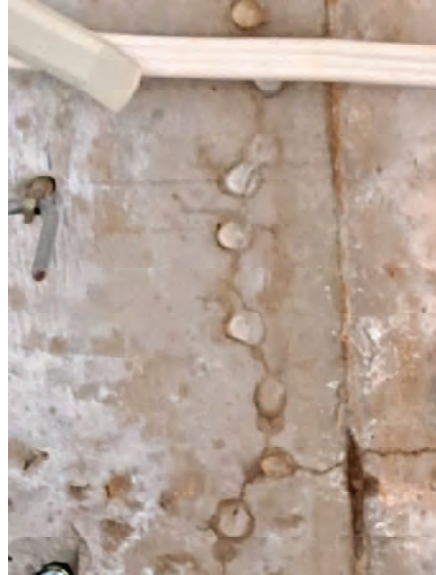
Photo - 44
Close up of water ingress through crack

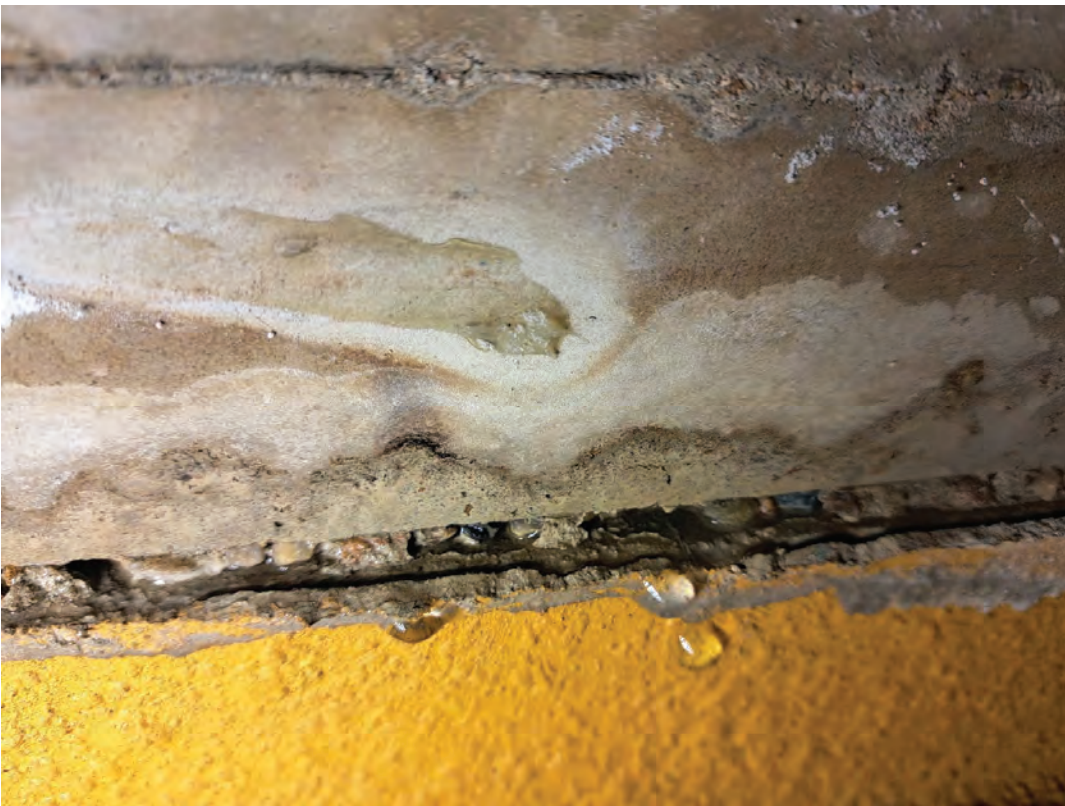
Photo 45 - Shows water ingress at slab joint old to extension coming down wall.

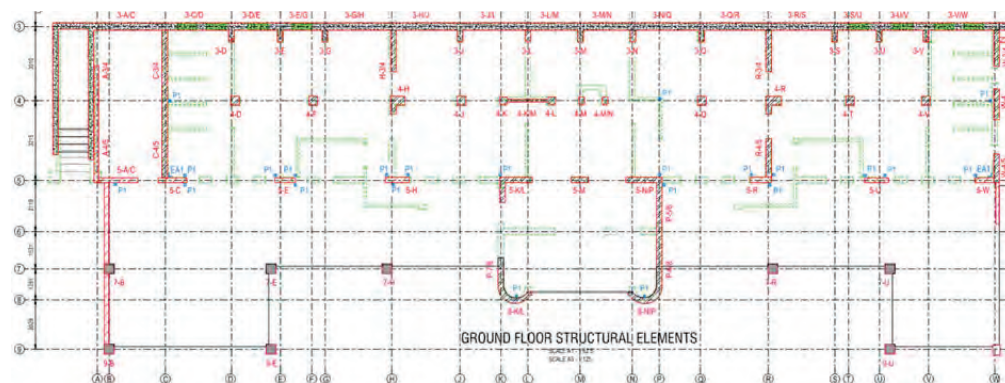
Figure 3: Internal original walls removed shown green, remaining walls black/red.

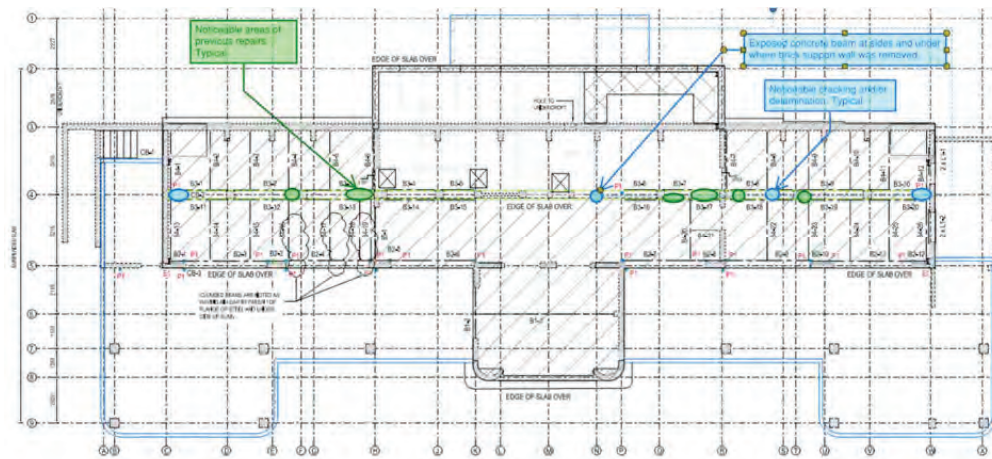
Figure 4: Plan showing existing repair locations and other major defects.

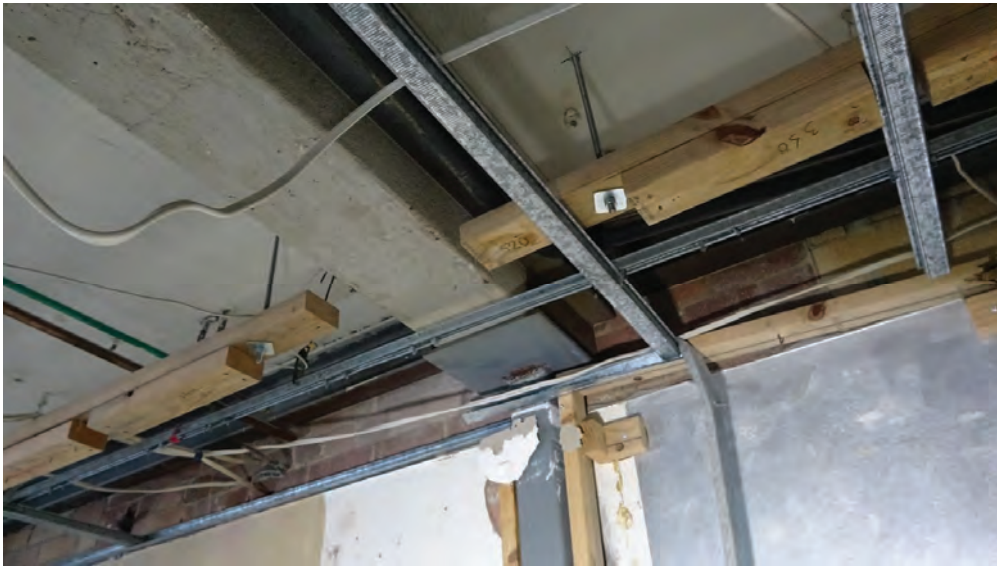
P1: Beam CB2 at 4:C/D cracking in render present, minor chips in render.

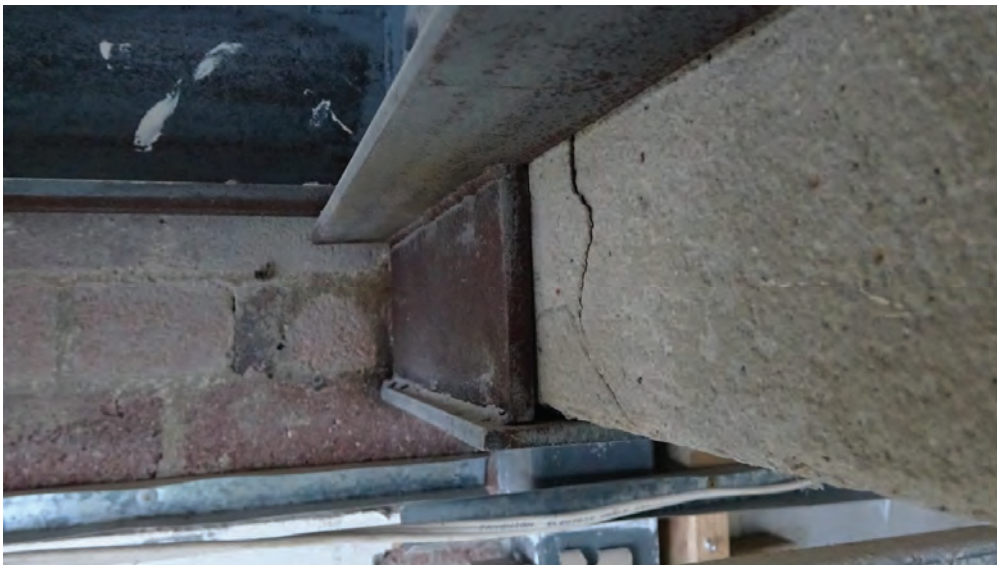
P2: View of end of CB2 at grid C:4 Note cracks in render and initiation of delamination at side of beam.

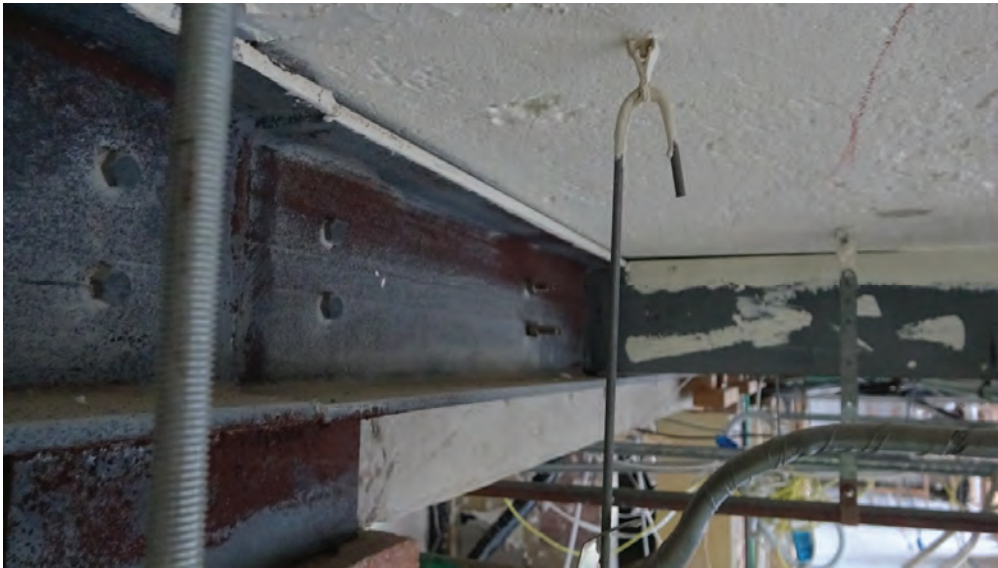
P3: Beam CB2 at grid 4:D/E shows side beam with bolts to concrete. Note chips and cracks in render.

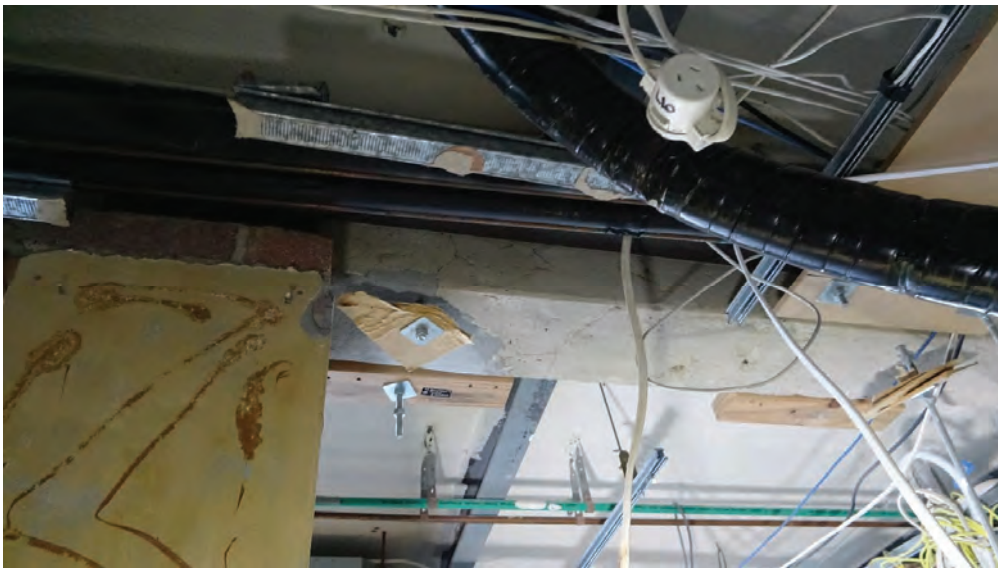
P4: Beam CB2 at 4:F/D Note column 4:F on the left hand side. Note previous repair and patch on soffit near column as well as cracks in side face and soffit.

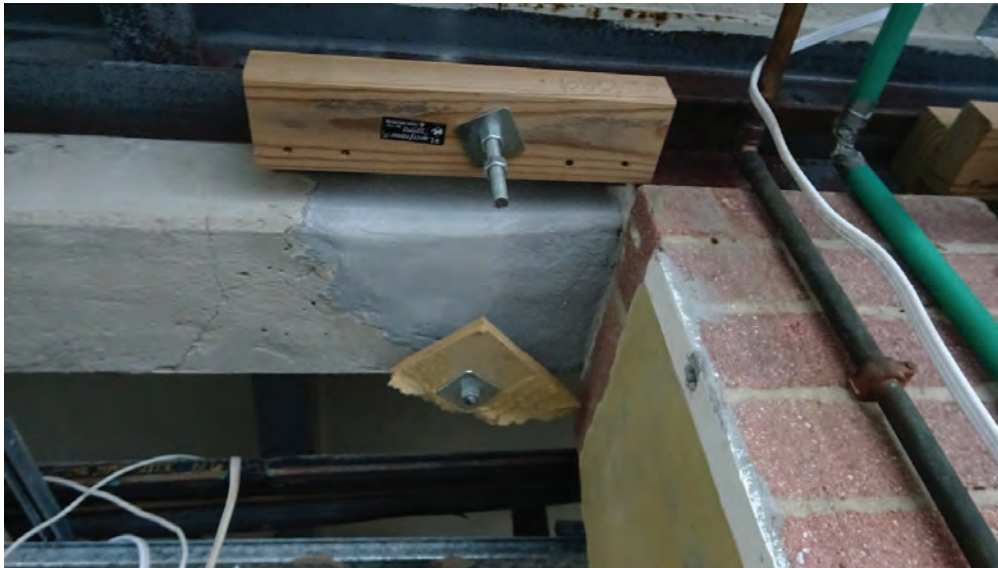
P5: Beam CB2 at 4:F Opposite side of above photo. Note repair patch on soffit and side face.

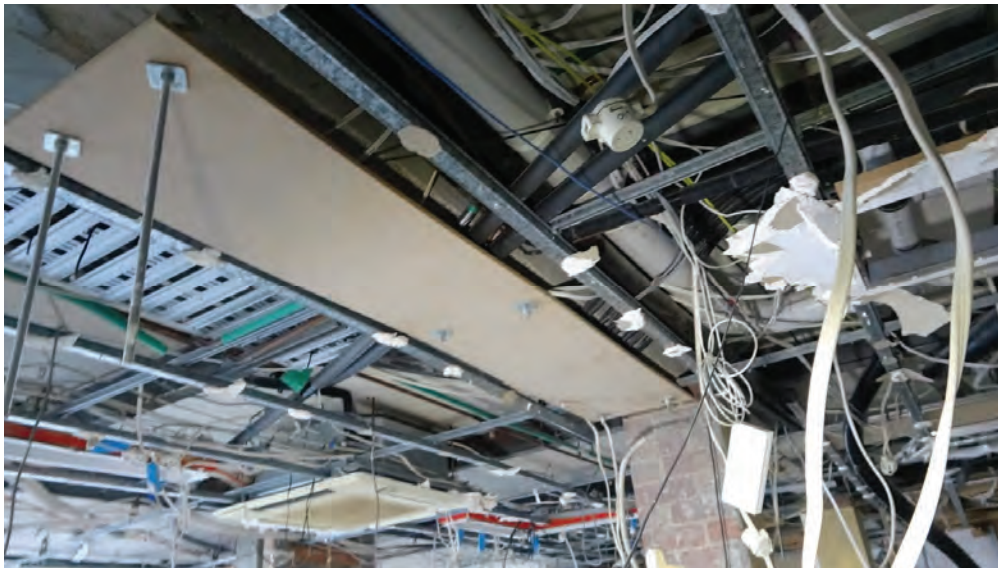
P6: Beam CB2 at 4:H/F covered with board, has minor cracking.
