JOINT REPORT ORIGINAL SUSPENDED SLAB

PAVILION 1, 50 MARINE PARADE, REDCLIFFE

COVEY ASSOCIATES AND ACOR CONSULTANTS

PROJECT NO: 223164
REF: RG/RG/37300RPT – ISSUE A
22 DECEMBER 2022

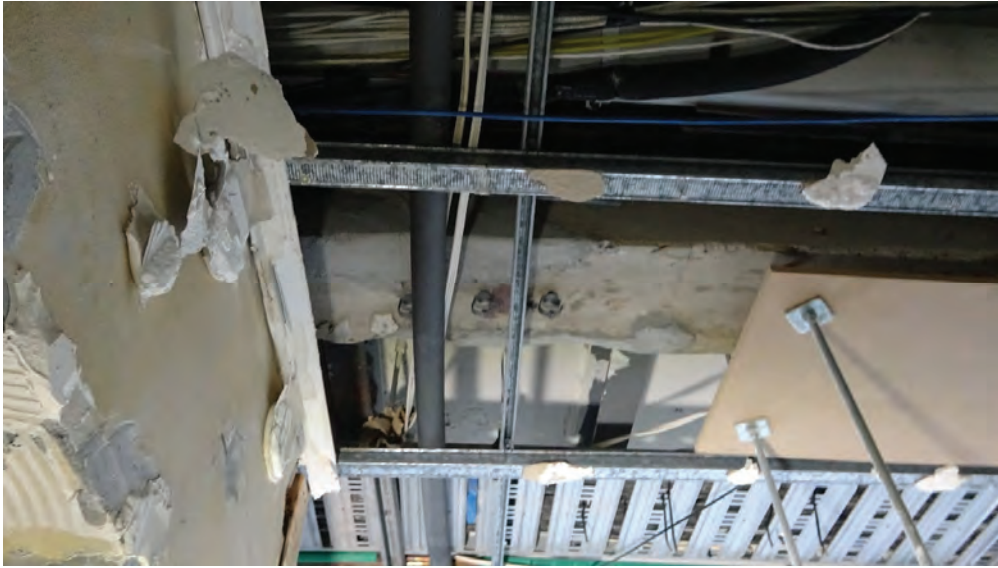
P7: Beam CB2 at 4:H/F Note repairs to both sides and underside of beam near wall at grid H as well as 3 connection points, removed render, discoloration etc.

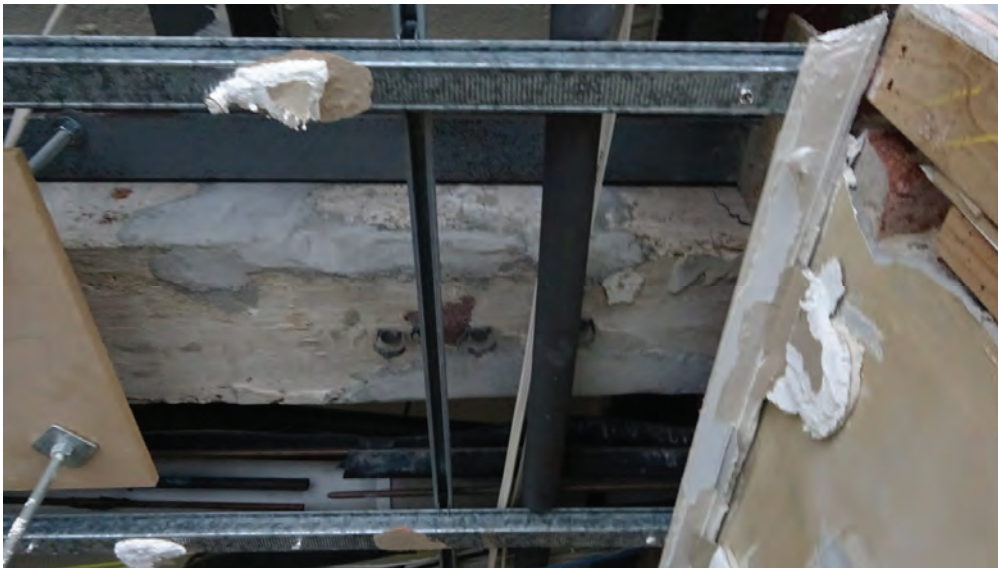
P8: Beam CB2 at 4:H Opposite side of the above beam. Note repairs on soffit and side face.

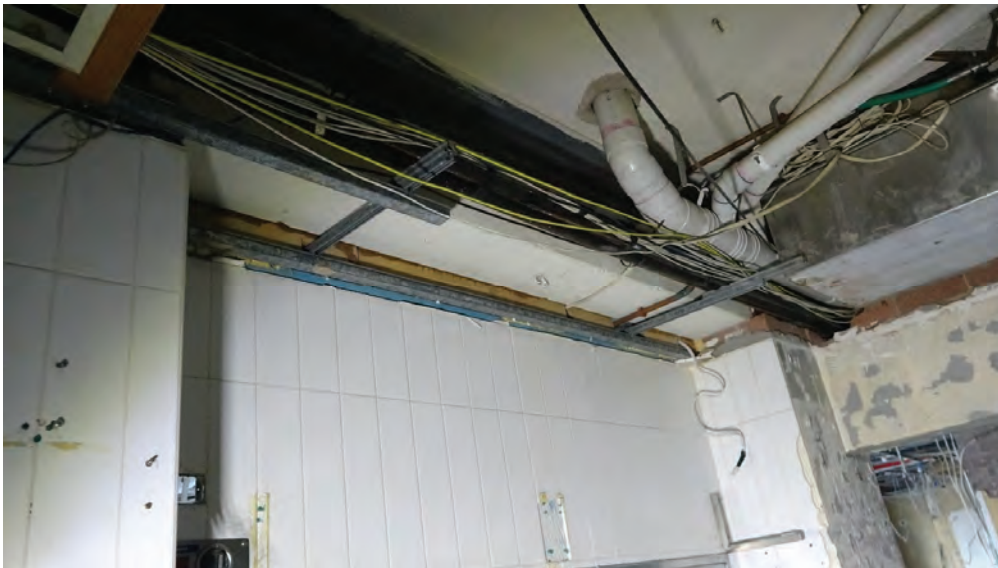
P10: Beam CB2 at 4:J/H is painted, note minor defects such as chips and cracks can be seen in the paint up close. Steel side beams are attached to this beam but stop at grid K.

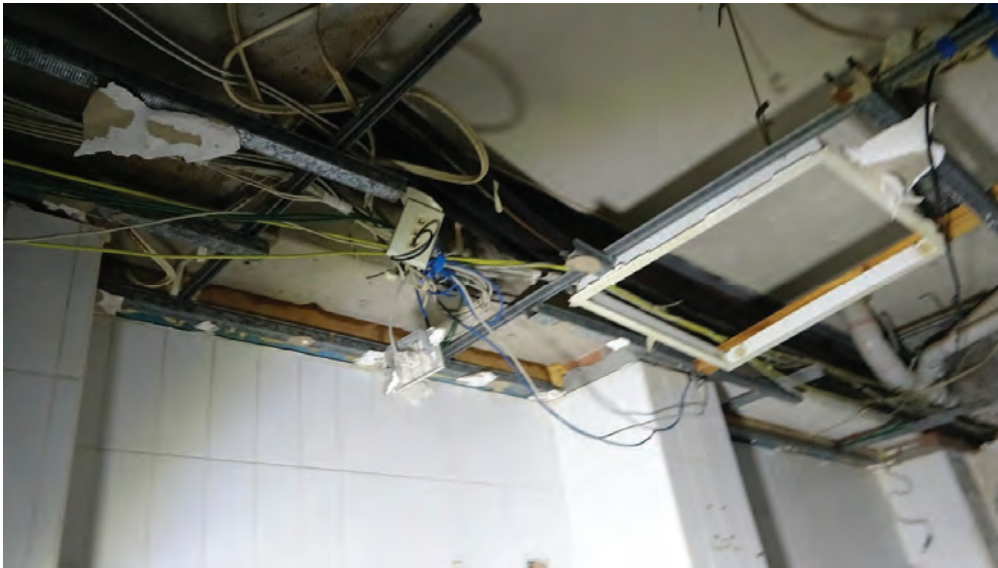
P11: Beam CB2 at 4:K/J is not painted, note minor defects such as chips, cracks in render, various bolt/connection holes and a larger gouge/chip in beam. The steel side beams stop from grid K to P.

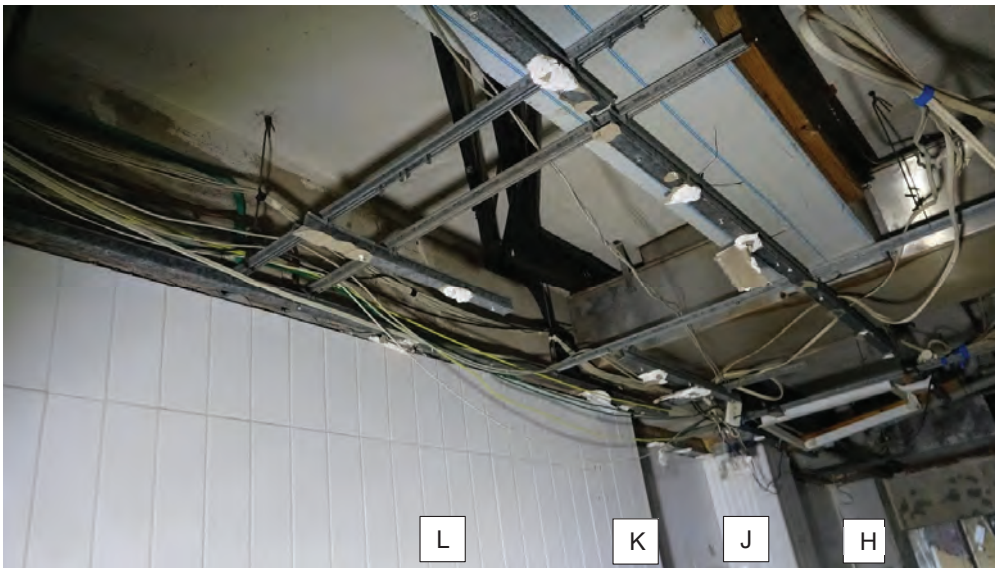
P12: Beam CB2 at 4:halfway between grids M and N to grid L. No major defects, only a few chips and cracks in render. Note that there was a wall removed at grid L:3/4 and has not been replaced or substituted with any steel beams or support. There is no render at this location and removal of the wall has taken some of the concrete with it and left less cover in this area.

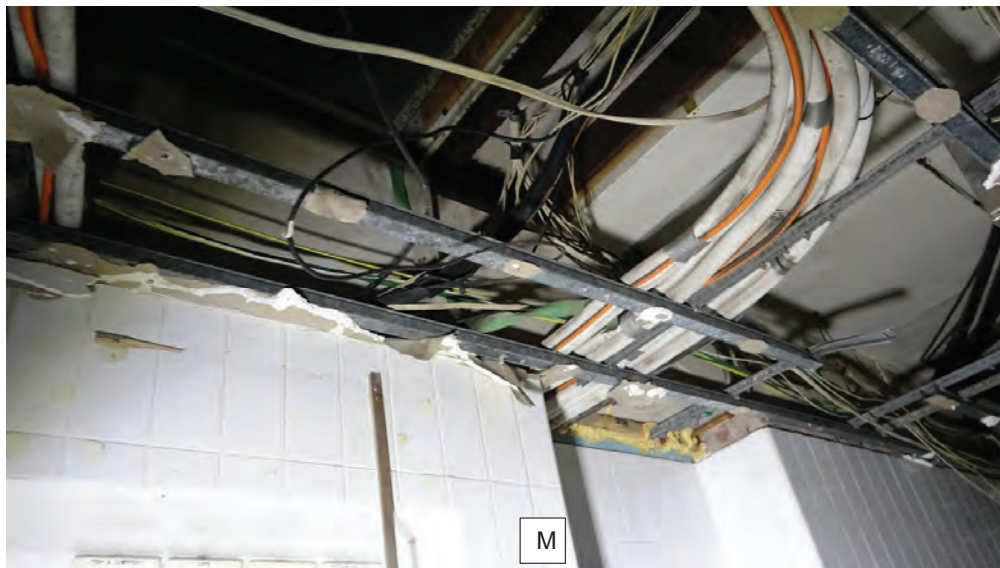
P14: Beam CB2 along grid 4 from half way between M and N towards M etc. This beam is not painted and does not have steel side beams. There are no significant defects, only minor chips and cracks in the render.

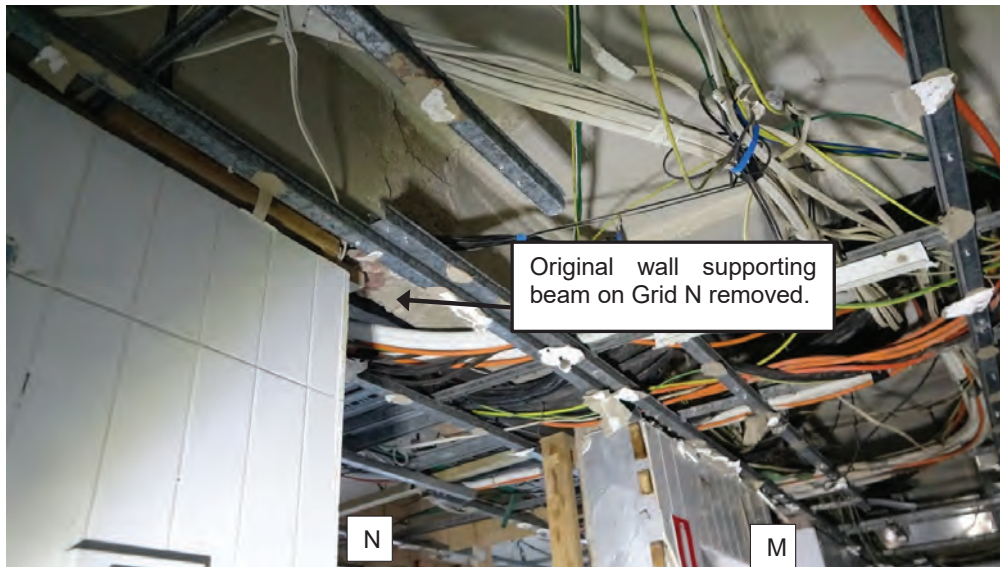
P15: Beam CB2 at 4:P/M Note this beam is not painted and does not have steel side beams. There are some chips and cracks in the render as well as exposed aggregate beam where previous support wall was removed from grid N:3/4. Note that no support under the beam and slab was reinstated at this location.

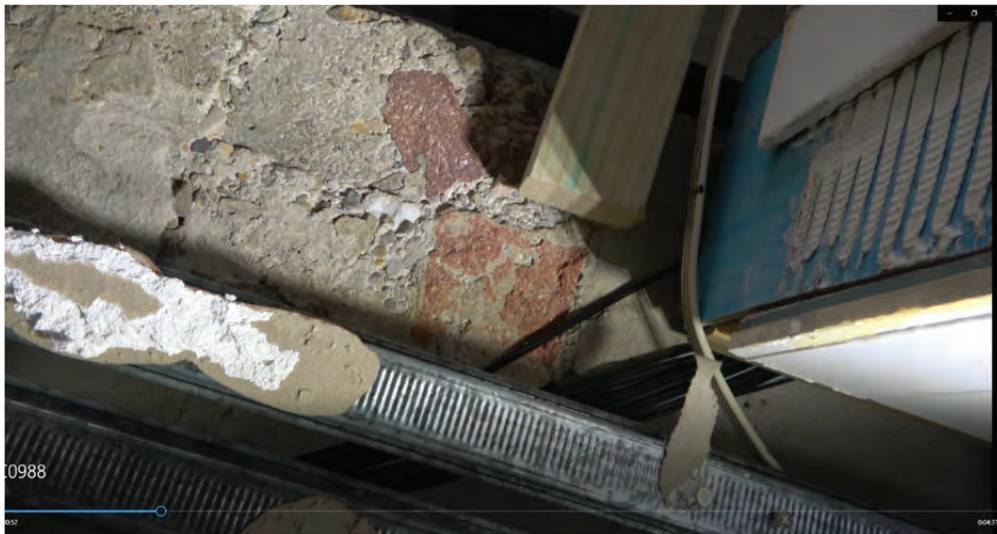
P16: Beam CB2 soffit at 4:N where previous support wall used to be.

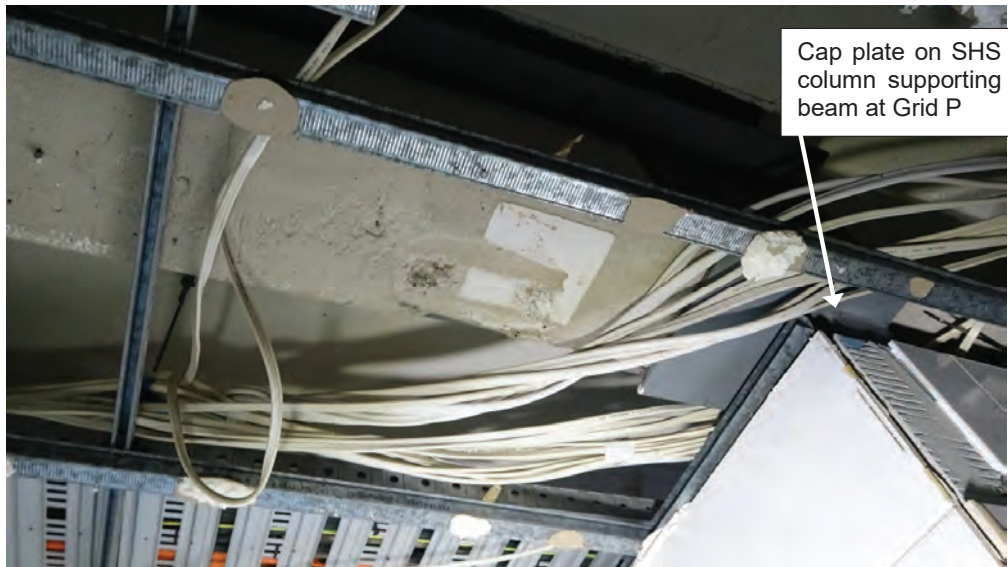
P17: Beam CB2 at 4:Q/P Note damage to beam soffit, holes, missing render, cracks in render etc.

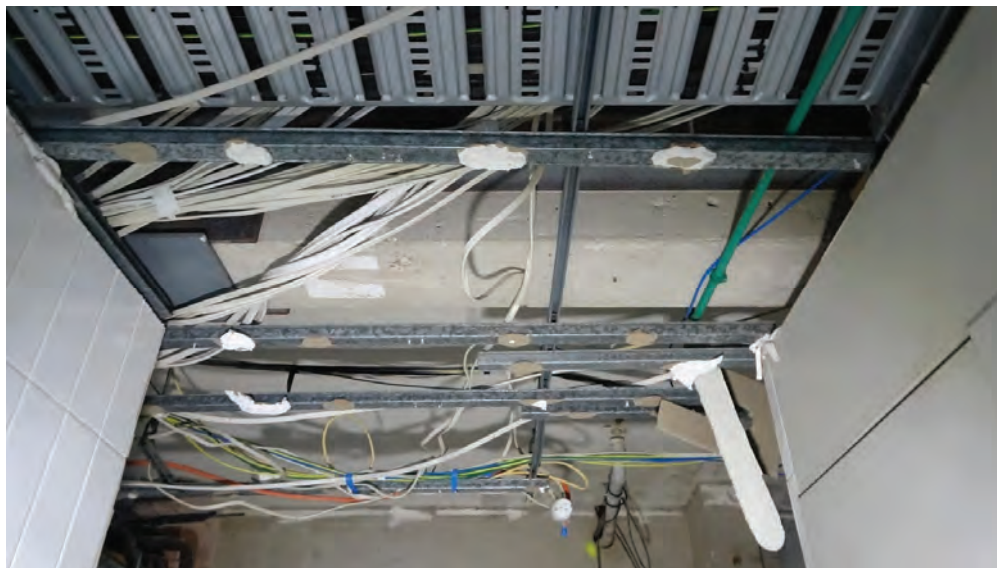
P18: Beam CB2 at 4:Q/P Photo taken from the other side. Note damage to beam soffit, holes, missing render, cracks in render, drill holes in side face etc. The steel PFC side beams start from Grid P to W.

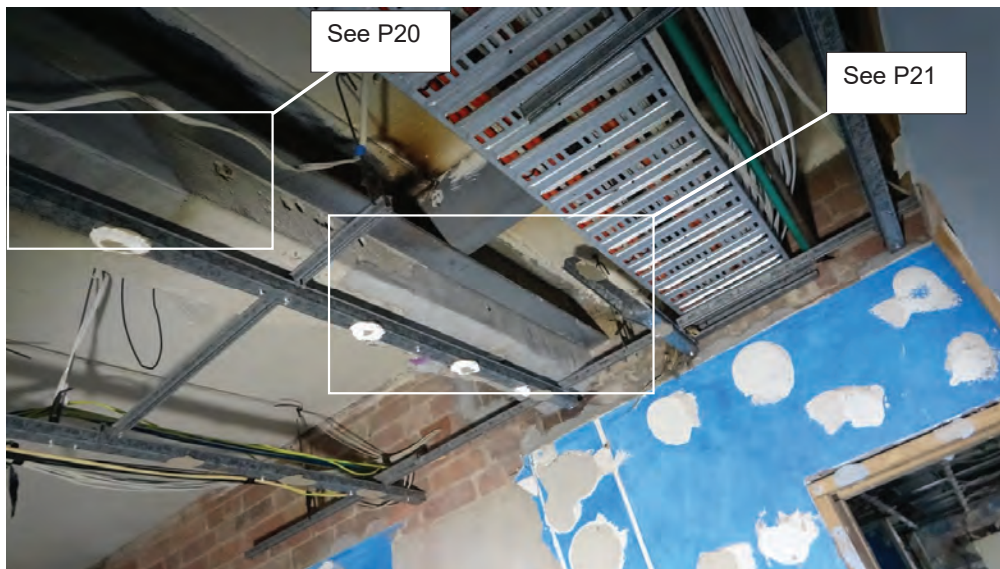
P19: Beam CB2 at 4:Q/R Shows 2 lots of repair patching.

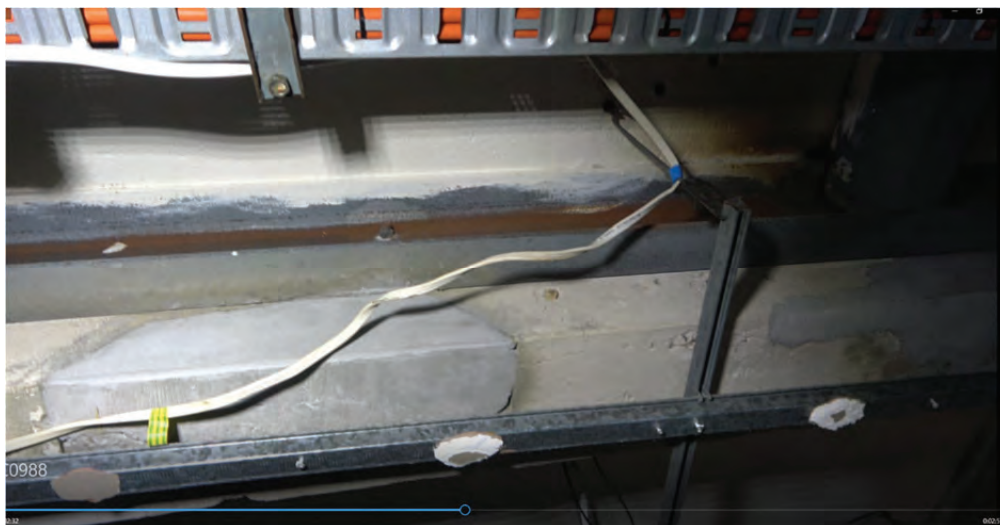
P20: Beam CB2 at 4:Q/R Close up of repair on left hand side of beam in Photo 19 above. Note repair patch to beam soffit and side face. Also note surface rust on PFC Side Beam.

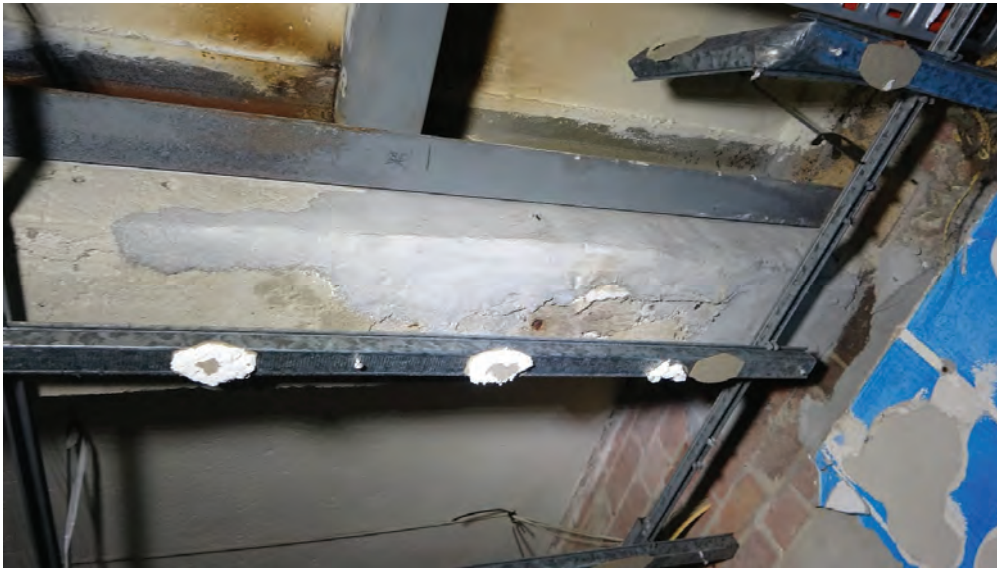
P21: Beam CB2 at 4:Q/R Close up of Right hand side of beam repair in Photo 19 above. Note repairs to soffit and side face of concrete beam, also missing render, rusty insert, chips and holes in render etc. Also note surface rust on steel side beam.

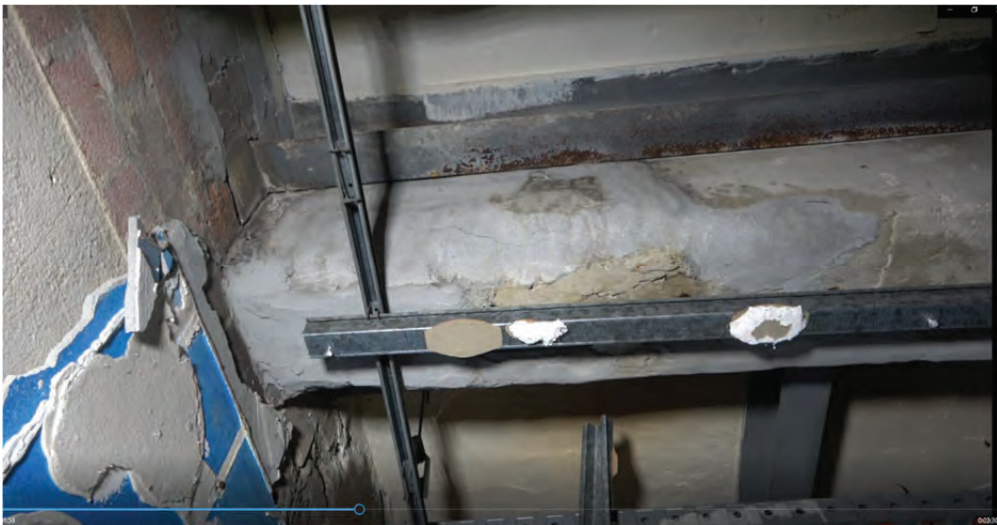
P22: BeamCB2 at 4:R/Q Opposite side of the above photo. Note repair patches, delaminating render, exposed concrete, rusty insert, etc. Also note rust on flange of PFC.

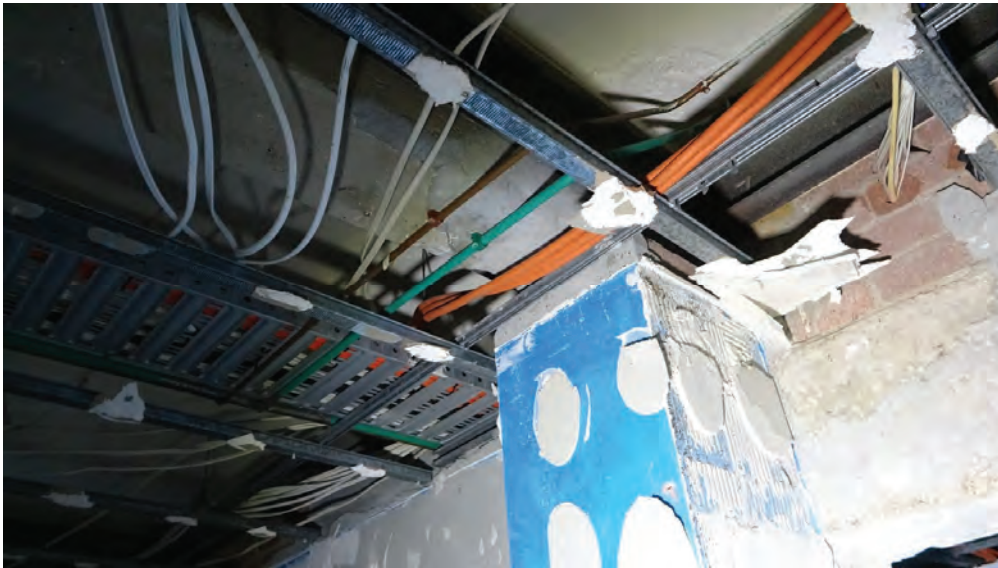
P23: Beam CB2 at 4:R Note repair patch to soffit and side face.

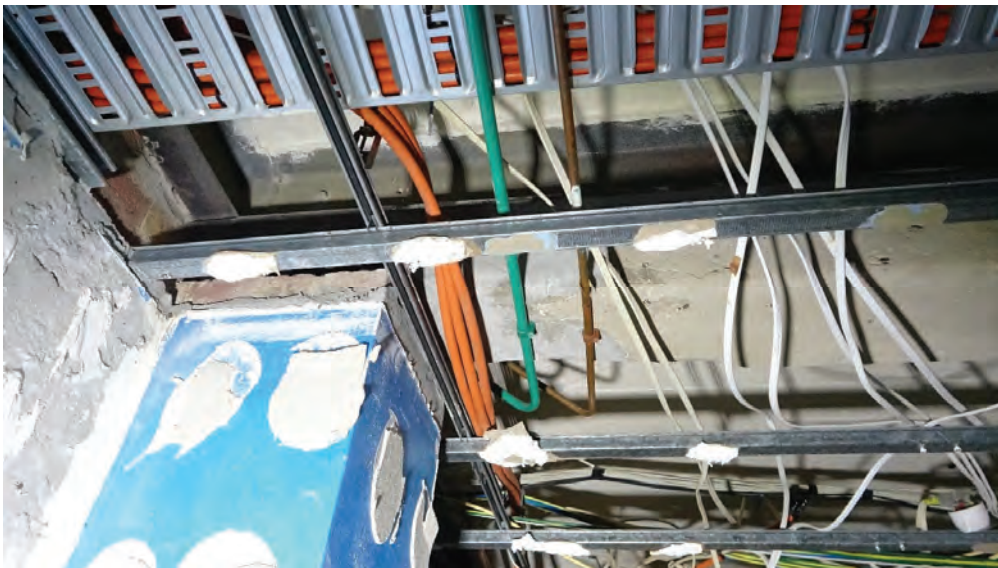
P24: Beam CB2 at 4:R taken from the other side to the above photo. Note repairs and cracks in side face.

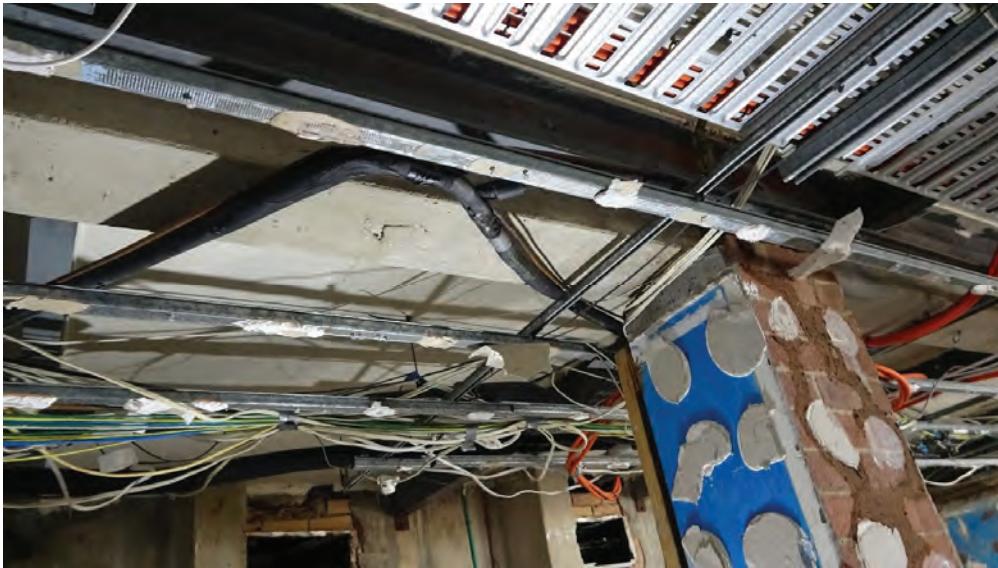
P25: Beam CB2 at 4:S/U Note delamination starting in the middle then the repair patch beyond the column.

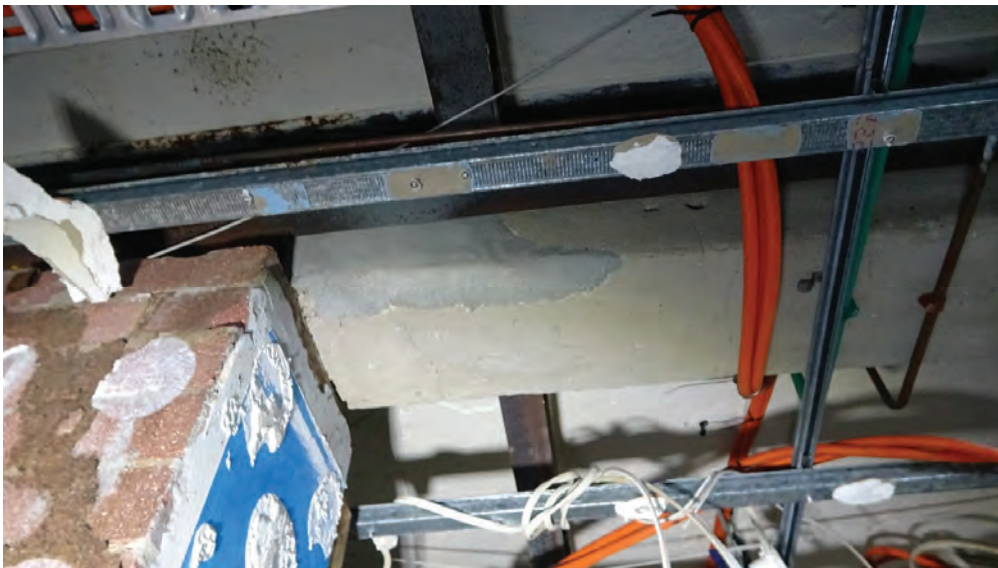
P26: Beam CB2 at 4:T Note close up of repair patch mentioned in photo P22 above.

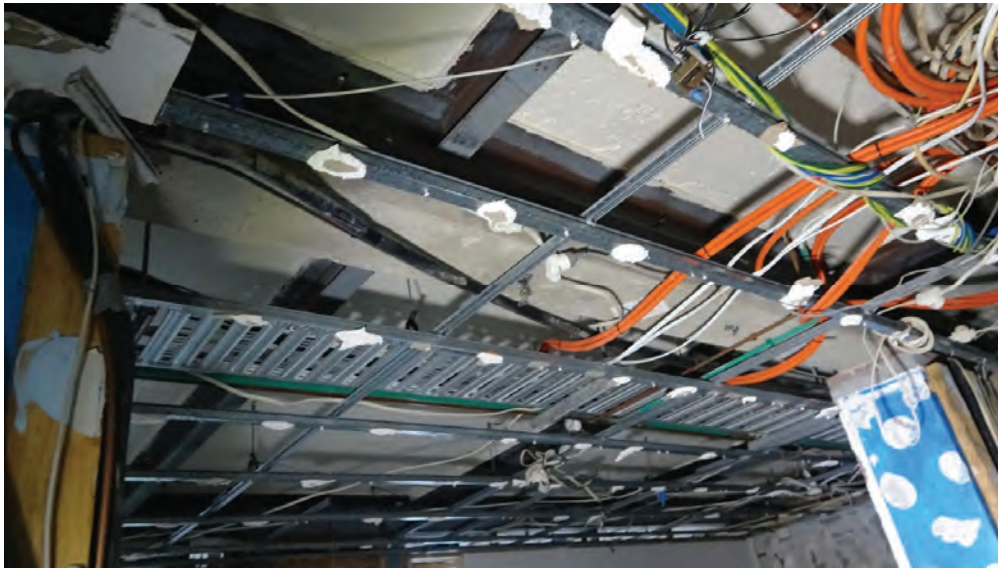
P27: Beam CB2 at 4:V/T Cracks and chips in beam render and concrete beam.

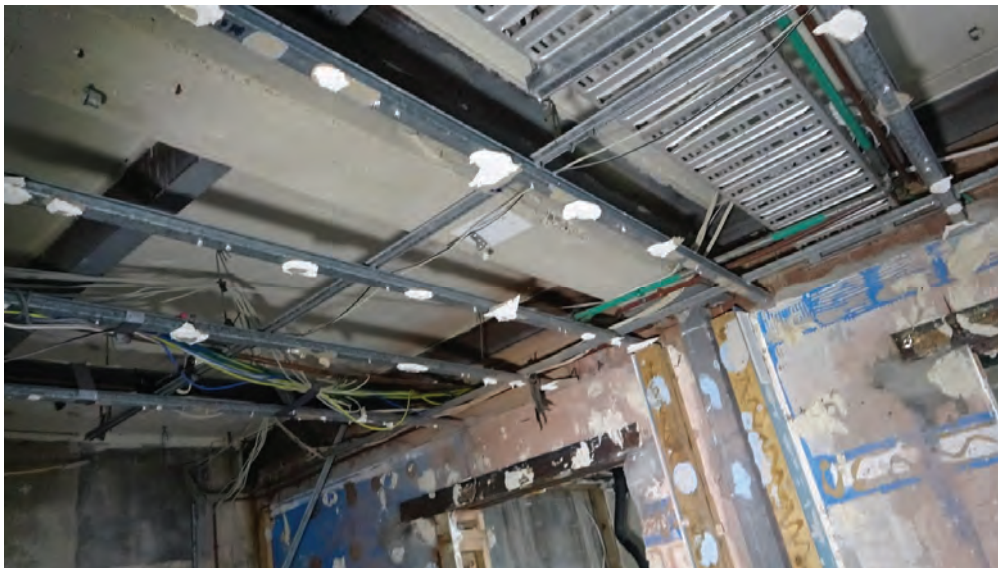
P28: Beam CB2 at 4:V/W Note chips off edges, exposed aggregate, cracks in render etc.

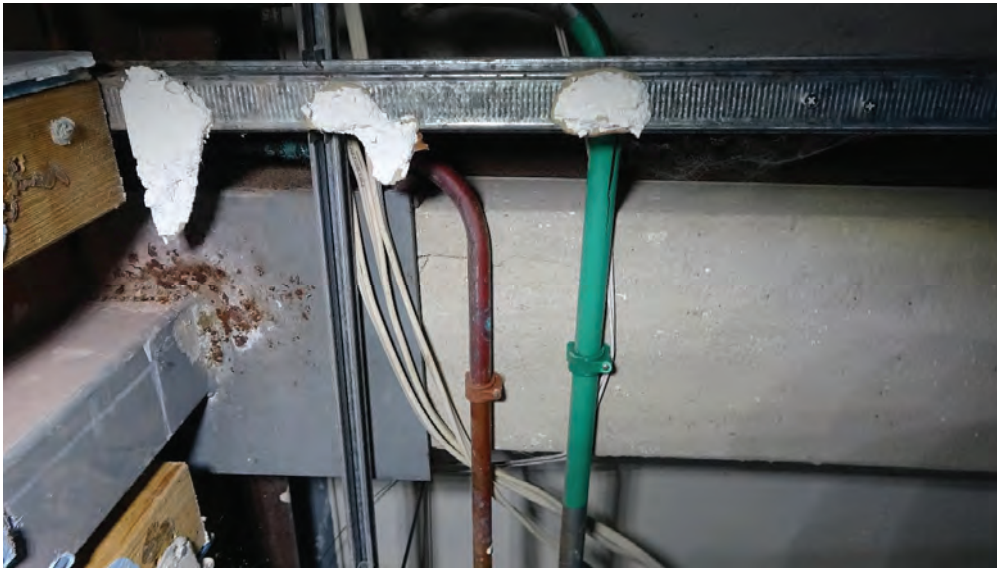
P29: Beam CB2 at 4:W on post support. Note pitting and rust on SHS and cap plate. Note Cracks in rendered concrete beam soffit.

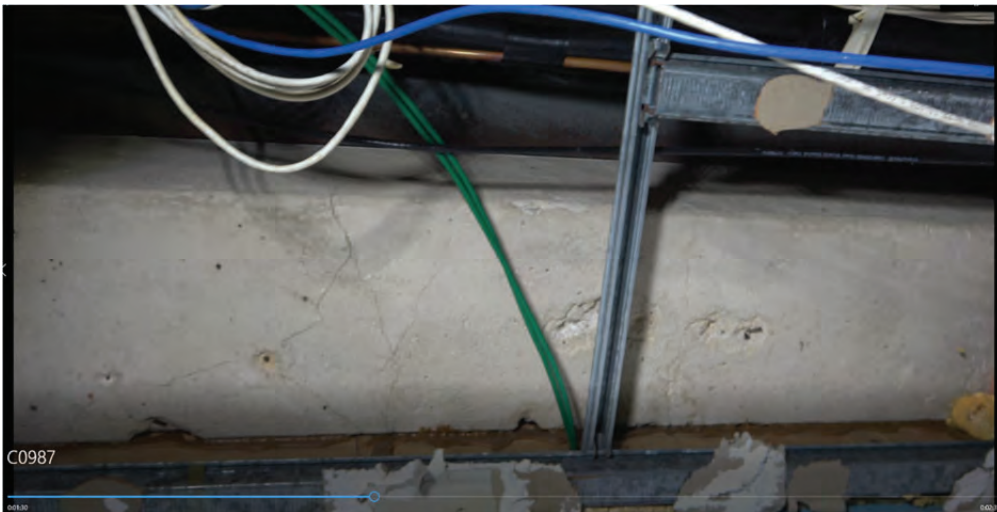
P30: Beam CB2 at 4:K/J Soffit. Note cracks and penetrations in render and beam.

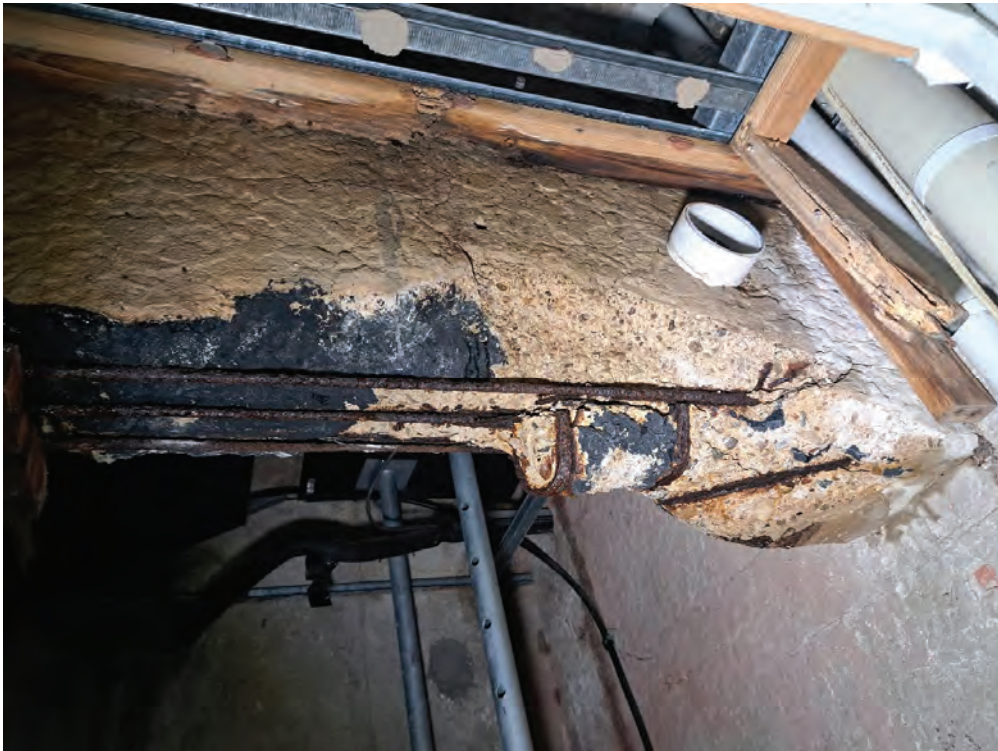
Note this area has been exposed top and bottom for years with the top being exposed its entire working life. The support beam (CB1) is in very poor condition with no residual life and is supported by props so is considered failed. See BG&E report. The stair and landing soffit appeared to have delaminating concrete and was sheeted and propped. This stair supports foot traffic to the ramp and should be rectified as a matter of priority. Propping should only be a temporary measure.

P31: Northern end of Beam CB1. Base of beam completely spalled beyond reinforcement, severe corrosion to reinforcement, more cracks evident and further spalling likely.

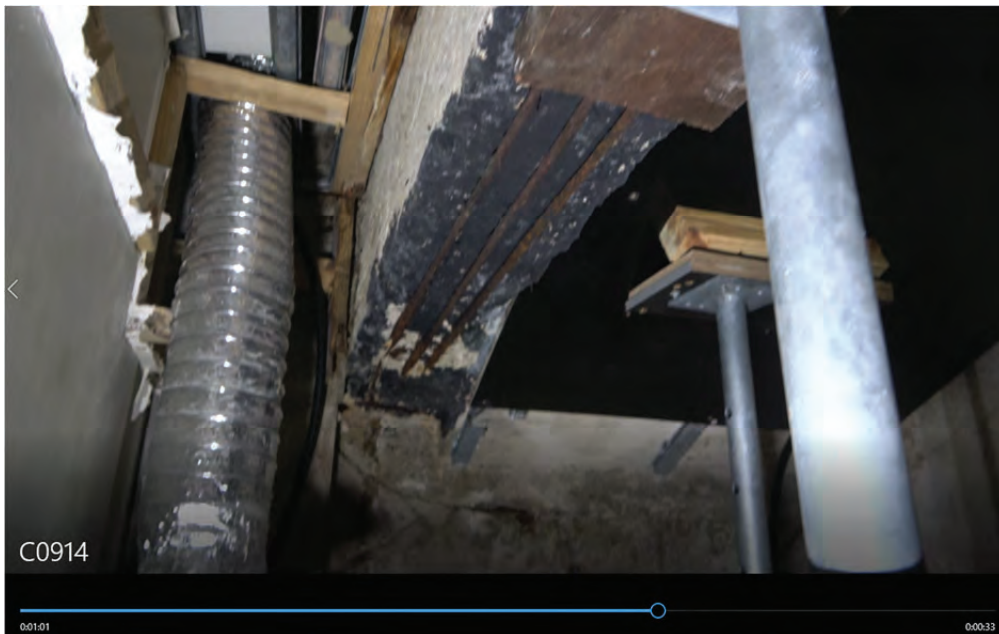
P32: Southern end of Concrete Stair beam in toilet area CB1.

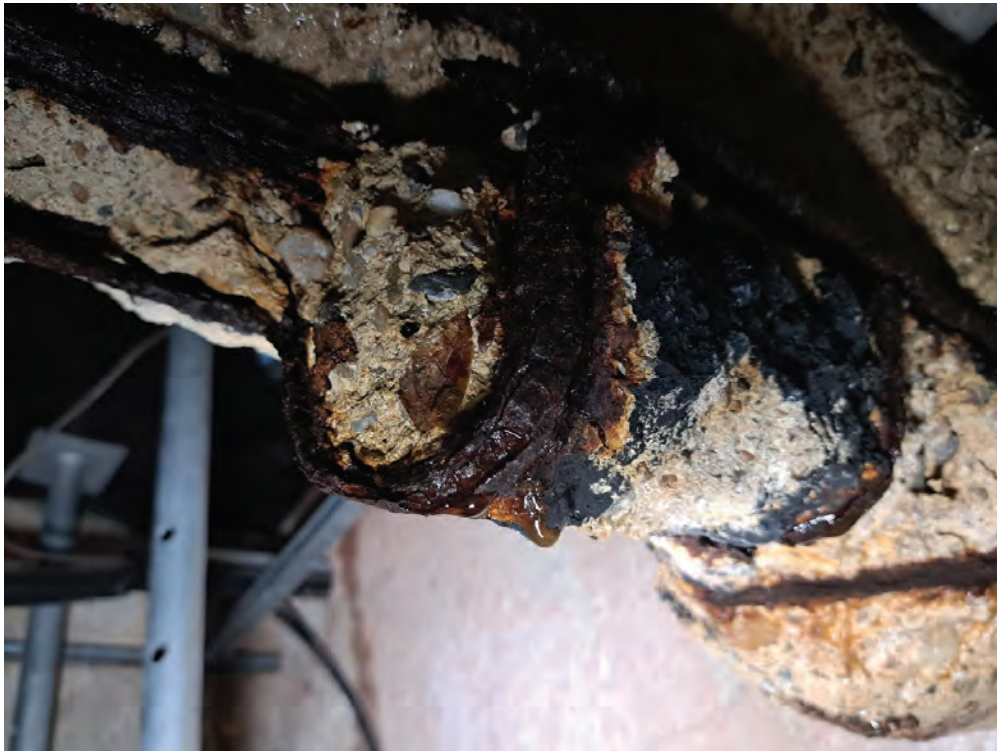
P33: Close up of Beam CB1 from above photo P31 shows water ingress, spalled concrete, corroded bars.
