APPENDIX I
JOINT REPORT: SLAB TESTING

JOINT REPORT
CARBONATION TESTING - SUSPENDED SLAB

PAVILION 1, 50 MARINE PARADE, REDCLIFFE

PROJECT NO: 223164
REF: 27735RPT - A
DATE: 22 DECEMBER 2022

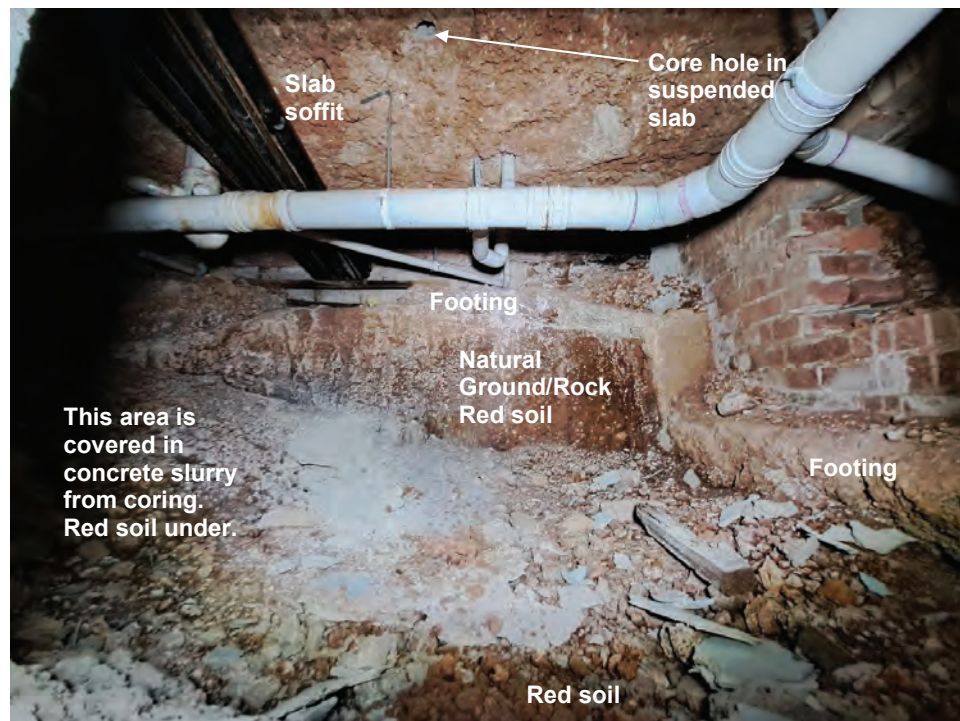
This first core was taken above the undercroft area located between grids 2-3:H-R. It is thought that this area was originally slab on ground and then dug out to put pipework in for toilets post circa 1975 to 2000. Note the uneven slab soffit with the same red soil on it as the ground beneath.

Image 1: Soffit of suspended slab above undercroft area.

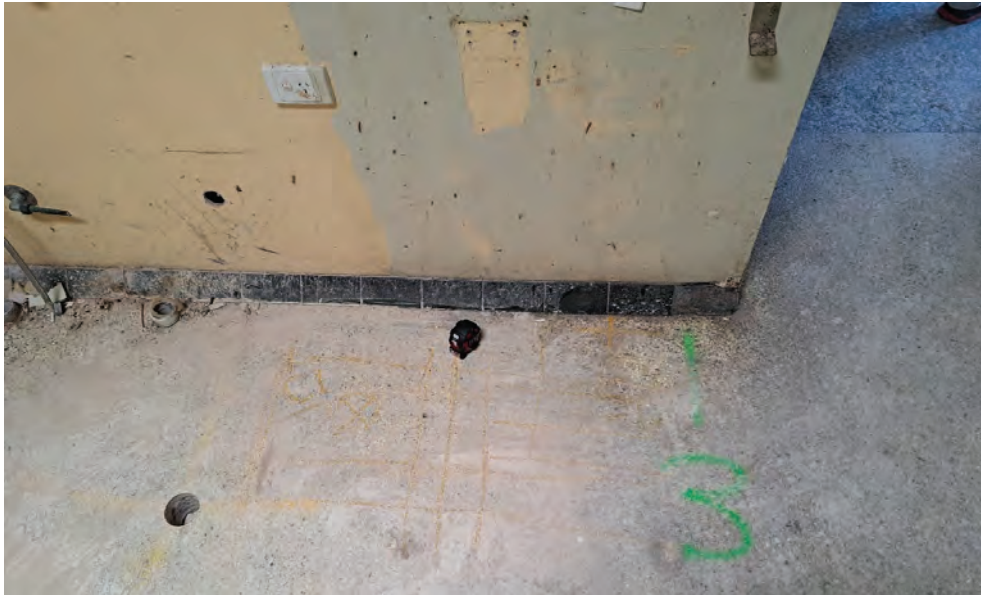
Image 2: Location of C1

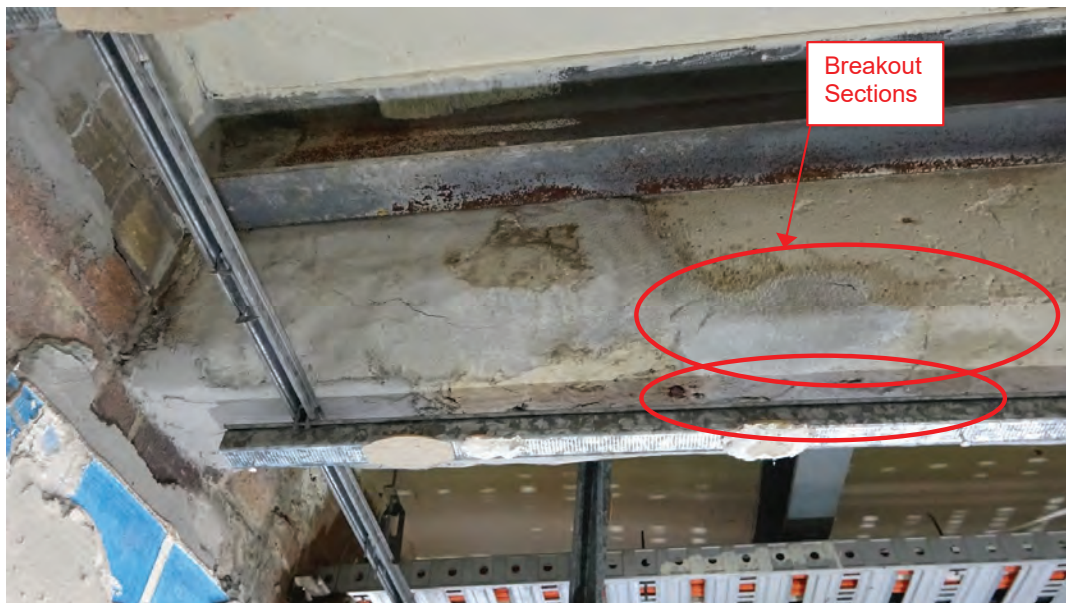
This breakout was undertaken in an area where there was previous repairs and patching in order to determine how well the patch repairs were done. Note the before and after images below. The breakout continued past the patched area to a section of beam where there was no patch.

Image 1: Before Breakout BR1

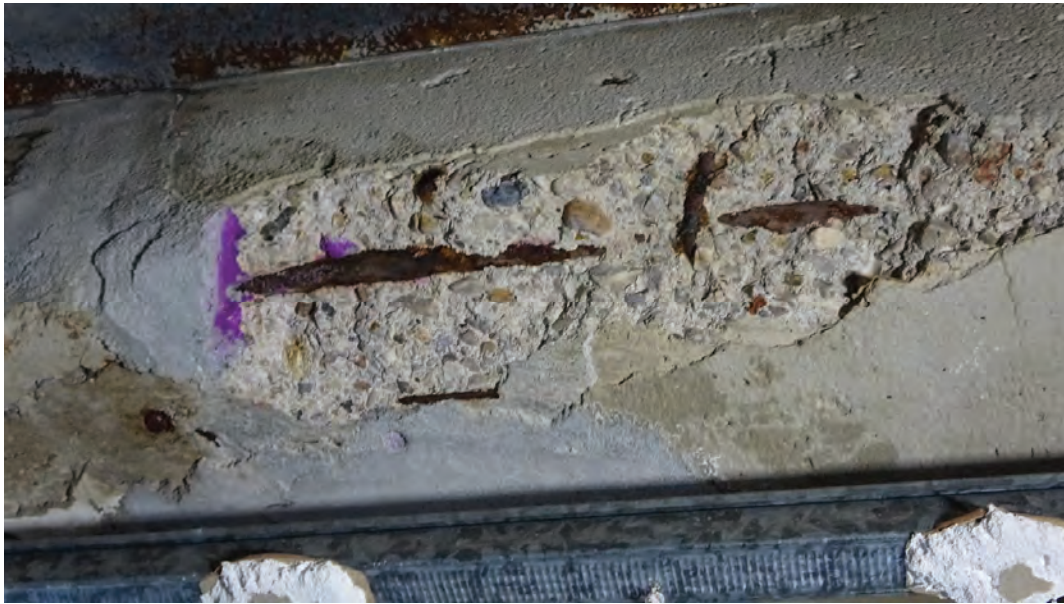
Image 2: After Breakout BR1

Clearly the reinforcement is in the carbonated zone and is rusting, expanding and delaminating where the previous repair patch was installed as well as in the extended breakout area.

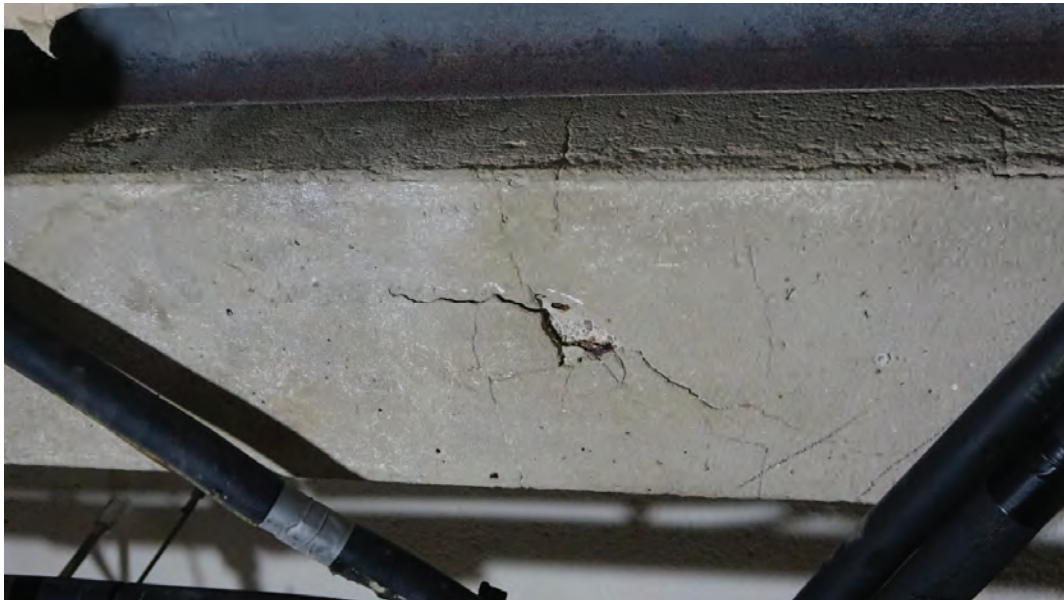
This breakout was undertaken in area where there was an existing defect. See before and after images below.

Image 3: Before Breakout BR2

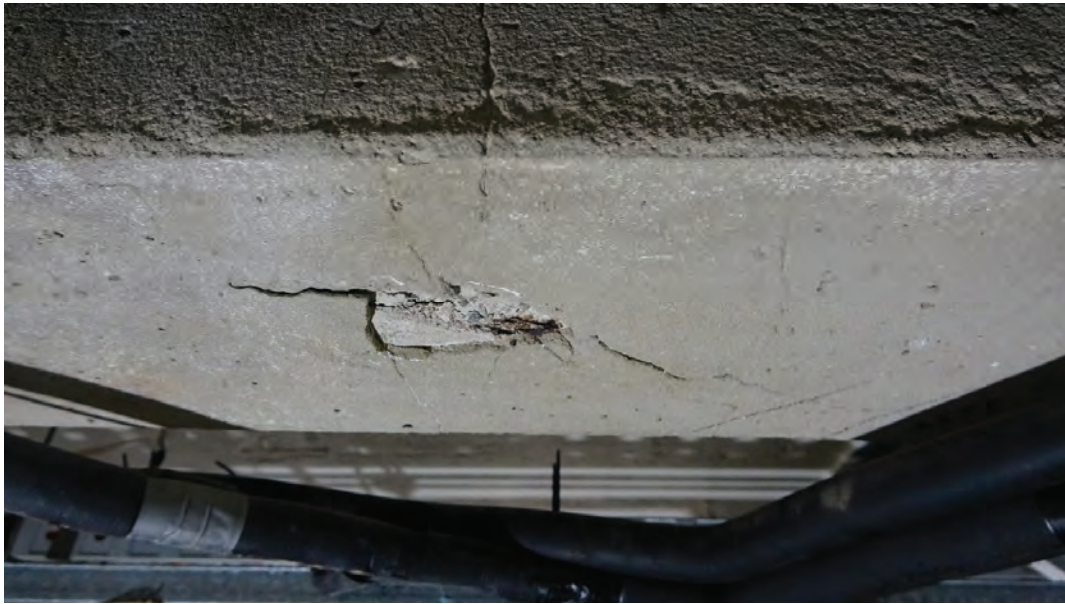
Image 4: Concrete delaminated easily at BR2

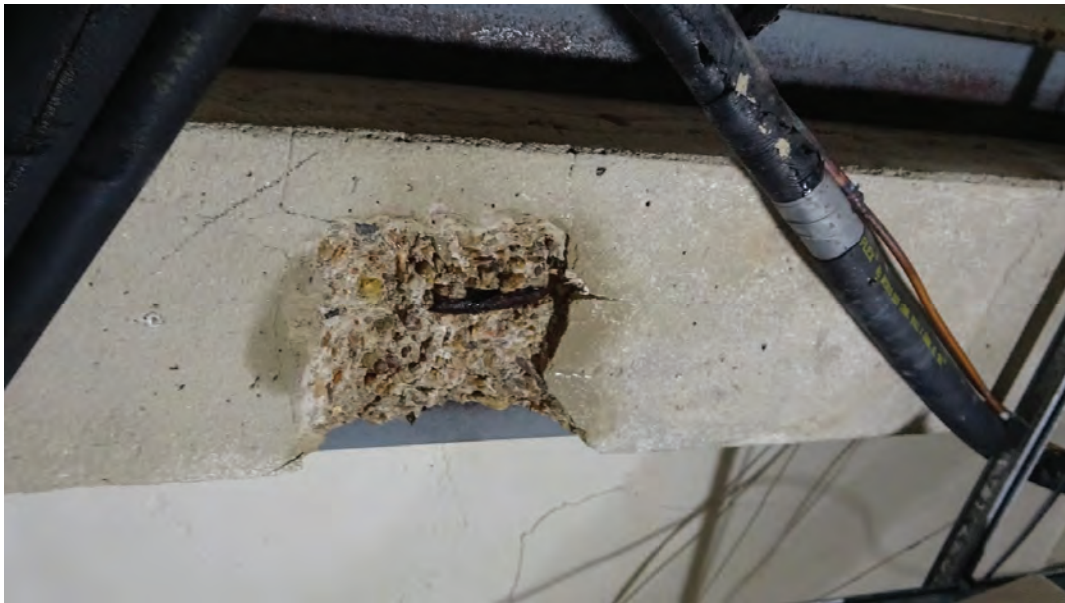
Image 5: Breakout at BR2 exposed bottom bar and lig – phenolphthalein spray still visible

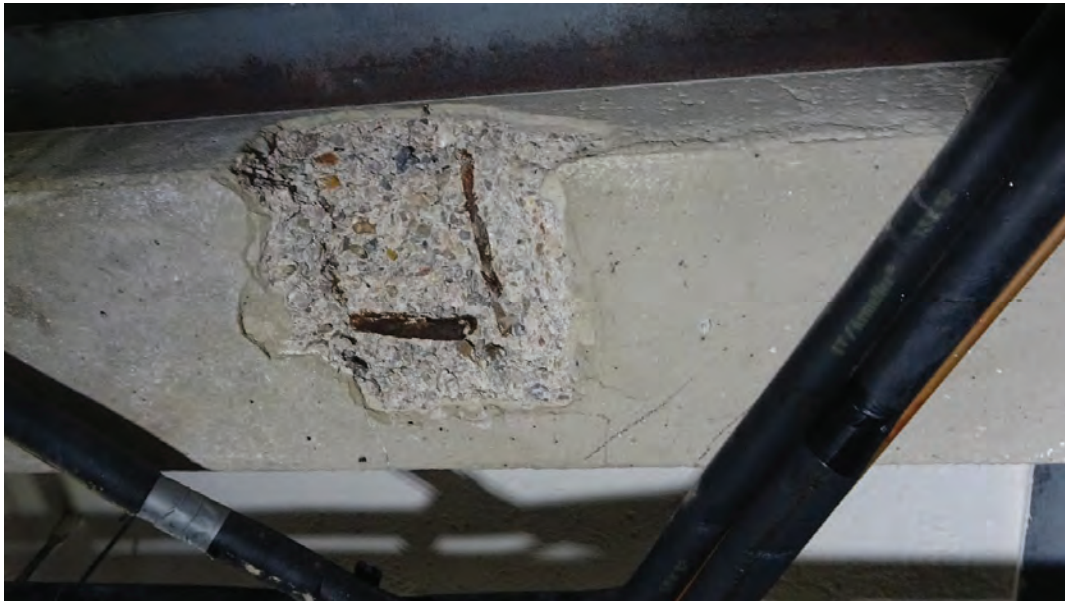
Image 6: Further breakout at BR2 exposed bottom lig – phenolphthalein sprayed at lig

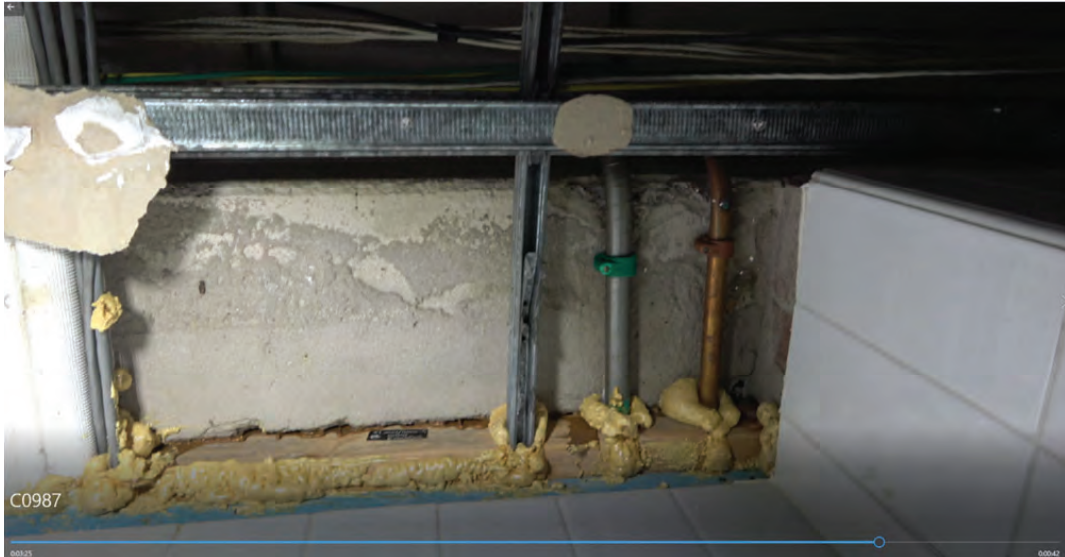
This breakout was carried out in the centre area of the beam that would have been the most protected over the years and where there appeared to be no defects.

Image 7: Before Breakout BR3

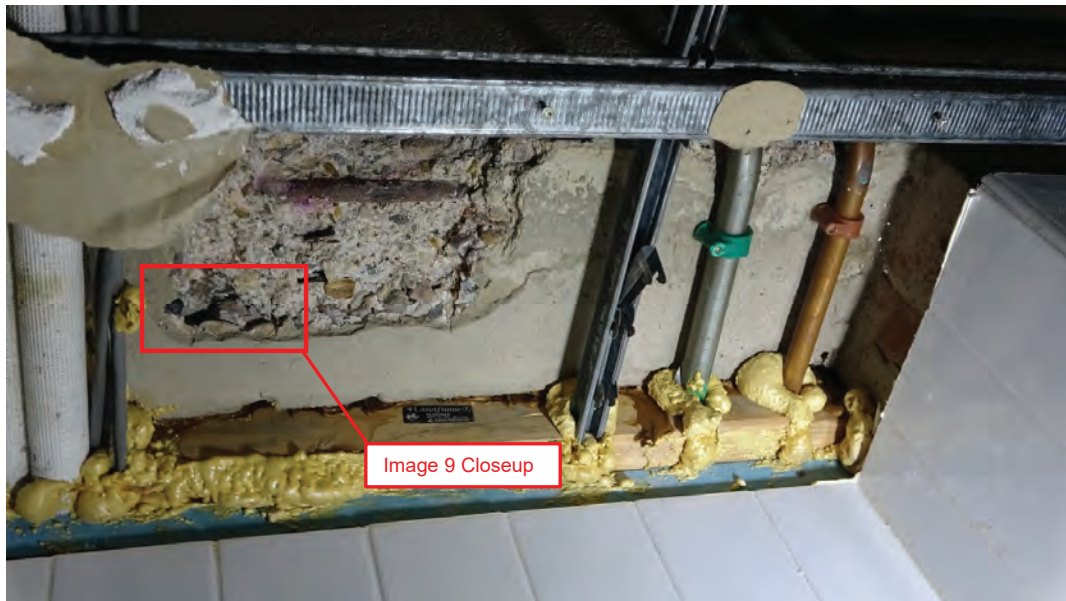
Image 8: Breakout BR3 – Fully Carbonated past bottom bar

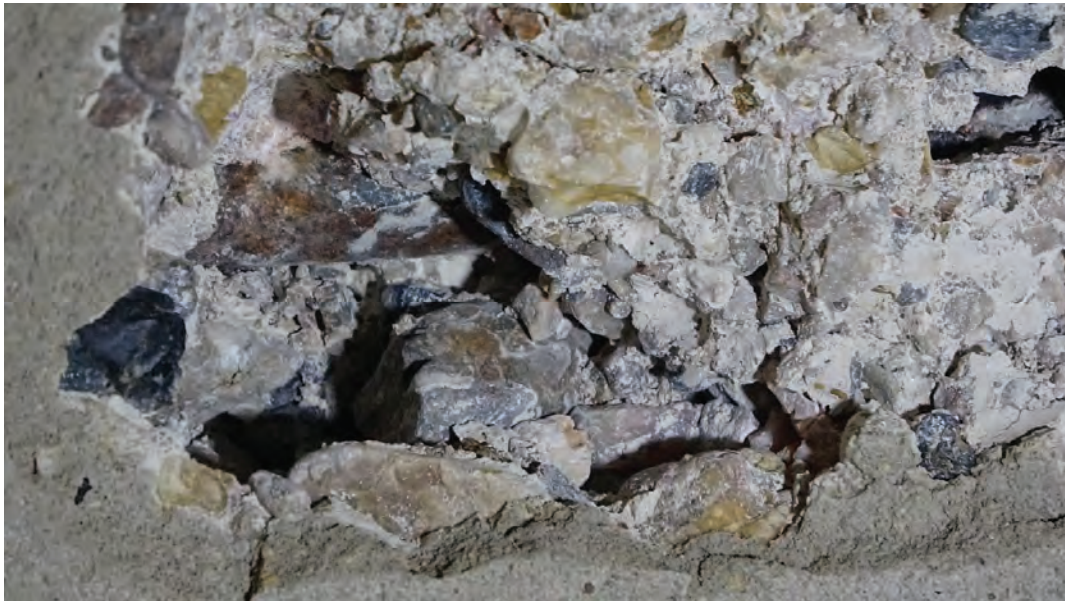
Image 9: Close up from image 8 shows

The reinforcement at this location appears to be in reasonable condition with minor surface rust, no loss of section or delamination.

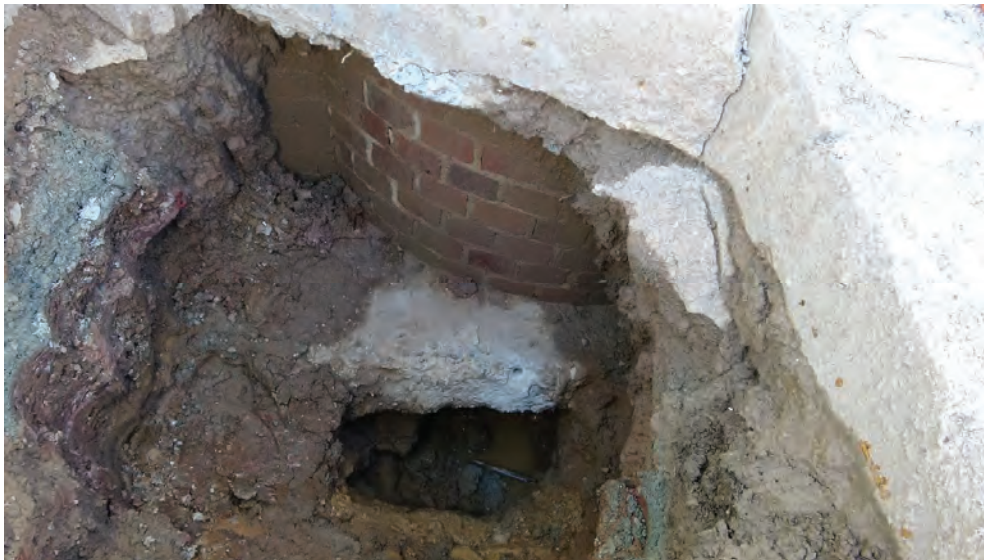
The external slab in front of the brick wall was cut and excavated using vacuum truck in the presence of the heritage consultant and the geotechnical engineer. It was found that the brick wall beneath the ground floor slab was approximately 700mm deep. The bricks and mortar appeared to be in excellent condition. The sub floor wall was sitting on a concrete footing approximately 300 deep.

Photo 1: Footing exposure at 8:N/P.

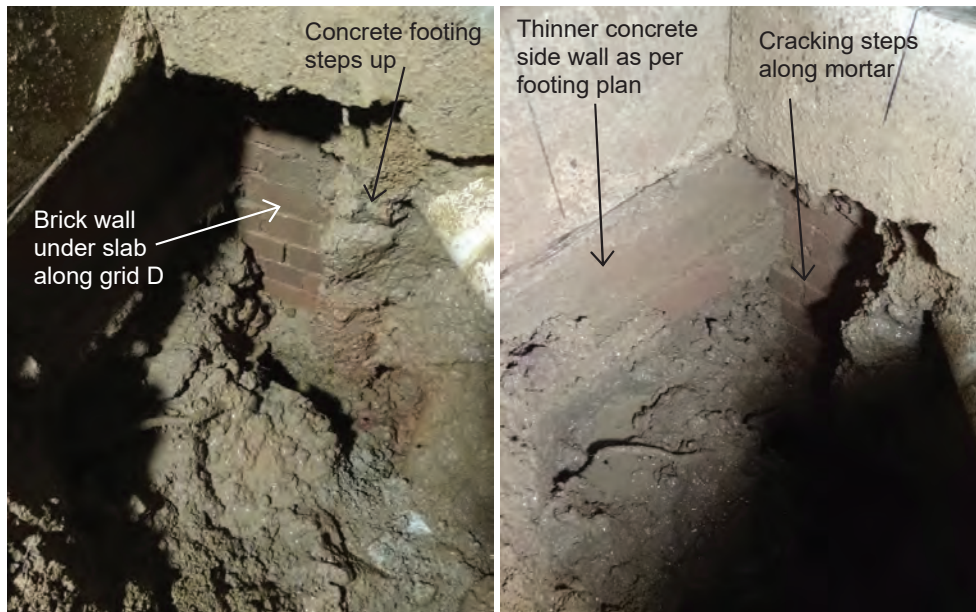
Photo 2: Sub floor wall and footing supporting Column at grid D:4.

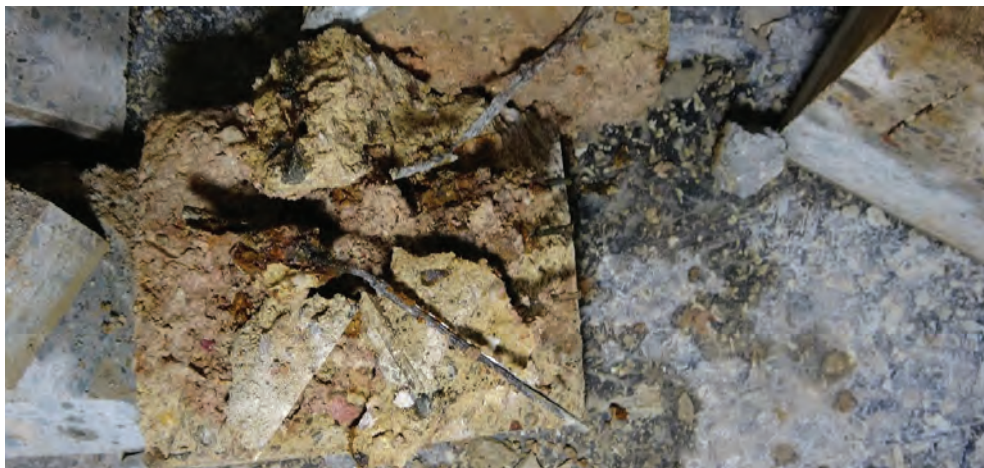
Photo 3: Underside of original slab on ground. Note reinforcement with no cover and some corrosion.

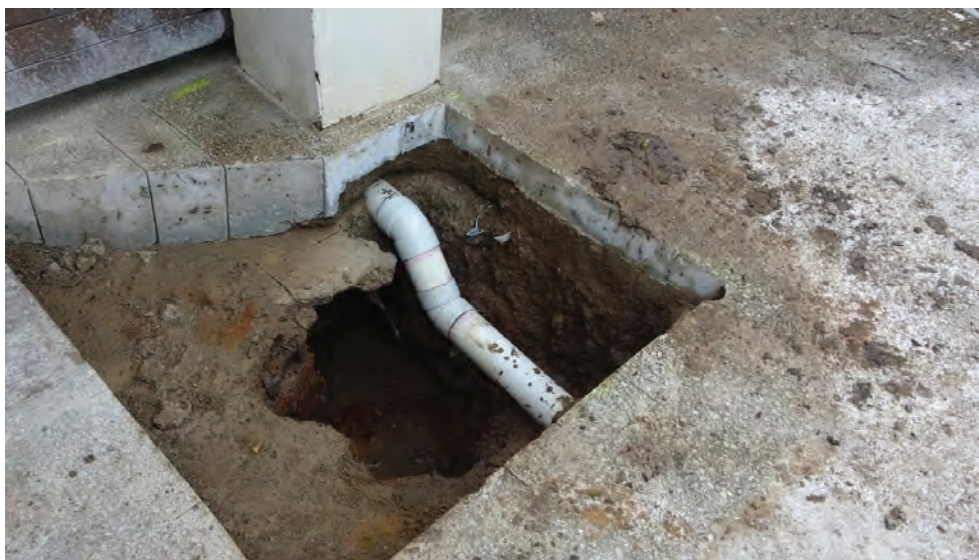
The external slab was cut and vacuum excavated to expose the concrete footing under the new column from the 2007 extension. The external slab was approximately 250mm deep over a concrete footing that was 450mm deep. A random exposed reinforcement bar was found in contact with the dirt with visible corrosion and sectional loss of steel.

Photo 4: Vacuum excavation at 9-X. Note stormwater pipe runs vertically inside the concrete column and then out here above the footing.

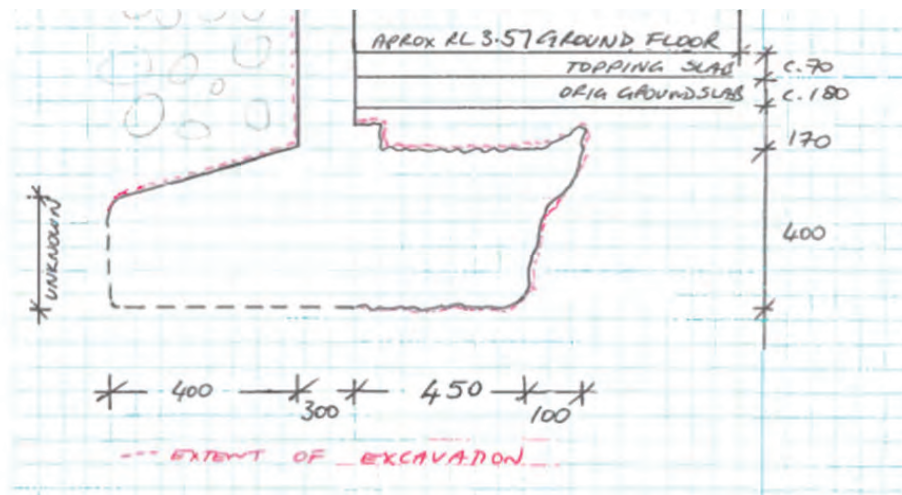
The internal slab and topping slab were cut out and vacuum excavated to expose the toe of the retaining wall. No key was found like shown on the original blueprints. Dimensions as per geotechnical references and sketch shown below.

Figure 5: Retaining wall footing excavation – measured internally at 3-R/S and externally at 3-C/E.

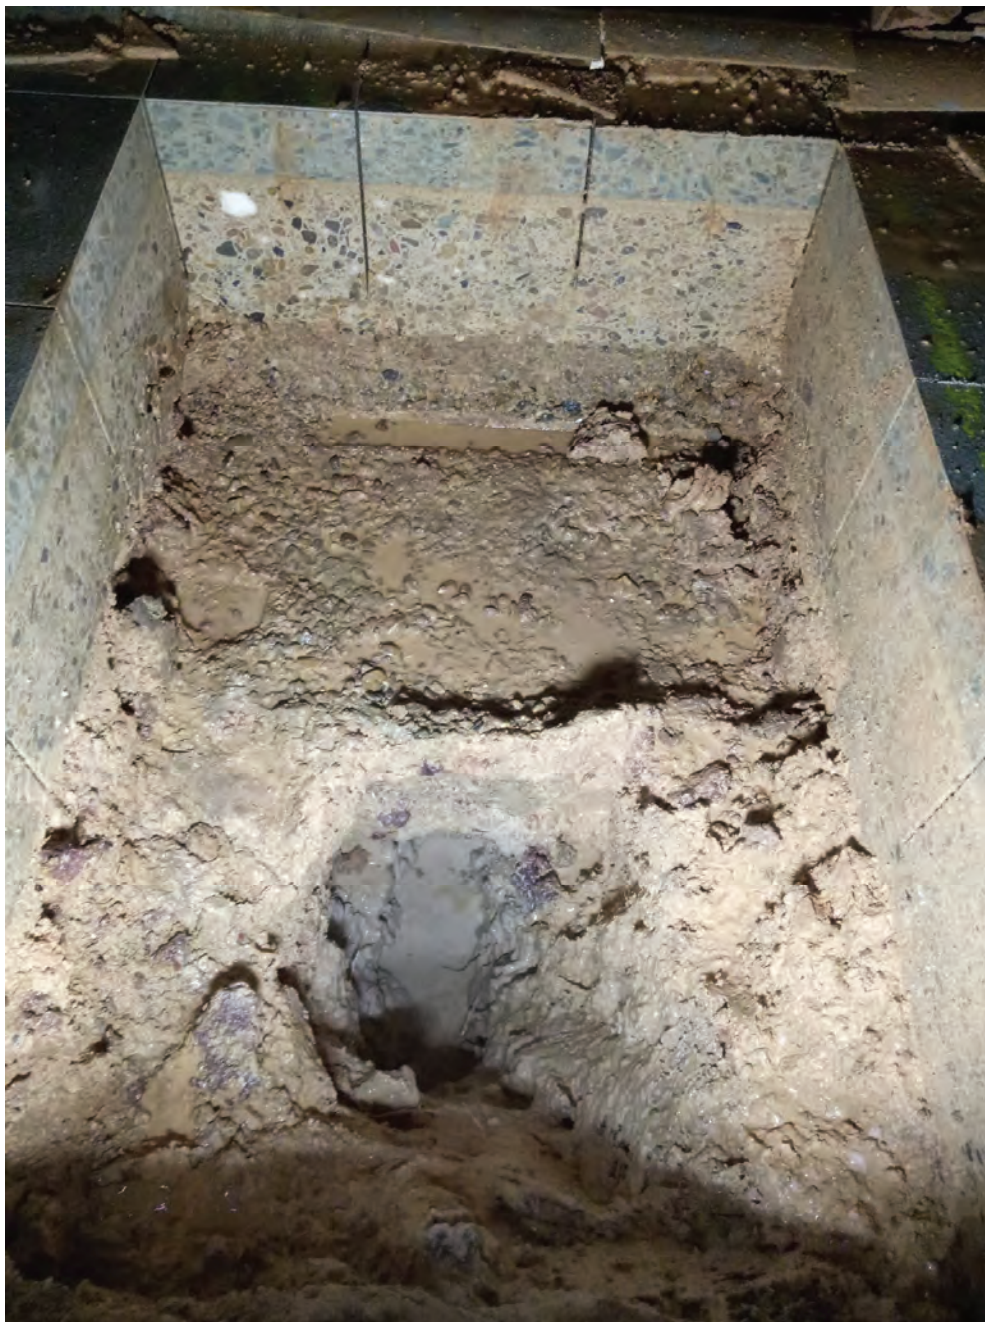
Photo 6: Vac Excavation showing footing at 3-R/S. Also note topping slab and slab on ground under.

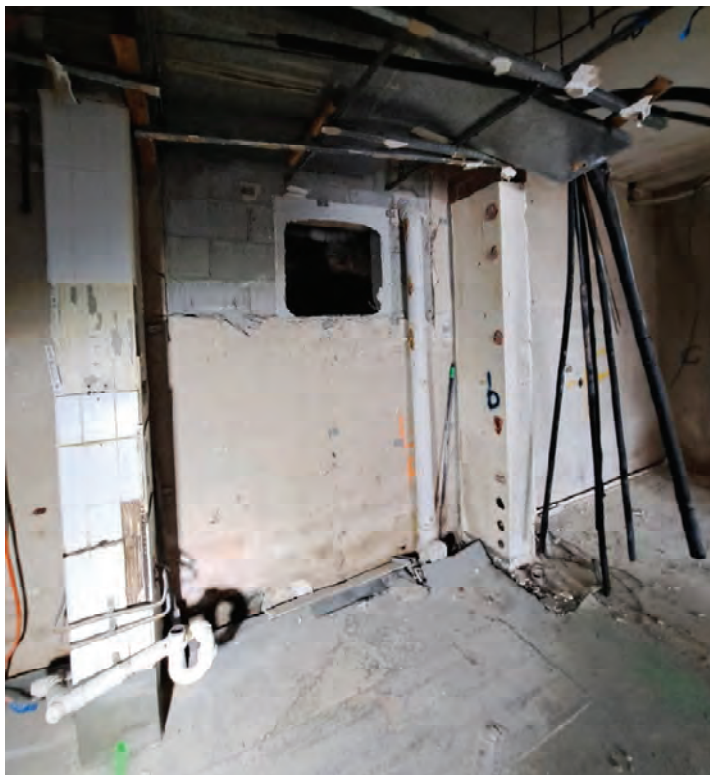
During the strip out a hole to the undercroft was found. Through it the suspended slab could be seen. Note this section of the suspended slab was originally slab on ground as discussed in the history section above.

Photo 8: Hole in rear retaining wall at 3:M-N.

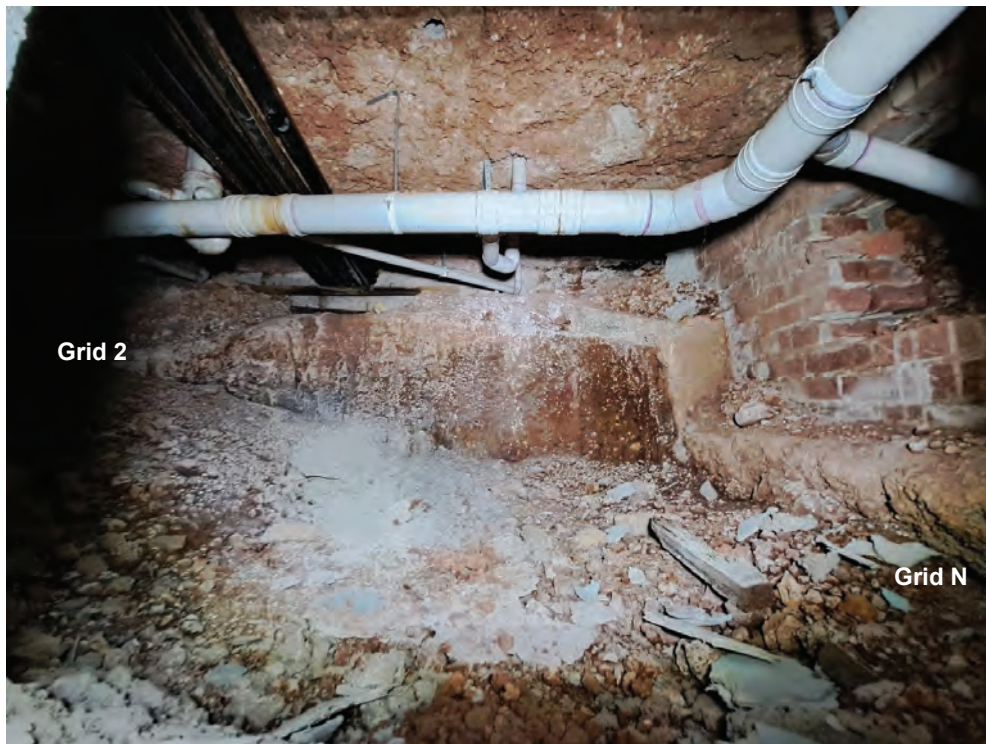
Photo 9: Taken through hole in rear retaining wall showing undercroft area. Note uneven soffit to suspended slab and same colour dirt – indicating that the slab was originally poured on ground. Also note the mass concrete footing 200-300 deep stepping up towards the back near grid 2. The brick wall was much wider than double skin. It appears to be triple skin brick with a number of removed and broken out bricks to install sewage pipes etc.

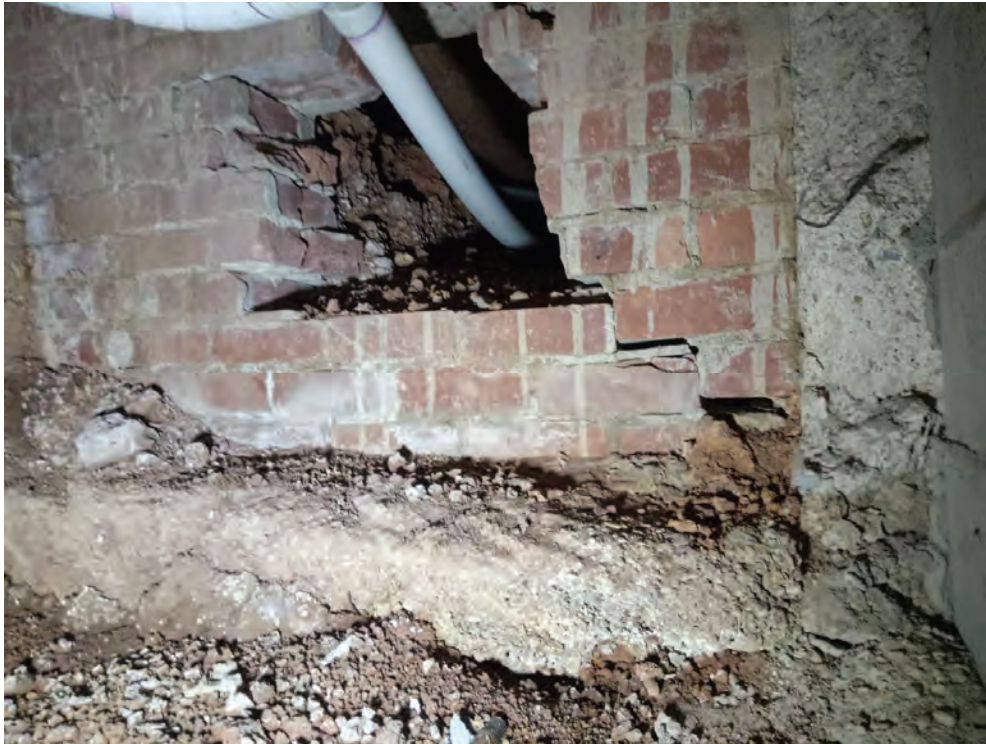
Photo 10: Diagonal cracking and gaps in undercroft sub floor support wall. Footing appears to be at least 300mm thick. Cracking indicates movement – the subfloor brick wall and footing has settled behind the rear retaining wall. This footing must not be tied to the rear retaining wall and can thus move/settle separately. See Geotech report for more details.

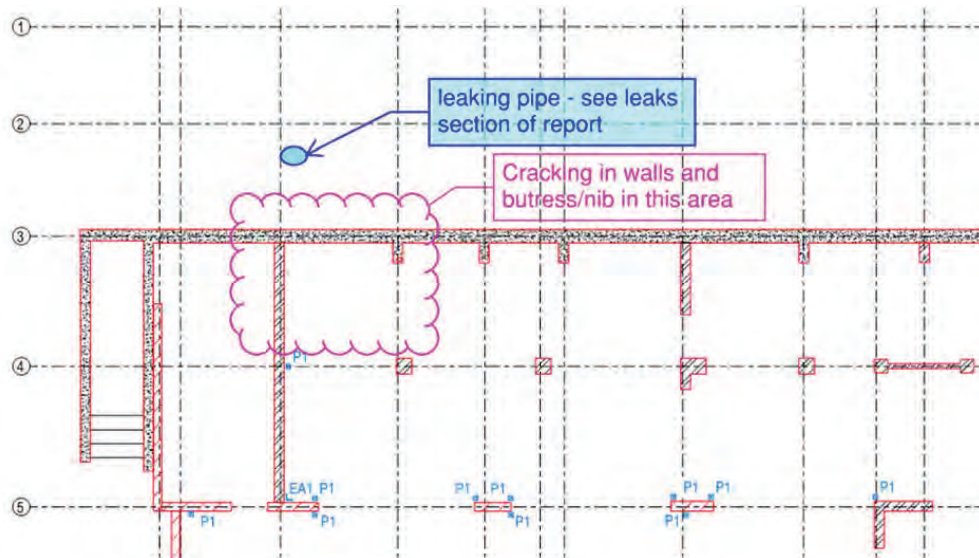
Figure 6: Plan showing corner with major cracking and leaking pipe proximity.

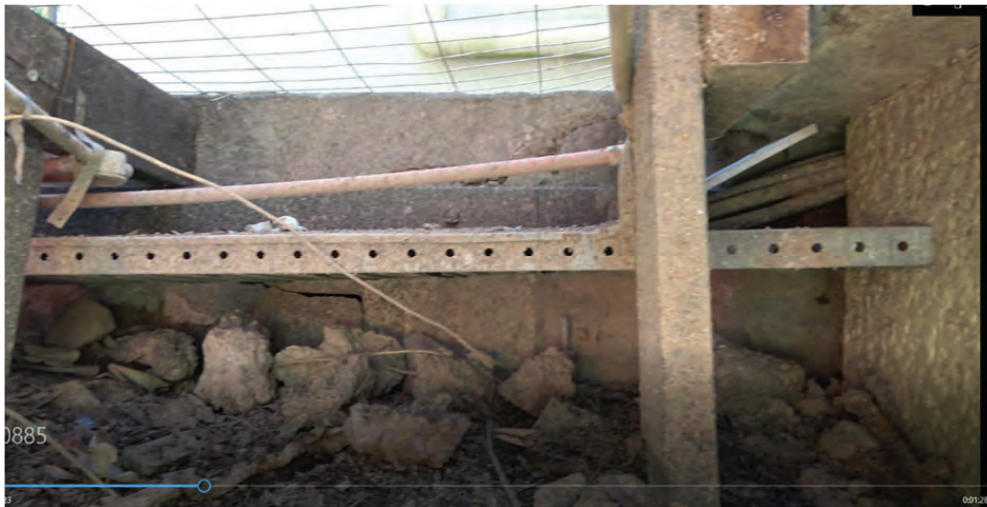
Photo 11: External cracking along sub floor walls and footing supporting slab edge at G-2/3.

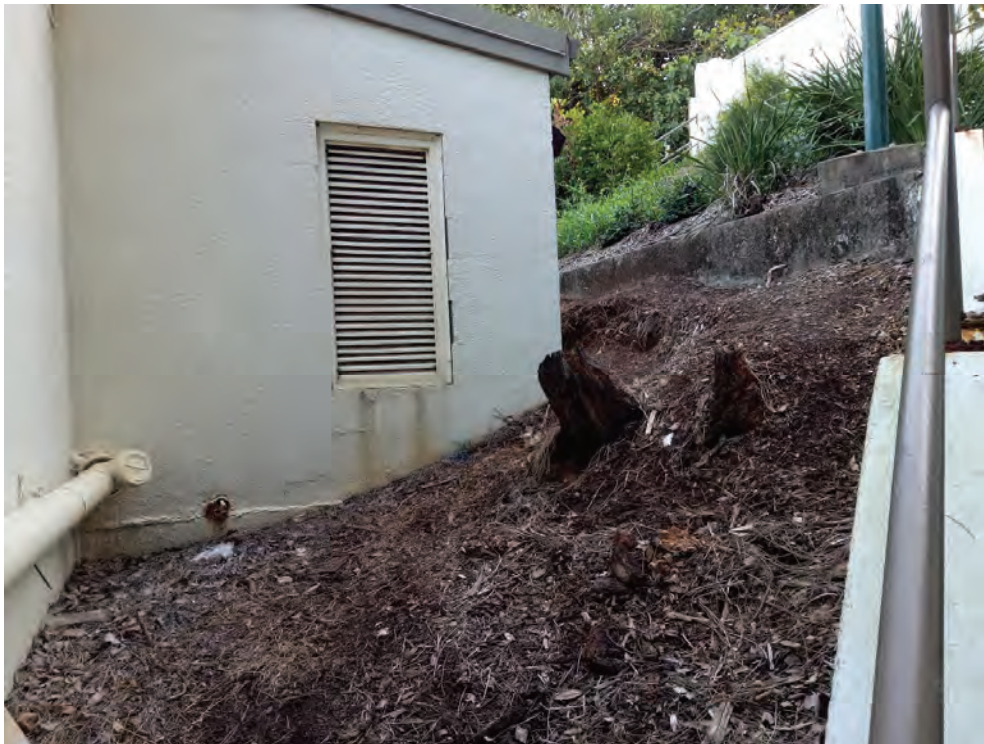
Photo 12: Stepped cracks in blockwork of plant room. Also note the horizontal crack near top left of window. These cracks indicate movement. Possibly settlement of high-level footings at the rear of the building along grid 1. Note the tree stump (termite ridden). Removal of this stump would have created a change in the moisture conditions of the surrounding soils, which in turn would affect the blockwork footings.

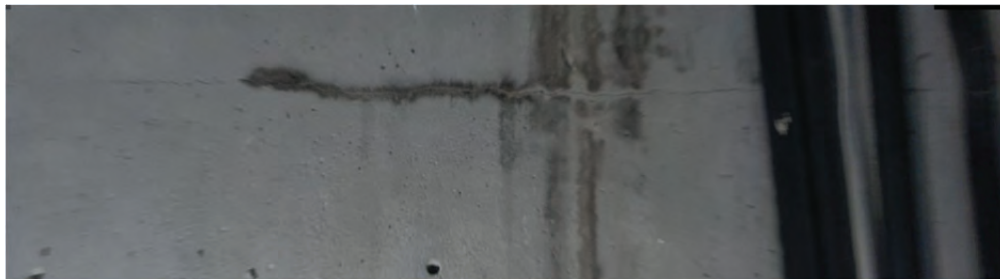
When internal linings and cladding were removed – water and moisture ingress was evident as some of these linings were warped, damaged and mouldy, same with the non-loadbearing wall framing.

Photo 3: Drip lines and mould at crack in rear retaining wall.

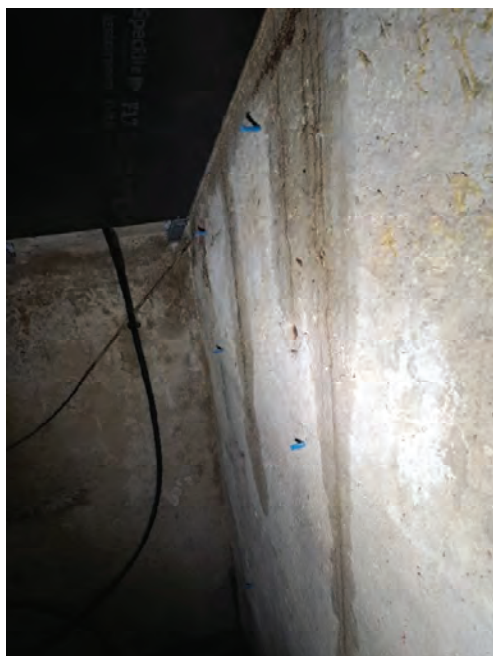
This section of wall was originally exposed beneath the stairs for many years before the area was enclosed in for a store room and later for amenities. There is a lot of water ingress in this area, especially at the stair to new suspended slab join and the top of the stair wall (see photos below). The suspended stair soffit is spalling and the beam has significant spalling, corrosion of reinforcement with section loss (*see report section on Original Concrete Beams*).

Photo 4: Water ingress at corner 3:A-B

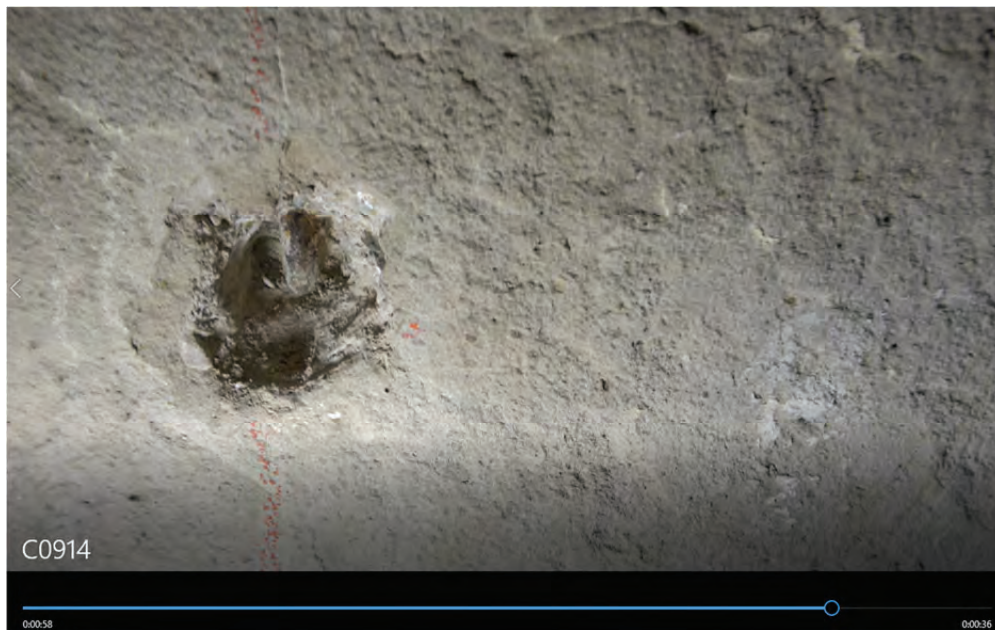
Photo 6: Break out to reinforcement in wall 3-A/C.

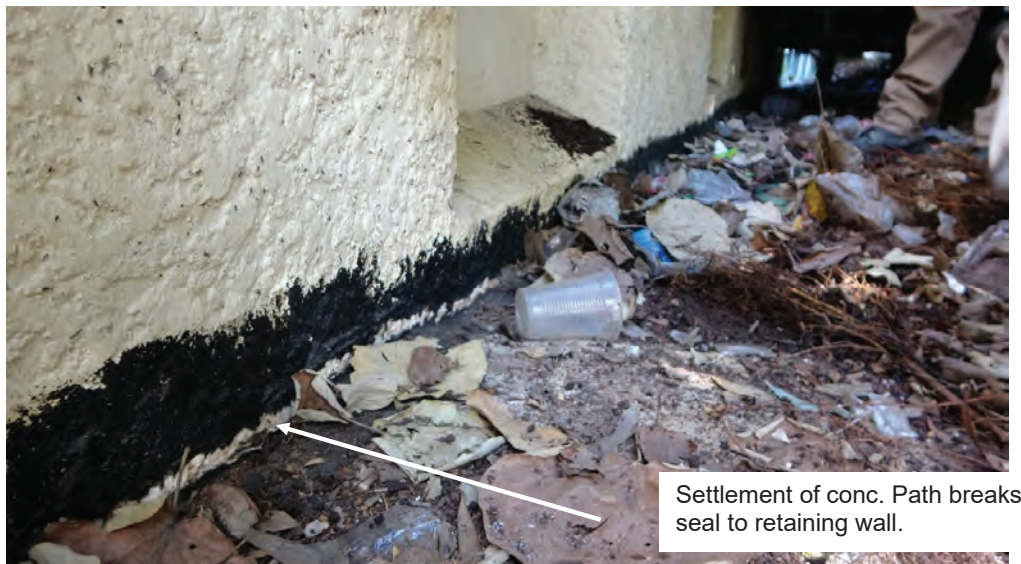
Externally the wall retains around 2m. A timber deck/path runs adjacent the back of the building through this section. There was a lot of debris – soil/leaf matter/rubbish/build up under this deck and above the concrete path/apron. The top concrete path had obviously dropped as there was a gap in the previous waterproofing (*black jack painted sealant*) that showed. Furthermore, this waterproofing was no longer sealing the joint between the wall and the external path slab.

Photo 7: Rear retaining wall section 3-D/C.

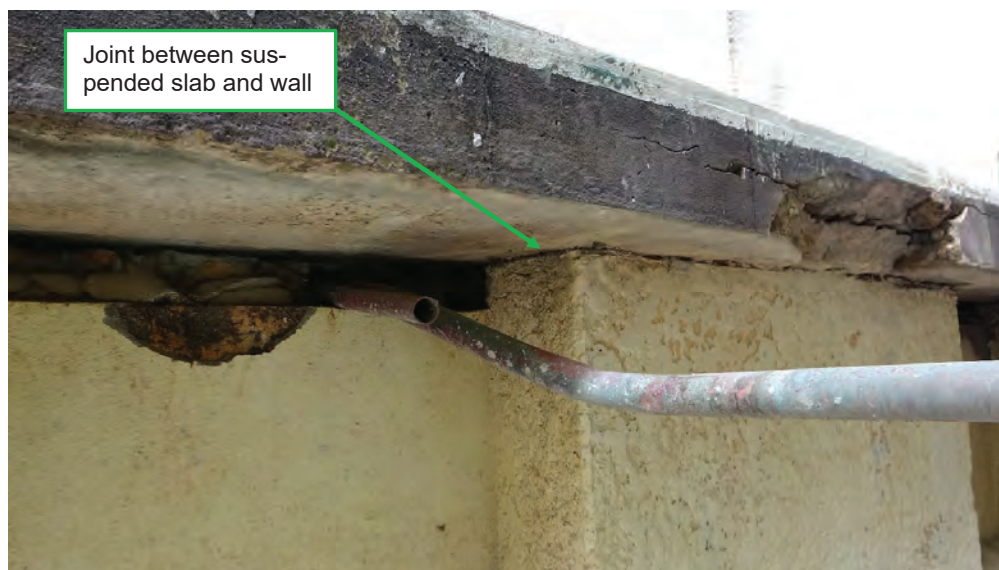
Photo 9: Rear retaining wall at approx. 3-D. Note gaps above window infills, spalling of concrete overhang, joint between suspended slab and wall.

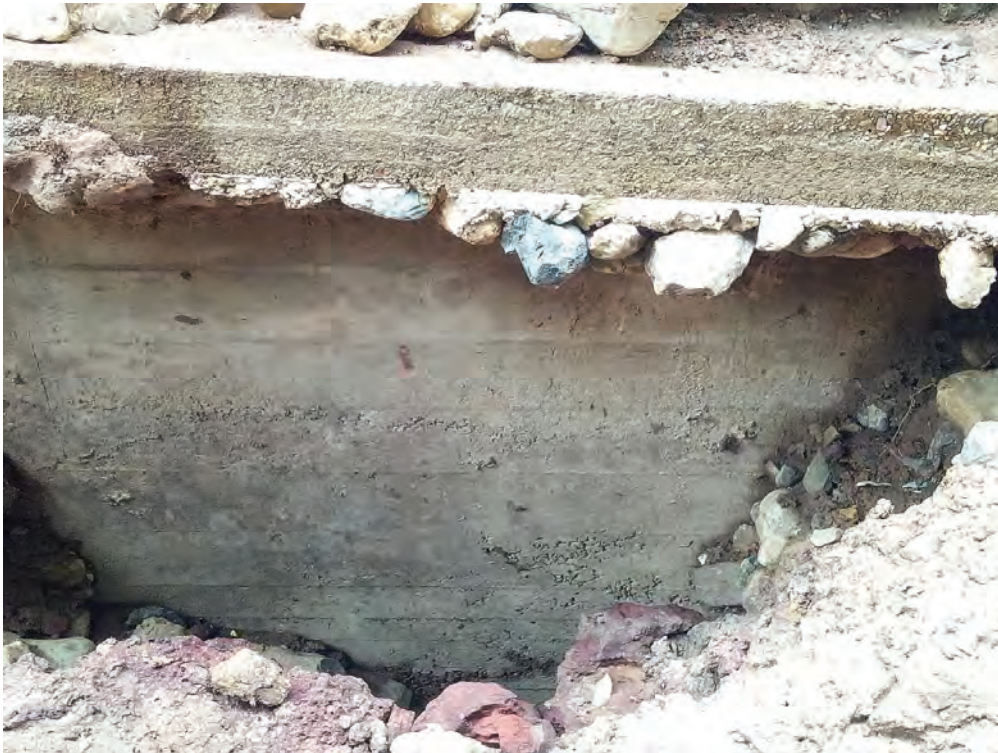
Photo 10: Rear retaining wall section 3-E/D. Note the rough surface of the concrete wall externally, with areas of boney concrete, cracks and timber form imprints. Also, the original spoon drain must have been poured directly over the original free draining backfill boulders.

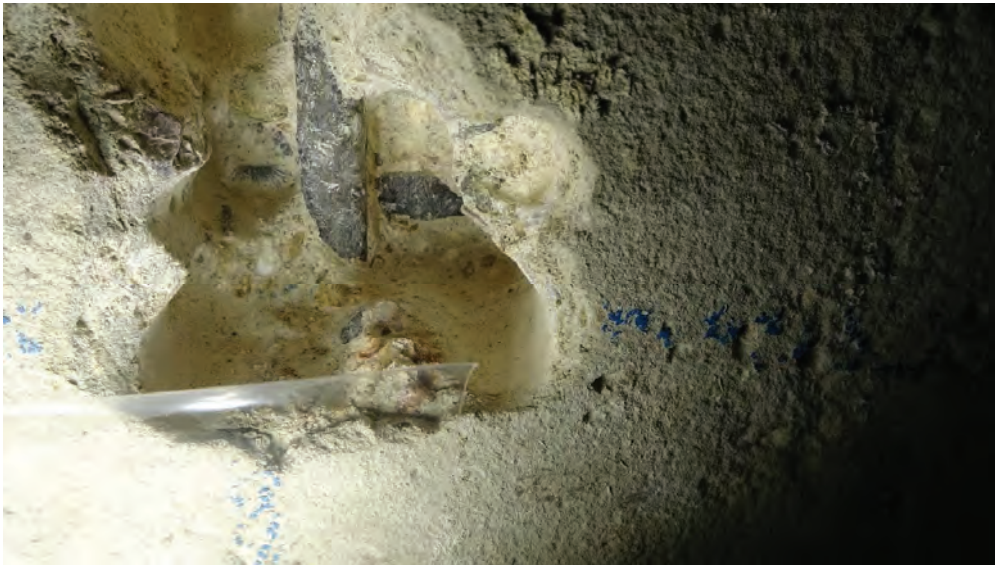
Photo 11: Shows breakout from internal face to steel reinforcement at 3:P.

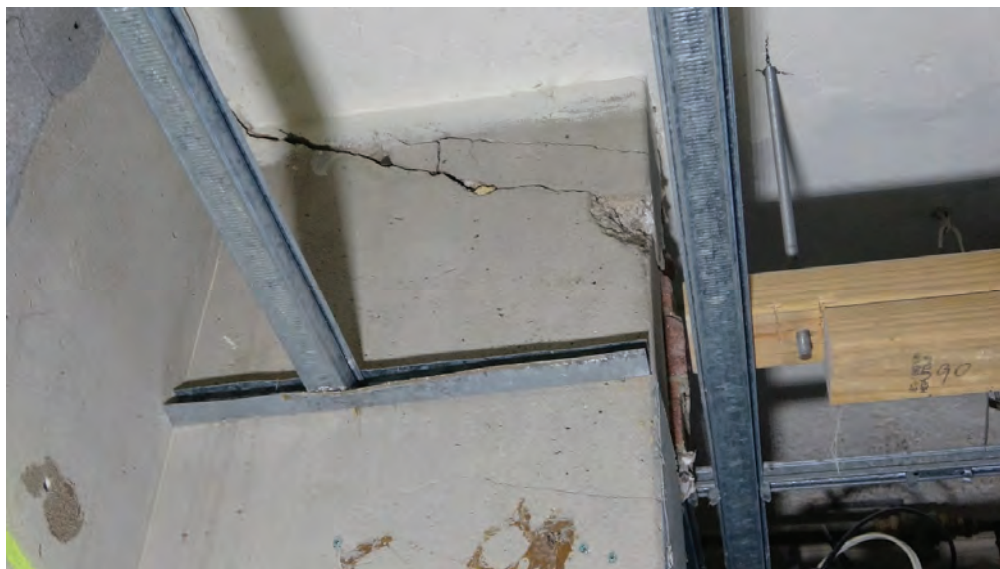
Photo 13: Photo at top of Butress column/wall at grids 3:D. Southern Face.

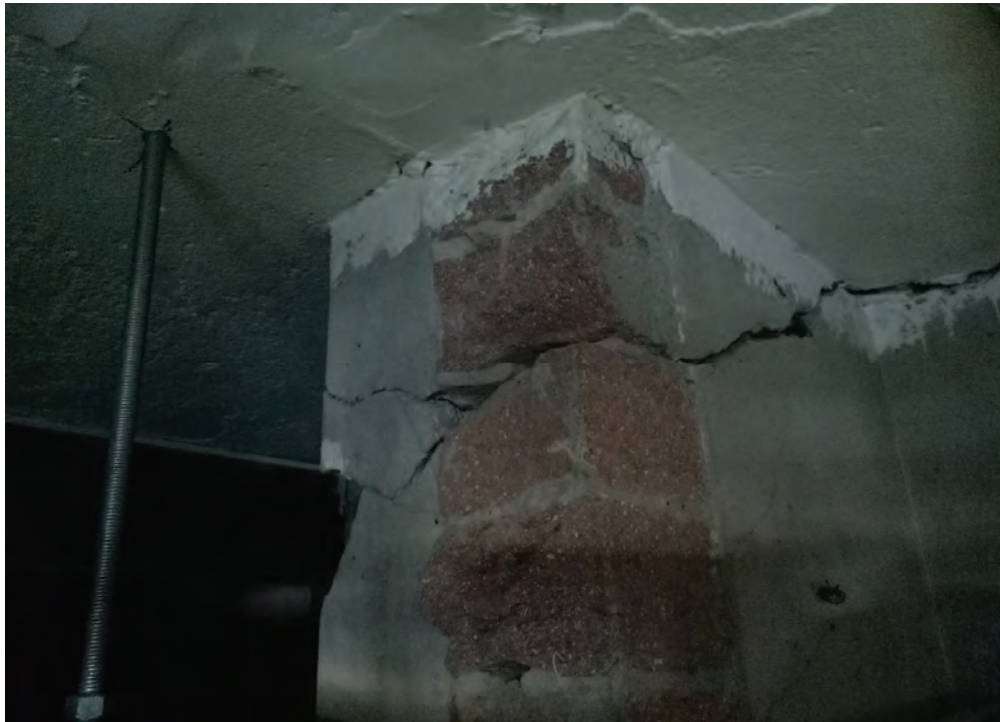
Photo 14: At top of Buttress column/wall at grids 3:D. Northern Face. The column is mostly concrete with a brick corner that used to be a continuous brick wall between the rear retaining wall on grid 3 and the column on grid 4.

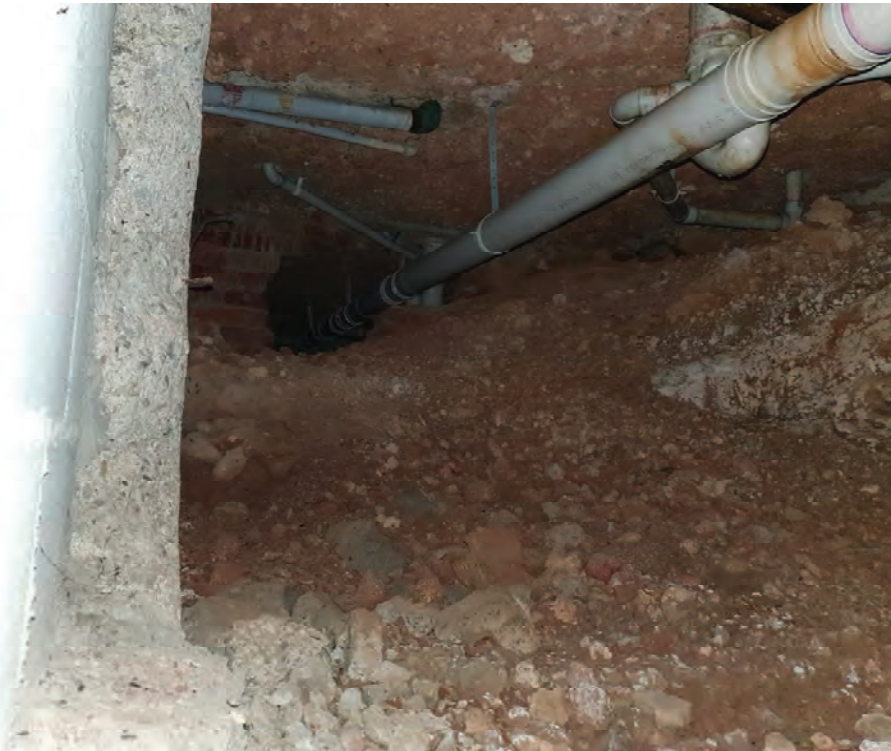
Photo 18: Taken inside undercroft area.

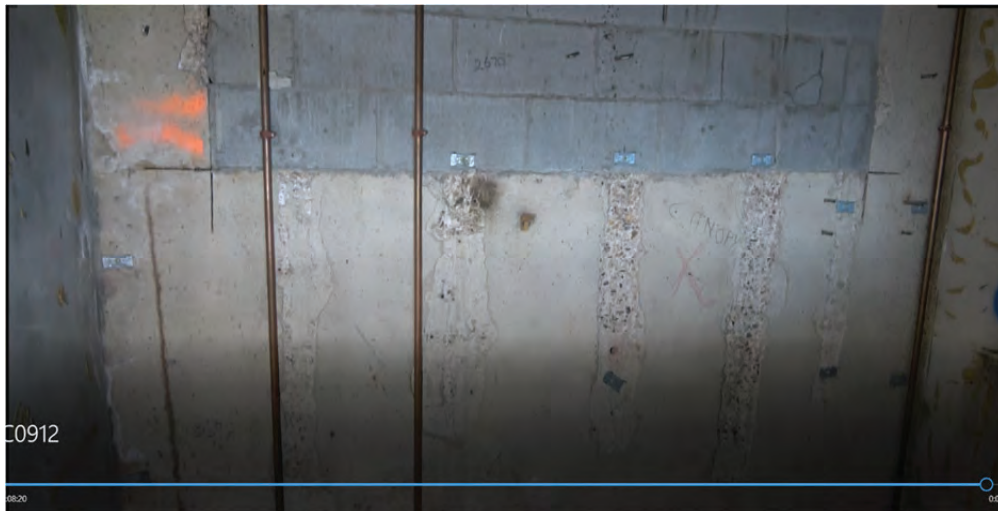
Photo 20: Wall 3:H-J is gouged out, cracked across the top at the join to suspended slab.
