APPENDIX I
JOINT REPORT: SLAB TESTING

JOINT REPORT
CARBONATION TESTING - SUSPENDED SLAB

PAVILION 1, 50 MARINE PARADE, REDCLIFFE

PROJECT NO: 223164
REF: 27735RPT - A
DATE: 22 DECEMBER 2022

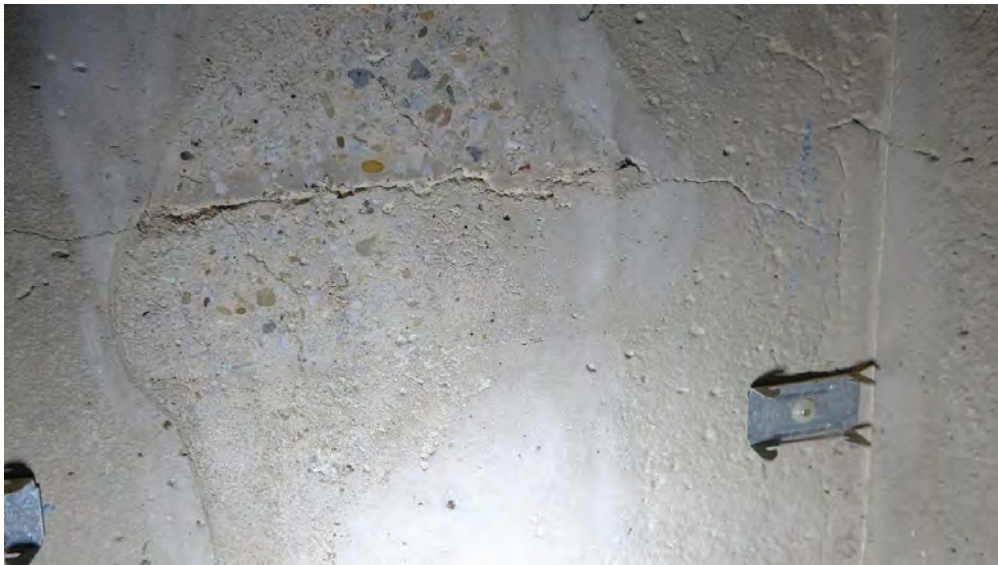
Photo 21: Rear retaining wall. Note the cracks in the render were ground back and are reflected in the concrete substrate.

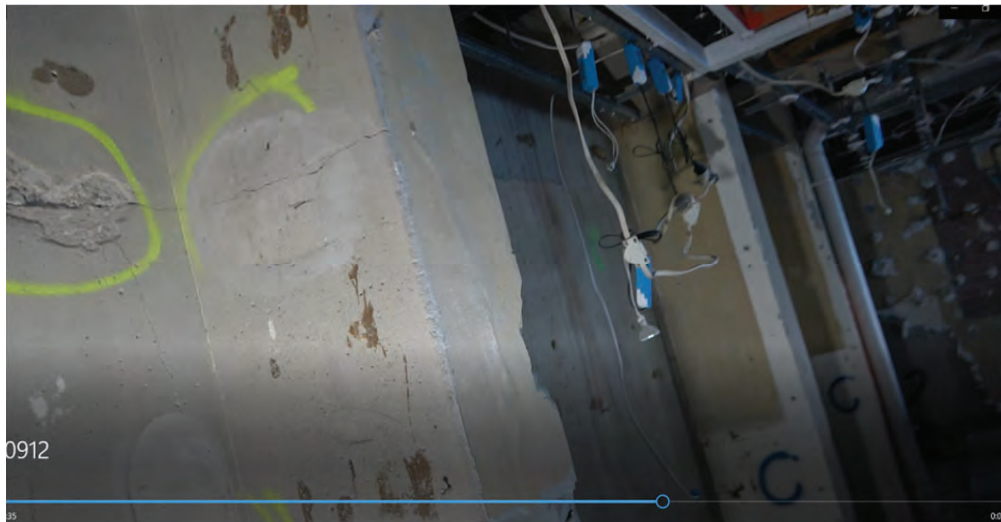
Photo 22: Cracks in render ground back show that crack is also in concrete wall and buttress substrate.

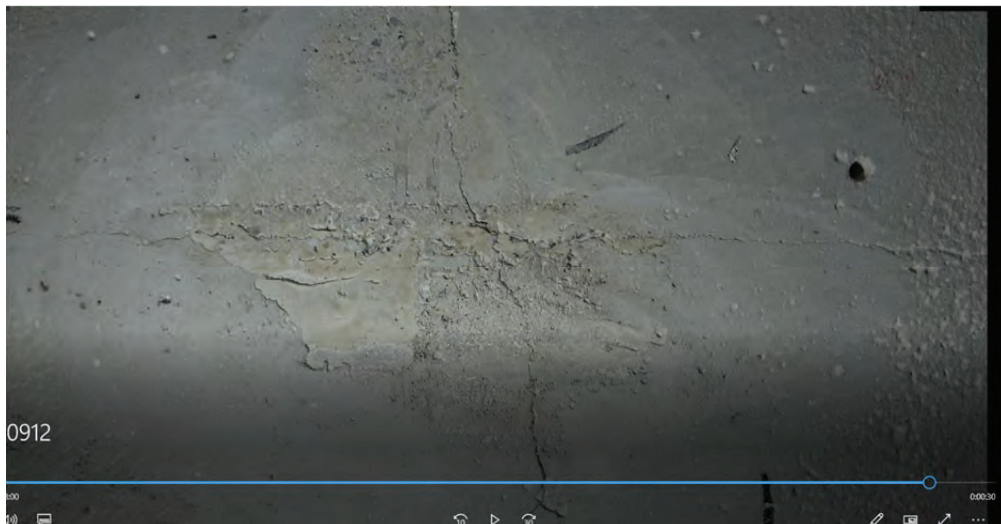
Photo 23: At 3-G/H Wall ground back shows cracks visible in render are also in wall below. Note both horizontal and vertical cracks on inside face – showing tensile capacity of concrete wall under load has been passed. Wall is operating as a cracked section.

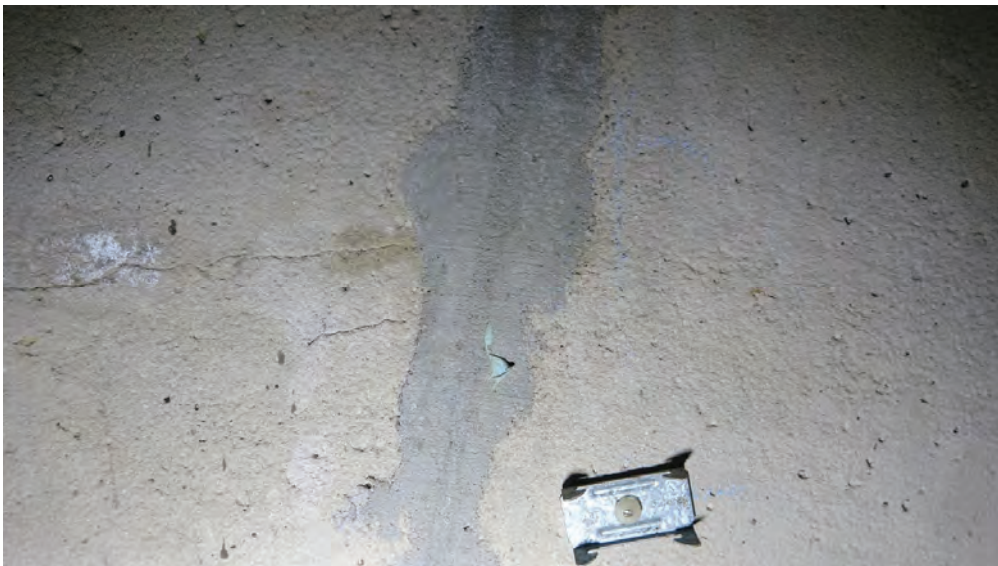
Photo 25: Rear retaining wall between grids R and S. Note the previously repaired vertical crack as well as horizontal cracks in the render.

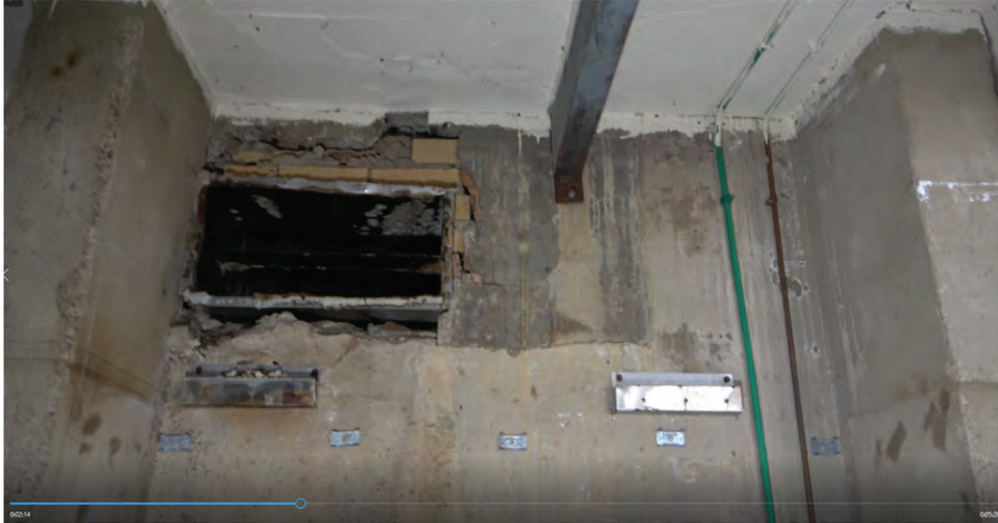
This section of wall has a similar history to that above. It should also be noted that the steel beam supporting the slab appears to be connected to the brick infill in the original window.

Photo 26: Rear retaining wall between grids S and T.

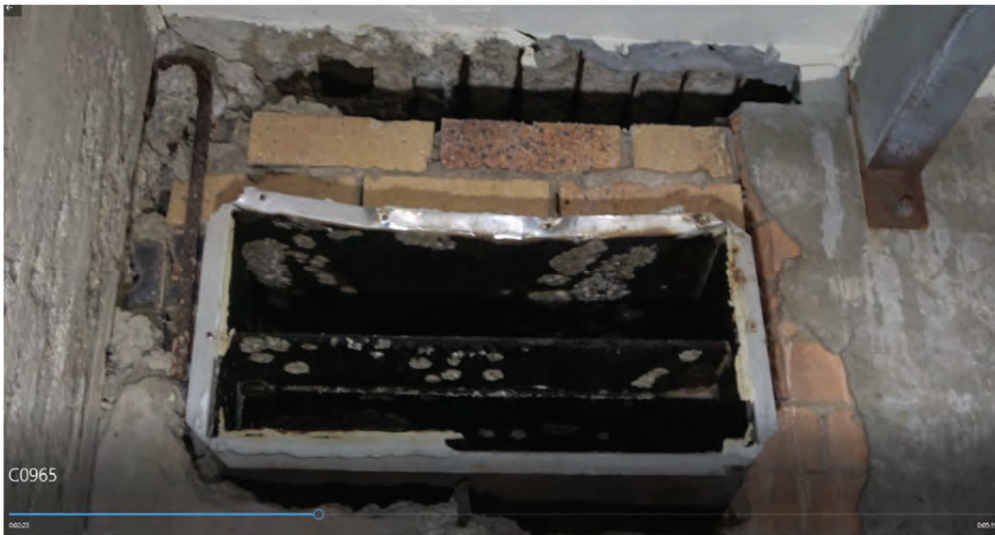
This section of wall has a similar history to that above where brick infill was used to fill the original openings, the vent openings have gaps and are not sealed. It should also be noted that the steel beam supporting the slab appears to be connected to the brick infill in the original window. The vent openings have gaps and are not sealed. The wall is not connected to the suspended slab.

Photo 27: Rear retaining wall between grids U and V. Note the vertical bar on the left cogs over below the slab level. Also note the exposed slab reinforcement due to the slab soffit falling down when the layer of bricks directly beneath it was removed.

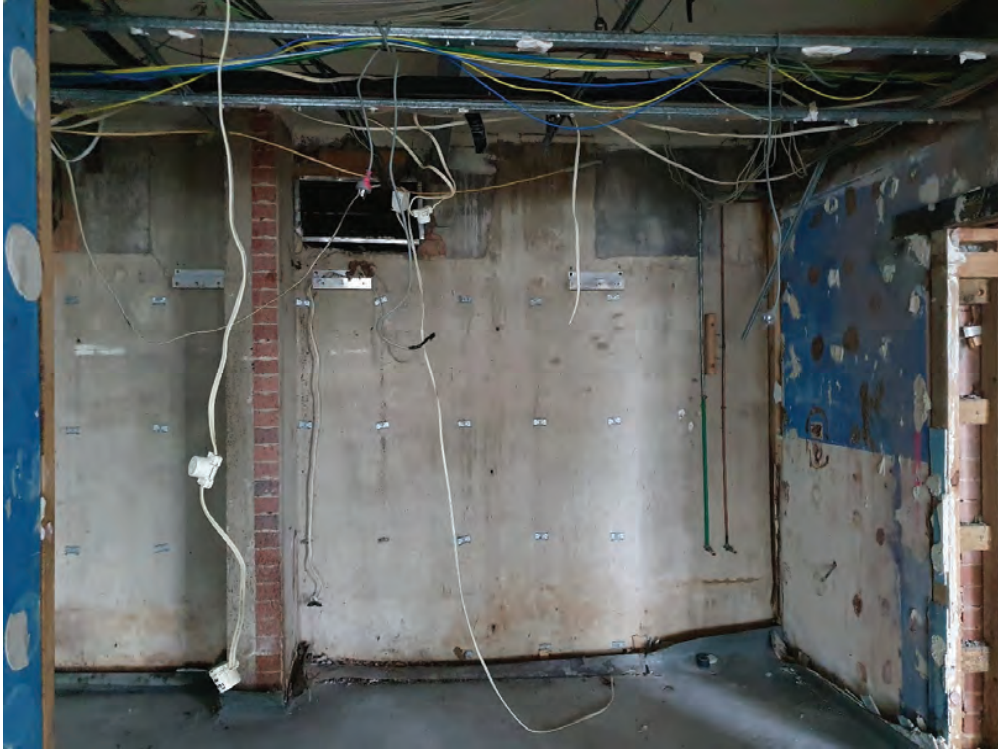
Photo 28: Rear retaining wall between grids V and W. Note darker grey grout on the brick infills in the original windows.

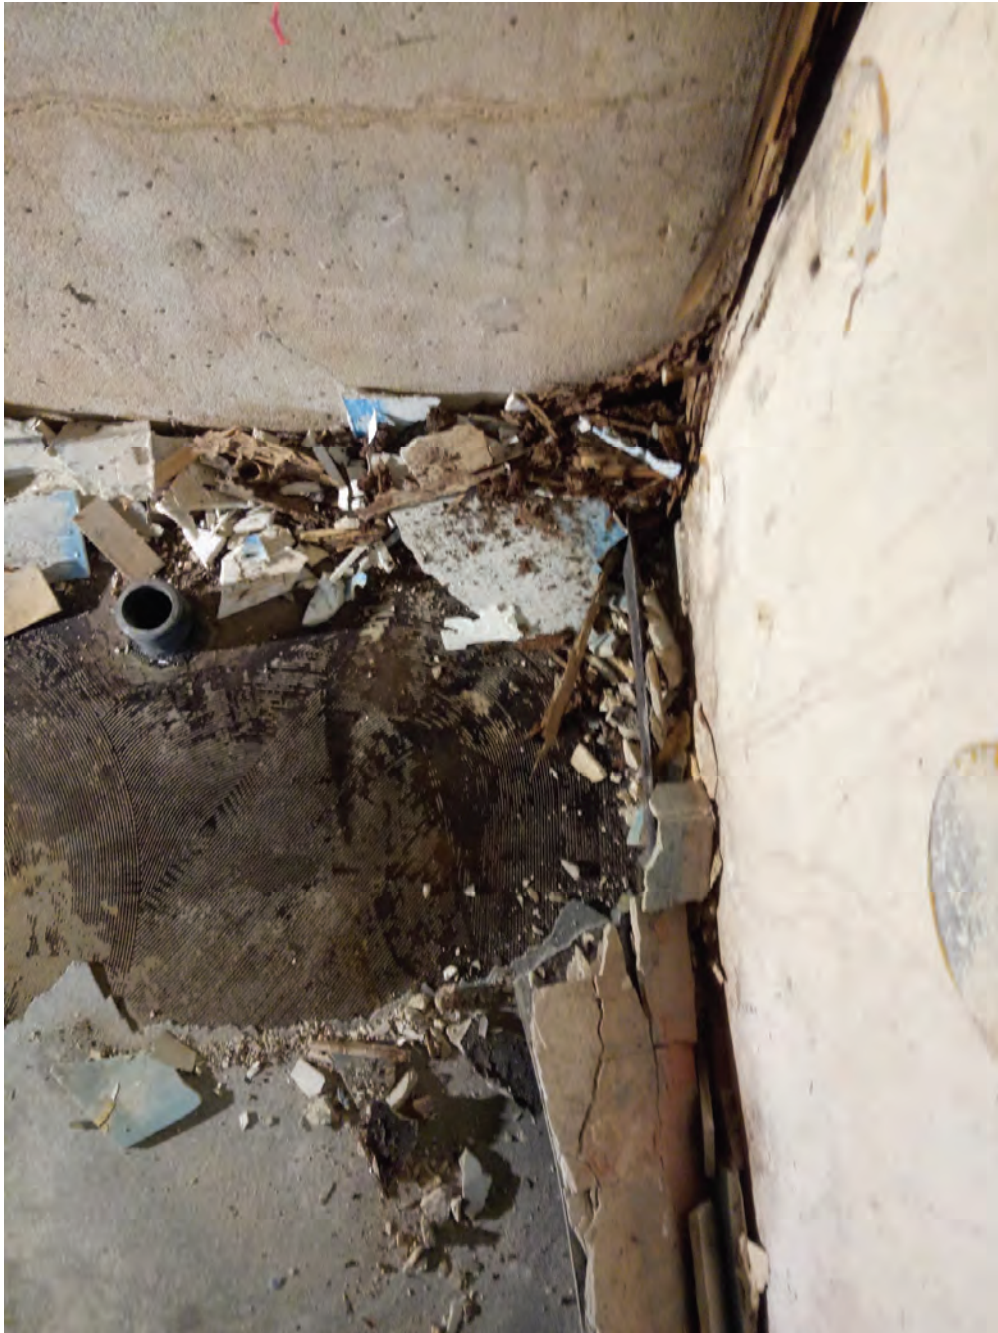
Photo 30: Corner at 3:W Shows severe termite damage and wet rot to non-loadbearing wall framing timber. Also note the horizontal crack has water marks around it.

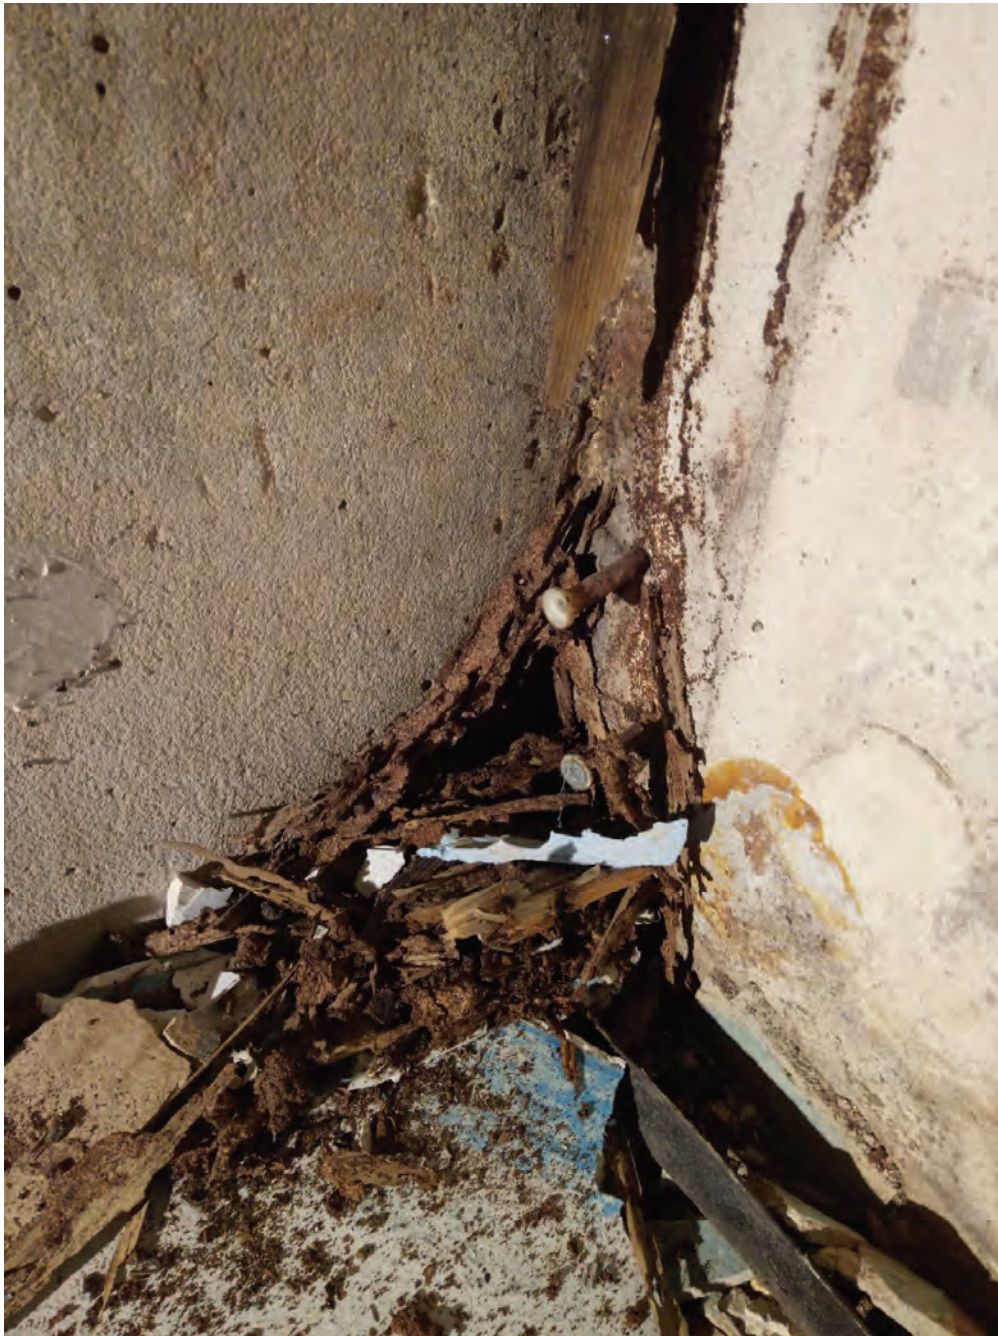
Photo 31: Close up of the above photo showing termite damage, wood rot and mould.

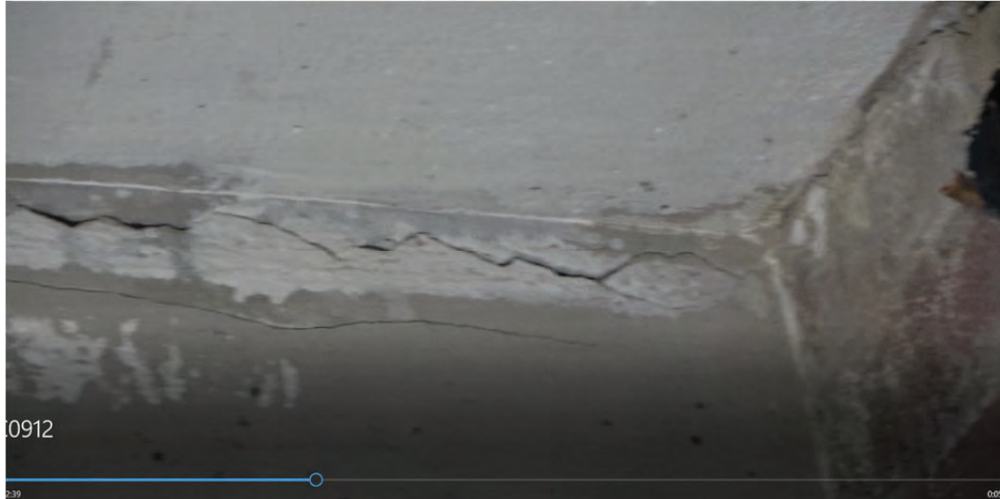
Wall to slab joint cracked in many places:

Photo 32: Cracks in top of retaining wall at join to suspended slab and brick wall at 3:R Southern side.

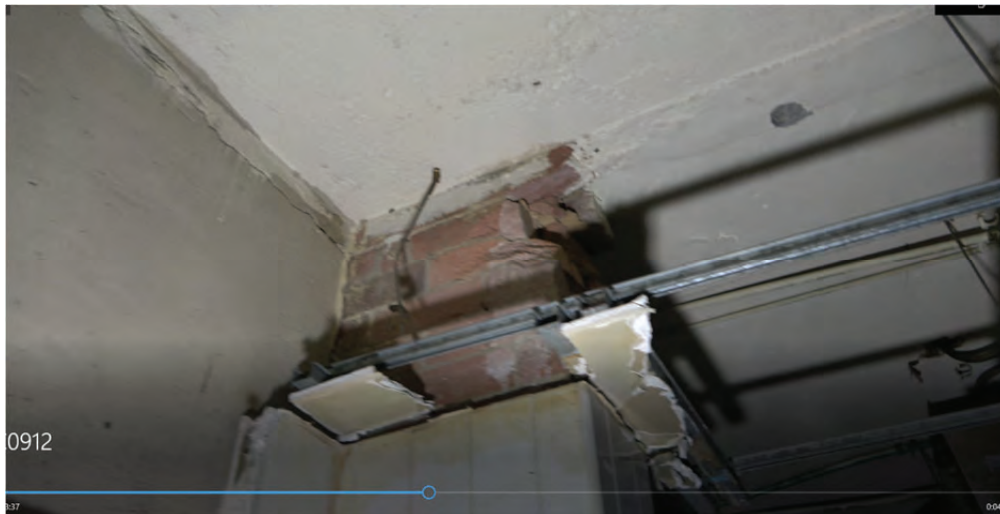
Photo 36: Removed brick wall at L-3/4. Note crack along the rear retaining wall to slab join as well as crack in slab and core hole through slab.

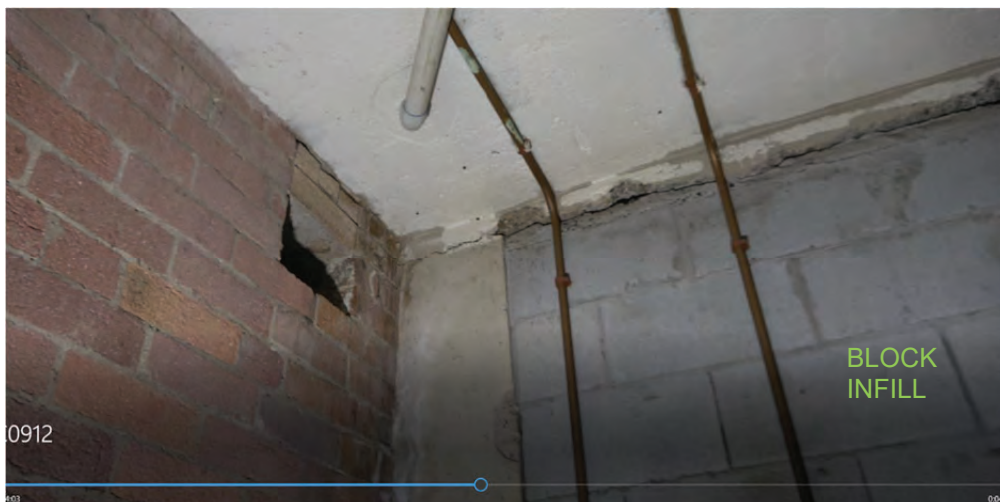
Photo 37: At 3-H/J Note cracking along top of what's left of the rear concrete retaining wall.

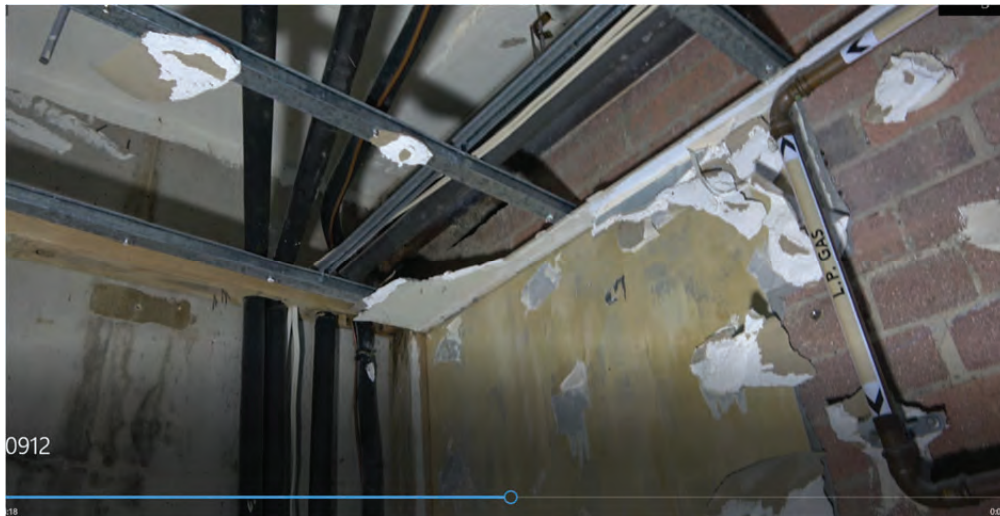
Photo 38: Wall at 3-G to H. Note horizontal cracks in rear retaining wall and mould. Also, perpendicular brick wall along grid H.

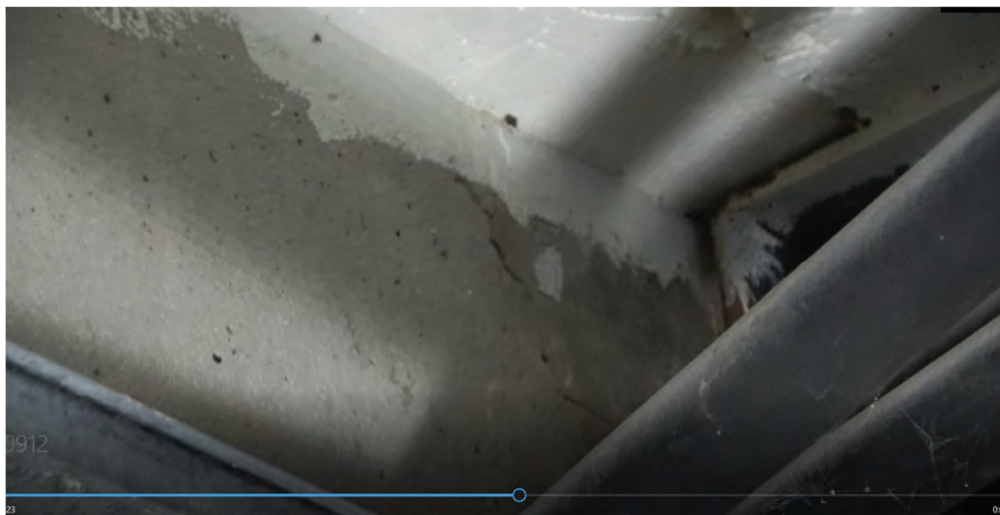
Photo 39: Cracking in rear wall (close up from above photo) at grid 3:H.

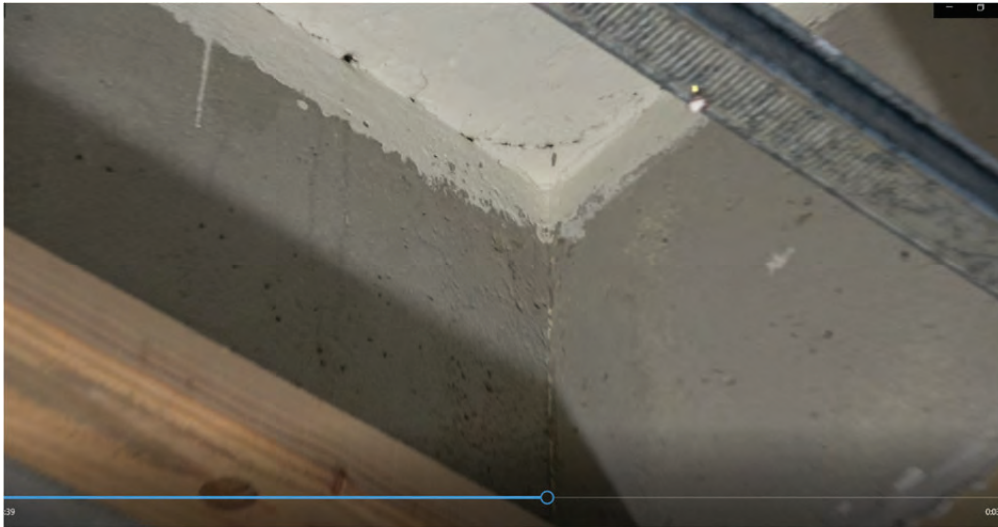
Photo 40: Cracking at 3:G in slab at buttress/wall.

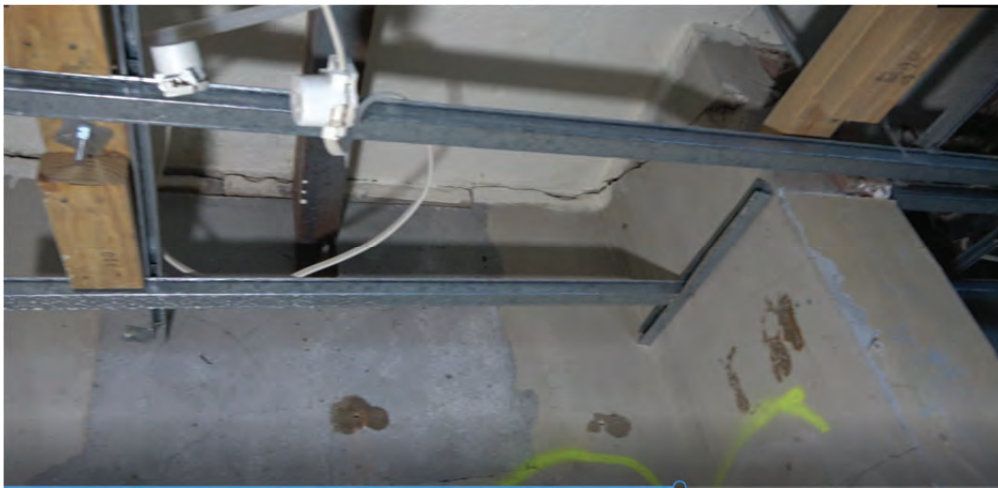
Photo 41: Crack/gap between slab and retaining wall all the way between 3:D-C.

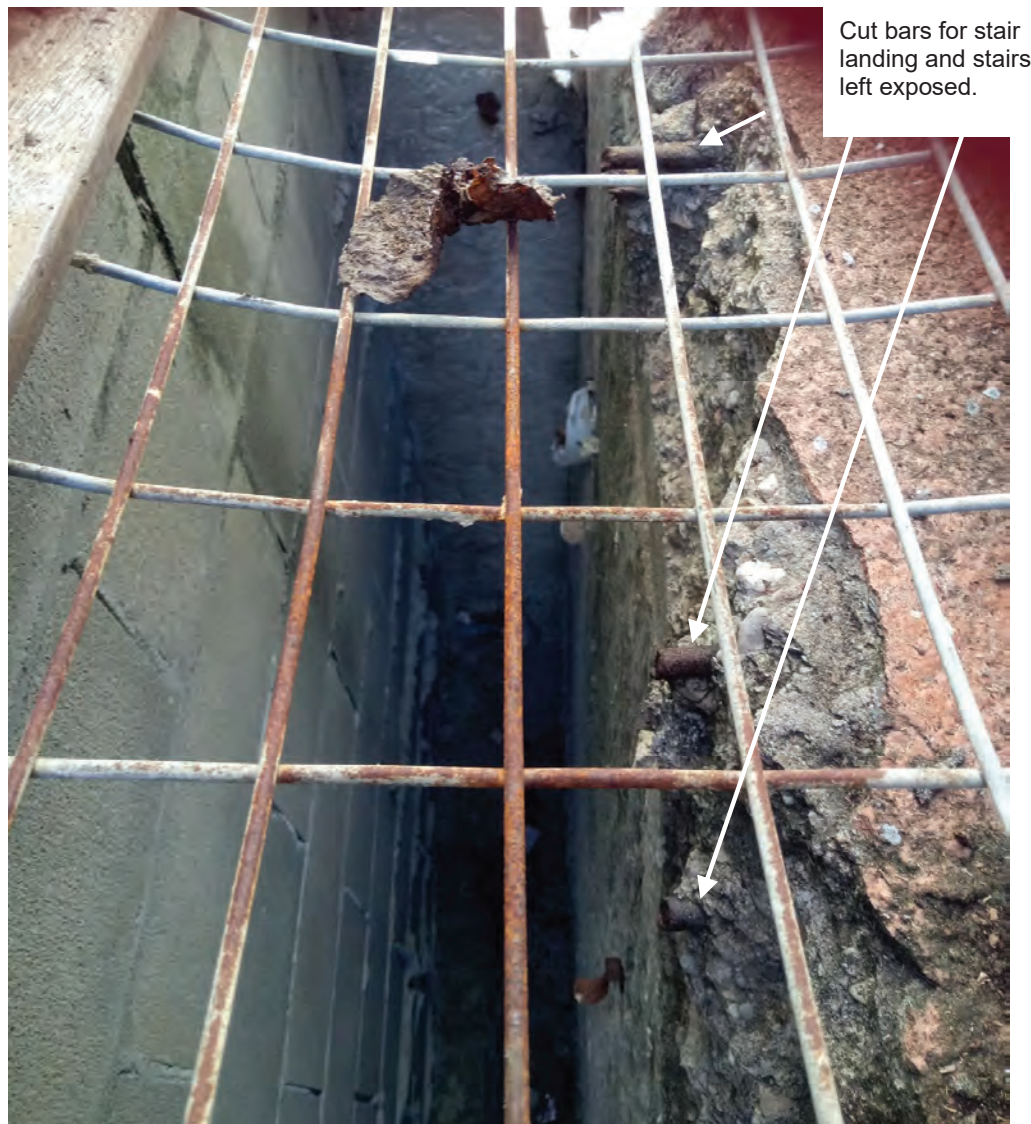
This section of the rear retaining wall was originally part of the suspended stairs but they were cut off leaving reinforcement exposed (possibly in 2001 renovations). This wall is in the “*Link Area*”. Part of it was exposed beneath the stairs for many years and was originally supported by the suspended stair, landing and the perpendicular section of the stairs. This wall is exposed to the weather.

Photo 43: Top view looking down at original rear retaining/stair wall on the right. Note cut exposed reo.

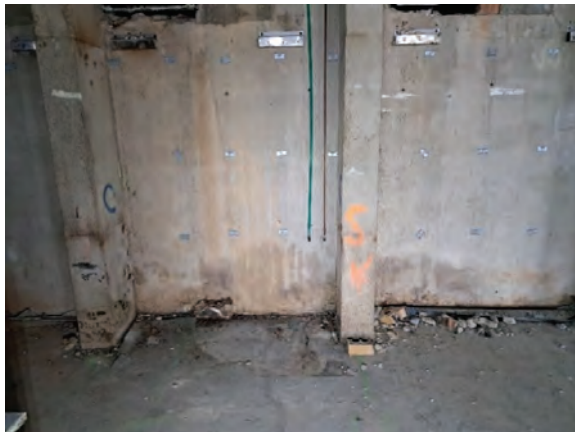
Although not quite obvious, the attached photo (3), taken at grid 3:S/U, is somewhat representative.

Photo 3 – vertical cracking at grid location 3:S/U
