STRUCTURAL ENGINEERING REPORT

Structural Condition Audit

**Sutton Beach Pavilion 1
Marine Parade, Redcliffe QLD 4020**

FS1499FL-SER01

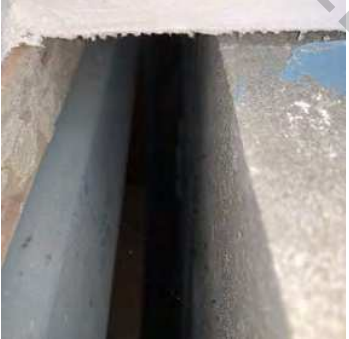
Defect D1 C5 Spalling concrete to soffit of Level 1 slab; evidence of past repairs, evidence of corroded reinforcement in local patches.	Removal of all finishes, framing and services to enable access to slab for full inspection and repair.
Ground Floor Grid H

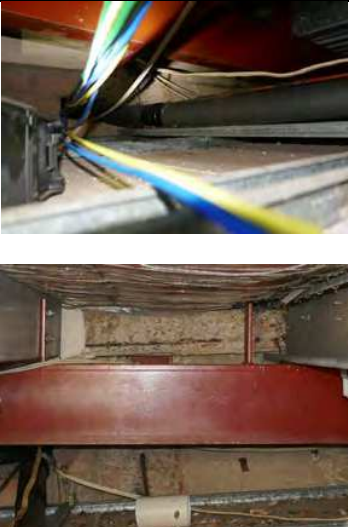
Defect D2 Exposed corroded reinforcement.	Access to area challenging due to new structures.

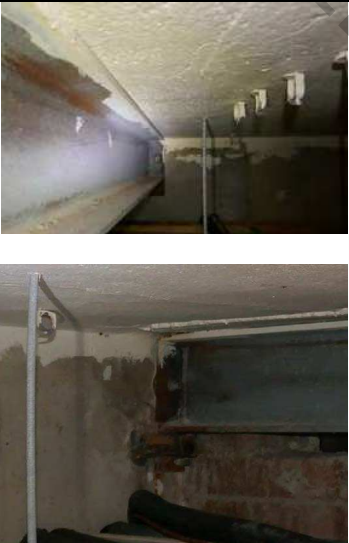
Defect D3 Connection supplementary floor beam to wall appeared unfit for purpose. Minor corrosion (S2) to unprotected steelwork	Removal of all finishes, framing and services to enable access to connection for design and installation of upgraded connection
Ground Floor Grid E

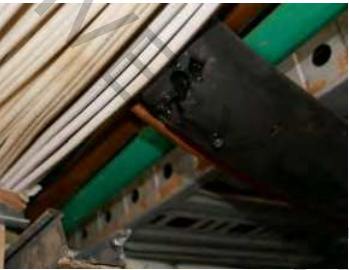
Defect D7 Noted condensation on existing refrigeration lines; likely resulting in water ingress to structural members and finishes	Removal of existing ceiling to enable make good works to refrigeration lines
Level 1 Grid A

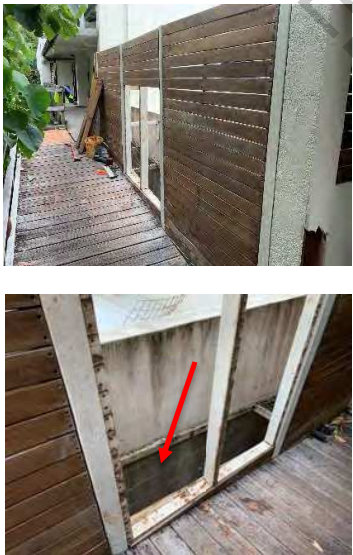
Defect D11 Location of block wall that does not appear to be waterproofed resulting in water ingress to Ground Level	Safe access to undertake repairs appears to be not possible due to the narrow access between original western wall and newer block wall. Repairs would require construction of a second retaining wall to the west.
Level 1 rear of 'link structure' – drainage void (from rear boardwalk)

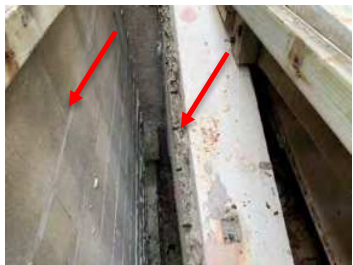
Defect D11 Location of block wall that does not appear to be waterproofed. Corrosion of exposed reinforcement to original wall.	Safe access to undertake repairs appears to be not possible due to the narrow access between original western wall and newer block wall. Repairs would require construction of a second

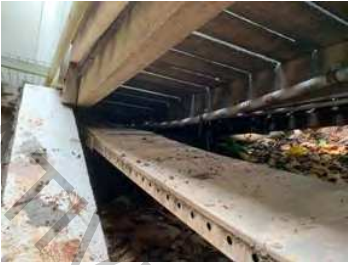
Defect D12 Failed structural support of electrical cable tray	Access via under boardwalk
Rear of 'link structure' – drainage void

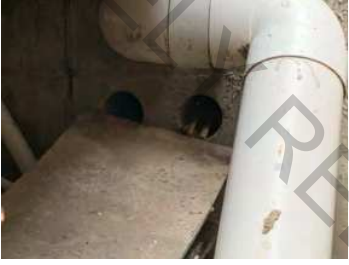
Defect D12 Failed structural support of electrical cable tray	Access via under boardwalk
Rear of 'link structure' – drainage void

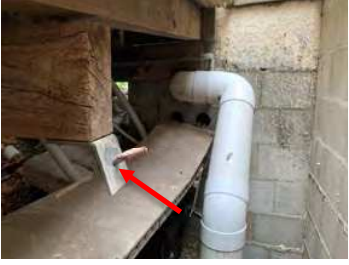
Defect D14 Local support of bearer has been compromised	Removal of boardwalk
Rear of 'link structure' – drainage void

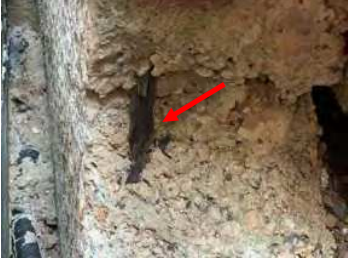
Defect D11 Corrosion of reinforcement in original structure	Safe access is impossible to achieve due to the narrow gap between original western wall and newer block wall

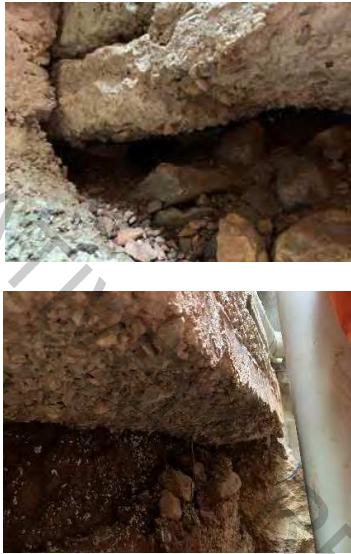
Defect D13 Undermining of original concrete approximately 1.5m above drainage void floor level	Removal of boardwalk and demolition of remaining pathway. Likely need to undertake batter stability or retaining works
Ground Level link structure - Internal rear wall

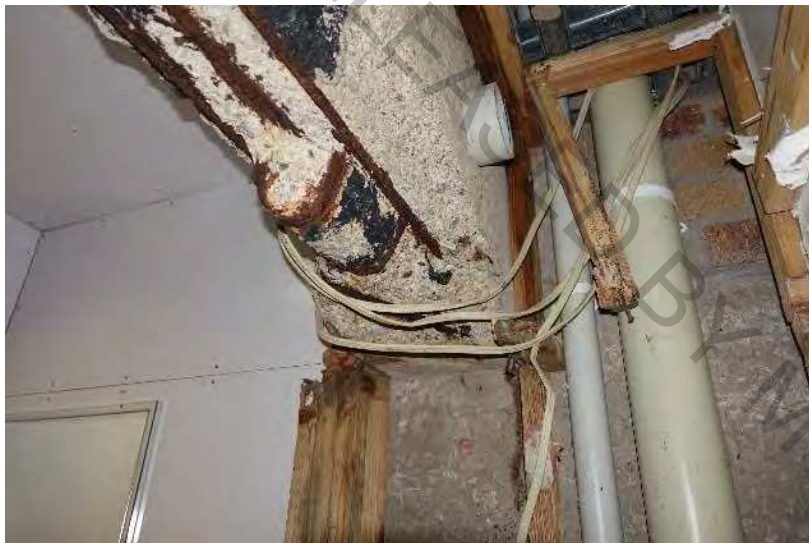
Significant concrete spalling and corroded reinforcement (C6) were identified to the beam and to the soffit of the Level 1 slab. A technical specification for the recommended remedial works to the beam and slab soffit was issued to MBRC by FSACE on 4 February 2020 (reference FS1499FL-SP01). This specification is not appended to this report.

Significant concrete defects were noted to the ceiling area of the Pavilion PWD facility (south west corner of building - D15 – see image below). Significant spalling and deterioration of the reinforcement through the support beam and ceiling of the PWD facility was noted.

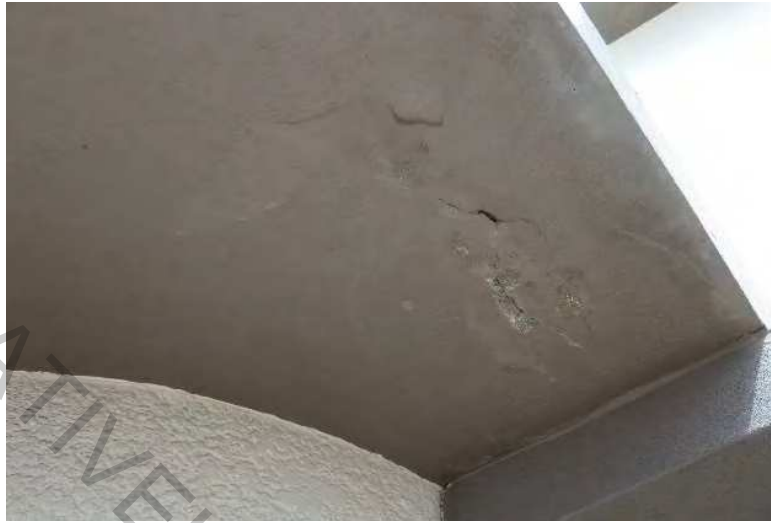
- Soffit of Level 1 slab (D1) on the west of Pavilion 1;
- Soffit of Level 1 slab (D4 – see image below) to the eastern original entry;
- Ground level western wall (D2);
- Northern wall in the Link section (D11).
- External concrete stairs to the south west of Pavilion 1 (D8 - noted as part of the original structure).

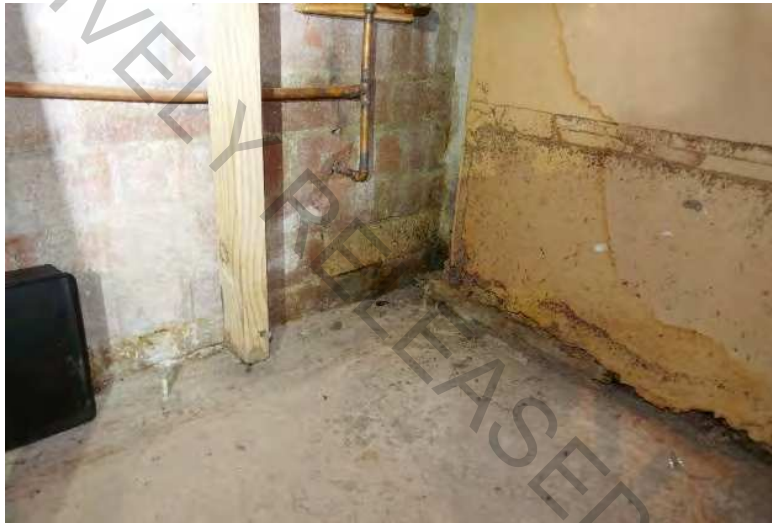
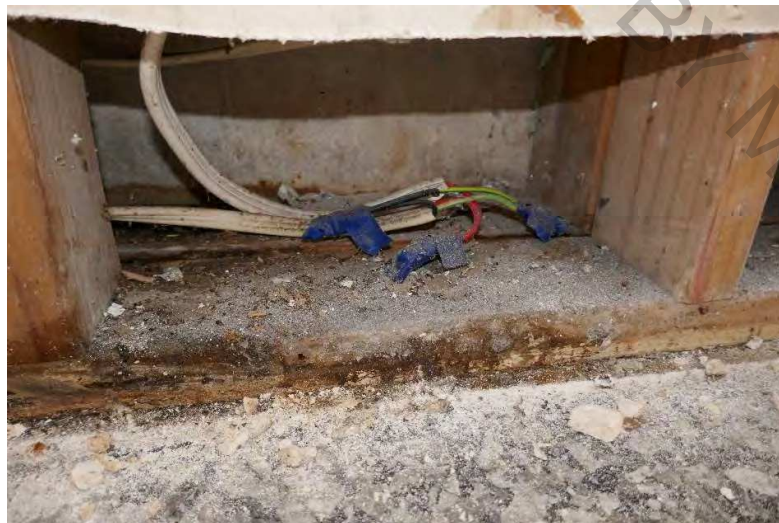
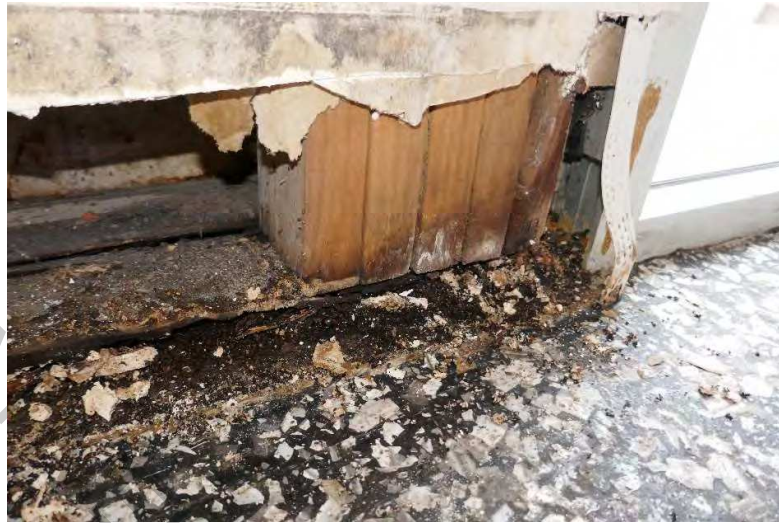
- Ground floor western wall internal lining framing (D5 - non-structural – first image below);
- Level 1 wall framing to perimeter of structure (D9 and D10 - assumed as a common defect to all upper level wall framing – second and third image below);
- Level 1 roof framing – corrosion noted generally to roof framing members with assumed water damage to roof framing where continued ingress has been occurring (assumptive based upon roof condition).

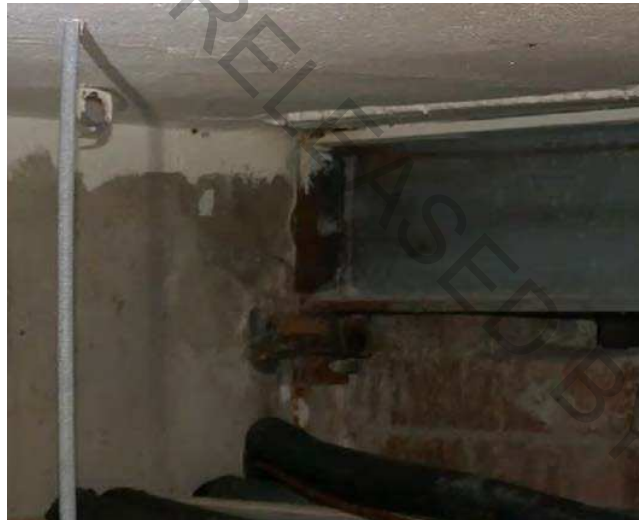
Further, partial invasive investigation into the ground floor ceiling space identified member surface corrosion and defective floor beam connections (D3 – refer image below).

- Repairs to floor framing connections is problematic without the removal of internal ceiling linings and services.
- Whilst ground floor framing is non-structural, repairs will be required at some point to mitigate local failure of the partition and its lining:
 - Repairs will require full stripping of all fit out along the back wall and replacement of same, which will be a significant undertaking considering the majority is kitchen equipment.
- Upper level wall framing to the full perimeter is deemed to be degraded, in several cases the bottom plate has completely collapsed rendering roof framing support compromised:
