Sutton Beach Pavilion, Redcliffe

Structural Condition Audit Peer Review

Moreton Bay Regional Council

Project no. 7366

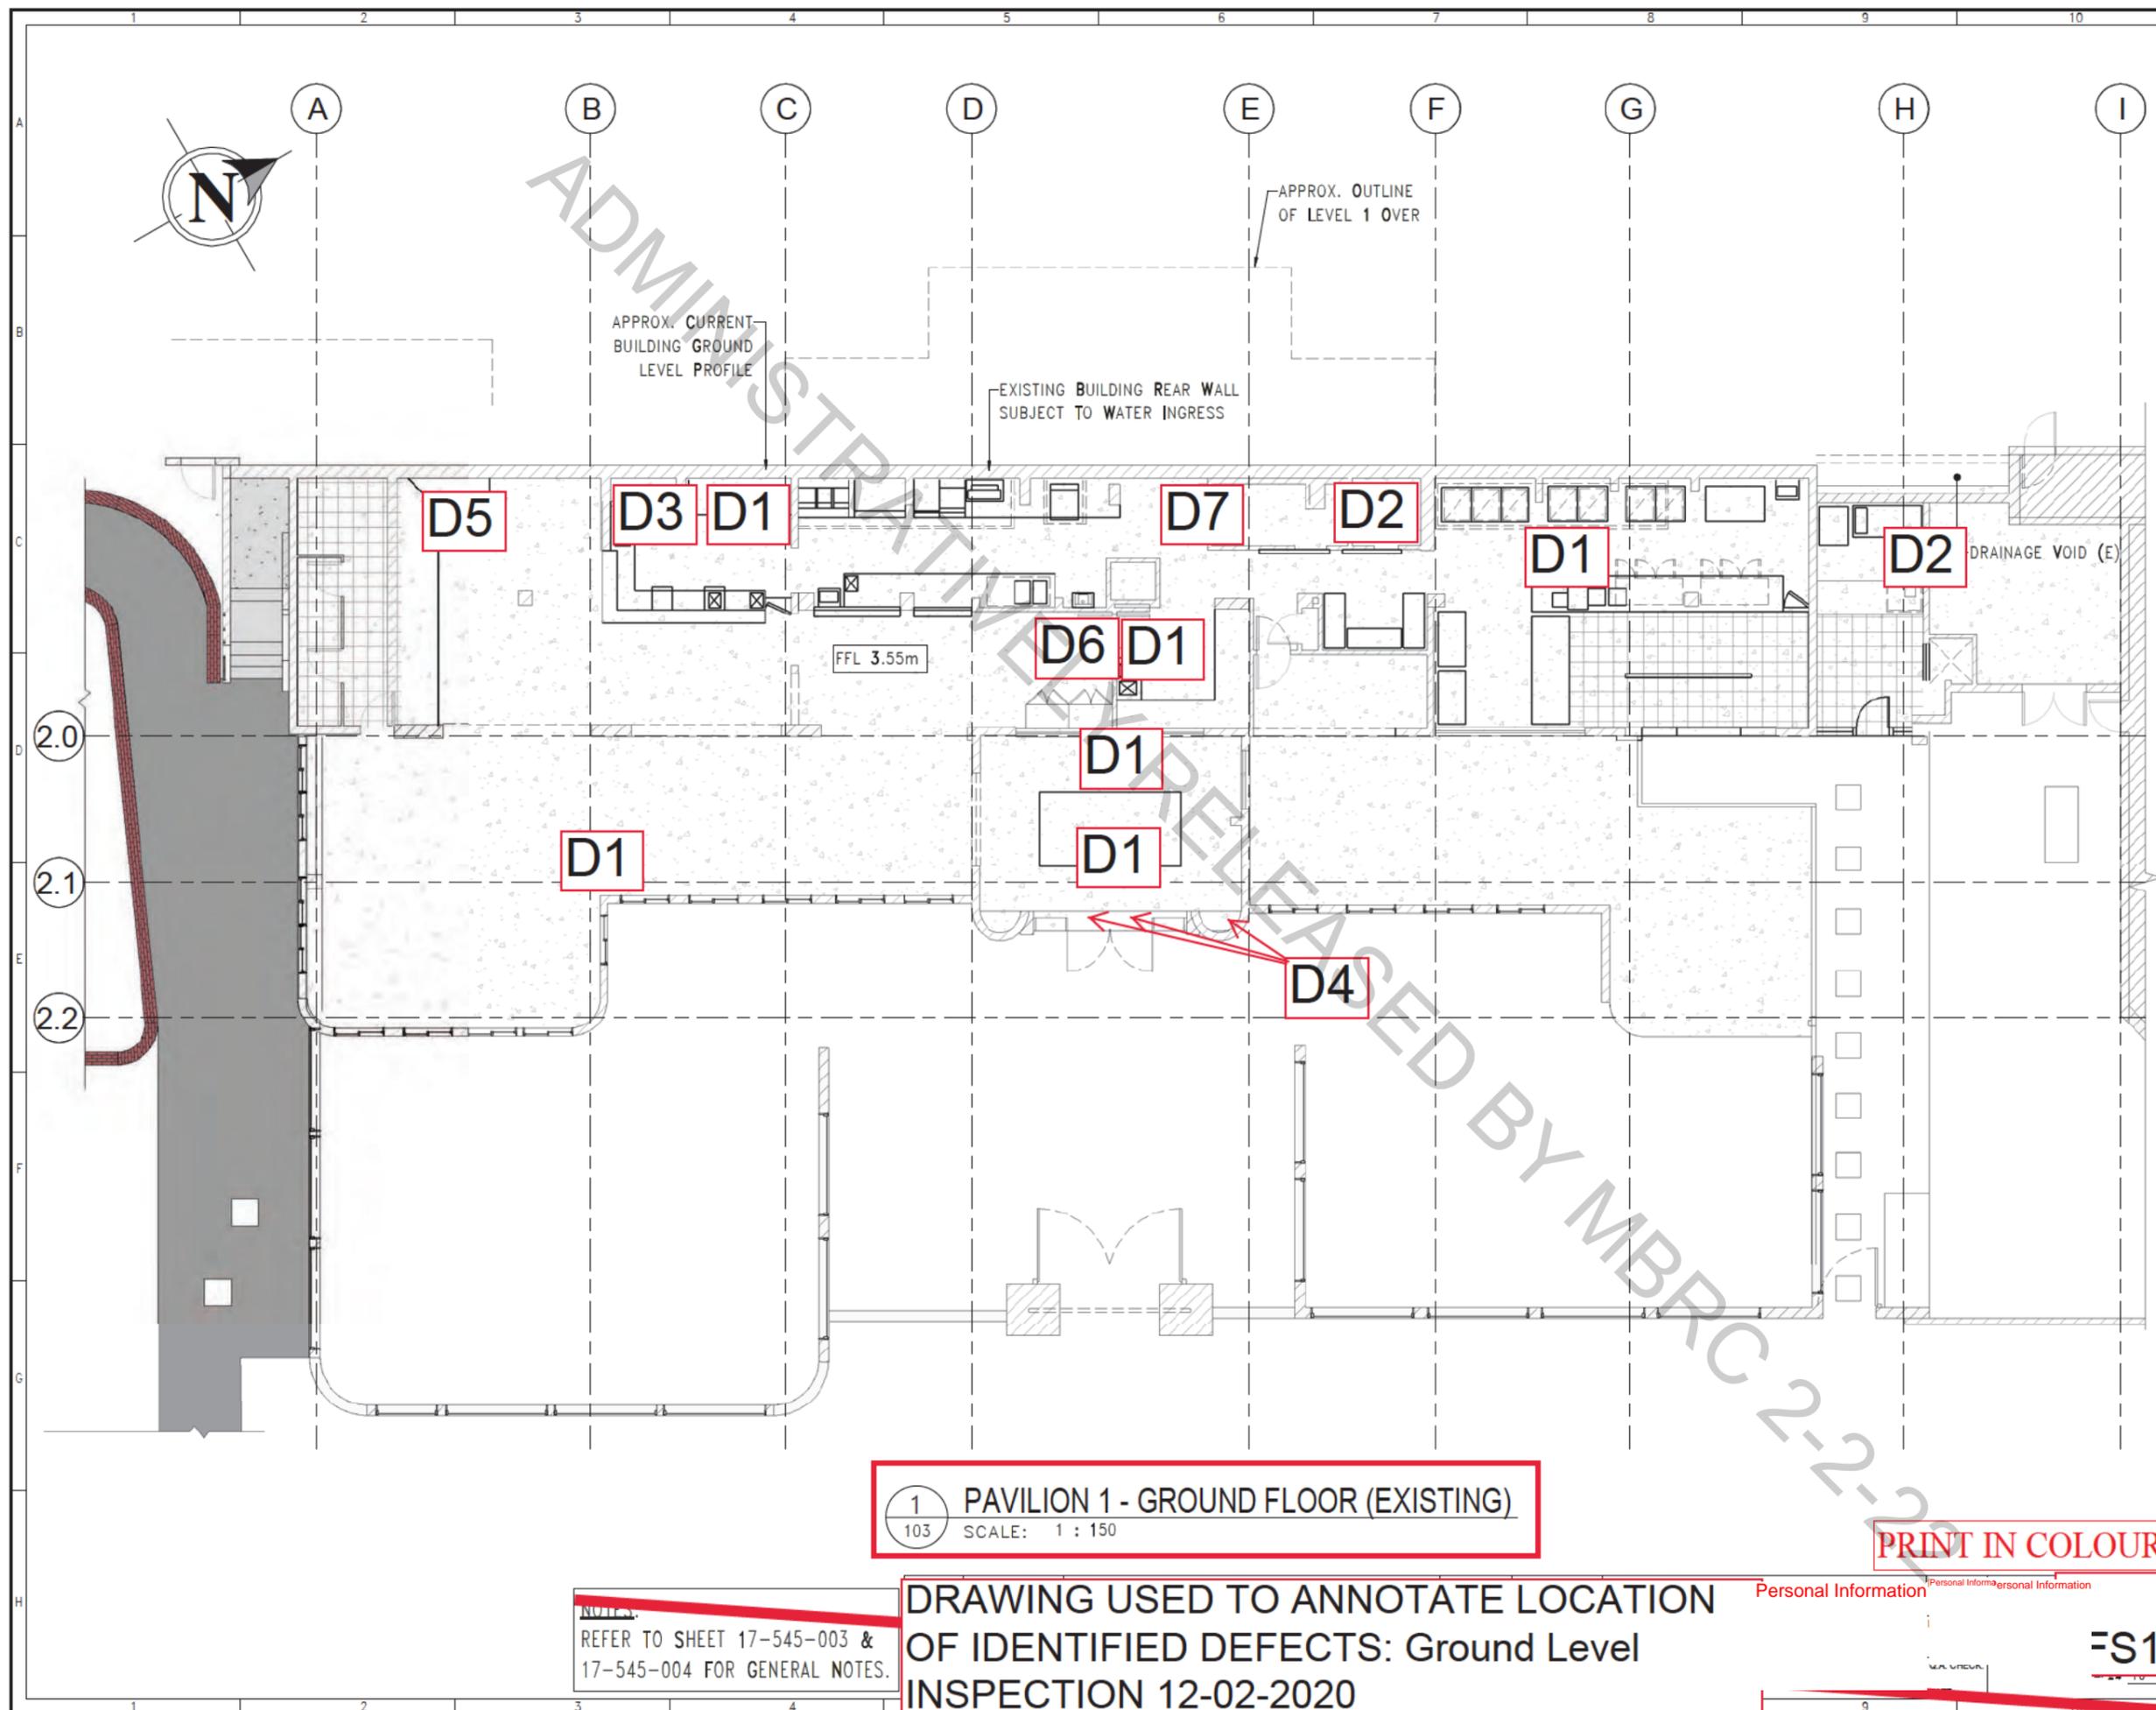
1 PAVILION 1 - GROUND FLOOR (EXISTING)
103 SCALE: 1 : 150

DRAWING USED TO ANNOTATE LOCATION OF IDENTIFIED DEFECTS: Ground Level INSPECTION 12-02-2020

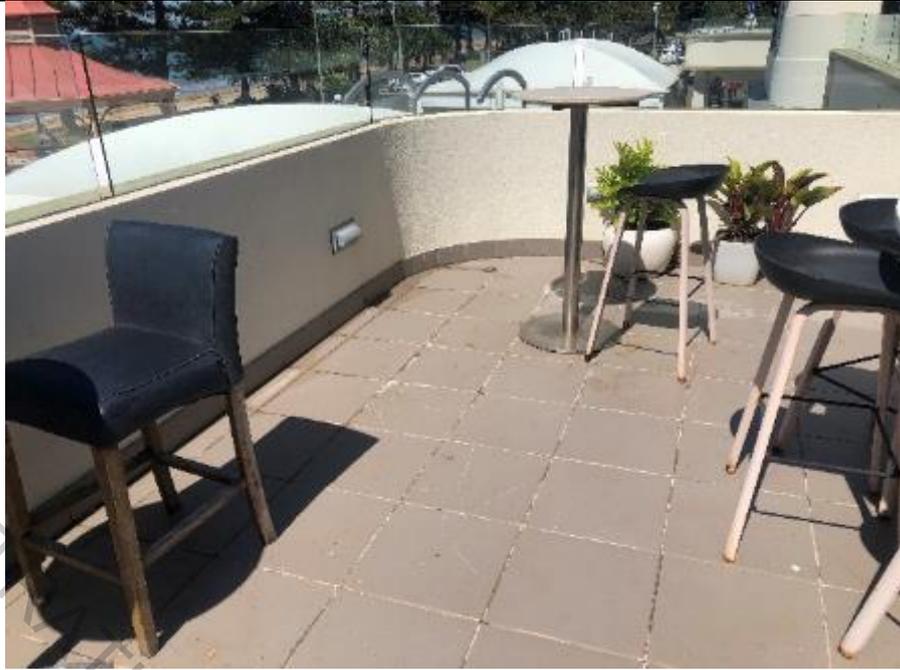
Figure 5: IMG_8601

Level 1 Balcony – general tile cracking

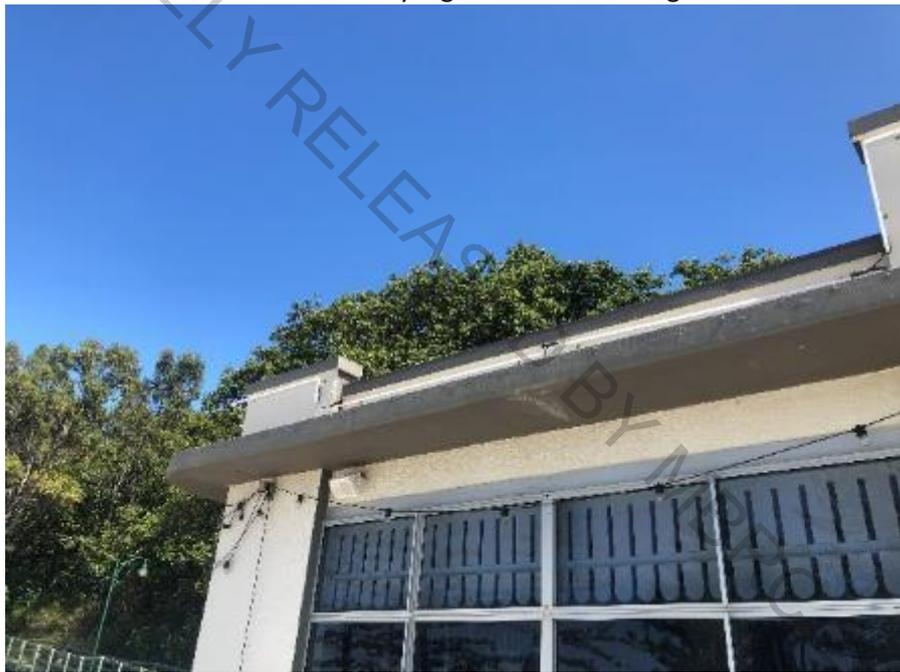
Figure 6: IMG_8610

Roof foam awning general degradation

Awning Level 1	Defect D19 Foam awnings (fiberglass lined) are degraded. Delaminating may contribute to water ingress to structural frame.	Removal and/or repair all foam awnings.	<i>All rendered foam awnings appear to be degraded/delaminating. Recommend to remove and replace all.</i>

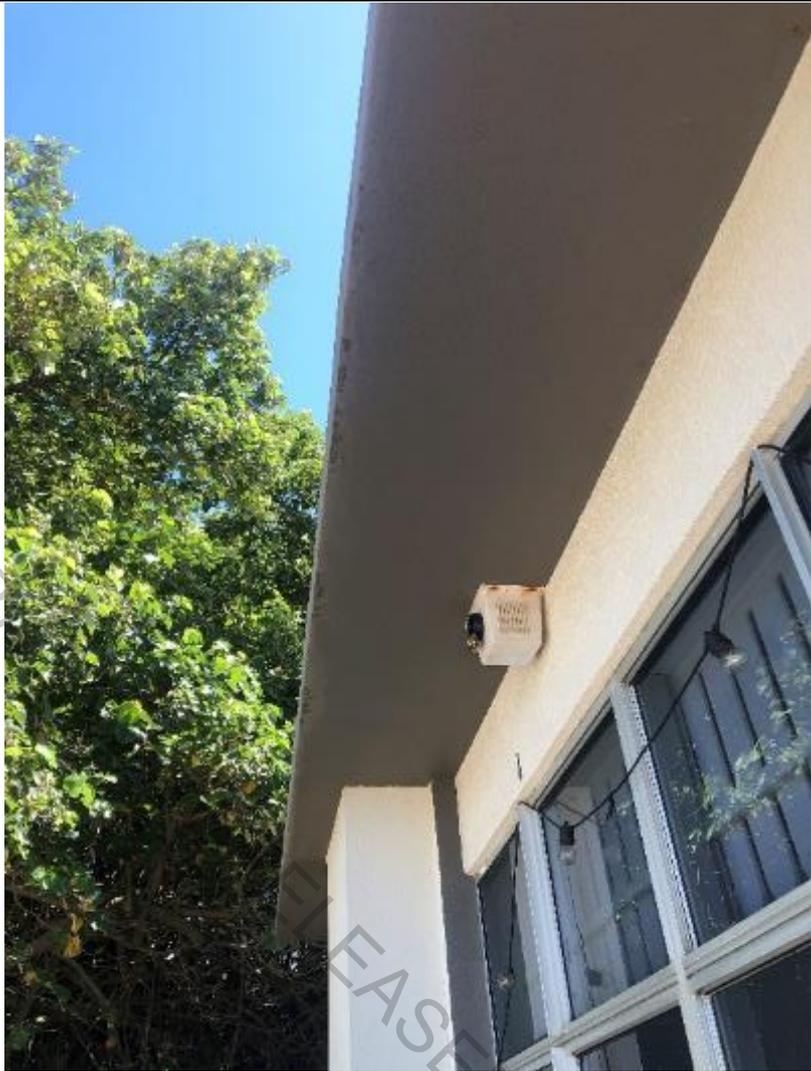
Figure 7: IMG_8611

Roof foam awning general degradation

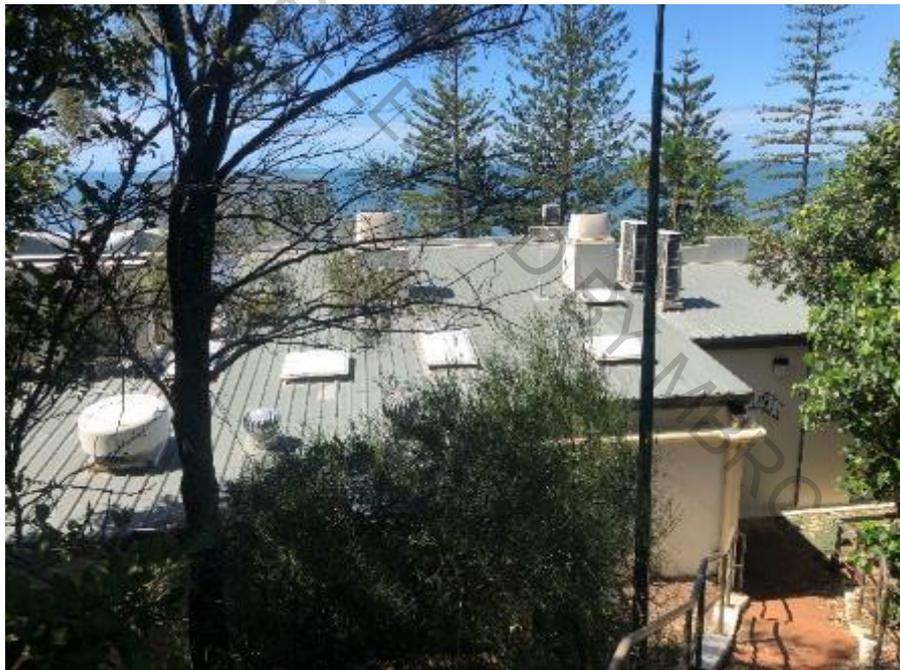
Figure 10: IMG_8633

General Roof

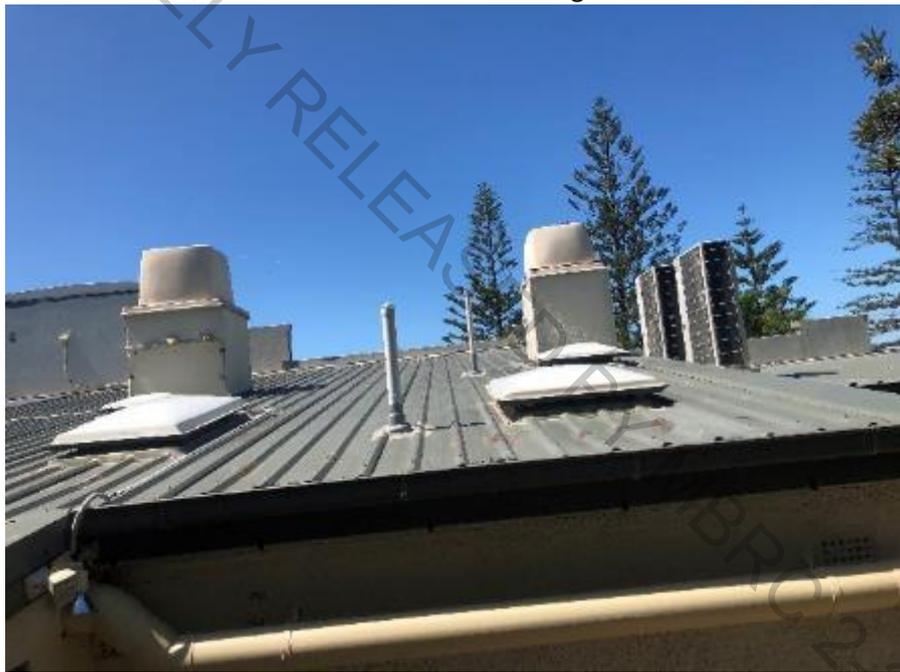
Figure 12: IMG_8635

Visible corrosion/deformation of roof sheeting

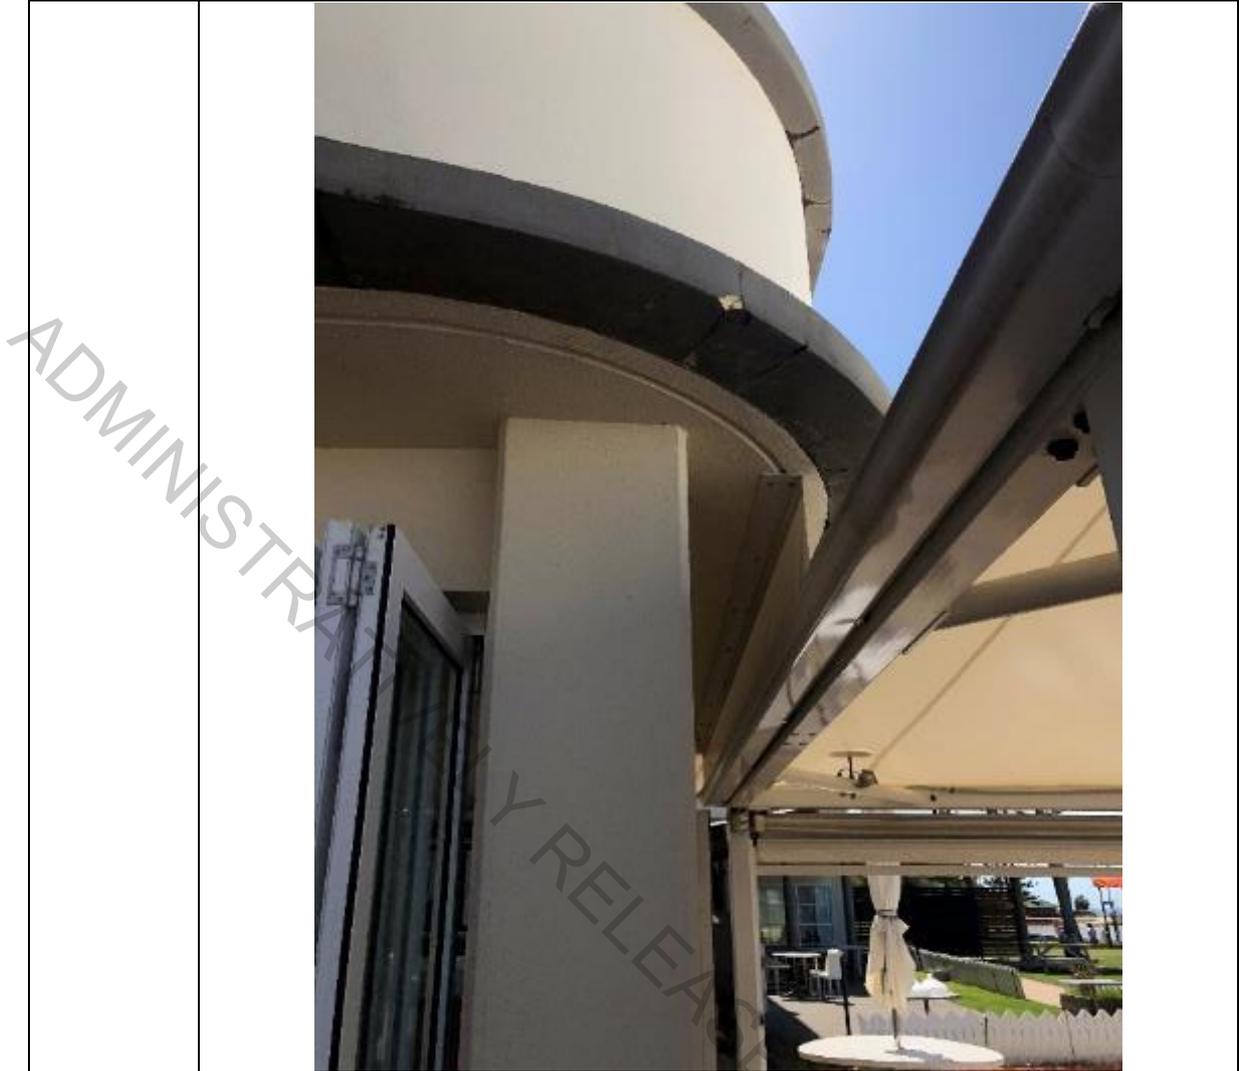
Figure 15: IMG_8646

General foam awning degradation

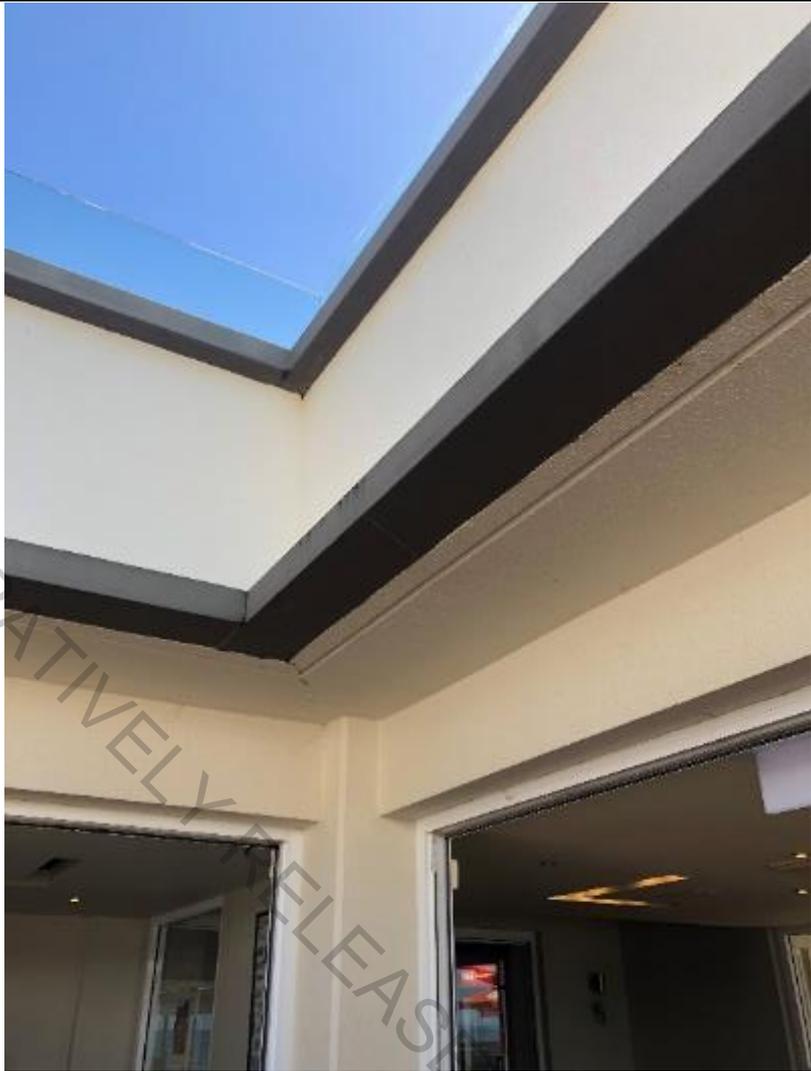
Figure 16: IMG_8647

General foam awning degradation

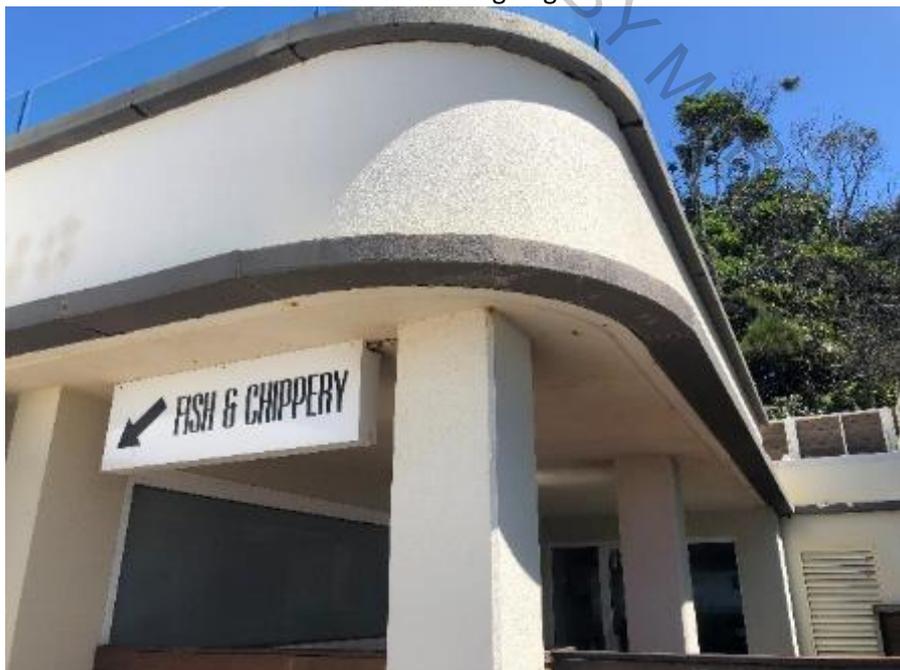
Figure 17: IMG_8649

General foam awning degradation

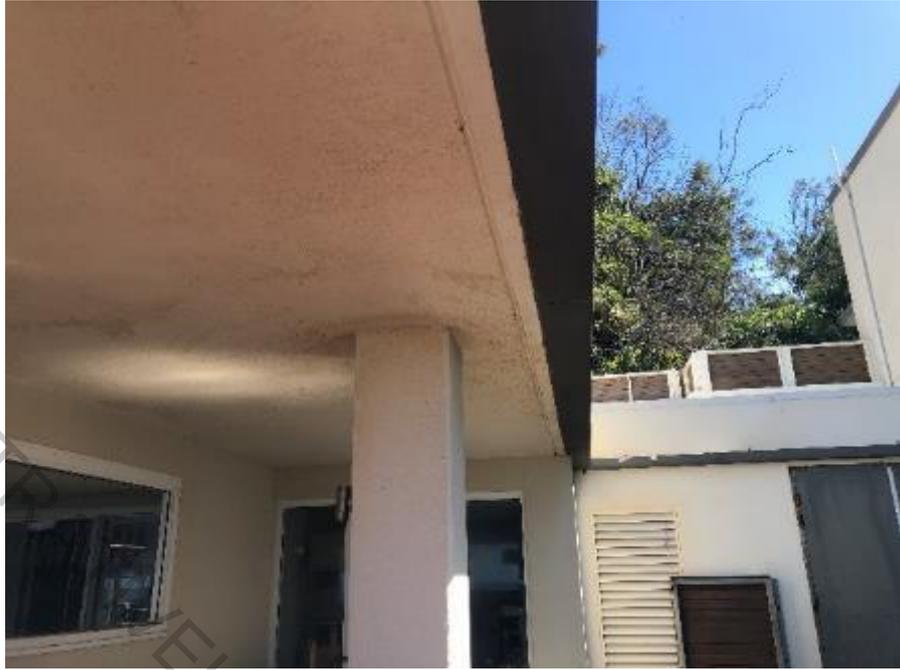
Figure 18: IMG_8650

Soffit of level 1 balcony – minor water ingress/stains

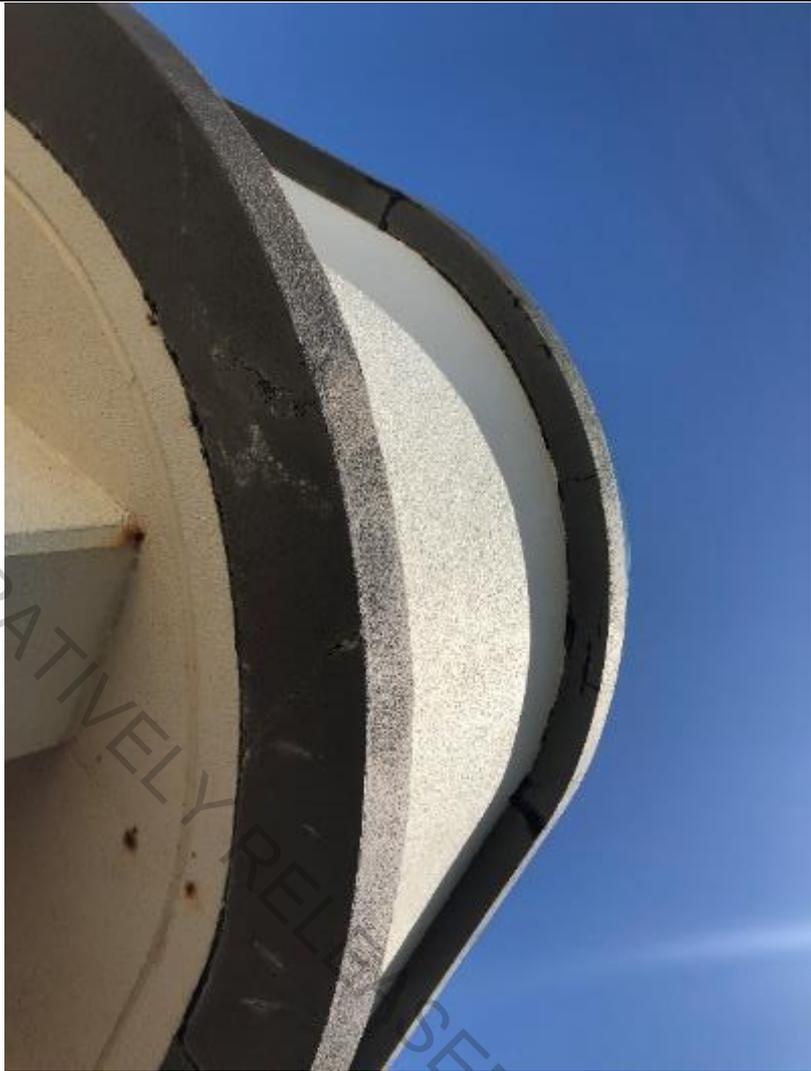
Figure 19: IMG_8653

General foam awning degradation

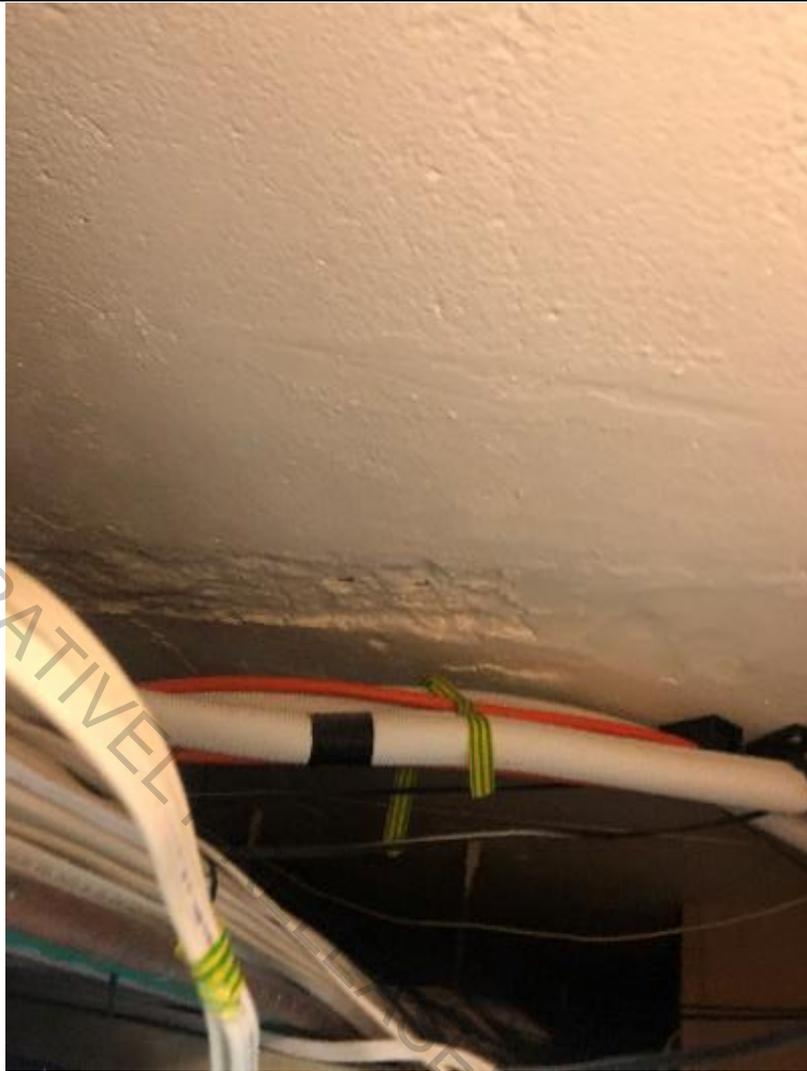
Figure 24: IMG_8538

G2 – underside construction joint – past repairs

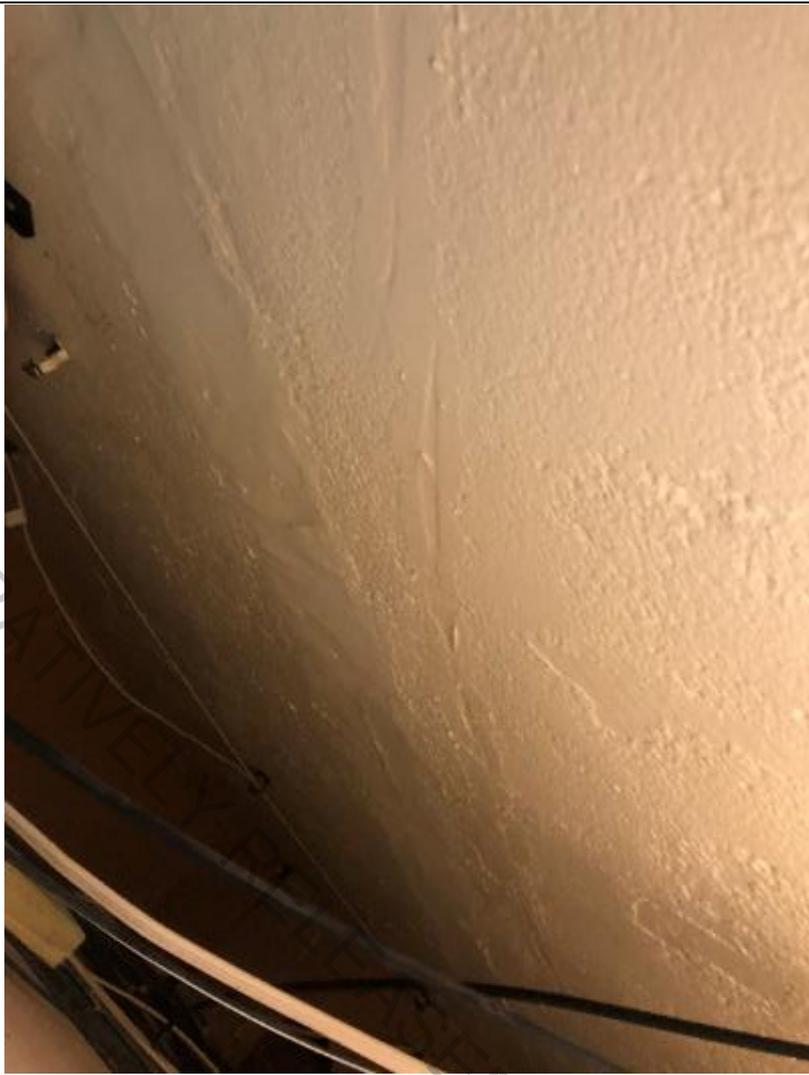
Figure 27: IMG_8539

G3: Ground Floor Grid D-E	Defect D1 C5 Spalling concrete to soffit of Level 1 slab; evidence of past repairs; evidence of corroded reinforcement in local patches.	Removal of all finishes, framing and services to enable access to slab for full inspection and repair.	BEC sighted & agrees with defect (refer above).
G4: Ground Floor Grid B-C	Defect D1 C5 Spalling concrete to soffit of Level 1 slab; evidence of past repairs; evidence of corroded reinforcement in local patches.	Removal of all finishes, framing and services to enable access to slab for full inspection and repair.	BEC sighted & agrees with defect (refer above).
G5: Ground Floor Grid B	Defect D1 C5 Spalling concrete to soffit of Level 1 slab; evidence of past repairs; evidence of corroded reinforcement in local patches.	Removal of all finishes, framing and services to enable access to slab for full inspection and repair.	BEC sighted & agrees with defect (refer above).

G3 – underside construction joint – past repairs

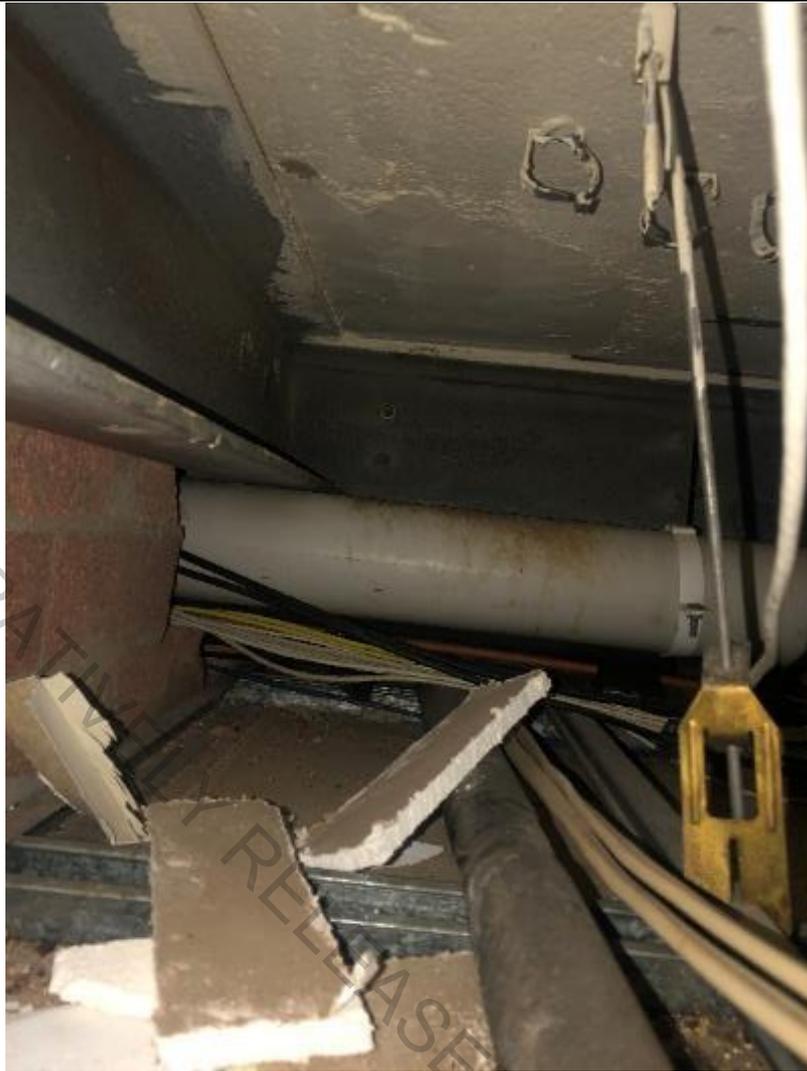
Figure 28: IMG_8526

G4 – Repaired slab soffit/spalling

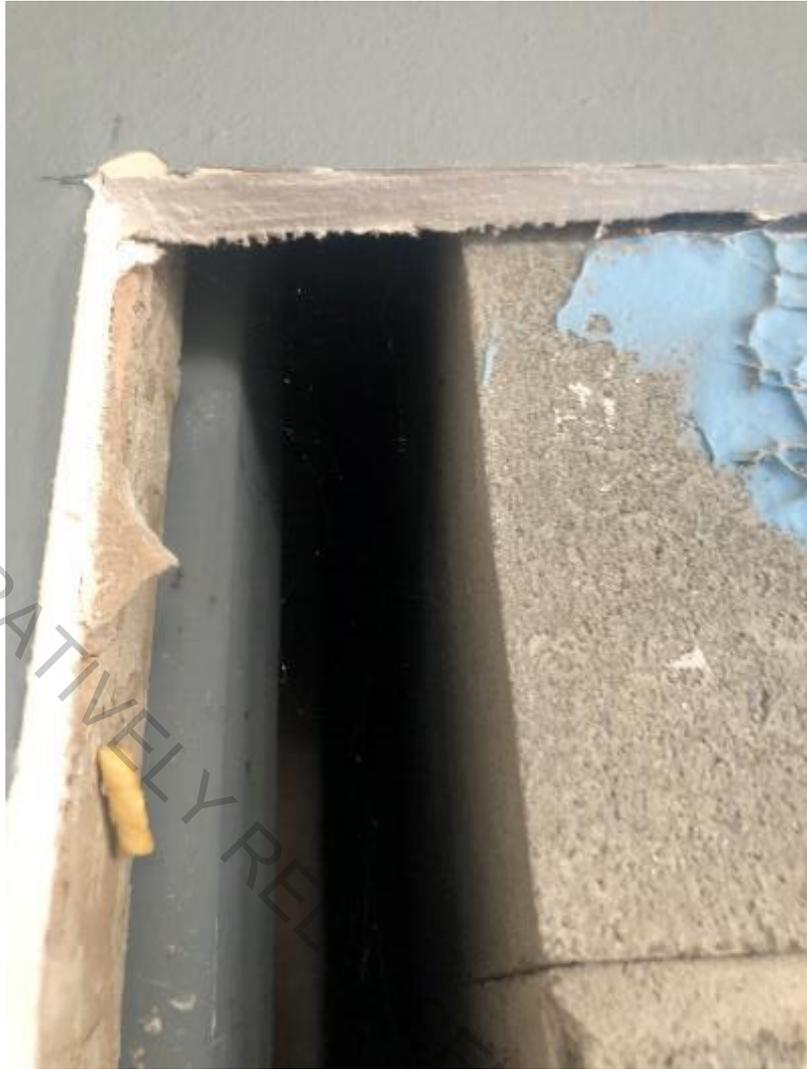
Figure 29: IMG_8512

G5 – Block Column – no sighted defect

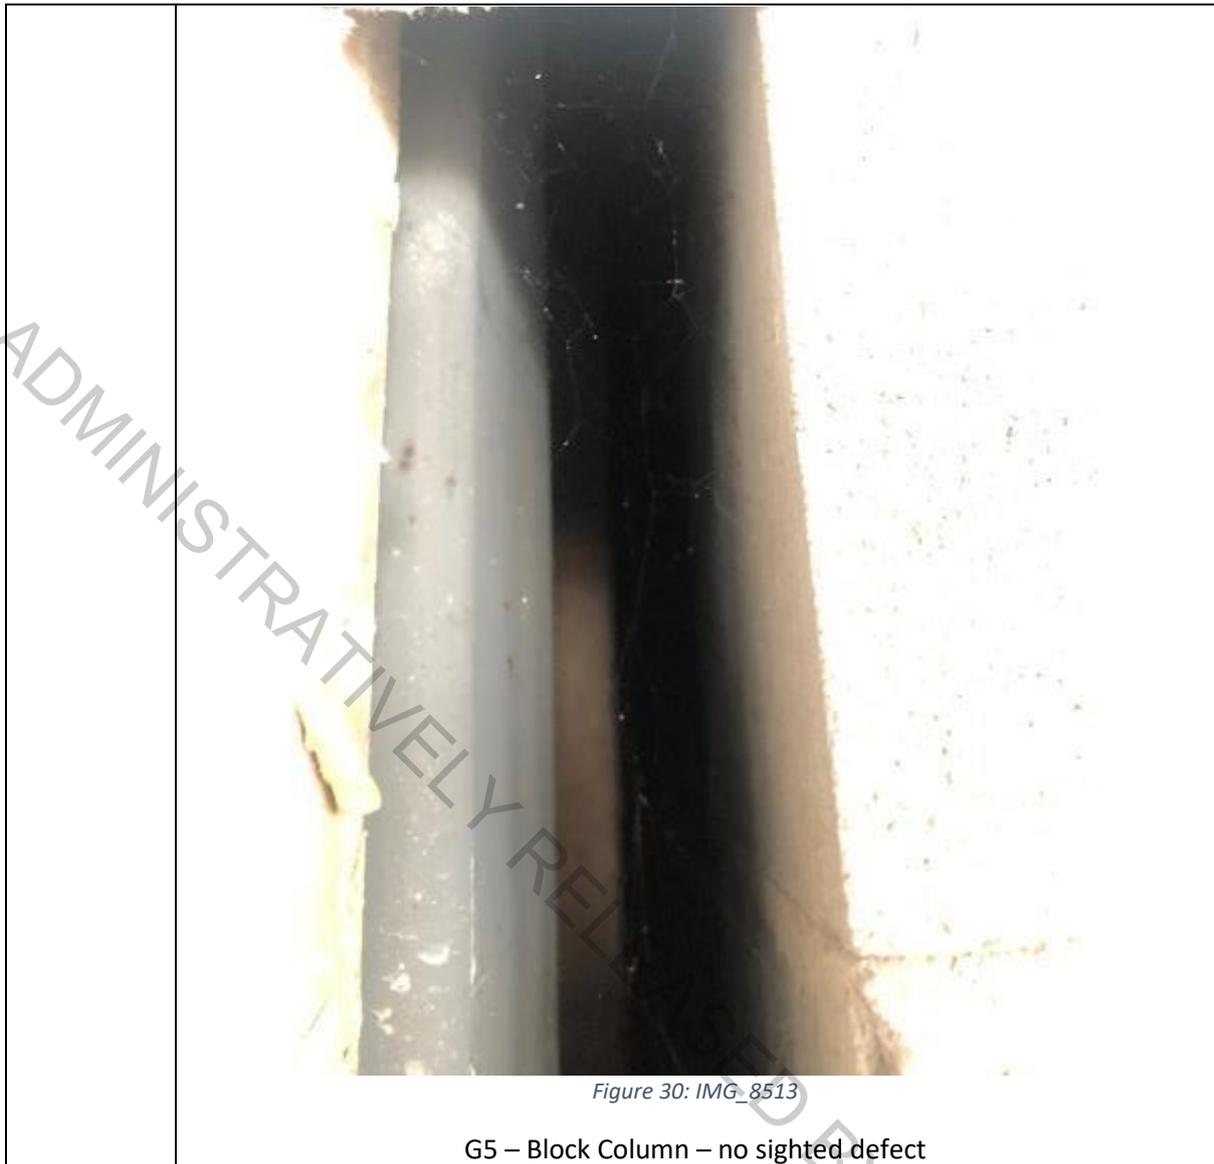
Figure 30: IMG_8513

G5 – Block Column – no sighted defect

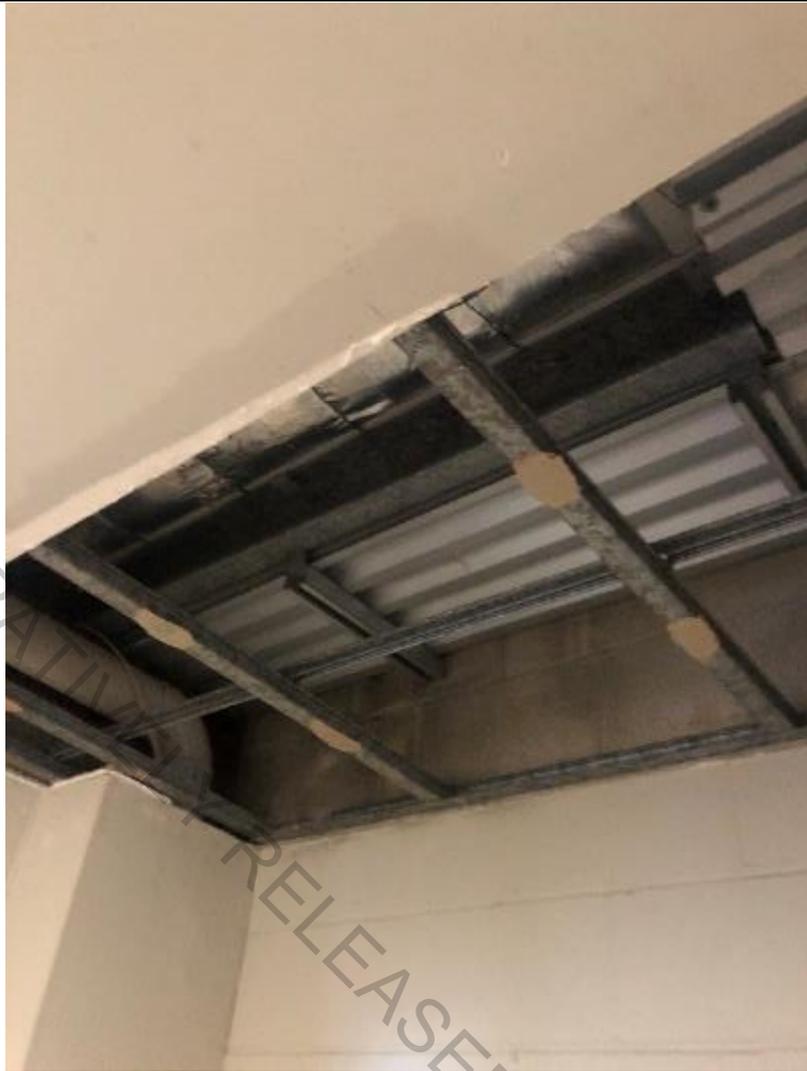
Figure 31: IMG_8544

G6: Ground Floor Grid H	Defect D2 Exposed corroded reinforcement.	Access to area challenging due to new structures.	Corroded bars sighted. BEC agrees that access is problematic. It is likely necessary to remove roof/gutter over to facilitate future inspection.
G7: Ground Floor Grid E-F	Defect D2 C5 Cracking in rear wall infill (or previous repair) section.	Removal of all finishes, framing and fit out to allow access for repair.	BEC sighted & agrees with defect & repair recommendation. Additionally, cracking was identified about the top of the engaged pier and slab (IMG_8534).
G8: Ground Floor Grid B-C	Defect D3 Connection supplementary floor beam to wall appeared unfit for purpose. Minor	Removal of all finishes, framing and services to enable access to connection for design and installation of upgraded connection	BEC sighted. In agreement with defect & proposed repair recommendation.

G6 – Box gutter over – leaking

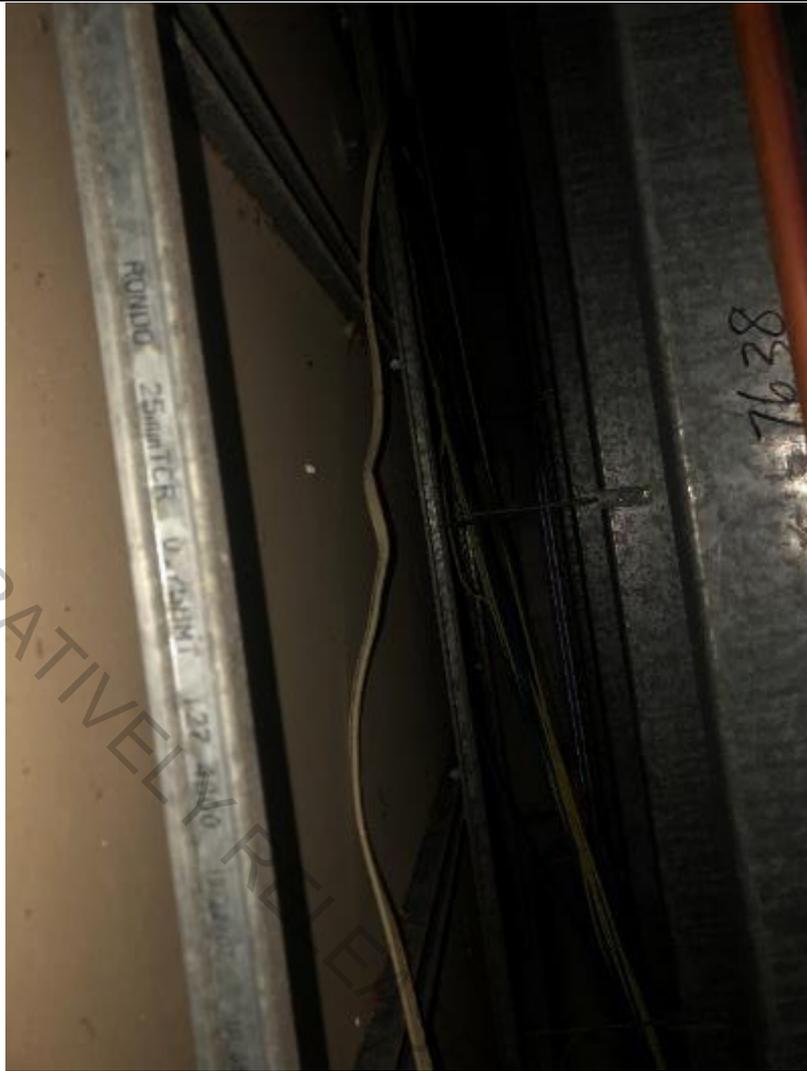
Figure 34: IMG_8547

G6 – Box gutter over – leaking

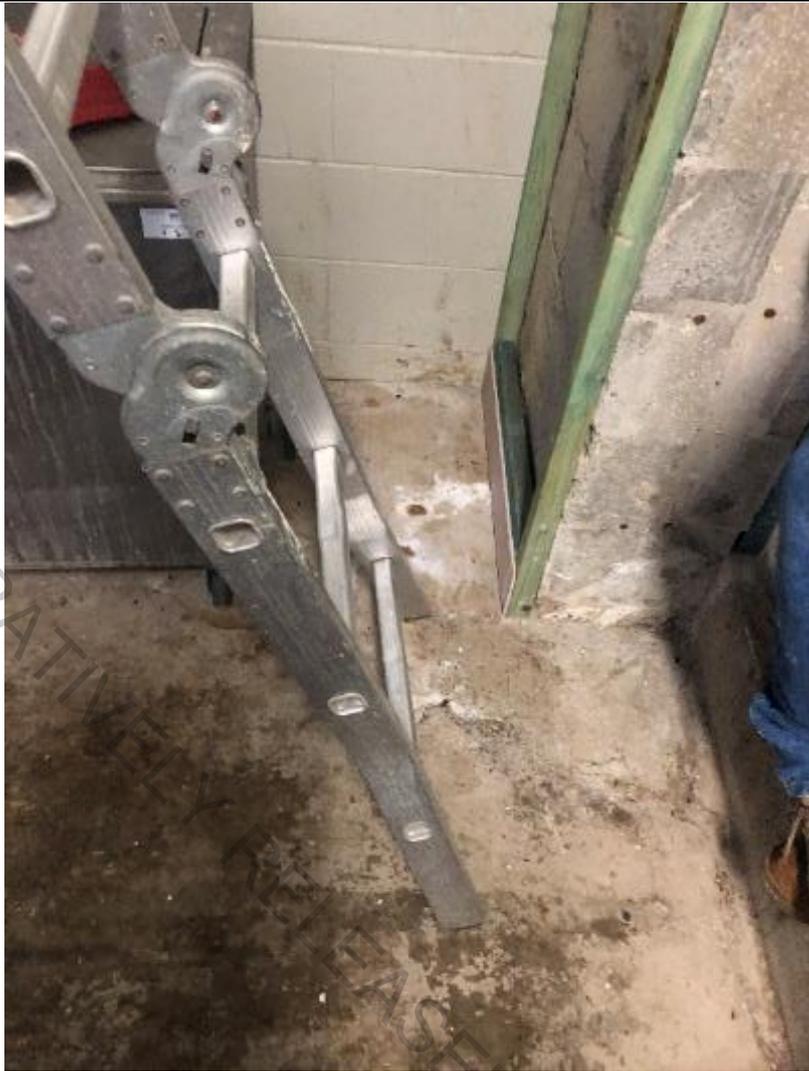
Figure 35: IMG_8548

G6 – Box gutter over and western wall leaking

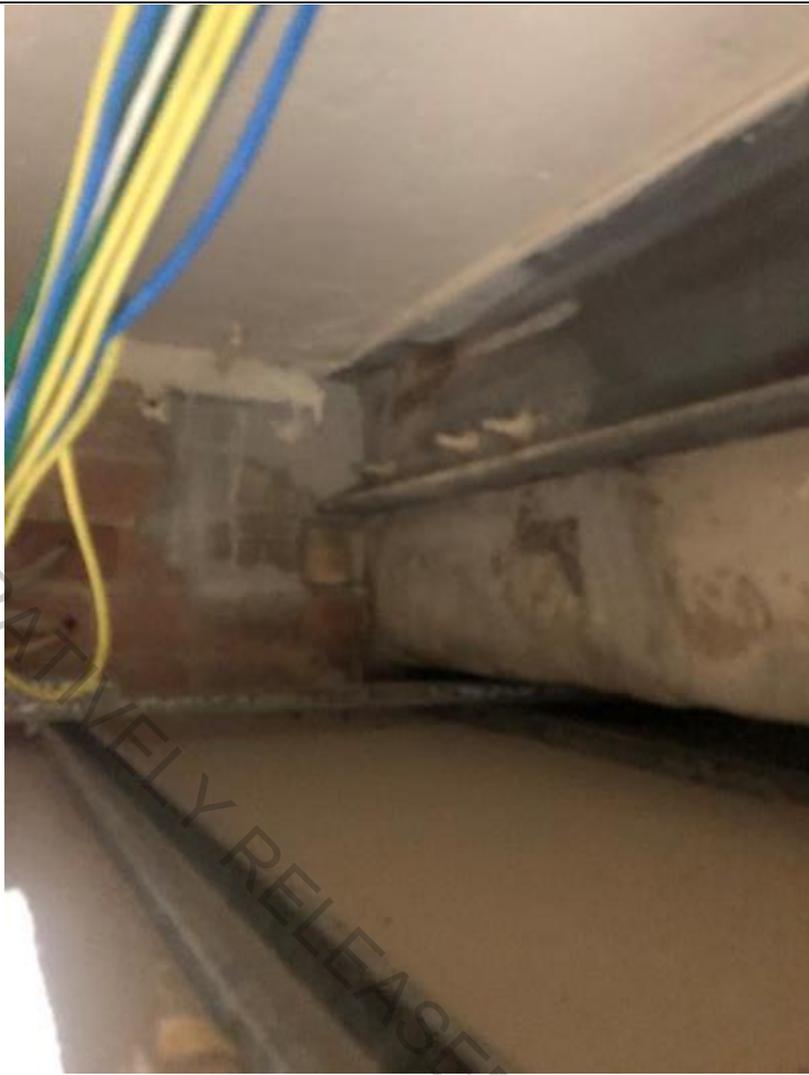
Figure 36: IMG_8532

G7 – Beam Corrosion at connection/ brick wall infill/cracking

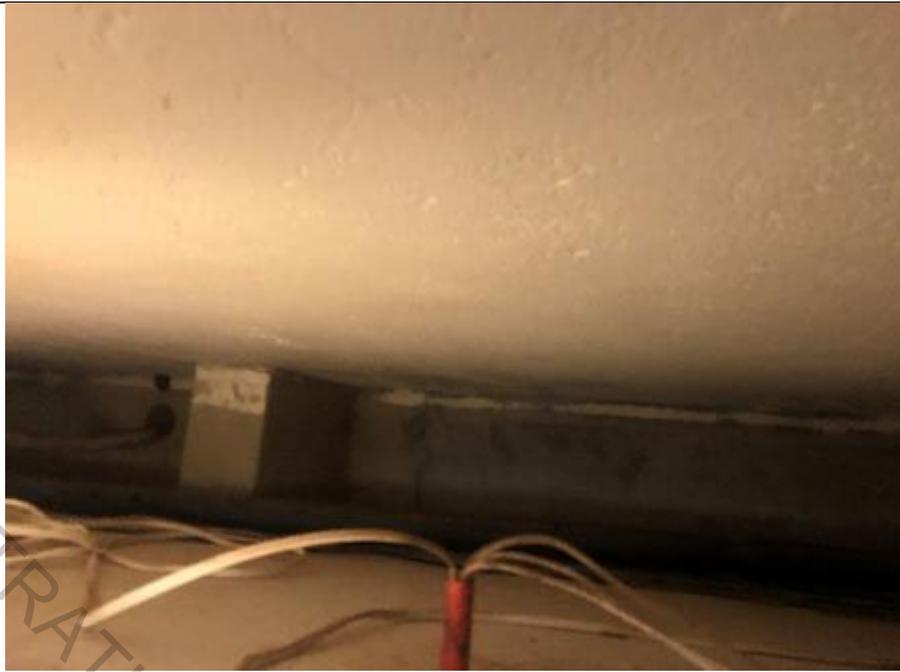
Figure 37: IMG_8534

Location	Defect Noted	Implications of remedial works	BEC Comment
G1 – G5: Ground Floor	Defect D1 C5 Spalling concrete to soffit of Level 1 slab, evidence of past repairs, evidence of corroded reinforcement in local patches.	Removal of all finishes, framing and services to enable access to slab for full inspection and repair.	Concrete slab likely at end of design life. Further spalling expected unless remediated. Further non-destructive (half-cell potential) and destructive testing (concrete core and carbonation) will be necessary to map the full extent of corrosion and remaining life of slab prior to major intervention. A potential remediation option may be to strip back deleterious material and application of a new protective membrane.
G7: Ground Floor Grid E-F	Defect D2 C5 Cracking in rear wall infill (or previous repair) section.	Removal of all finishes, framing and fit out to allow access for repair.	BEC sighted. In agreeance with defect & proposed repair recommendation. Additional cracking was sighted about the top of the engaged pier at the slab interface (IMG_8534).

G7 –brick wall column cracking

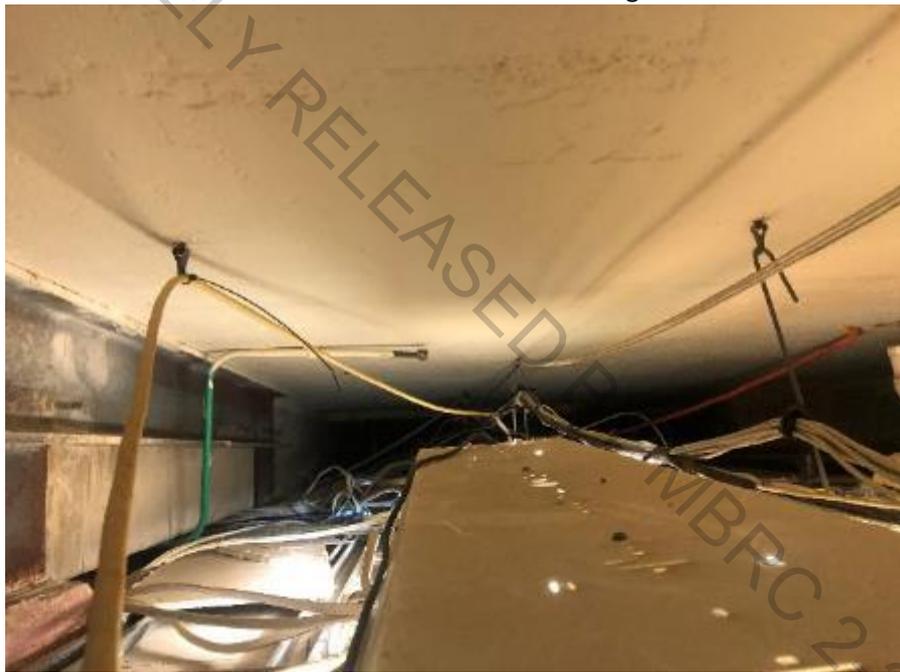
Figure 38: IMG_8535

G7 –slab soffit – no defects sighted

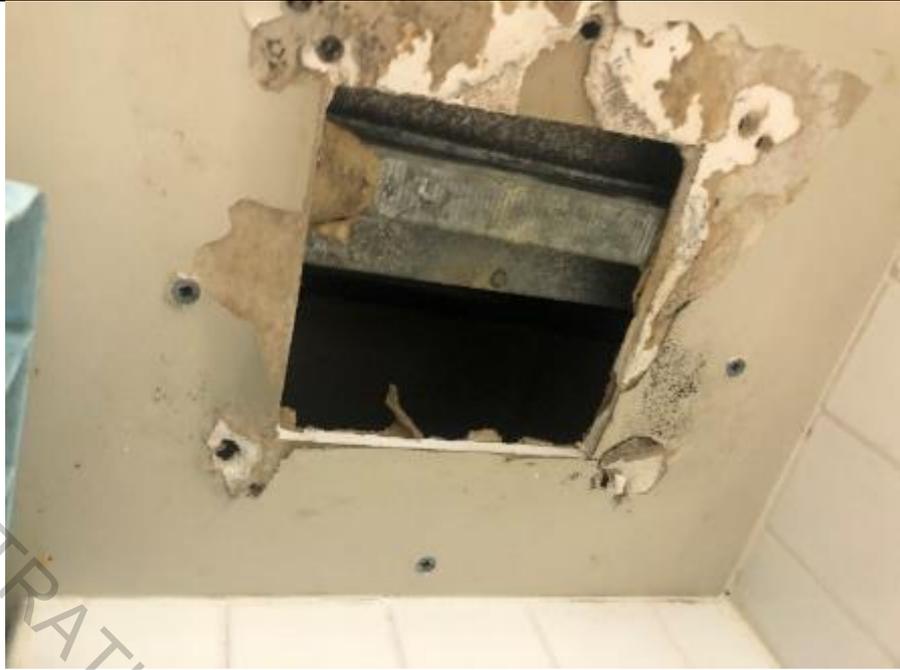
Figure 39: IMG_8522

G8 – Ceiling water damage
