Sutton Beach Pavilion, Redcliffe

Structural Condition Audit Peer Review

Moreton Bay Regional Council

Project no. 7366

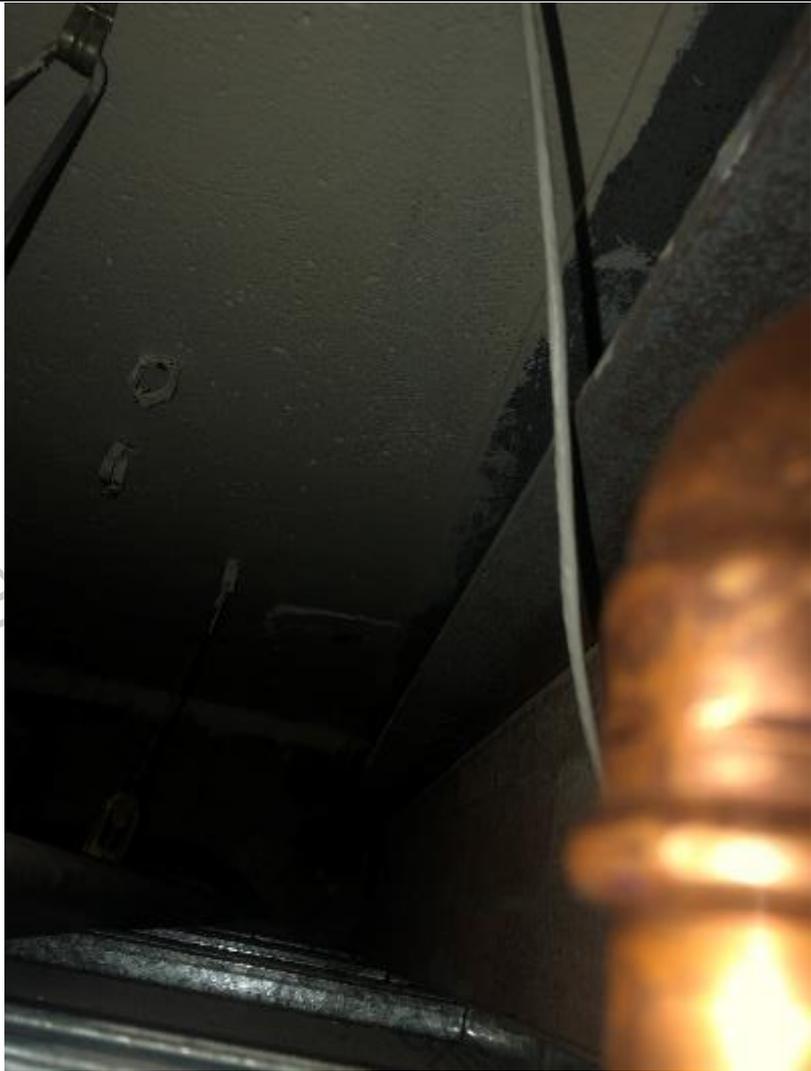
Figure 41: IMG_8524

G8 – Beam Corrosion

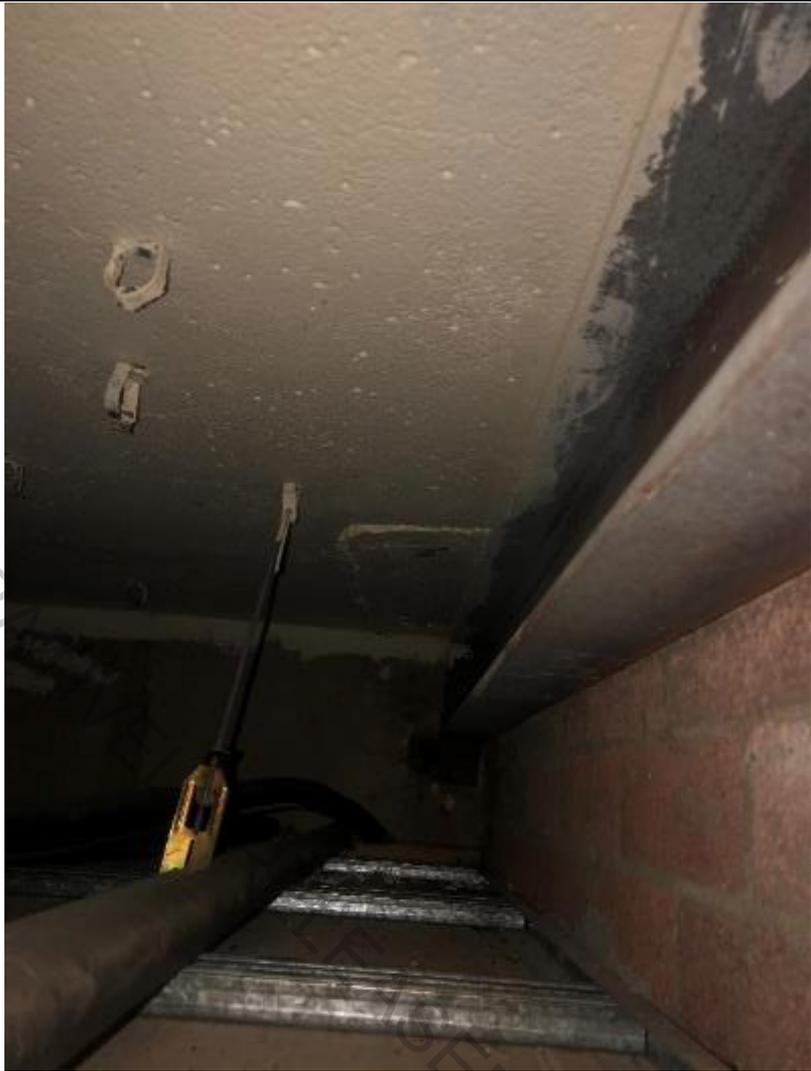
Figure 42: IMG_8525

G8 – Beam Corrosion

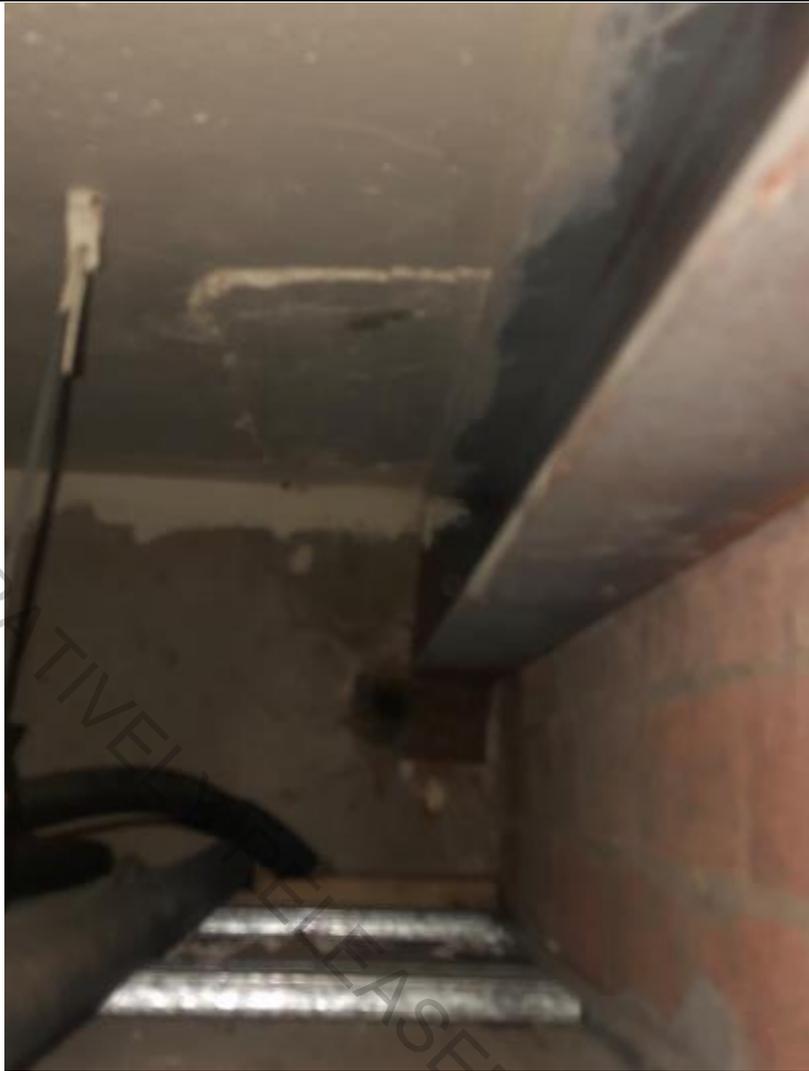
Figure 43: IMG_8529

G8 – Beam Corrosion at connection

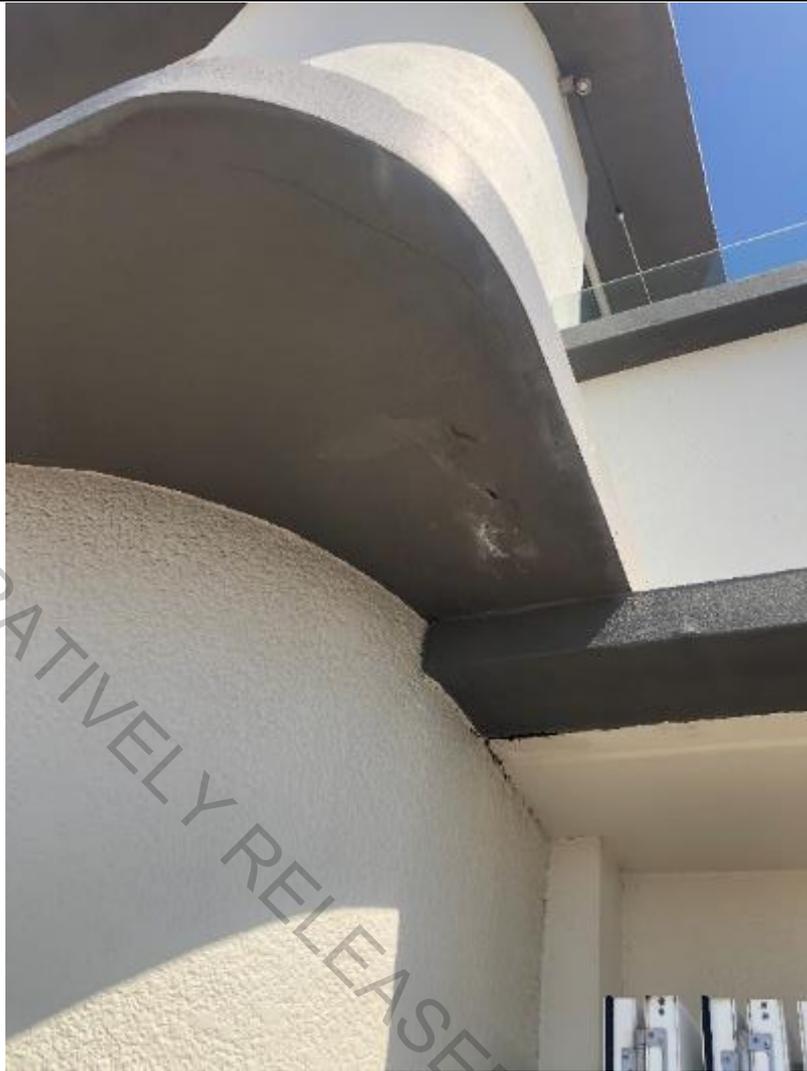
Figure 44: IMG_8551

G9: Ground Floor Grid E	Defect D4 C6 Spalling concrete	Exclusion zone beneath affected area; remove spalling to mitigate the risk of spalling concrete dropping and resulting in injury; undertake concrete repair works.	BEC considers this element to be part of the foam awning. To be removed and/or replaced. (refer IMG_8555).
G9: Ground Floor Grid D-E	Defect D4 C6 Spalling concrete	Exclusion zone beneath affected area; remove spalling to mitigate the risk of spalling concrete dropping and resulting in injury; undertake concrete repair works.	BEC considers this element to be part of the foam awning. To be removed and/or replaced. (refer IMG_8555).
G10: Ground Floor Grid A-B	Defect D5 Water damage along full extent of western wall resulting in severe dry rot of	Complete removal of kitchen fit out and all framing members. Resolution of water ingress	BEC sighted. In agreeance with defect & proposed repair recommendation. BEC additionally recommends additional termite inspections/

G9 – Water damage to awning

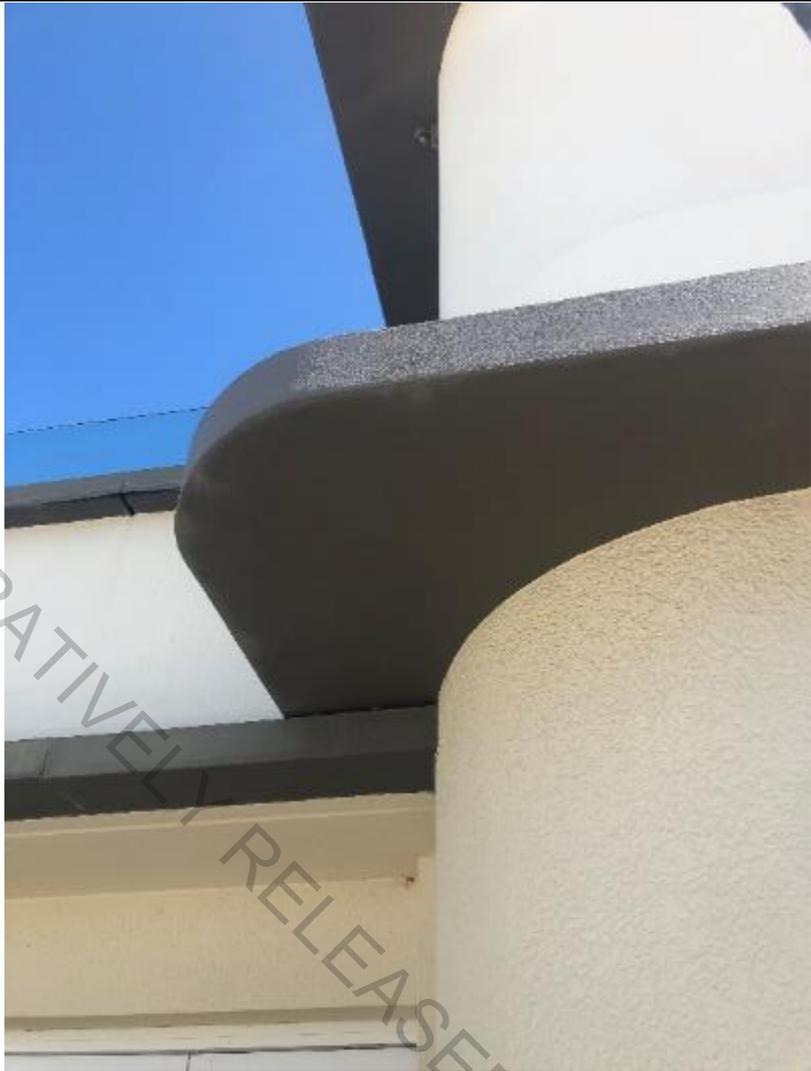
Figure 45: IMG_8552

G9 – Water damage to awning

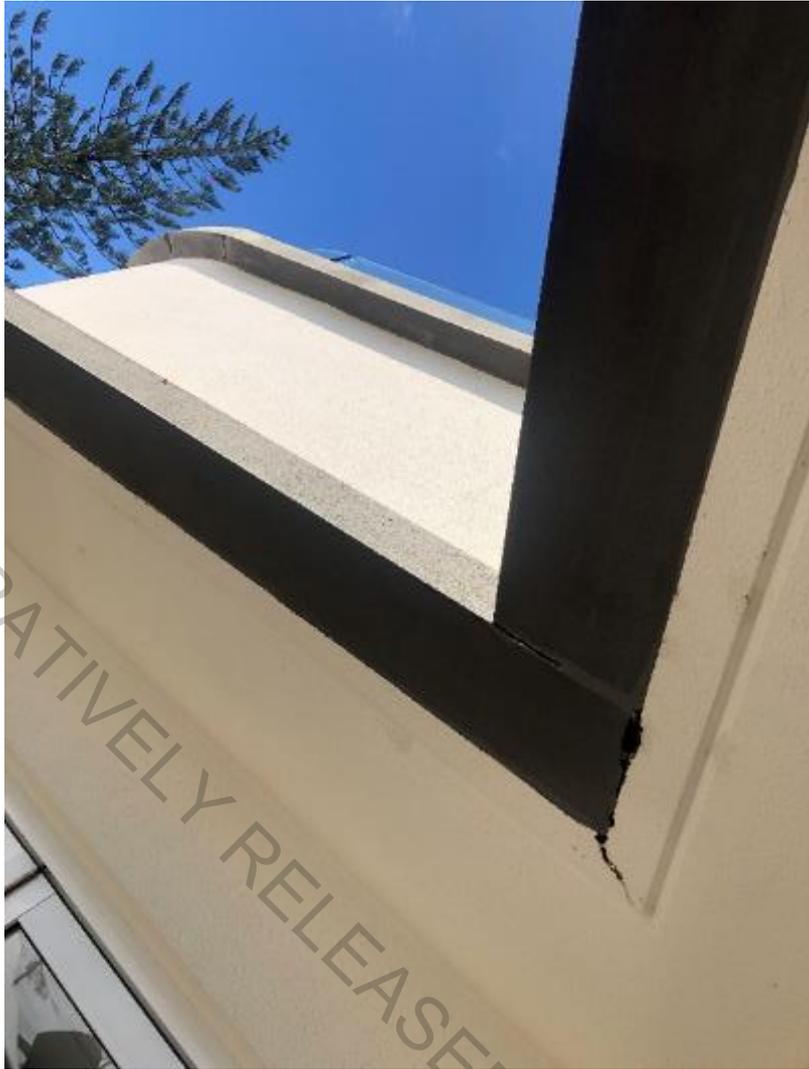
Figure 46: IMG_8553

G9 – Water damage to awning

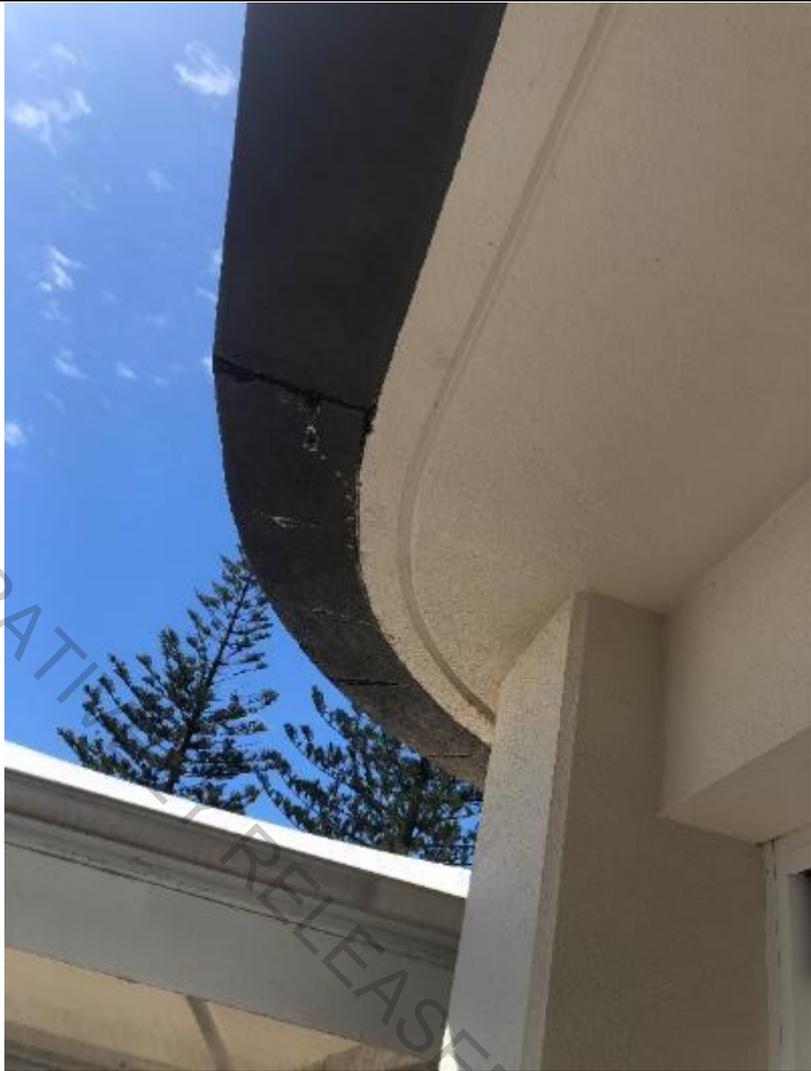
Figure 47: IMG_8554

G9 – Water damage to awning

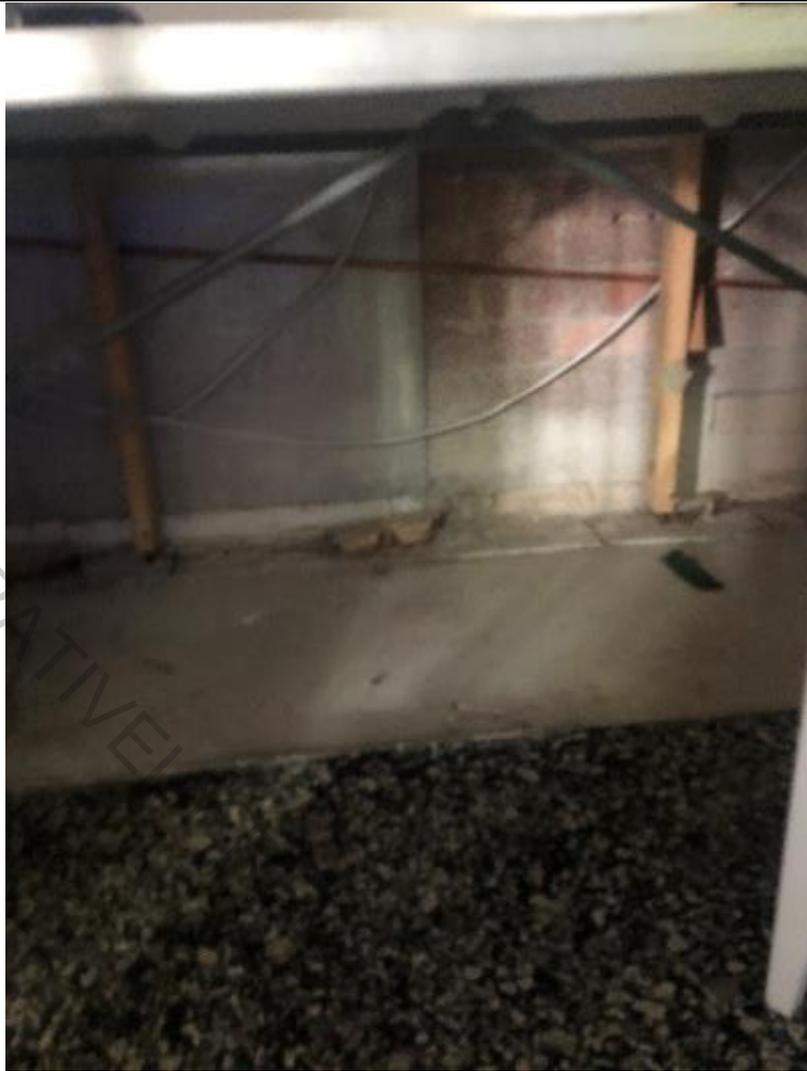
Figure 51: IMG_8514

G10: Ground Floor Grid A-B	Defect D5 Water damage along full extent of western wall resulting in severe dry rot of timber. Evidence of termite damage.	Complete removal of kitchen fit out and all framing members. Resolution of water ingress through western wall is problematic.	<i>BEC sighted. In agreeance with defect & proposed repair recommendation. Additional termite inspections / monitoring recommended.</i>
G11: Ground Floor Grid D-E	Defect D6 Ceiling failure due to weight of services cables.	Removal of existing ceiling sheeting & installation of new system to support required cables.	<i>Unable to inspect. Ceiling appears to be patched in this area; repairs may have already been conducted.</i>
G12: Ground Floor Grid D-E	Defect D7 Noted condensation on existing refrigeration lines that is likely resulting in water ingress to structural members and finishes.	Removal of existing ceiling to enable make-good works to refrigeration lines.	<i>Note - Incorrect photo provided by FSACE. Sited refrigerant lines resulting in water ingress. (refer IMG_8523)</i>

G10 – Wall water damage

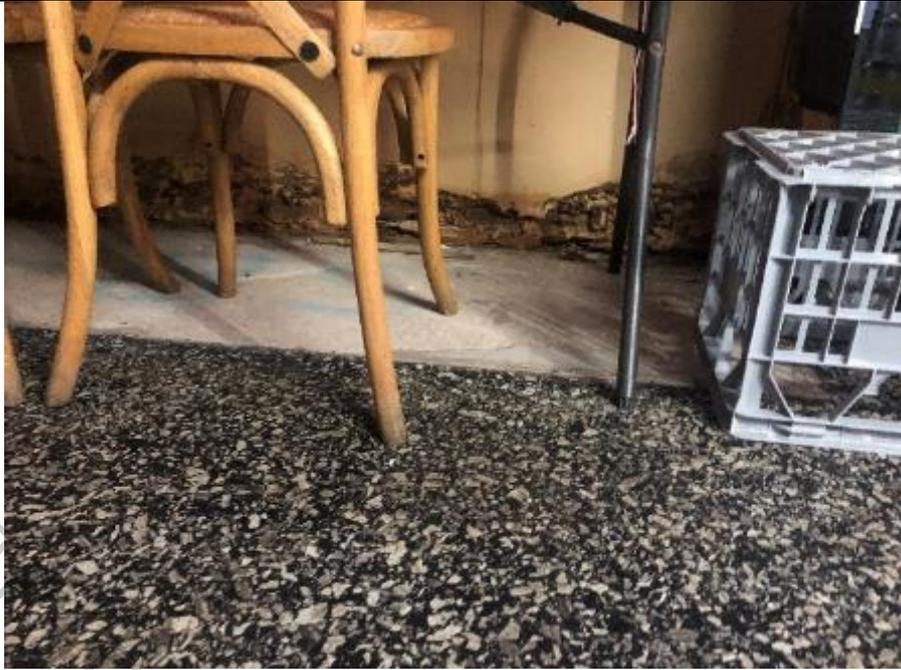
Figure 52: IMG_8515

G10 – Wall water damage

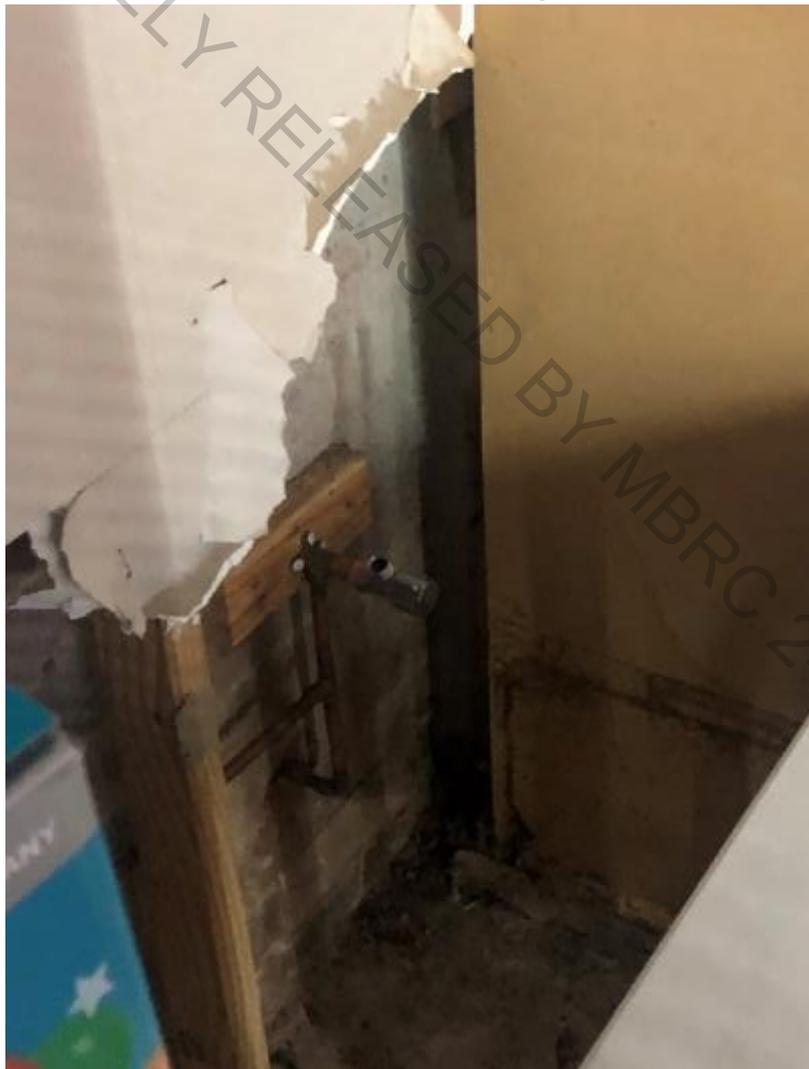
Figure 53: IMG_8517

G10 – Wall water damage

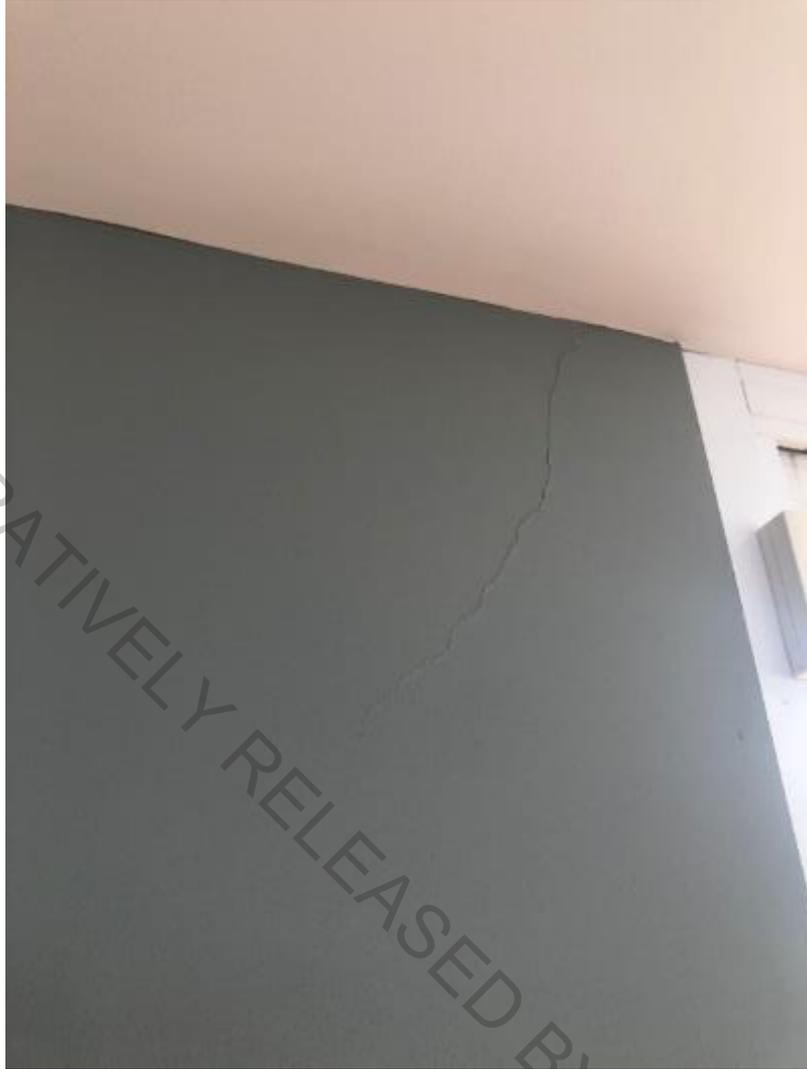
Figure 54: IMG_8518

G10 – Wall water damage

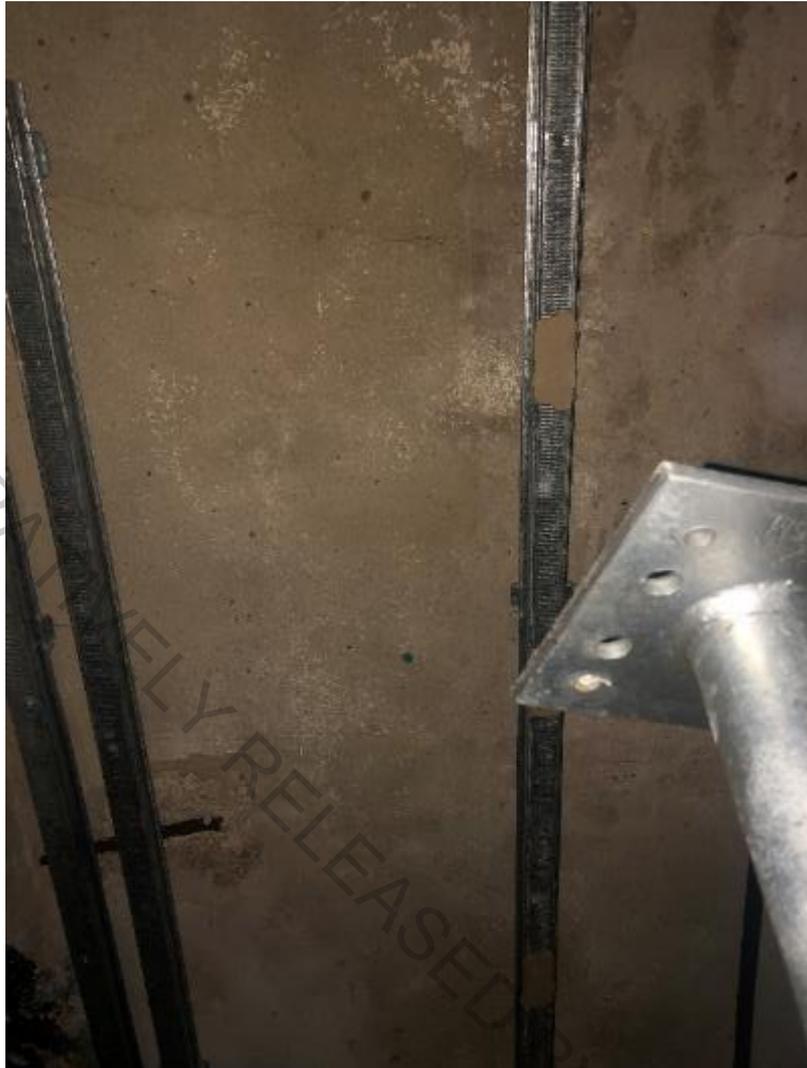
Figure 66: IMG_8503

G20 – Slab soffit over – corroded rebar

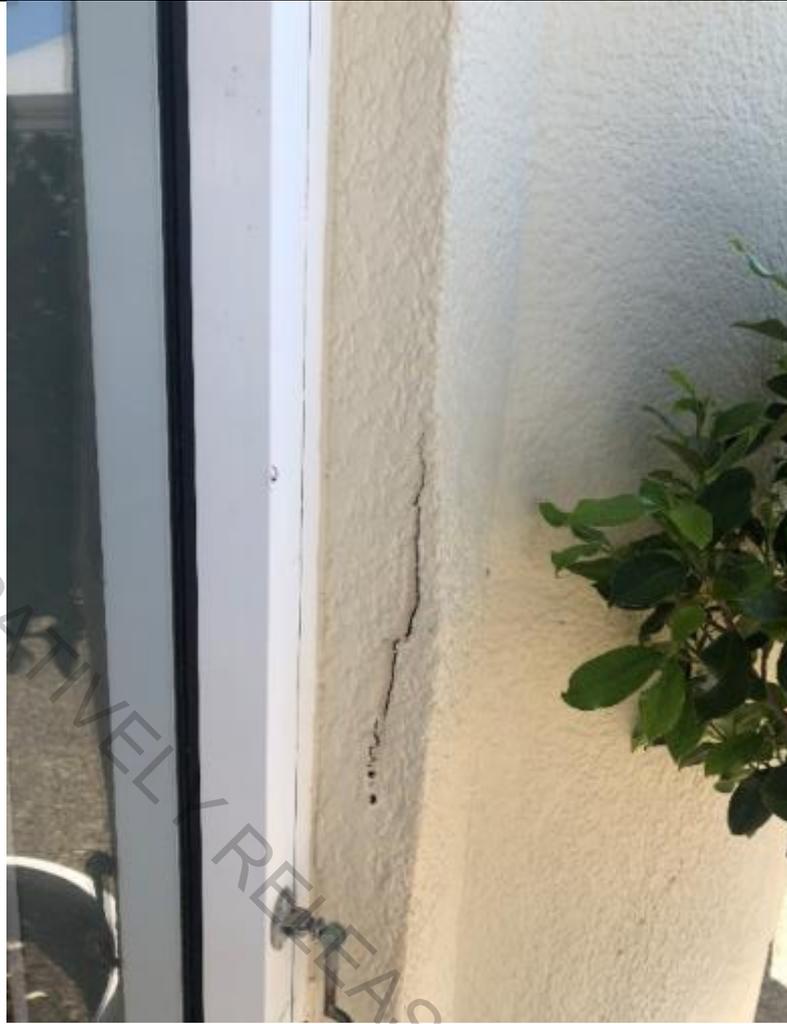
Figure 73: IMG_8558

G30 – Additional external cladding water damage

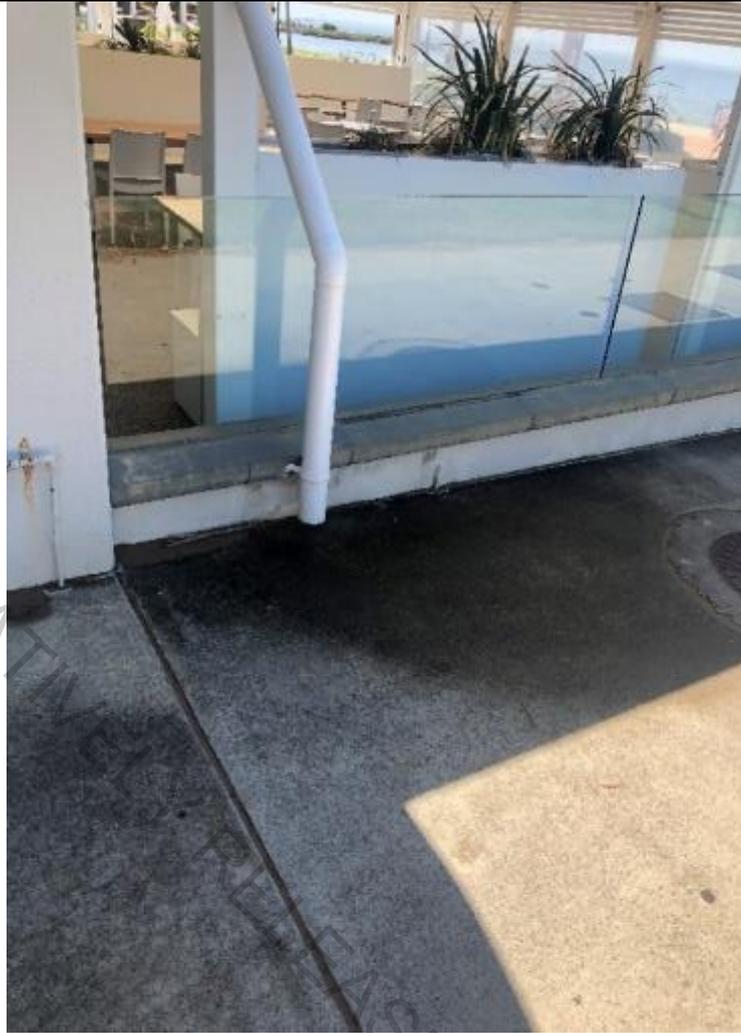
Figure 74: IMG_8559

G31 – Stormwater discharge to ground – minor corrosion of water pipe fixings

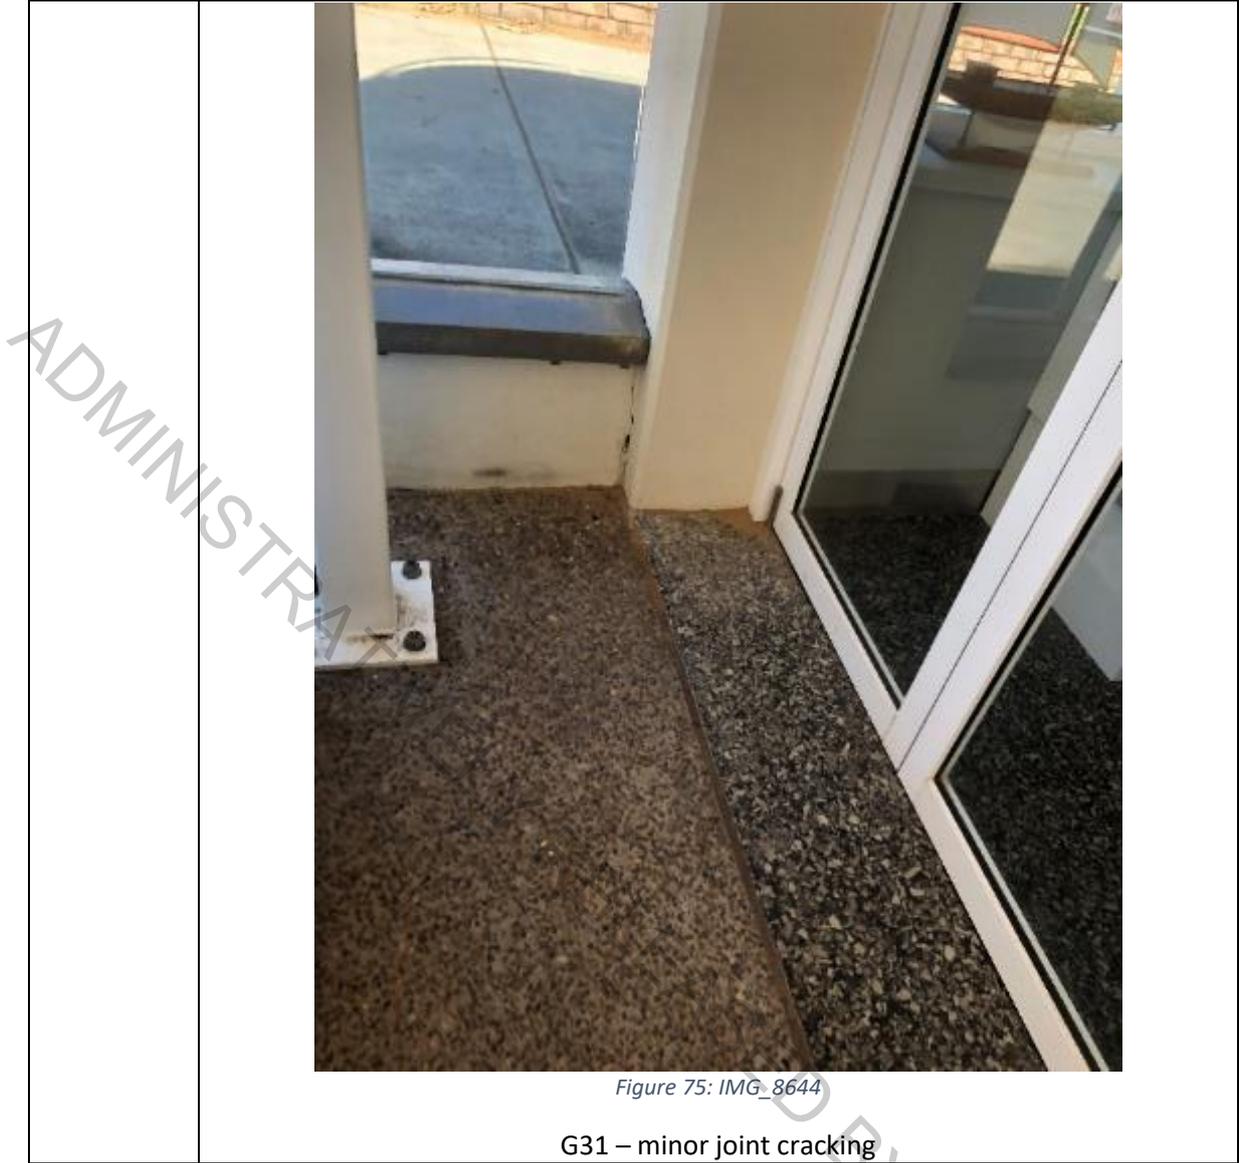
Figure 75: IMG_8644

G31 - minor joint cracking

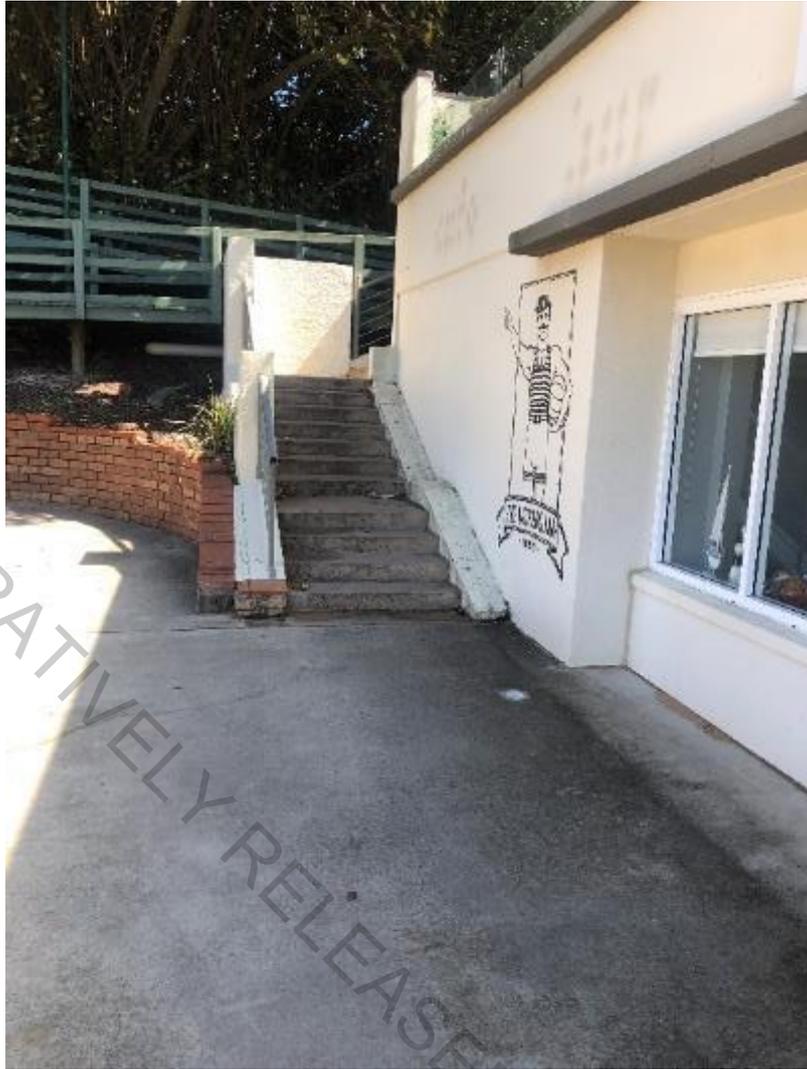
Figure 76: IMG_8560

F1: Level 1 Grid A	Defect D8 C5 cracking in reinforced concrete stair wall in southern access stairs.	Access available for repairs.	<i>BEC sighted. In agreeance with defect identification & proposed repair recommendation.</i>
F2: Level 1 Grid A	Defect D8 C5 cracking in reinforced concrete stair wall in southern access stairs.	Access available for repairs.	<i>BEC sighted. In agreeance with defect identification & proposed repair recommendation.</i>
F3: Level 1 Grid H	Defect D9 Failure of external lining water ingress into frame is likely.	Access up to external area of Level 1: strip linings and undertake repair works as required.	<i>BEC sighted. In agreeance with defect identification & proposed repair recommendation.</i>
F4: Level 1 Grid B	Defect D10 Water damage to full extent (assumed) of upper level wall framing – image adjacent shows repaired framing installation. This is resulting in the bottom plate & lower portion of the studs suffering initial,	To undertake repairs to achieve a current best practice outcome, the full removal of all external cladding would be required. Repair works & framing repairs are also required (assumed as minimum to all bottom plate and a majority of studs). Install external wall membrane &	<i>BEC sighted. In agreeance with defect identification & proposed repair recommendation.</i>

F1 & F2 – Stair cracking

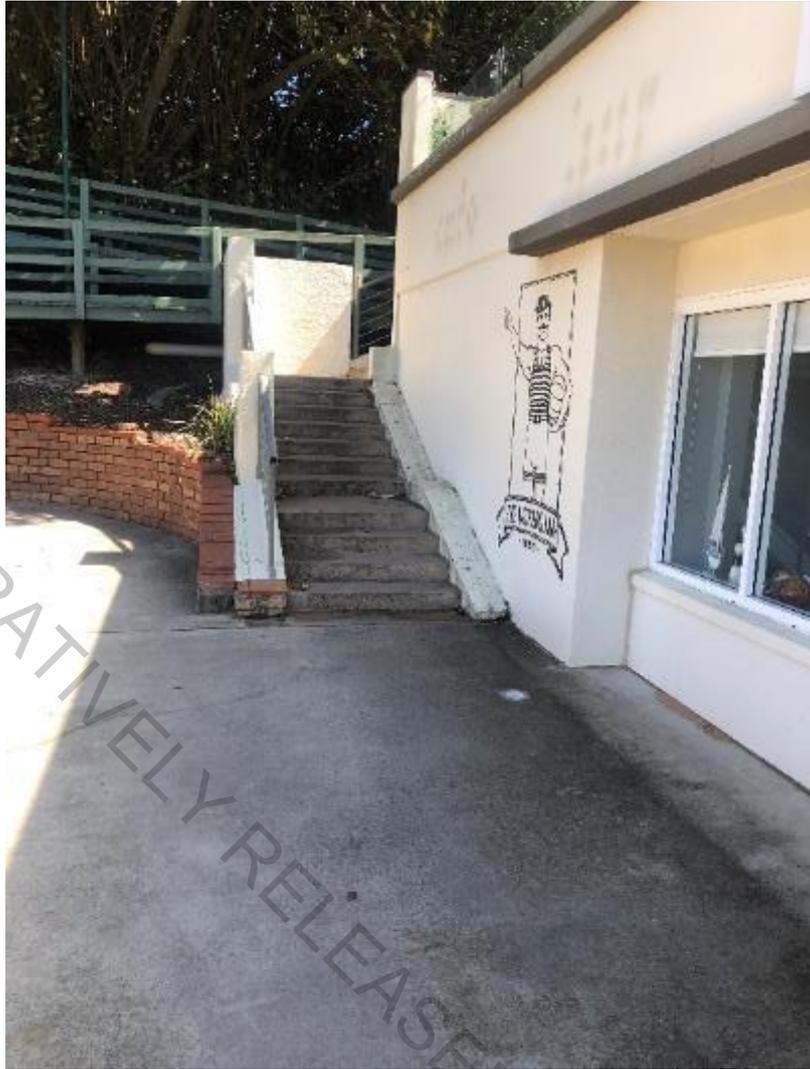
Figure 77: IMG_8560

F1 & F2 – Stair cracking

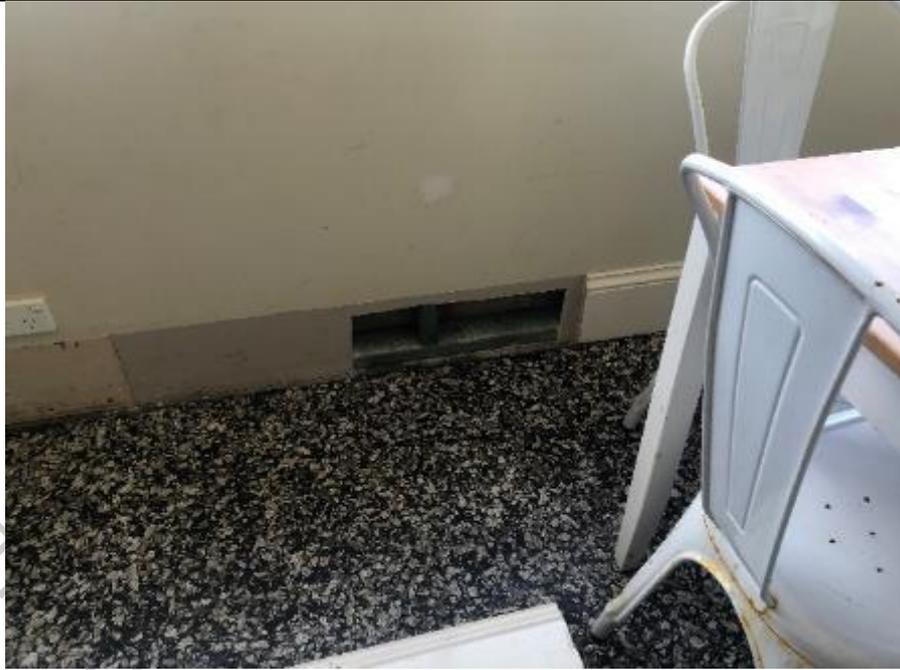
Figure 78: IMG_8563

F4 – Water damage to frame

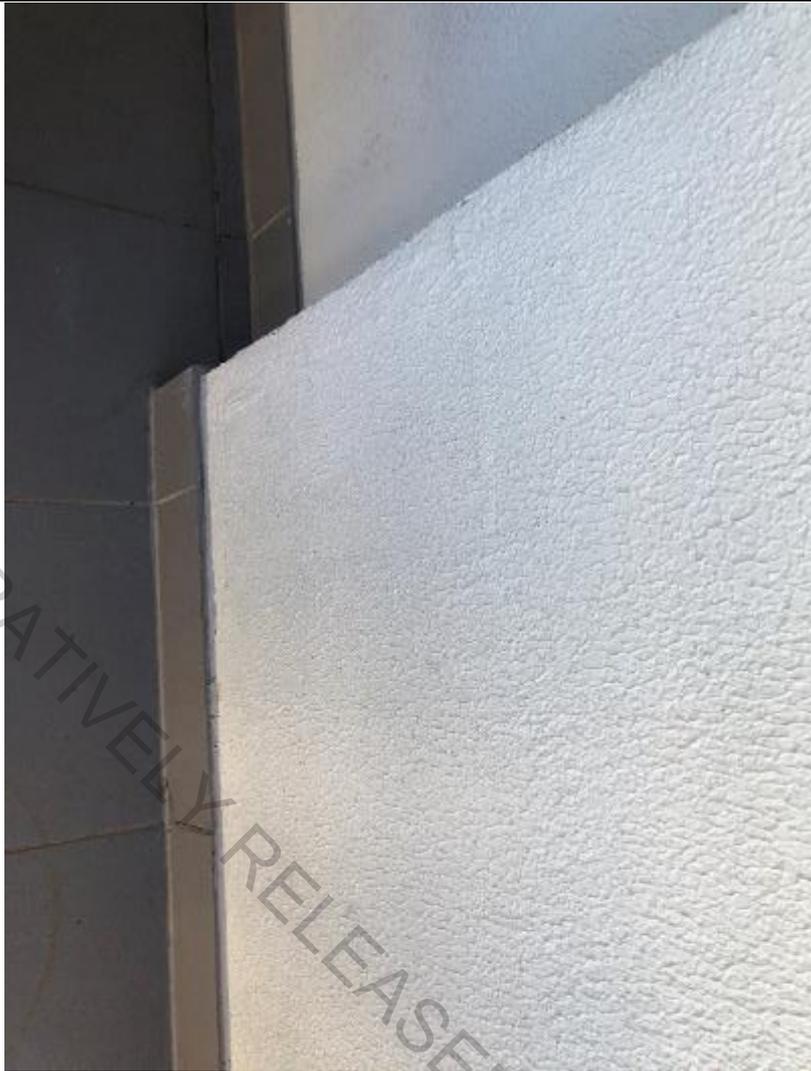
Figure 79: IMG_8612

F4 – External wall water damage – Tiles recently sealed

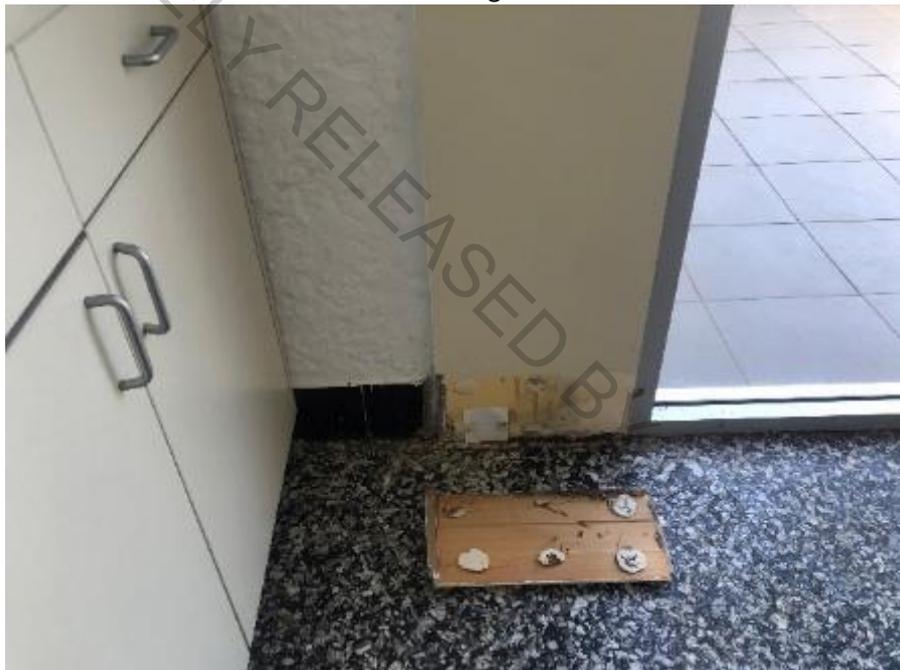
Figure 81: IMG_8565

F5 – Water damage to frame

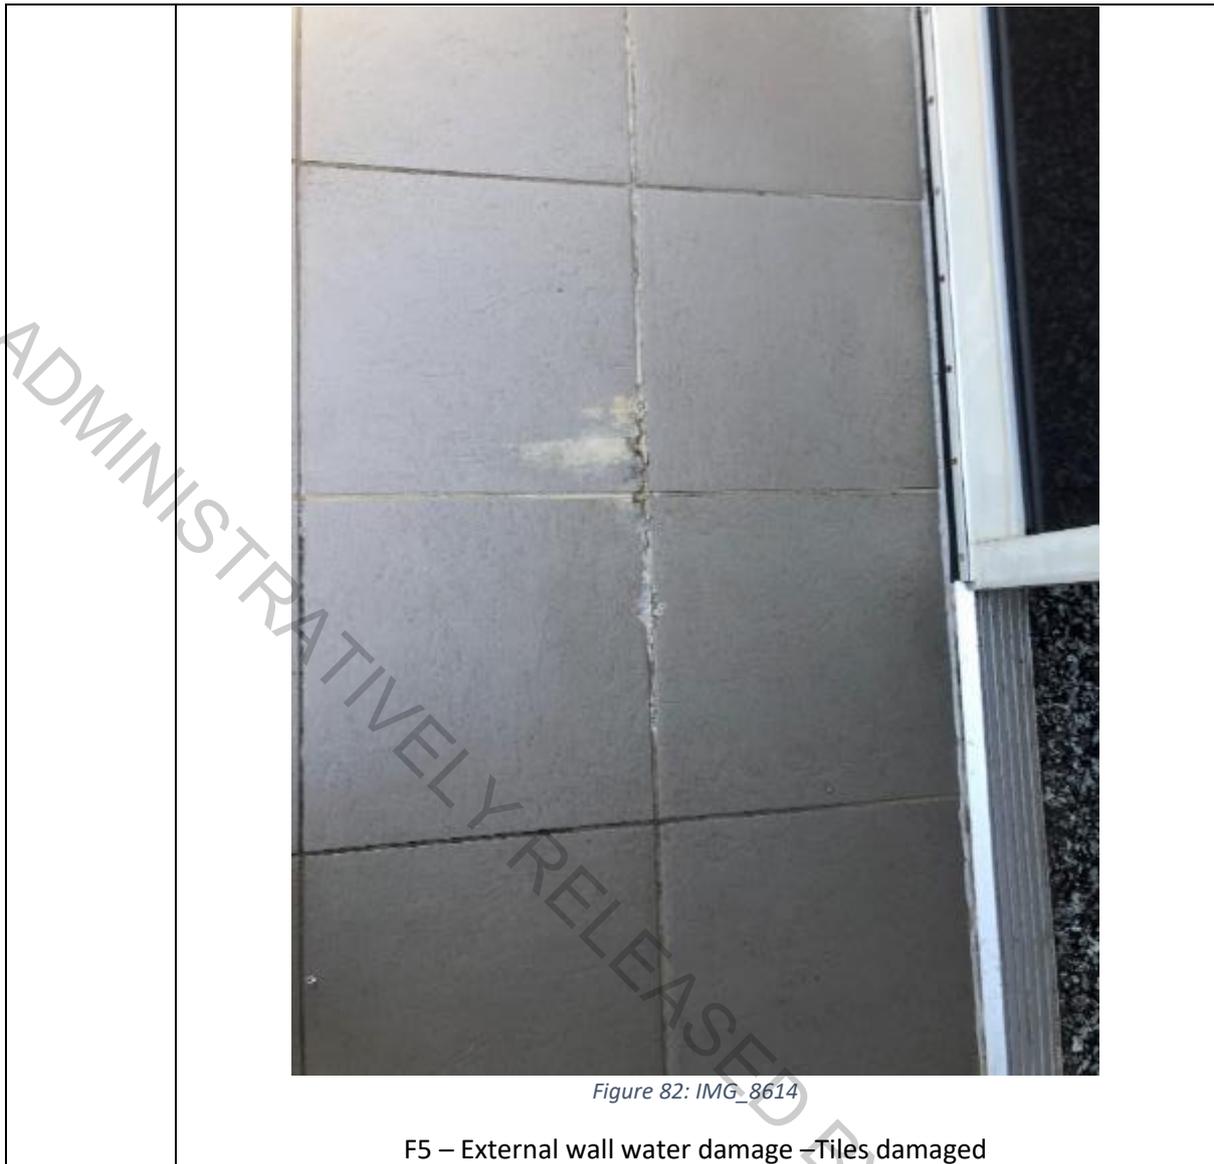
Figure 82: IMG_8614

F5 – External wall water damage – Tiles damaged

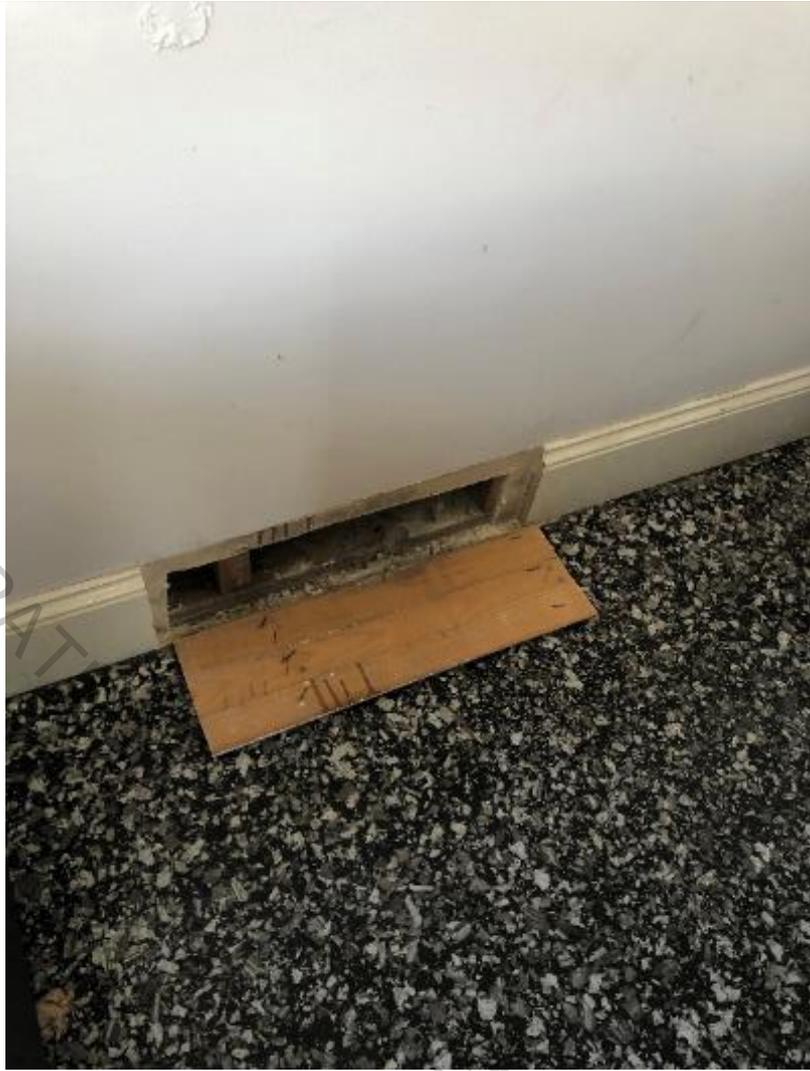
Figure 83: IMG_8576

F6 – Water damage to frame

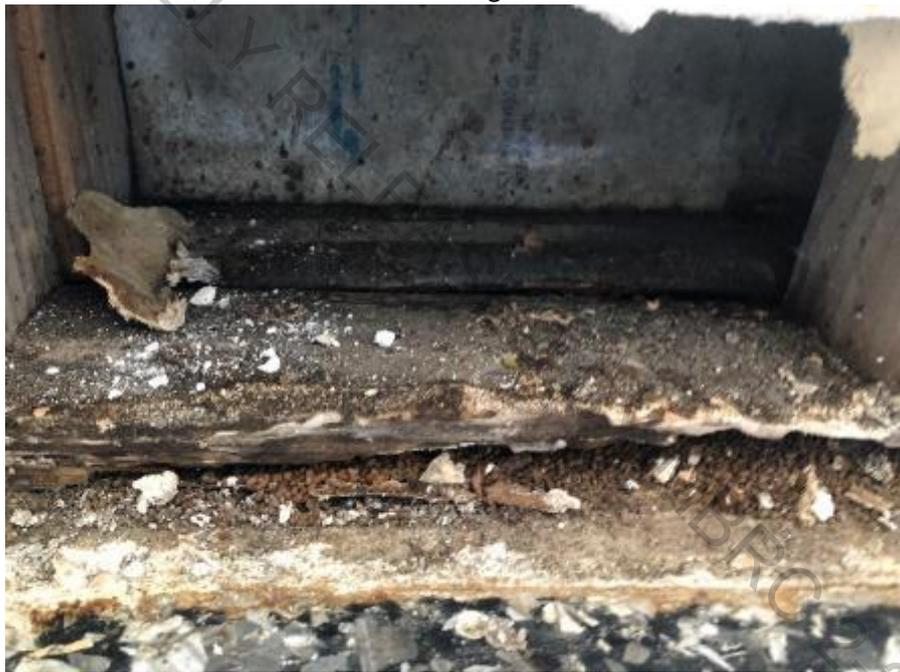
Figure 85: IMG_8578

F7 – Water damage to frame

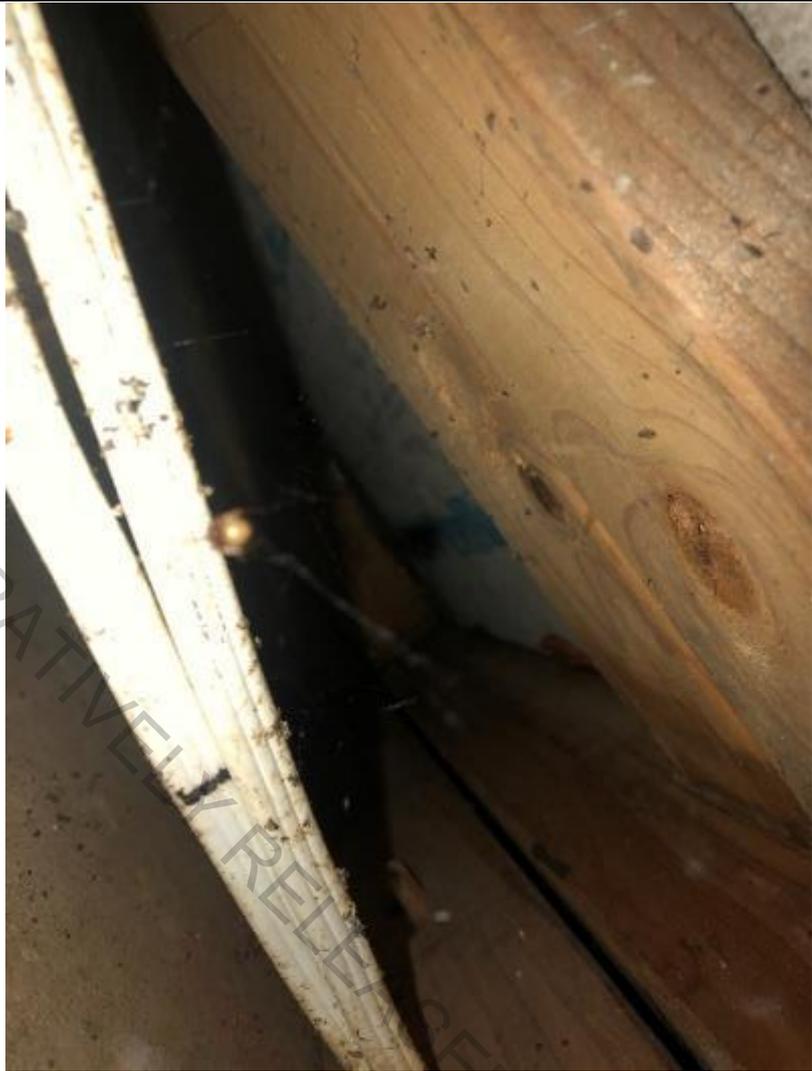
Figure 86: IMG_8579

F7 – Water damage to frame

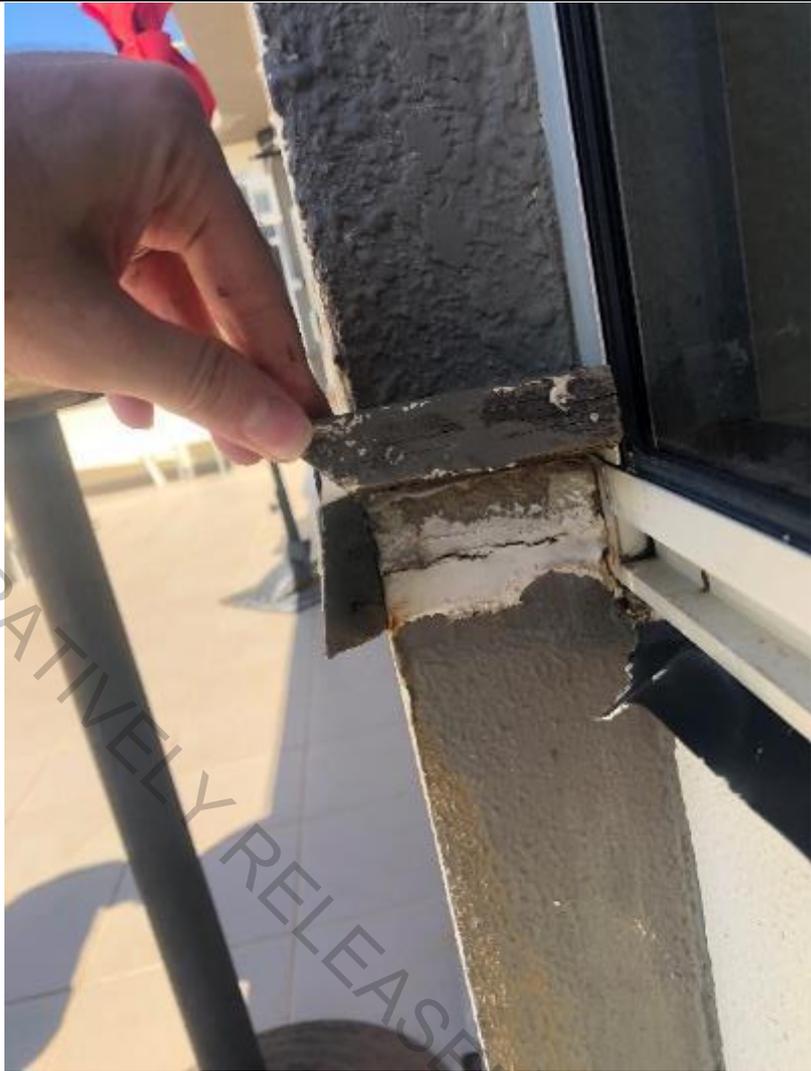
Figure 89: IMG_8597

F7 – External side – water damage
