Sutton Beach Pavilion, Redcliffe

Structural Condition Audit Peer Review

Moreton Bay Regional Council

Project no. 7366

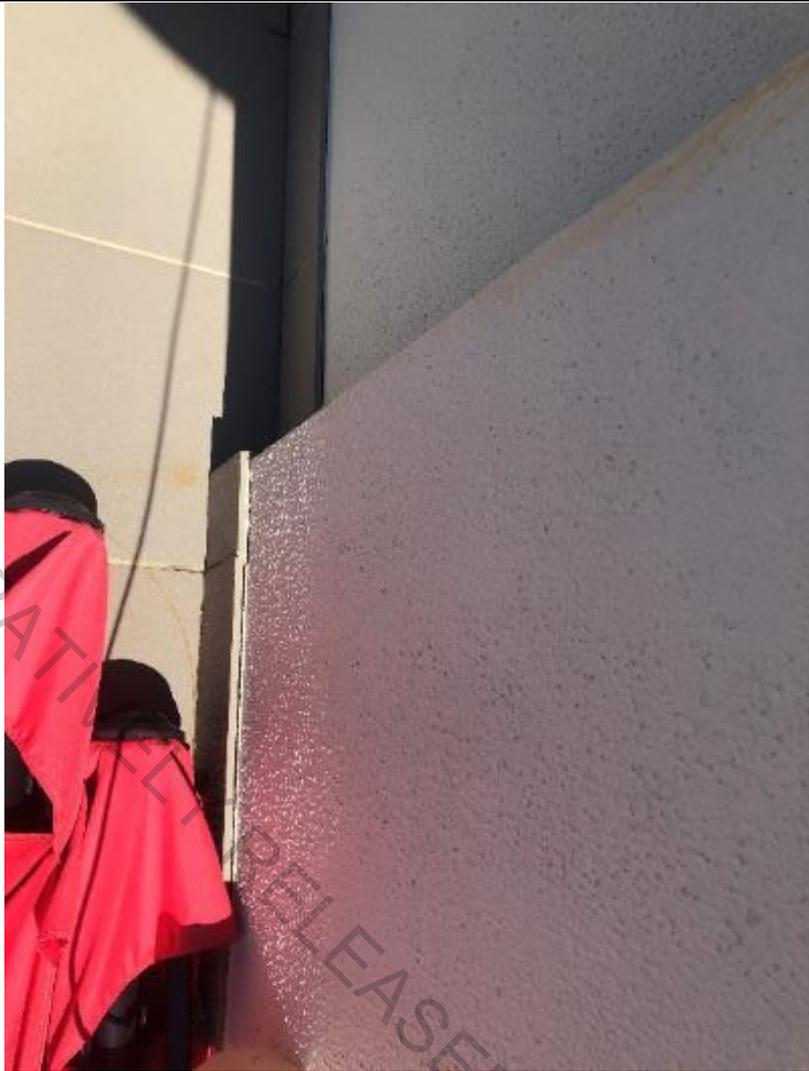
Figure 90: IMG_8598

F7 – External side – water damage

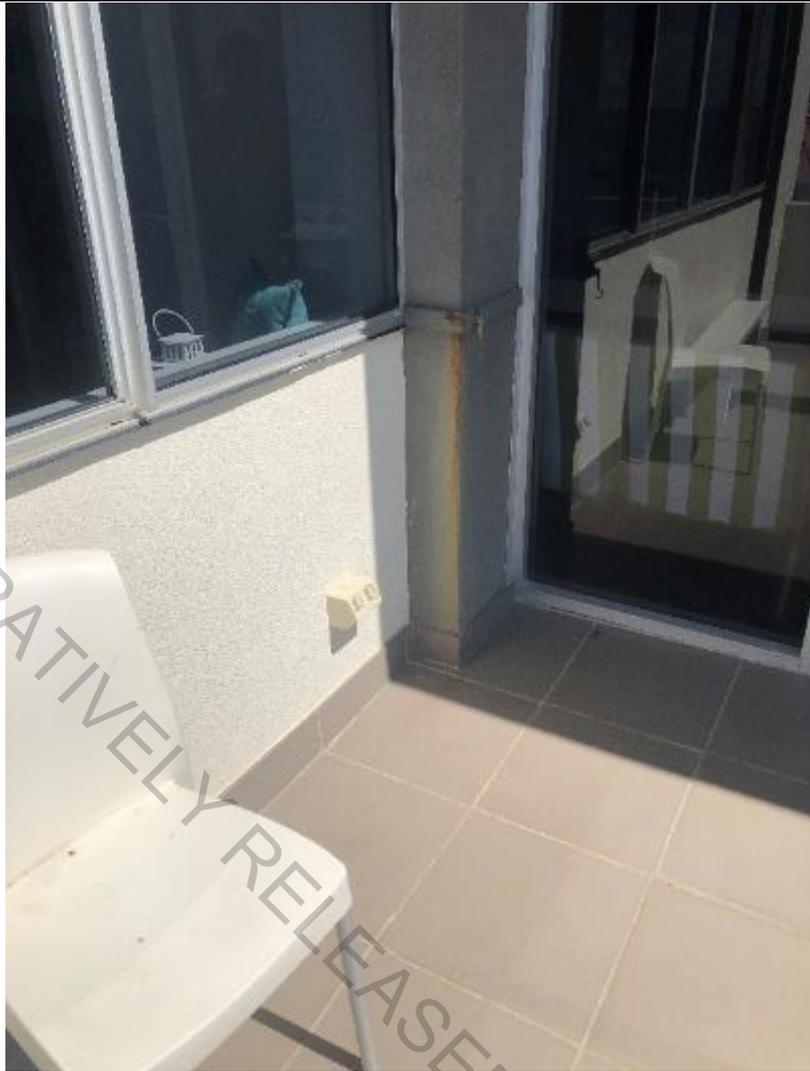
Figure 91: IMG_8605

F7 – External side – water damage

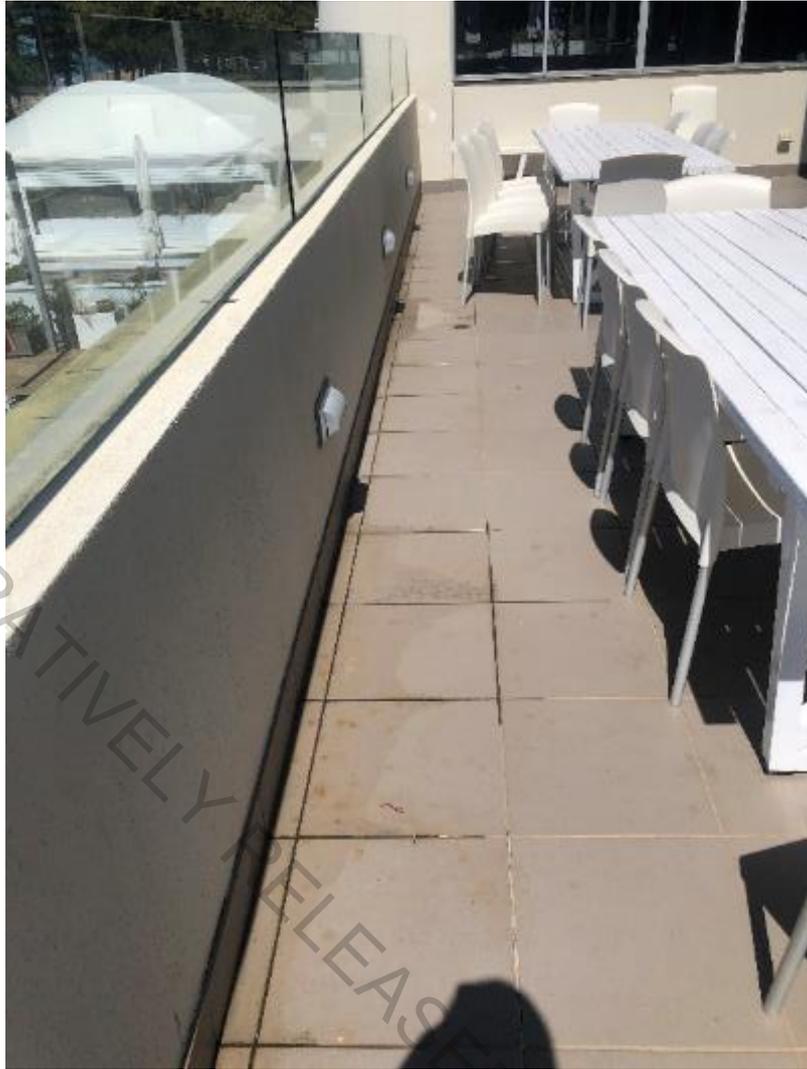
Figure 92: IMG_8602

F9 – Distant wall water damaged – ponding on tiles

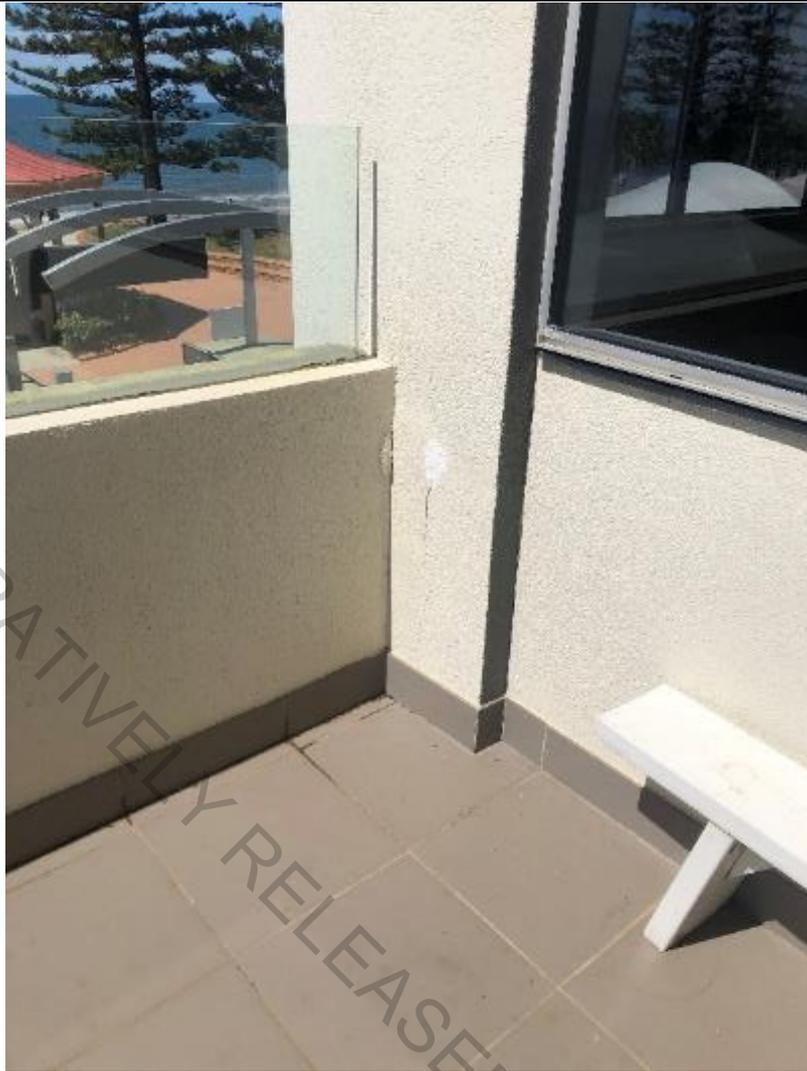
Figure 93: IMG_8604

F9 – Wall water damaged

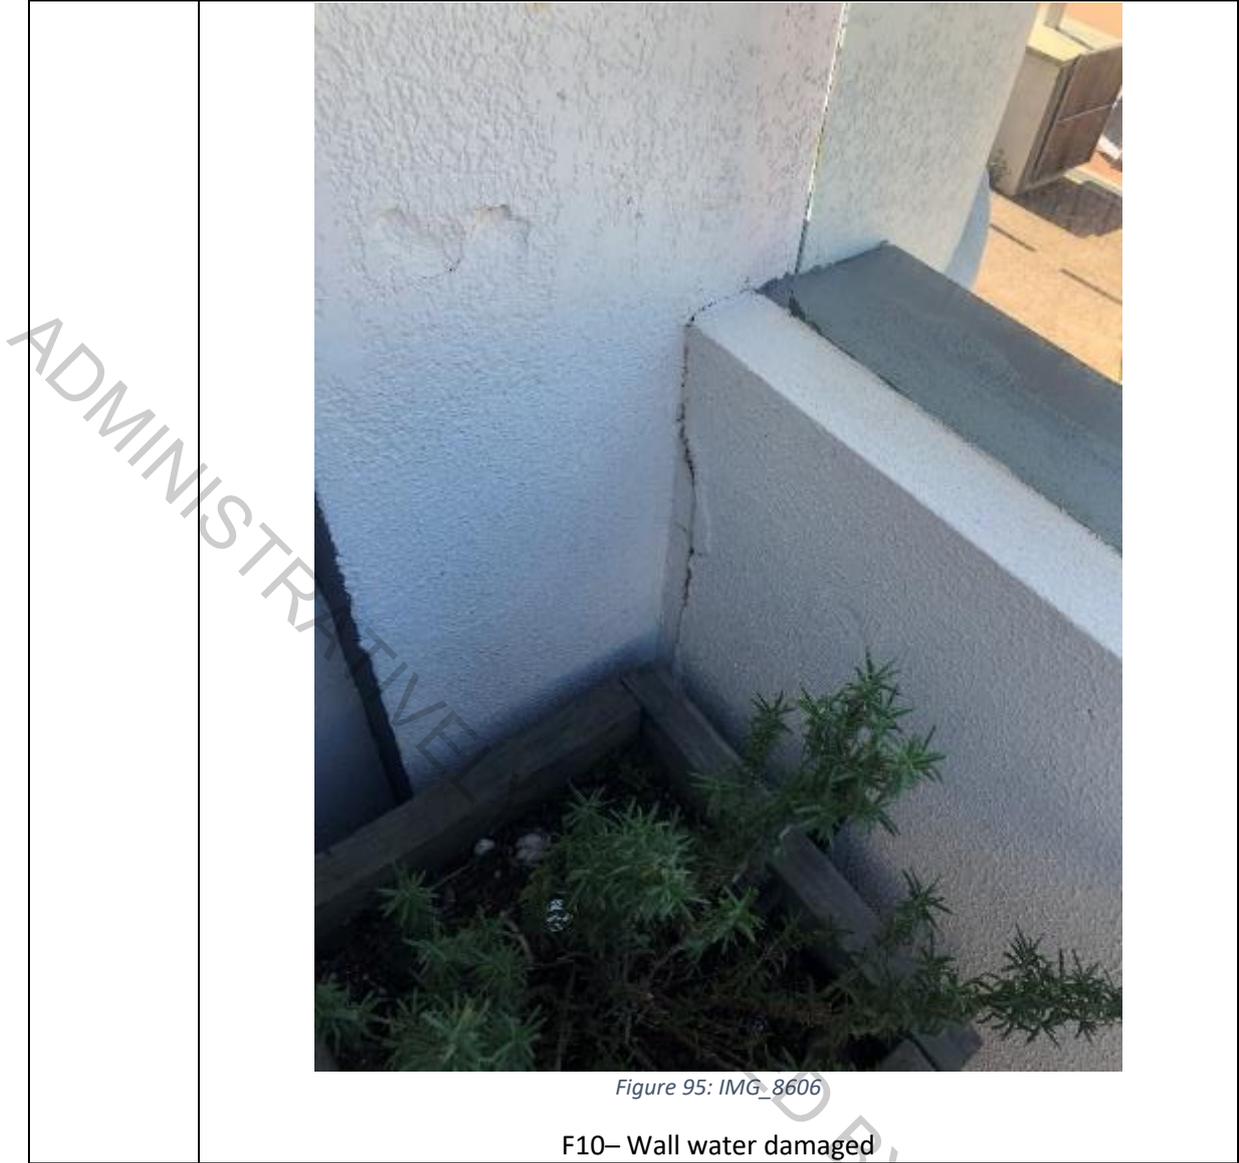
Figure 95: IMG_8606

F10- Wall water damaged

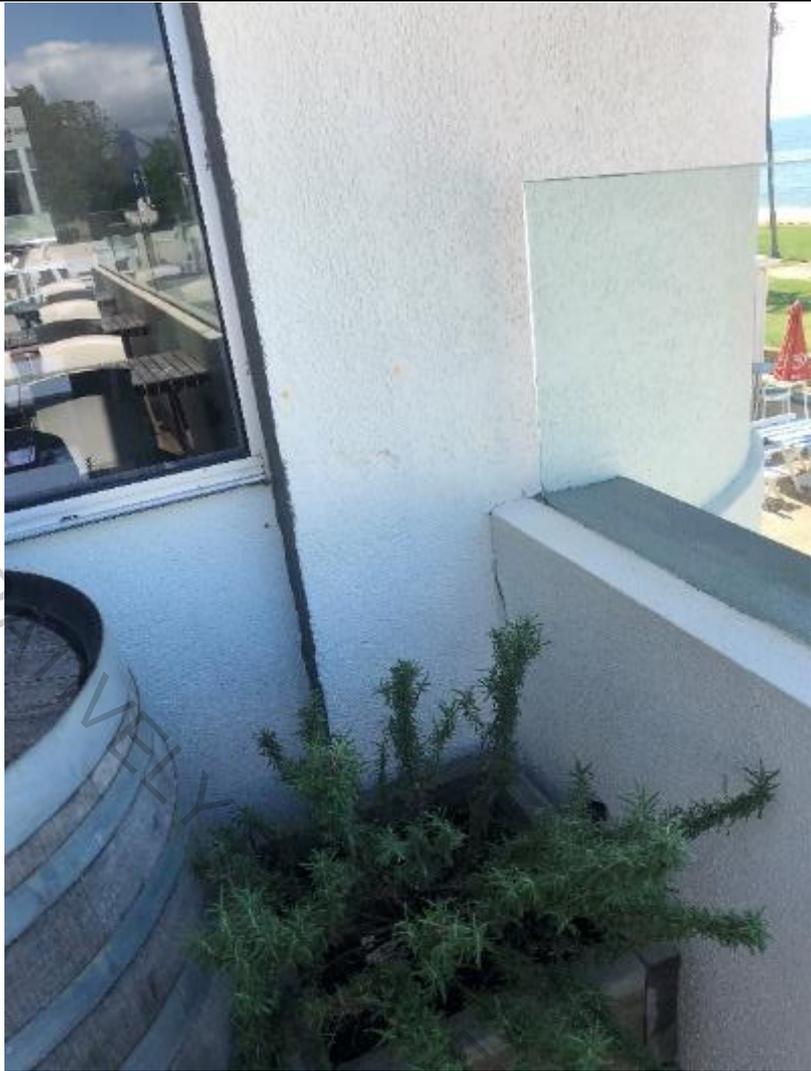
Figure 96: IMG_8607

F10- Wall water damaged

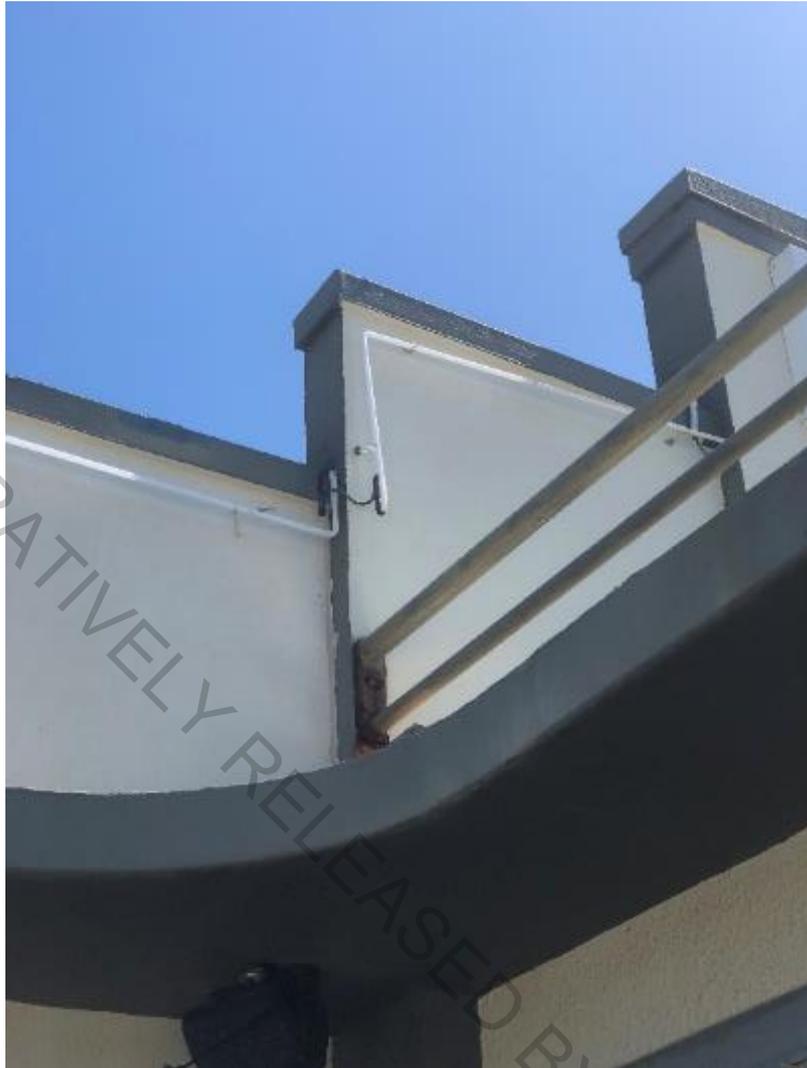
Figure 98: IMG_8615

F10 – Roof Balustrade corroded fixings

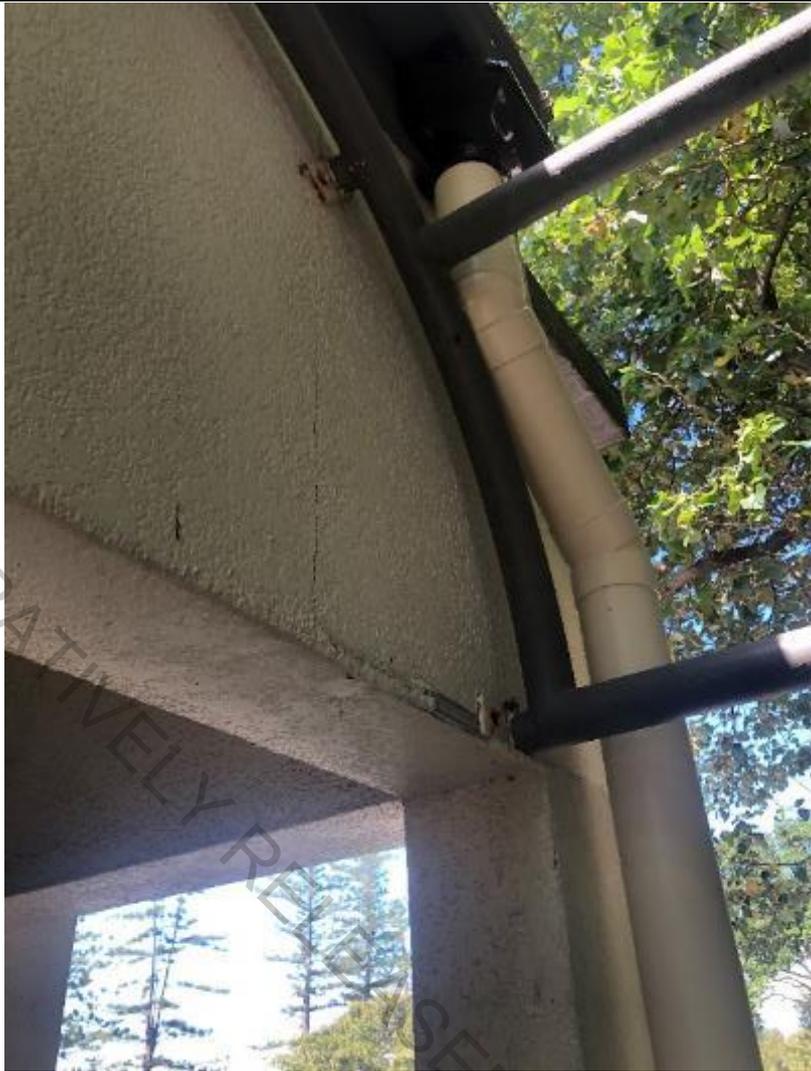
Figure 100: IMG_8561

F20 – Steel Frame Awning Corroding

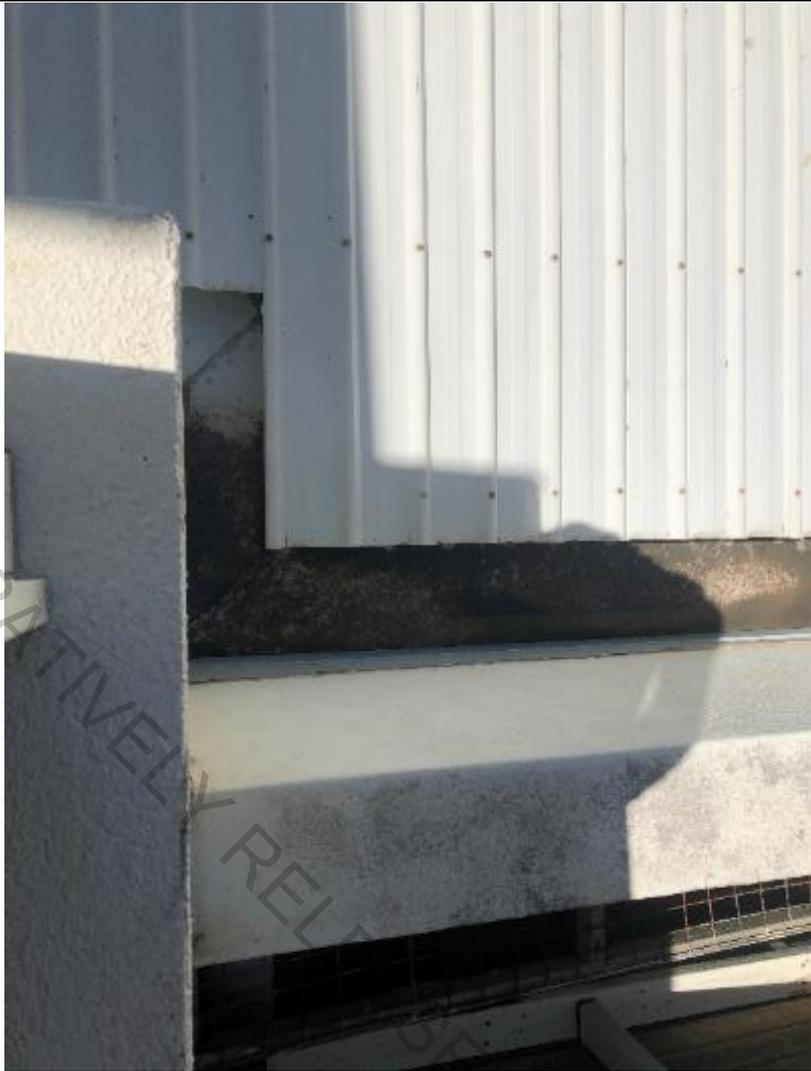
Figure 101: IMG_8582

F20 – Box gutter – water ponding

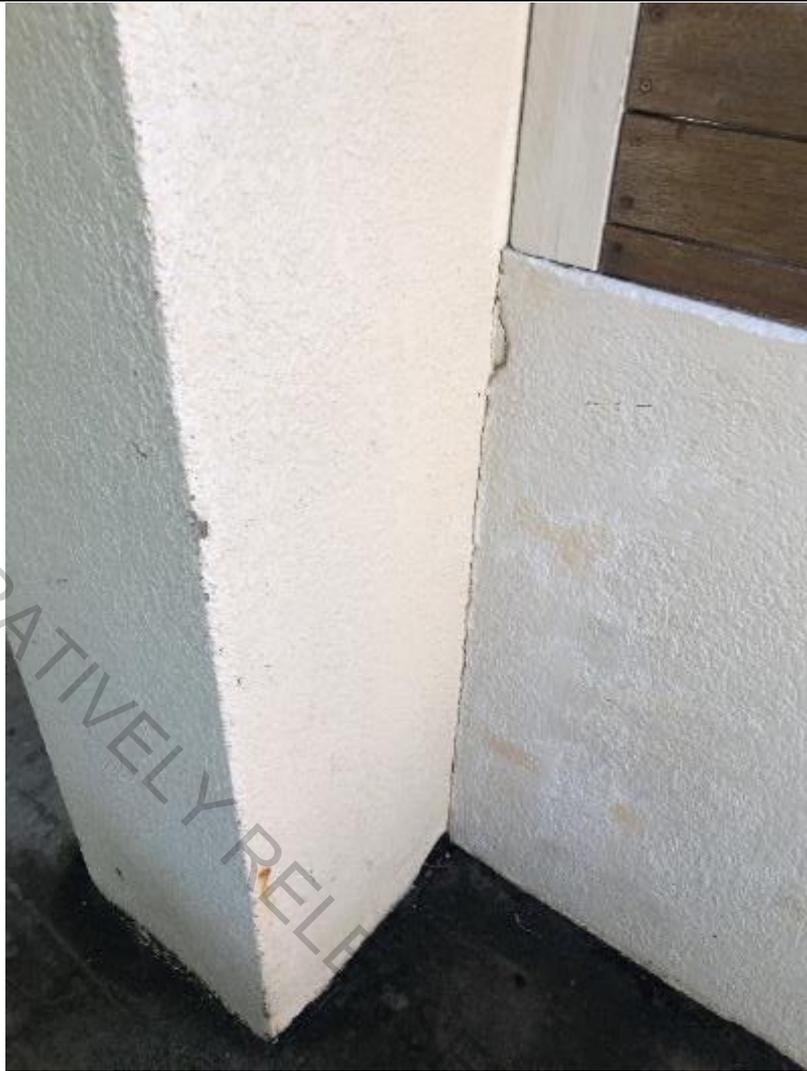
Figure 102: IMG_8588

F20 – General tie of balustrade to pavilion 2, minor corrosion spots on column

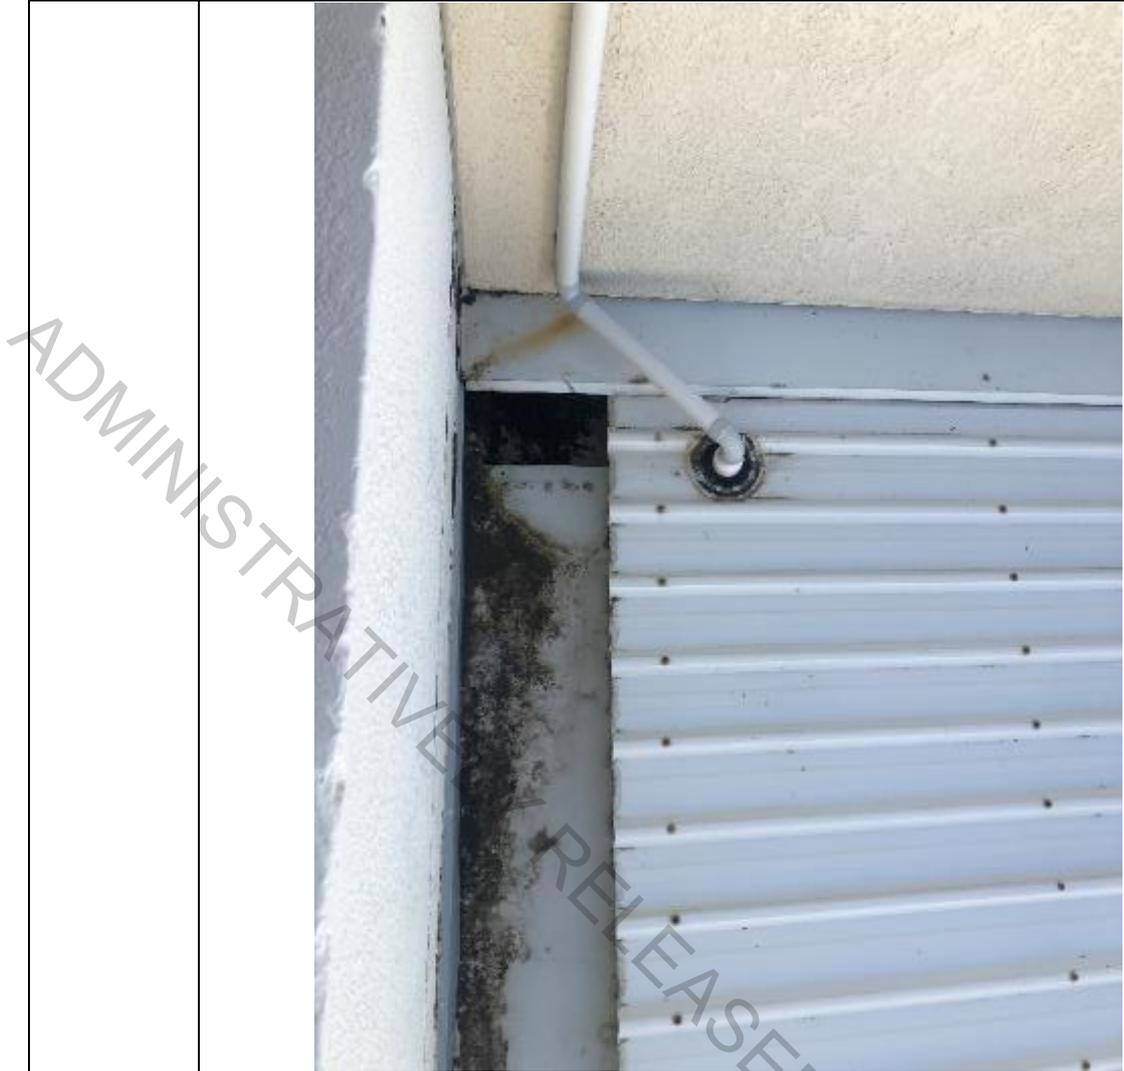
Figure 103: IMG_8589

F20 – Box gutter – water ponding

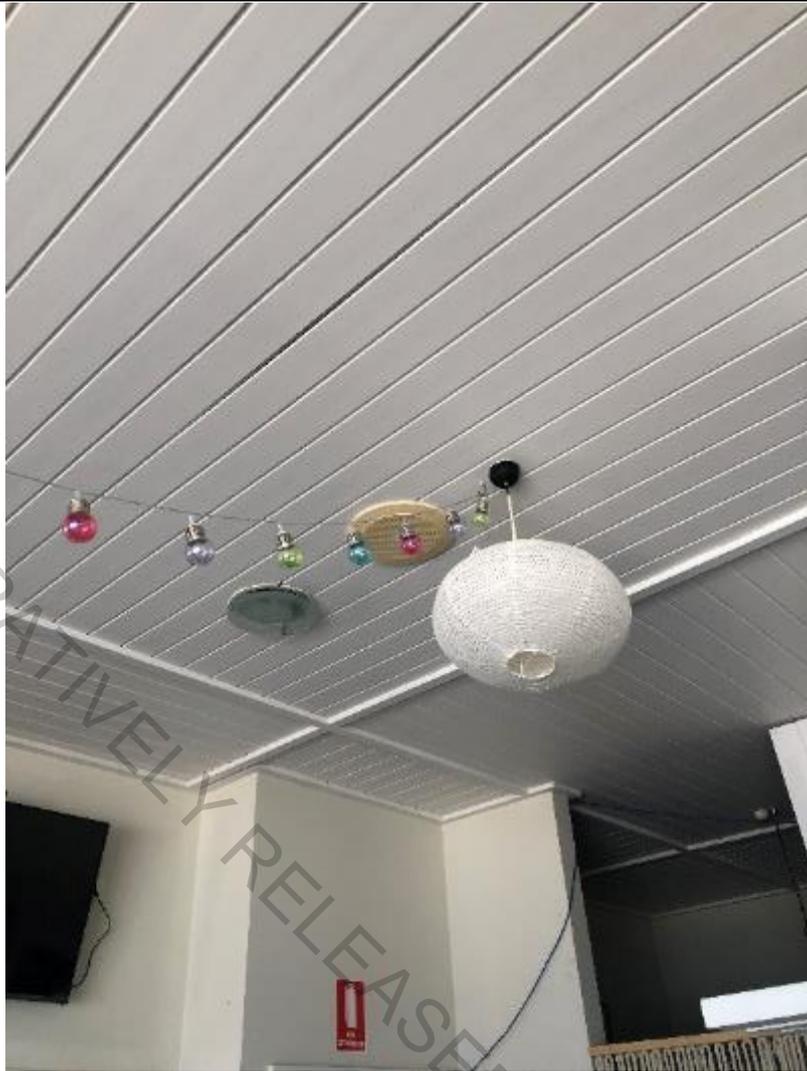
Figure 116: IMG_8580

F31 – Potential ceiling sag/water damage

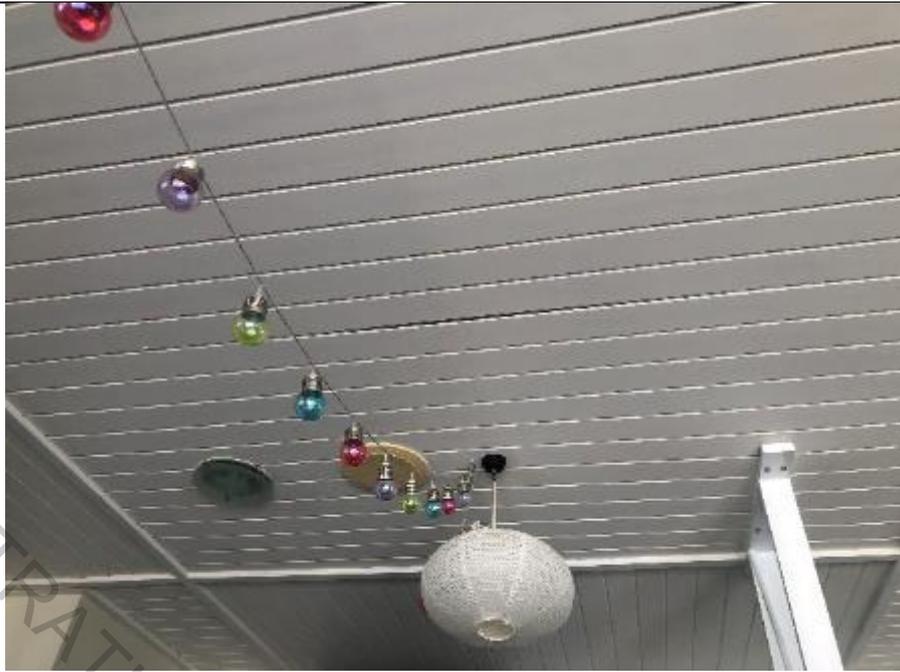
Figure 117: IMG_8581

F31 – Potential ceiling sag/water damage

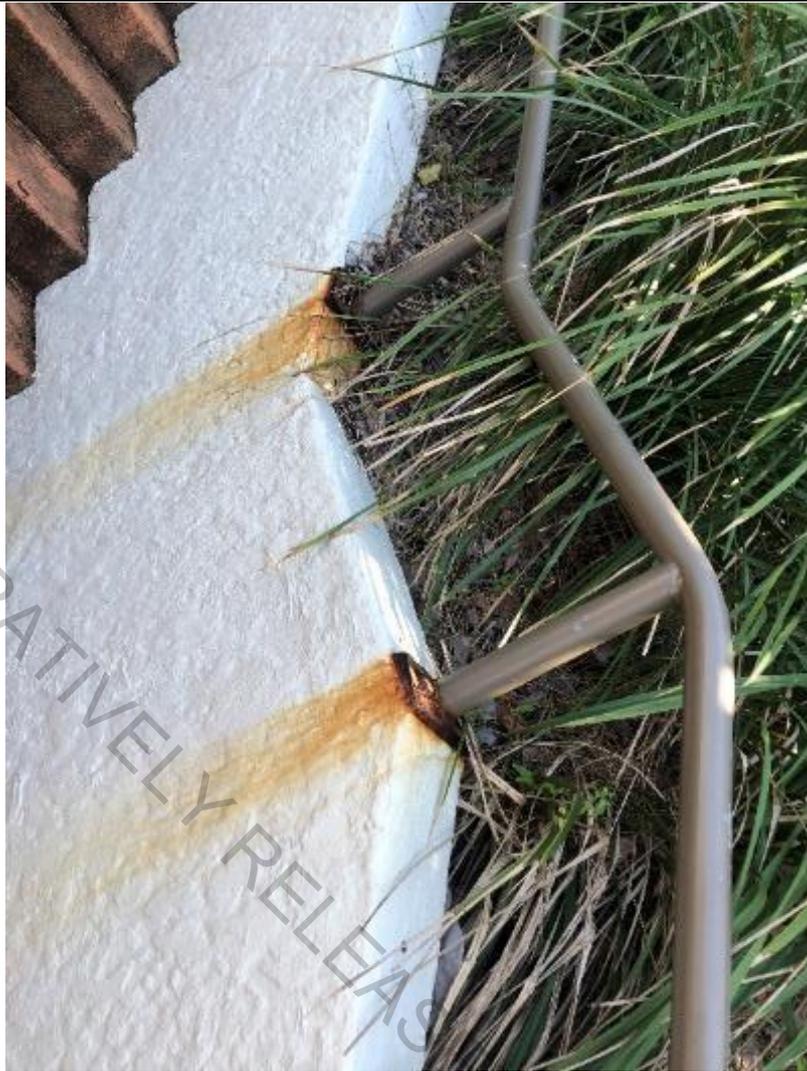
Figure 119: IMG_8628

F33 – Stair handrails corroded

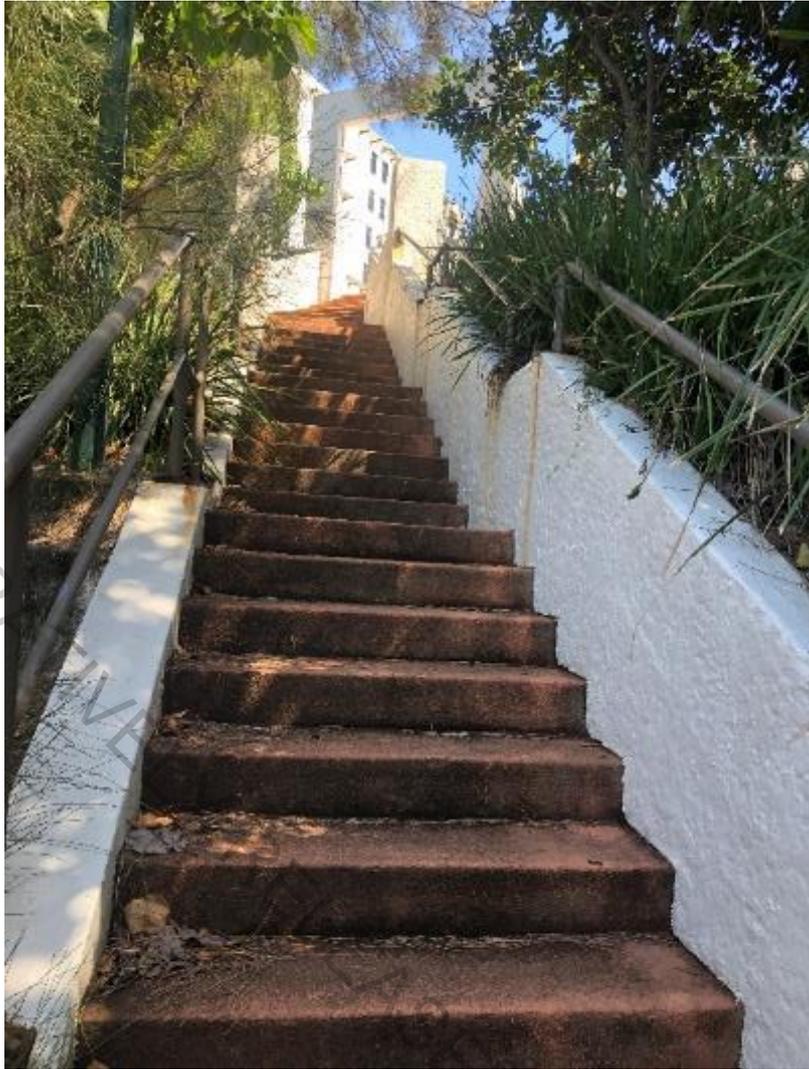
Figure 120: IMG_8629

F33 – Stair handrails corroded

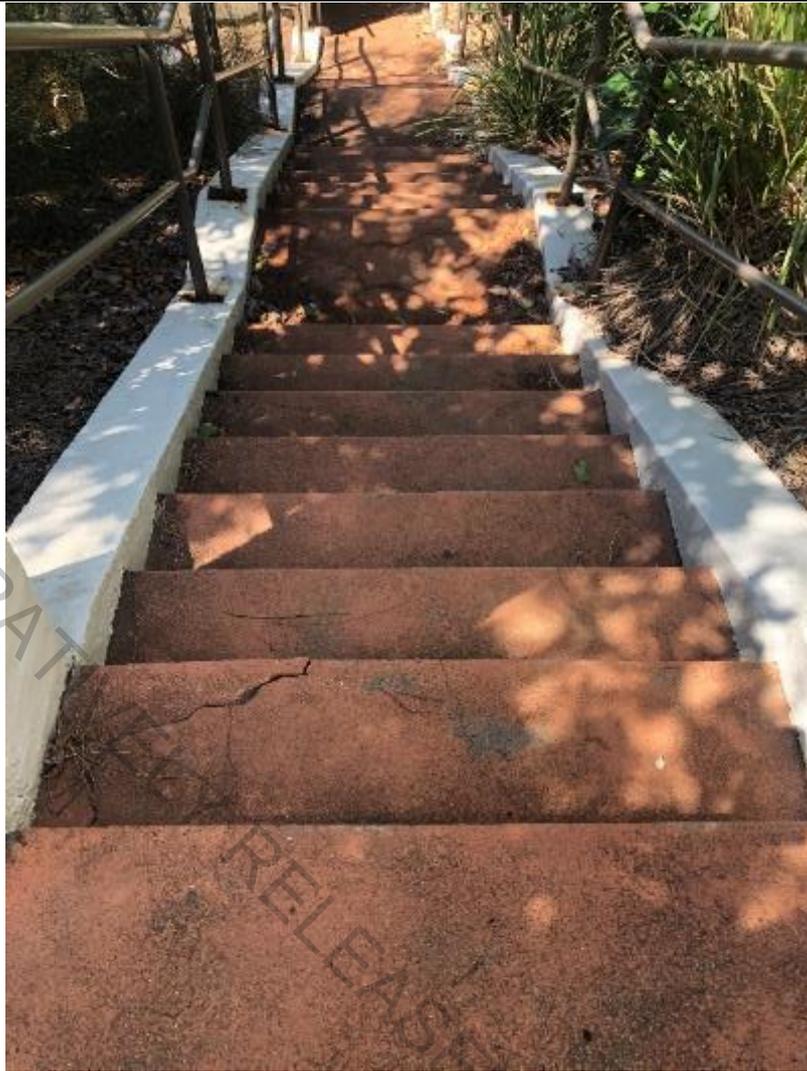
Figure 121: IMG_8631

F34 – Stair handrails corroded/cracking of stair tread

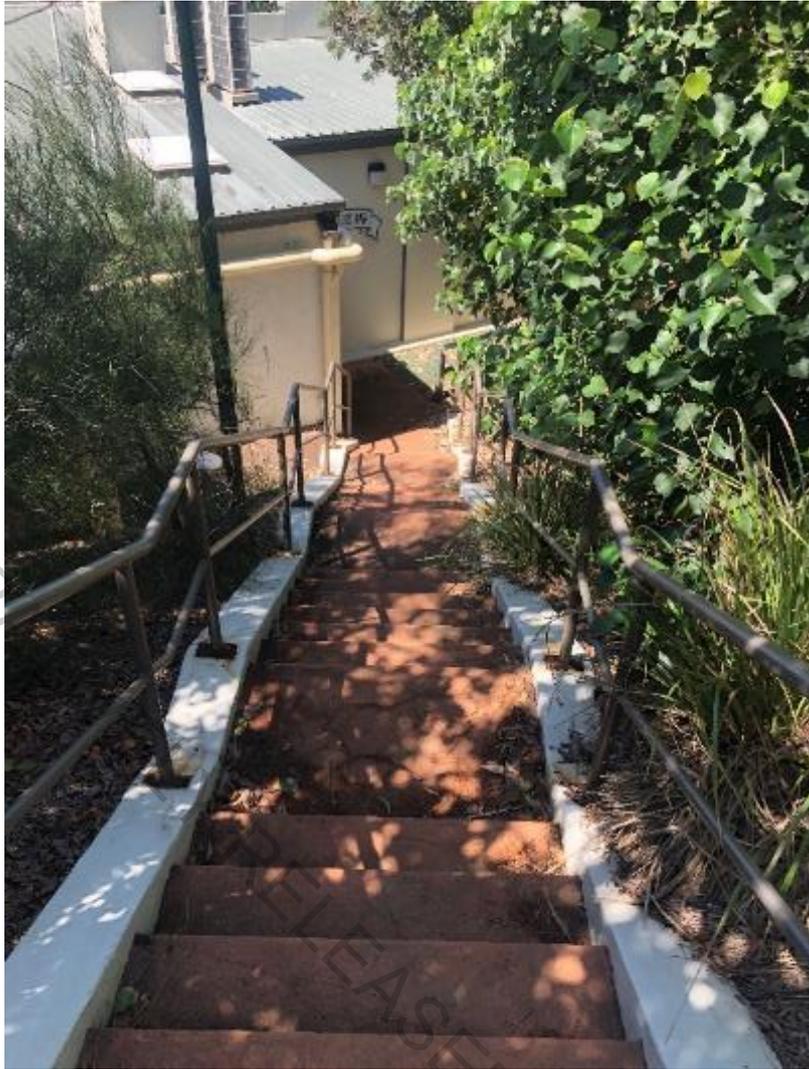
Figure 122: IMG_8632

F34 – Stair handrails corroded/cracking of stair
