CONSULTANCY STRUCTURAL ENGINEERING REVIEW

SUTTONS BEACH PAVILION 1

MARINE PARADE, SUTTONS BEACH, REDCLIFFE 4020

REPORT No: 62015RPT

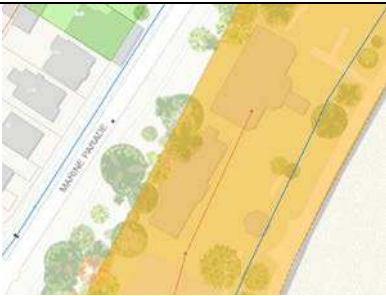
<p>Figure 1 – Site Sewer Connection</p>	The Pavilion 1 is serviced from the Unitywater sewer main to the south of the building. The approximate location of the property sanitary drains has been indicated in the report provided by FSA Consulting Engineers Dwg No. 17-545-102 refer Appendix A of this report. This is a 150 mm VC sewer main.	The integrity of the site sanitary drainage pipes is not known. We recommend a CCTV investigation be conducted to ensure if further development of the site is proposed that the existing drains would be adequate.

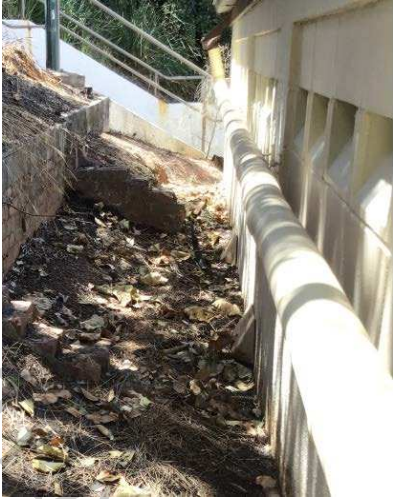
<p>Figure 2 – Site Roof water collection pipe</p>	<p>The Pavilion 1 building is serviced by stormwater collection pipes that discharge the collected roof water to ocean outfall. The roof water that falls to the rear of the building on the Marine Parade frontage is collected via a 150mm suspended UPVC stormwater pipe which discharges to a grated surcharge pit and to the kerb frontage on the south western side of the building. Roof and pavement run-off from the front of the building discharges direct to ocean out fall.</p>	<p>The integrity of the site stormwater collection pipes is not known. We recommend a CCTV investigation be conducted to ensure if further development of the site is proposed that the existing drains would be adequate.</p>
Site Water Supply

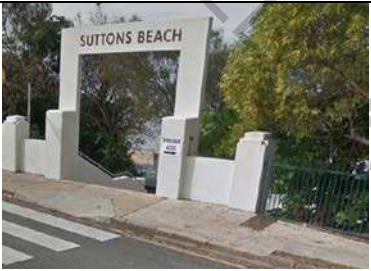
<p>Figure 3 – Site water meter location</p>	<p>The Pavilion 1 building is serviced by metered water service on the Marine Parade frontage adjacent to the entry to Suttons Beach. It is then reticulated via in-ground pipe and suspended in the back of house services area</p>	<p>The water meter seems to be in good order.</p>

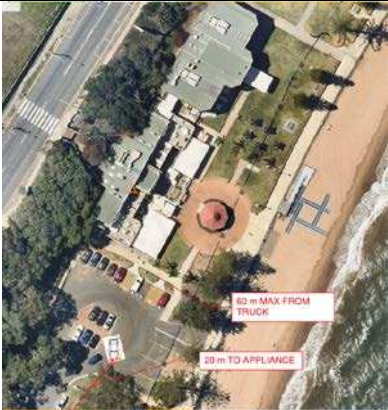
<p>Figure 4 – Site Fire Hydrant Location</p>	<p>The hydrants provide a required flow for fire fight purposes. The design is to be in accordance with AS 2419.1-2005 and National Construction Code. At the time of inspection, it was not known the condition or the current fire fight flows and pressures achievable from the main</p>	<p>The current fire fight scenario is not in accordance with the relevant codes. We recommend an assessment should be conducted on the hydrant cover to the building.</p>

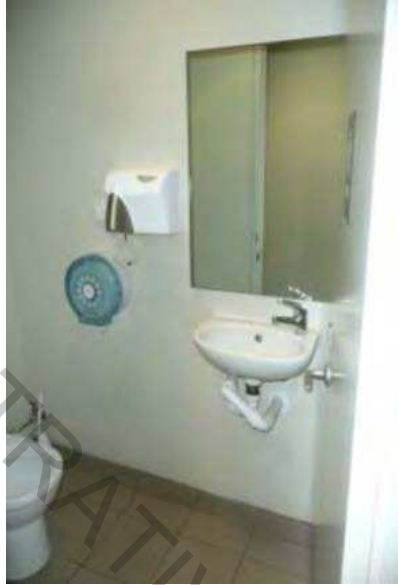
<p>Toilet Male</p>

<p>The lower-level male toilet was provided with a toilet suite and basin. The water supply to the areas was provided by pipe work run at high level in the ceiling over and dropped to services. The drainage seems to be in good order and in accordance with AS3500.2-:2018 – Sanitary and Plumbing and Drainage</p>	<p>The taps and fittings were in working order. If the building was to be refurbished, we would recommend replacement of the sanitary fittings. Hot water used would need to be tempered in accordance with AS 3500.4:2018 – Heated Water Services</p>
<p>Toilet Female</p>

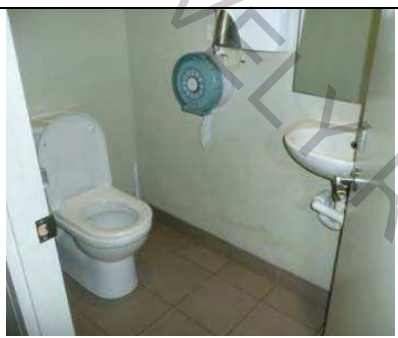
<p>Figure 5 - Female toilet Ground Floor</p>	<p>The lower-level female toilet was provided with a toilet suite and basin. The water supply to the areas was provided by pipe work ran at high level in the ceiling over and dropped to services. The drainage seems to be in good order and in accordance with AS3500.2-:2018 – Sanitary and Plumbing and Drainage</p>	<p>The taps and fittings were in working order. If the building was to be refurbished, we would recommend replacement of the sanitary fittings. Hot water used would need to be tempered in accordance with AS 3500.4:2018 – Heated Water Services</p>

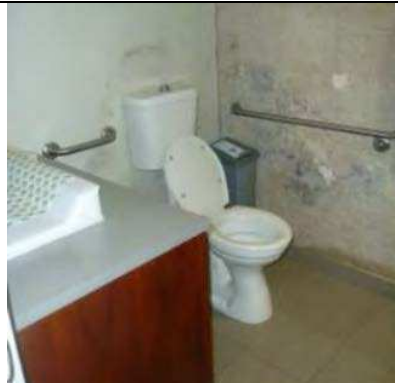
<p>Figure 6 – Unisex PWD</p>	<p>The lower-level disabled toilet was provided with a toilet suite and basin. The water supply to the areas was provided by pipe work ran at high level in the ceiling over and dropped to services. The drainage seems to be in good order and in accordance with AS3500.2-:2018 – Sanitary and Plumbing and Drainage</p>	<p>The taps and fittings were decommissioned at the time. If the building was to be refurbished, we would recommend replacement of the sanitary fittings. Hot water used would need to be tempered in accordance with AS 3500.4:2018 – Heated Water Services</p>

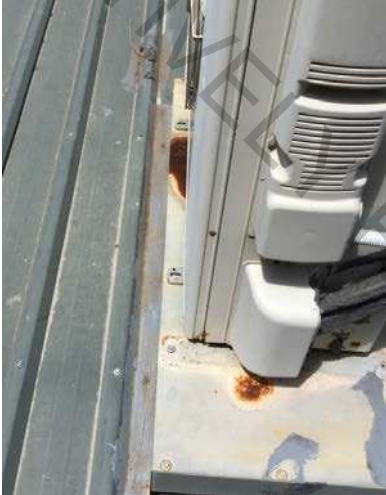
<p>Figure 9 – Faulty installation with penetrations through pan of roof sheet</p>

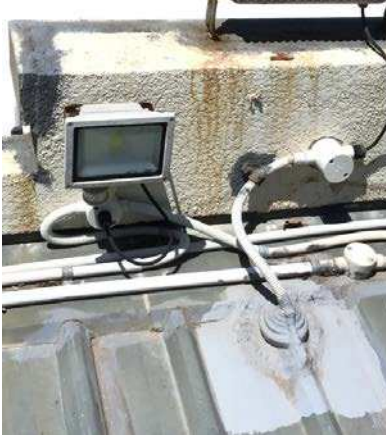
<p>Figure 9.1 – Delapidated water proofing around services penetrations</p>	This area of roof is of material of Colourbond roof sheeting pitched toward a collection eaves gutter towards the Sutton esplanade rear of the building. The gutter is serviced by a series of PVC downpipes located down the external walls of Pavilion One. Some of these collection down pipes. Both the gutter and roof are showing signs of weathering. The roof sheet pans have been damaged in certain areas approx. 50% plus by roof traffic. The supporting structure under the roof sheets shows sign of deflection and sagging and hence the roof sheets now hold water within the pans of the sheets. The roof sheets in areas are not a continuous piece from the top to the bottom of the roof. Numerous roof screws have worked loose overtime	We recommend in the interim of total roof replacement that all loose screws be replaced or fastened tight; the short sheets be replaced with roof sheets the full length of the pitch of the roof. We recommend roof structural supports be placed on the bottom side of the penetrations. We recommend as a suitable

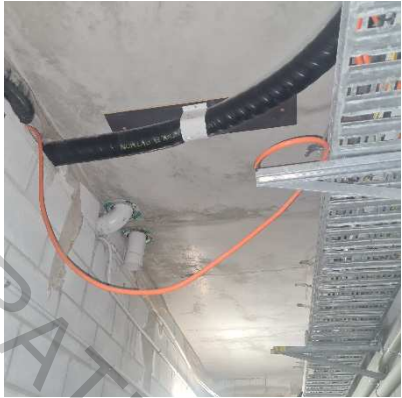
<p>Figure 20- Defective install</p>	Unsecured cable off cable tray. Unsafe installation.	Secure cable in accordance with AS/NZS 3000.
E1.10

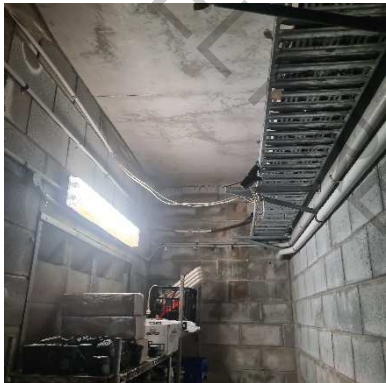
<p>Figure 21- Defective install</p>	Unsecured cable off cable tray. Unsafe installation.	Secure cable in accordance with AS/NZS 3000.
E1.11

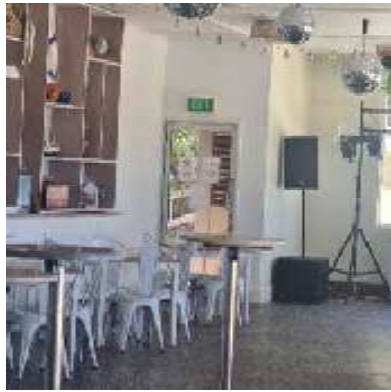
<p>Figure 12 – non-compliant sign</p>	Old style Exit sign plus should be illuminated.	Re-lamp and update to running man symbol to bring up to AS2293 and NCC.

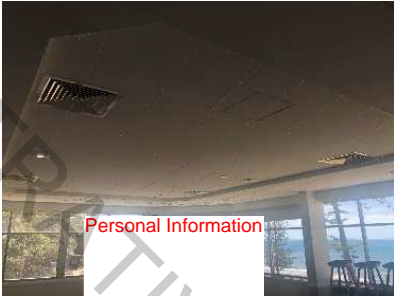
<p>Figure 16 – Pavilion Two function area</p>	Typical reception area supply air diffuser layout. Areas are served by split system ducted units with filtered outside air supply from roof mounted fan and filter bank.	The outdoor air quantities need to be checked for these areas to ensure compliance with current codes.
MI.5

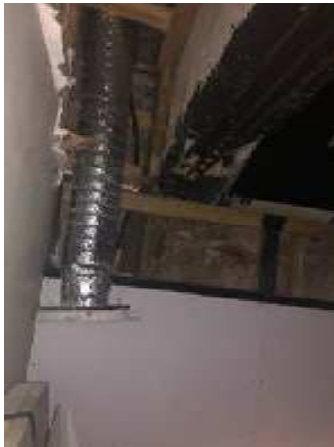
<p>Figure 7</p>	Toilets in the rear south-west corner had been partially demolished to attend to termite infestation. Services were no longer operable.	Re-instatement required at some point with a rebalance of exhaust system.
MI.8

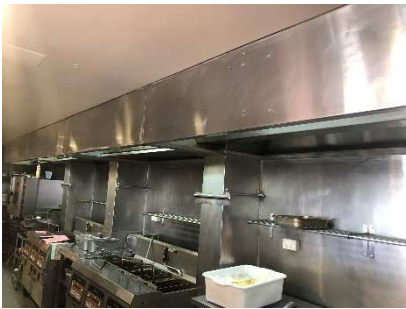
<p>Figure 8.1</p>	Kitchen hood exhausts to both cooking equipment (fig. 8.1) and dishwashers (fig 8.2) was comprehensive throughout the various kitchens. Air quantities were not able to be checked but all looked to be professionally done.	Air quantities could be checked for code compliance.

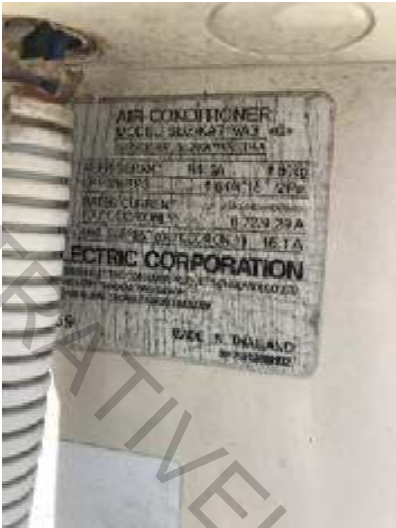
<p>Figure 12</p>	Electrical entering roof mounted condensing unit with flexible conduit broken away from condenser body.	Generally, all electrical work to mechanical equipment on the roof should be inspected and repaired as required.
MI.13

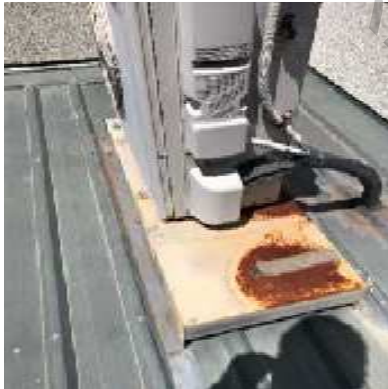
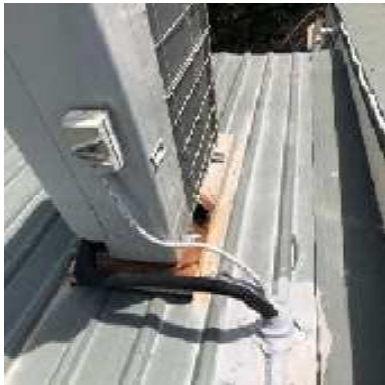
<p>Figure 13.2</p>	Corrosion of various metal parts, in this case condensing unit footing stands, is widespread due to the corrosive salt air environment. Note also the roof penetrations here, there are a large number of these across the roof. Fans, pipe work and electrical all penetrate the roof and are silicone for weatherproofing.	Rusting footing stands should be reviewed and replaced as required before they collapse. Fixings through the roof should always be through the top of the roof material ridges. Roof penetrations should be checked for water tightness (storm) and repaired as required.

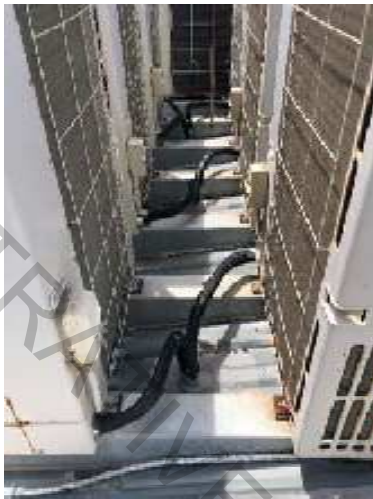
<p>Figure 14</p>	Roof mounted condensing units; these we believe serve the restaurants et al. cassette units.	Units generally are still in quite good shape considering the seaside air they are subjected to. All units should be checked and cleaned regularly to remove salt. If possible, it would be advised to apply a reputable corrosion protective coating and repeating as per the manufacturer's recommendations.
