## CONSULTANCY STRUCTURAL ENGINEERING REVIEW

SUTTONS BEACH PAVILION 1

MARINE PARADE, SUTTONS BEACH, REDCLIFFE 4020

REPORT No: 62015RPT

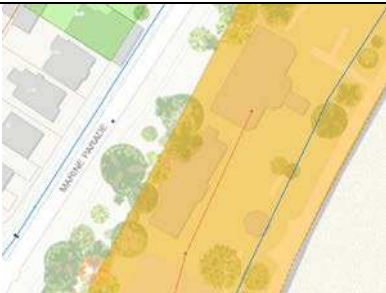
<p>Figure 1 – Site Sewer Connection</p>	The Pavilion 1 is serviced from the Unitywater sewer main to the south of the building. The approximate location of the property sanitary drains has been indicated in the report provided by FSA Consulting Engineers Dwg No. 17-545-102 refer Appendix A of this report. This is a 150 mm VC sewer main.	The integrity of the site sanitary drainage pipes is not known. We recommend a CCTV investigation be conducted to ensure if further development of the site is proposed that the existing drains would be adequate.

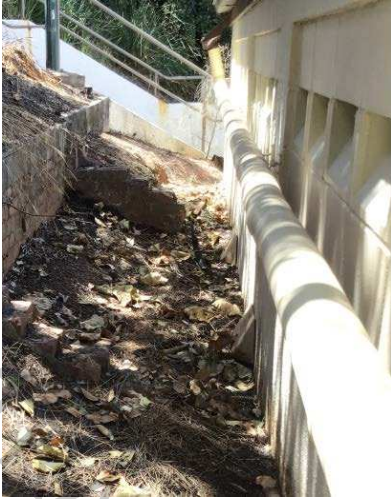
<p>Figure 2 – Site Roof water collection pipe</p>	<p>The Pavilion 1 building is serviced by stormwater collection pipes that discharge the collected roof water to ocean outfall. The roof water that falls to the rear of the building on the Marine Parade frontage is collected via a 150mm suspended UPVC stormwater pipe which discharges to a grated surcharge pit and to the kerb frontage on the south western side of the building. Roof and pavement run-off from the front of the building discharges direct to ocean out fall.</p>	<p>The integrity of the site stormwater collection pipes is not known. We recommend a CCTV investigation be conducted to ensure if further development of the site is proposed that the existing drains would be adequate.</p>
Site Water Supply

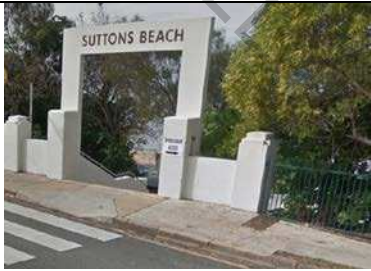
<p>Figure 3 – Site water meter location</p>	<p>The Pavilion 1 building is serviced by metered water service on the Marine Parade frontage adjacent to the entry to Suttons Beach. It is then reticulated via in-ground pipe and suspended in the back of house services area</p>	<p>The water meter seems to be in good order.</p>

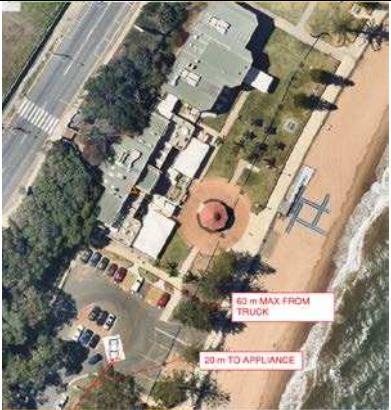
<p>Figure 4 – Site Fire Hydrant Location</p>	<p>The hydrants provide a required flow for fire fight purposes. The design is to be in accordance with AS 2419.1-2005 and National Construction Code. At the time of inspection, it was not known the condition or the current fire fight flows and pressures achievable from the main</p>	<p>The current fire fight scenario is not in accordance with the relevant codes. We recommend an assessment should be conducted on the hydrant cover to the building.</p>

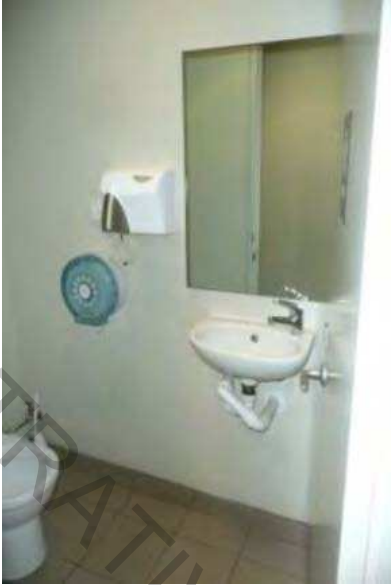
<p>Toilet Male</p>

<p>The lower-level male toilet was provided with a toilet suite and basin. The water supply to the areas was provided by pipe work run at high level in the ceiling over and dropped to services. The drainage seems to be in good order and in accordance with AS3500.2-:2018 – Sanitary and Plumbing and Drainage</p>	<p>The taps and fittings were in working order. If the building was to be refurbished, we would recommend replacement of the sanitary fittings. Hot water used would need to be tempered in accordance with AS 3500.4:2018 – Heated Water Services</p>
<p>Toilet Female</p>

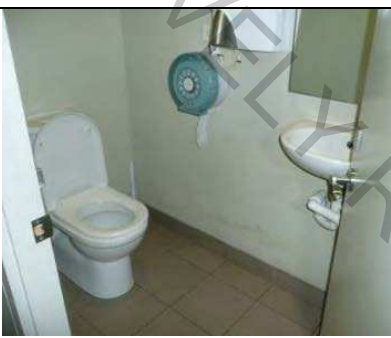
<p>Figure 5 - Female toilet Ground Floor</p>	<p>The lower-level female toilet was provided with a toilet suite and basin. The water supply to the areas was provided by pipe work ran at high level in the ceiling over and dropped to services. The drainage seems to be in good order and in accordance with AS3500.2-:2018 – Sanitary and Plumbing and Drainage</p>	<p>The taps and fittings were in working order. If the building was to be refurbished, we would recommend replacement of the sanitary fittings. Hot water used would need to be tempered in accordance with AS 3500.4:2018 – Heated Water Services</p>

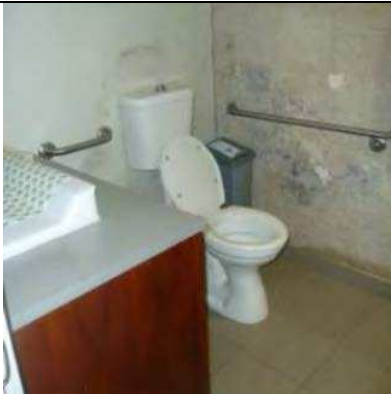
<p>Figure 6 – Unisex PWD</p>	<p>The lower-level disabled toilet was provided with a toilet suite and basin. The water supply to the areas was provided by pipe work ran at high level in the ceiling over and dropped to services. The drainage seems to be in good order and in accordance with AS3500.2-:2018 – Sanitary and Plumbing and Drainage</p>	<p>The taps and fittings were decommissioned at the time. If the building was to be refurbished, we would recommend replacement of the sanitary fittings. Hot water used would need to be tempered in accordance with AS 3500.4:2018 – Heated Water Services</p>

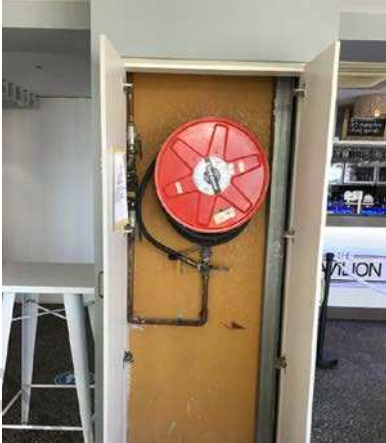
<p>Figure 7 – Fire Hose Reel Ground Floor</p>	<p>This area of the Pavilion one lower level was provided with a fire hose reel the fire house reel was not installed in accordance with the National Construction code Part E1 – Fire Equipment</p>	<p>The taps and fittings were in working order. If the building was to be refurbished, we would recommend replacement of the sanitary fittings. Hot water used would need to be tempered in accordance with AS 3500.4:2018 – Heated Water Services. We recommend a backflow audit be conducted on the fixtures within the kitchen connected to the cold-water supply. An assessment of fire hose reel location and cover should be conducted.</p>
Fish and Chippery	Not photo taken	<p>The cold prep has a number of display fridges. The water supply to the areas was provided by pipe work ran at high level in the ceiling over and dropped to services. The drainage seems to be in good order and in accordance with AS3500.2-:2018 – Sanitary and Plumbing and Drainage.</p>	<p>The taps and fittings were in working order. If the building was to be refurbished, we would recommend replacement of the sanitary fittings. Hot water used would need to be tempered in accordance with AS 3500.4:2018 – Heated Water Services. We recommend a backflow audit be conducted on the fixtures within the kitchen connected to the cold-water supply.</p>

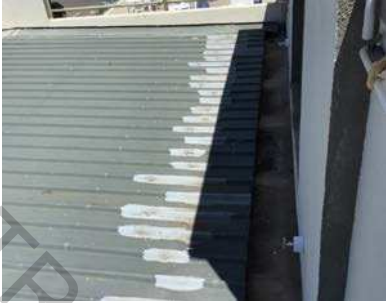
<p>Figure 8 – Damage to Roof Sheeting</p>	This area of roof is of material of Colourbond roof sheeting pitched toward a collection box gutter towards the Sutton esplanade rear of the building. There is no provision in the design for an overflow in the gutter	Due to the age of the installation, it is recommended the gutter be replaced and provided with an overflow to the southern end of the gutter.
Upper-Level roof sheeting over the dinning amenities and food preparation area

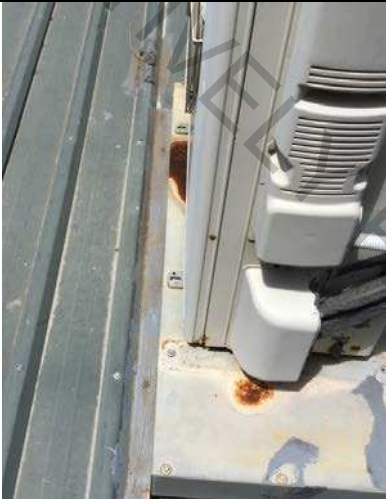
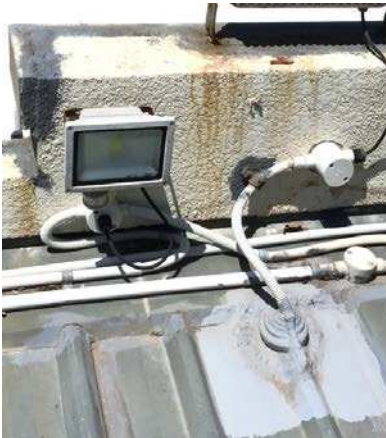
<p>Figure 9 – Faulty installation with penetrations through pan of roof sheet</p>

<p>Figure 9.1 – Delapidated water proofing around services penetrations</p>	This area of roof is of material of Colourbond roof sheeting pitched toward a collection eaves gutter towards the Sutton esplanade rear of the building. The gutter is serviced by a series of PVC downpipes located down the external walls of Pavilion One. Some of these collection down pipes. Both the gutter and roof are showing signs of weathering. The roof sheet pans have been damaged in certain areas approx. 50% plus by roof traffic. The supporting structure under the roof sheets shows sign of deflection and sagging and hence the roof sheets now hold water within the pans of the sheets. The roof sheets in areas are not a continuous piece from the top to the bottom of the roof. Numerous roof screws have worked loose overtime	We recommend in the interim of total roof replacement that all loose screws be replaced or fastened tight; the short sheets be replaced with roof sheets the full length of the pitch of the roof. We recommend roof structural supports be placed on the bottom side of the penetrations. We recommend as a suitable

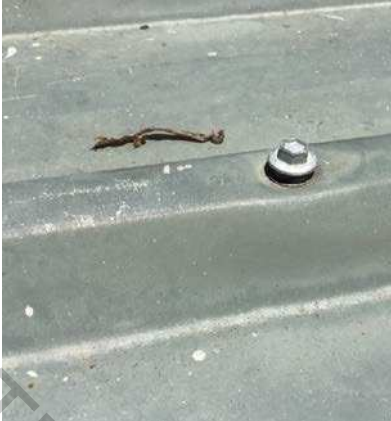
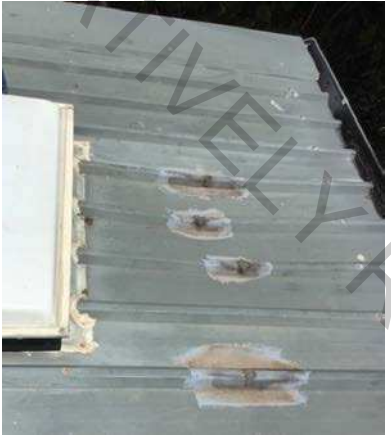
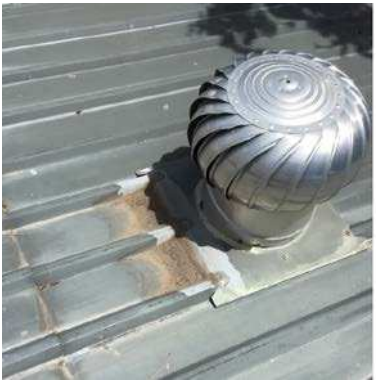
</div> <div data-bbox="316 678 708 741"><p>Figure 10 – Loose fasteners on the roof</p></div> <div data-bbox="316 745 708 1178">

</div> <div data-bbox="316 1211 708 1274"><p>Figure 10.1 – Damage to Roof Sheeting</p></div> <div data-bbox="316 1308 708 1686">

</div> <div data-bbox="316 1720 708 1816"><p>Figure 10.2 – Incorrect roof penetration flashing causing roof water pools</p></div>	<p>The roof has various items installed upon and penetrating the roof sheeting. There are several ventilations whirly birds installed. There are a number of sky lights installed through the roof and there are a number of mechanical plant equipment pieces installed upon the roof sheets. The plumbing services penetrate the roof sheets. These all have roof flashings associated with the installation.</p>	<p>We recommend the flashings to the whirly ventilators and sky lights be installed to general practice standards. (i.e. the over flashings should be flashed with all laps overlapping from the roof to the penetration/ flashing. The support fastenings for the mechanical units should not be passed through the pans of the roof sheeting. The corrosive part of the support strapping be replaced.</p>

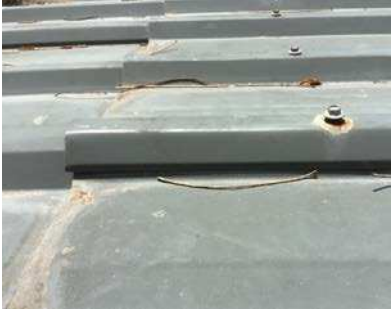
<p>Figure 11- Incorrect roof sheeting installation</p>		
--	--	--	--

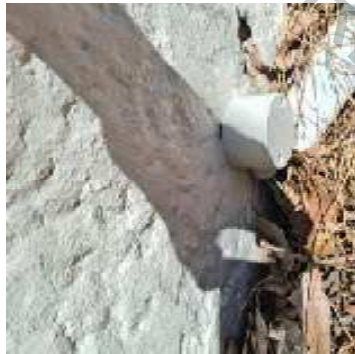
<p>Figure 12- Exposed services</p>	Exposed/unprotected single insulated cable at bottom of external conduit j-box.	Safety issue – conduit to be installed to protect cable in accordance with AS.NZS 3000.
EI.2

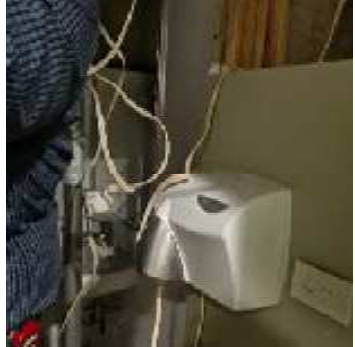
<p>Figure 13 – Loose cables</p>	Cables loose and not secured.	Safety issue – cable to be tidied up and secured in accordance with AS.NZS 3000.

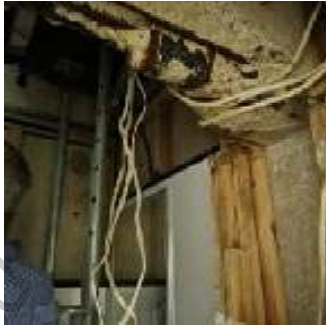
<p>Figure 14- Loose cables</p>	Cables loose and not secured.	Safety issue – cable to be tidied up and secured in accordance with AS.NZS 3000.
El.4

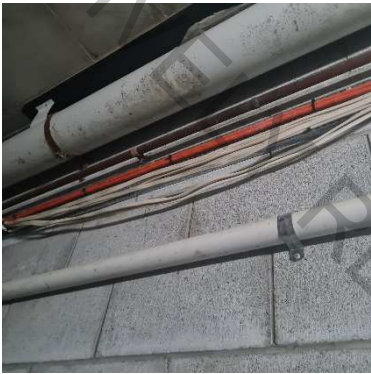
<p>Figure 15 – Insufficient ties</p>	Cables - insufficient ties on cable tray.	Safety issue – cable to be tidied up and secured in accordance with AS.NZS 3000.
El.5

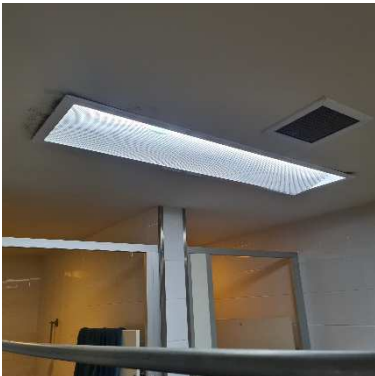
<p>Figure 16 – Damaged fitting</p>	Troffer light fitting damaged and not sitting secure in ceiling.	Potential safety issue – replace fitting with new.

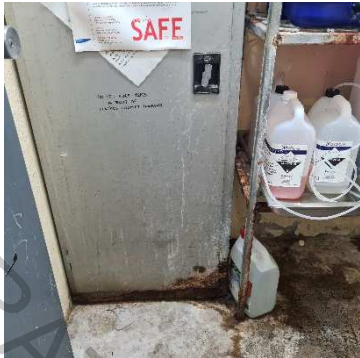
<p>Figure 17 – Damaged cabinet</p>	Slight corrosion starting on the lift control cabinet.	Scrape and clean up to prevent further corrosion. Wipe down regularly to keep chemicals off.
E1.7

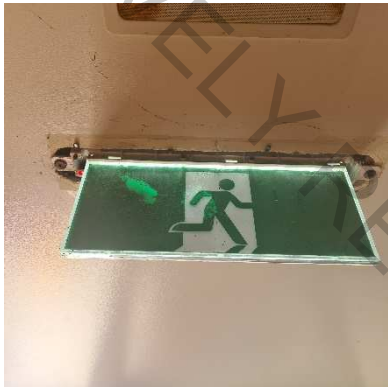
<p>Figure 18- non-compliant sign</p>	Exit sign body cover missing – live parts potentially exposed.	Fitting should be replaced.
E1.8

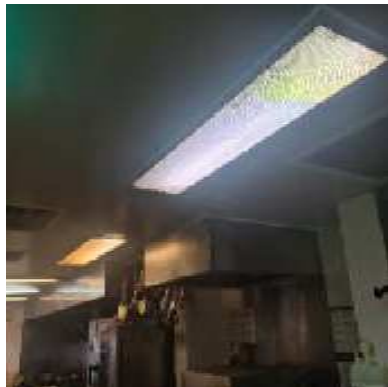
<p>Figure 19 – Defective lights</p>	Kitchen troffer lights cracked and broken. Should be clean room sealed for dust and vermin prevention.	Replace diffusers and/or fittings.

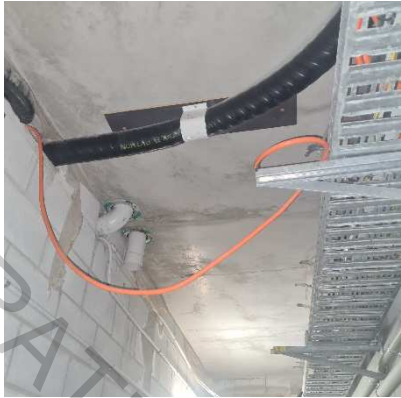
<p>Figure 20- Defective install</p>	Unsecured cable off cable tray. Unsafe installation.	Secure cable in accordance with AS/NZS 3000.
E1.10

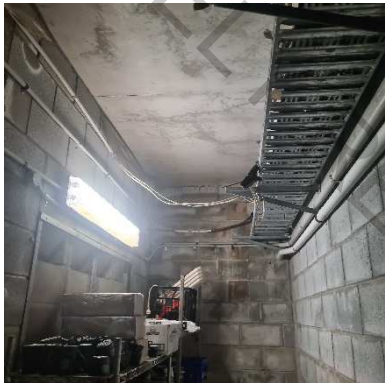
<p>Figure 21- Defective install</p>	Unsecured cable off cable tray. Unsafe installation.	Secure cable in accordance with AS/NZS 3000.
E1.11

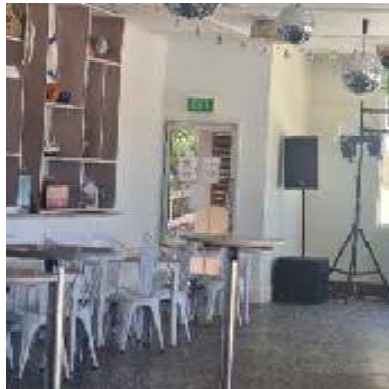
<p>Figure 12 – non-compliant sign</p>	Old style Exit sign plus should be illuminated.	Re-lamp and update to running man symbol to bring up to AS2293 and NCC.

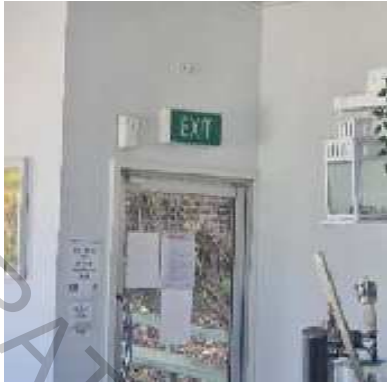
<p>Figure 13 - non-compliant signs</p>	Old style Exit sign plus should be illuminated.	Re-lamp and update to running man symbol to bring up to AS2293 and NCC.

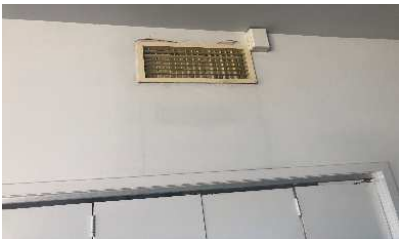
<p>Figure 14 – Water damage</p>	Supply air vent in reception wing lobby showing signs of moisture damage due to condensation.	A difficult problem to resolve in an area where an entry door allows warm humid air to enter a conditioned space with cold metal diffusers. Entry air locks and or the fitting of good quality air curtains are the most successful remedies.
MI.2

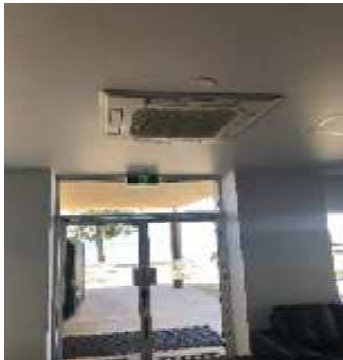
Cassette at reception entry	It is unlikely that this unit can handle outside air requirement for this space. This needs to be checked in accordance with current Australian Standards.

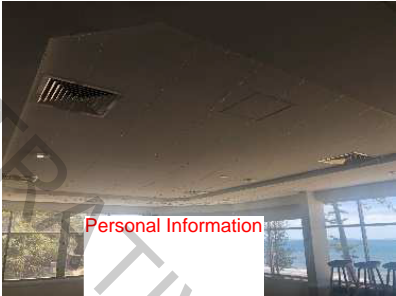
<p>Figure 16 – Pavilion Two function area</p>	Typical reception area supply air diffuser layout. Areas are served by split system ducted units with filtered outside air supply from roof mounted fan and filter bank.	The outdoor air quantities need to be checked for these areas to ensure compliance with current codes.
MI.5

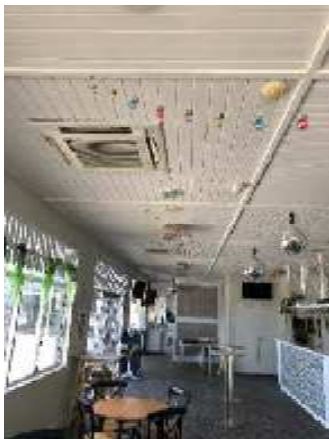
<p>Figure 17 – Upper level bar reception area</p>	Typically, the dining and bar areas are served by split system cassettes. It is unlikely that these provide sufficient outside air to these areas.	Outside air supply quantities should be checked for compliance with code.
MI.6		Toilets to the upstairs function room above the restaurant are naturally ventilated via skylight vents.	While this may be code compliant it is less than desirable for a space of this quality as generally smells are not adequately removed. It is recommended that mechanical exhaust be considered.

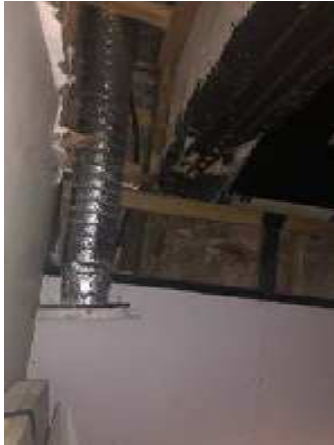
<p>Figure 7</p>	Toilets in the rear south-west corner had been partially demolished to attend to termite infestation. Services were no longer operable.	Re-instatement required at some point with a rebalance of exhaust system.
MI.8

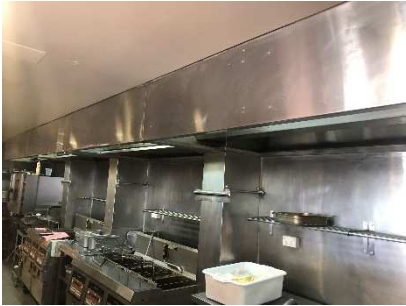
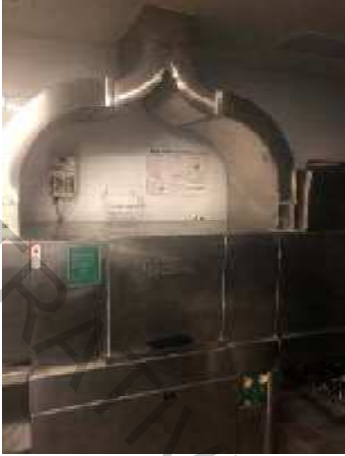
<p>Figure 8.1</p>	Kitchen hood exhausts to both cooking equipment (fig. 8.1) and dishwashers (fig 8.2) was comprehensive throughout the various kitchens. Air quantities were not able to be checked but all looked to be professionally done.	Air quantities could be checked for code compliance.

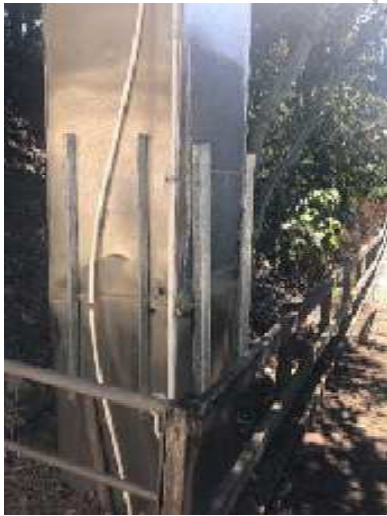
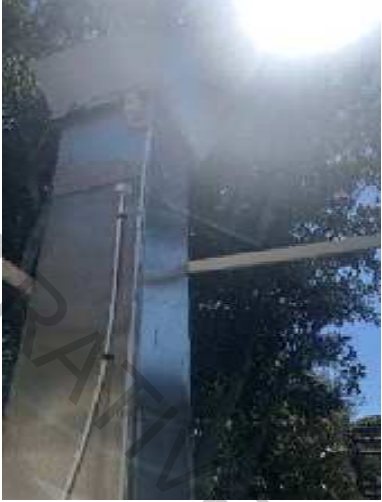
<p>Figure 9.1</p>	<p>Kitchen exhaust fan adjacent the rear walkway was blown over during winds with damage to duct and electrical conduit. The duct had been stabilized with a number of angle brackets (fig 9.1) and timber cross braces (fig 9.2)</p>	<p>The patch up job should be refined to make safe (sharp points and edges on the angle pieces) and the electrical conduit fixed with stainless steel conduit clips. The timber should be replaced with cross bracing that is weather and corrosion resistant.</p>

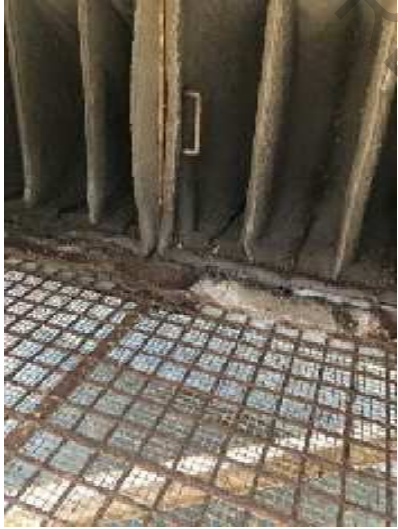
<p>Figure 10</p>	Outside air fan filters at roof level.	Filters do not appear to have been serviced. These will require replacement and regular servicing.
MI.11

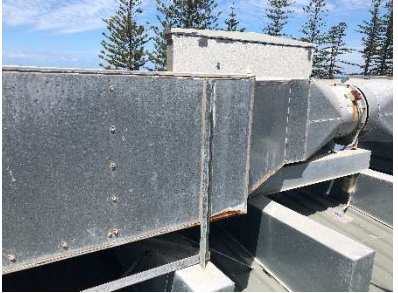
<p>Figure 11</p>	Outside air fan and ductwork on roof of pavilion 1.	Fan junction box, flange bolts and ductwork require attention to rust.

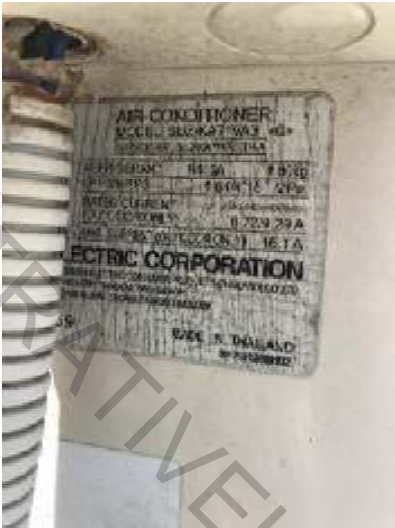
<p>Figure 12</p>	<p>Electrical entering roof mounted condensing unit with flexible conduit broken away from condenser body.</p>	<p>Generally, all electrical work to mechanical equipment on the roof should be inspected and repaired as required.</p>
<p>MI.13</p>

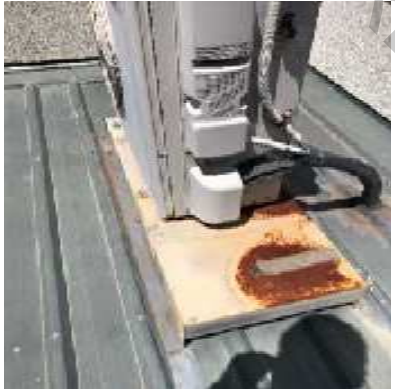
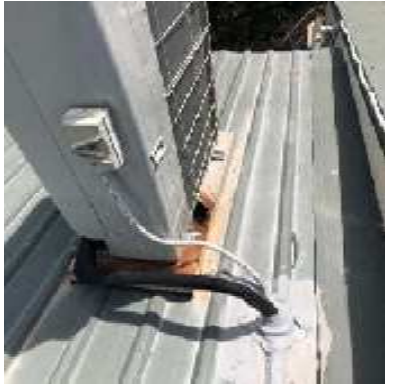
<p>Figure 13.1</p>

<p>Corrosion of various metal parts, in this case condensing unit footing stands, is widespread due to the corrosive salt air environment. Note also the roof penetrations here, there are a large number of these across the roof. Fans, pipe work and electrical all penetrate the roof and are silicone for weatherproofing.</p>	<p>Rusting footing stands should be reviewed and replaced as required before they collapse. Fixings through the roof should always be through the top of the roof material ridges. Roof penetrations should be checked for water tightness (storm) and repaired as required.</p>

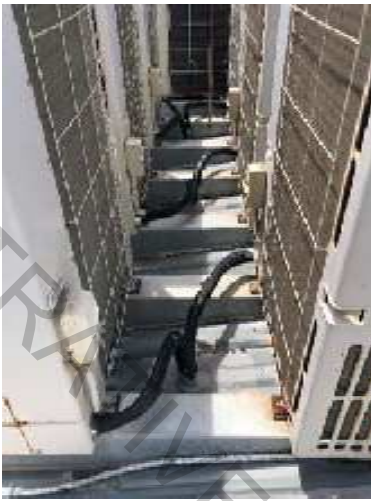
<p>Figure 14</p>	Roof mounted condensing units; these we believe serve the restaurants et al. cassette units.	Units generally are still in quite good shape considering the seaside air they are subjected to. All units should be checked and cleaned regularly to remove salt. If possible, it would be advised to apply a reputable corrosion protective coating and repeating as per the manufacturer's recommendations.
