Suttons Beach Pavilion Strategic Assessment and Options Analysis

Prepared for Moreton Bay Regional Council

March 2023

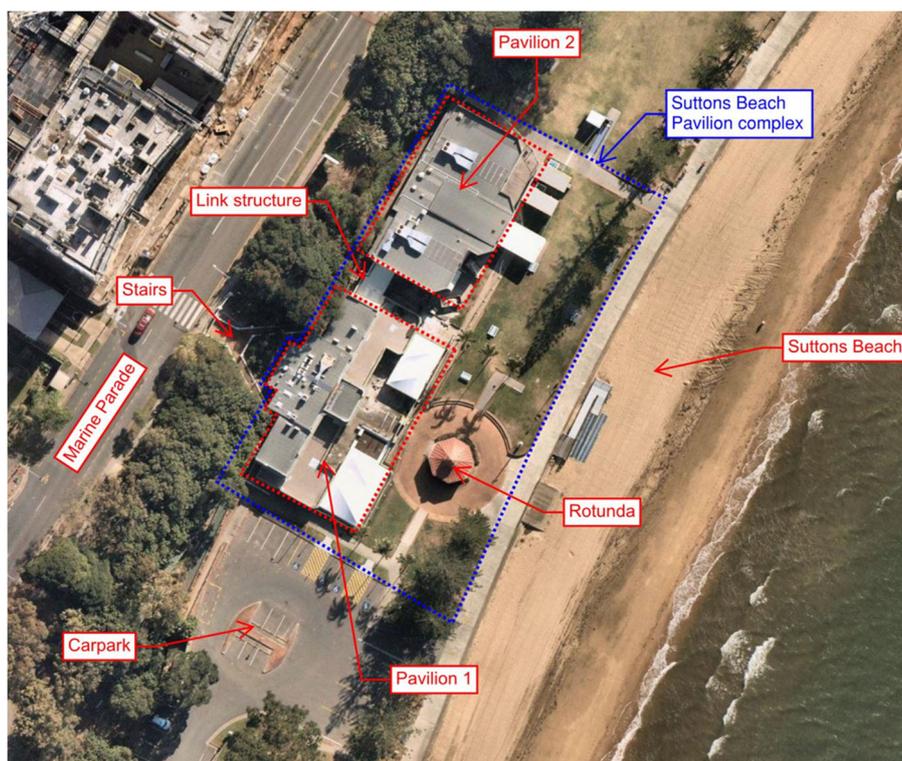
Figure 2. SBP and SBP complex

SBP consists of connected buildings and associated structures that have been constructed at different periods in history and are in differing stages of deterioration. In this report, unless otherwise specified, SBP refers to (Figure 2):

References made to Suttons Beach complex refer to SBP excluding the access stairs from Marine Parade (Figure 2).

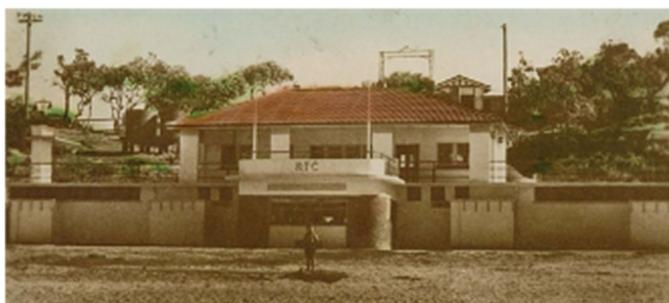
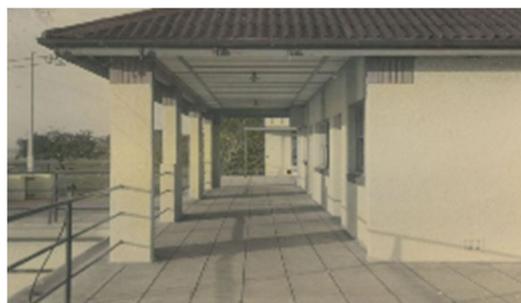
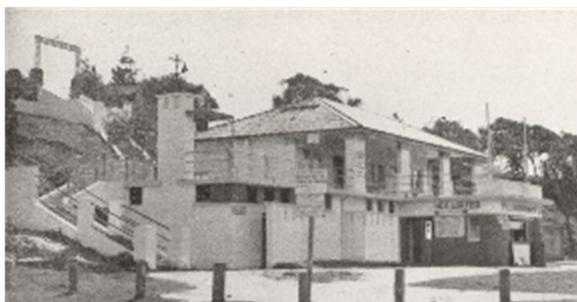
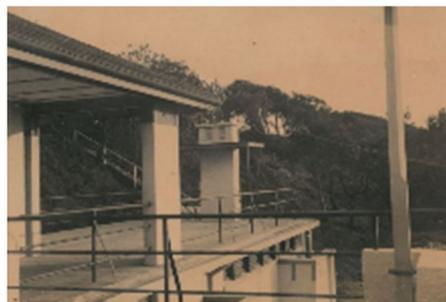
Figure 6. Original Suttons Beach Bathing Pavilion

All bathing pavilions were designed by the Brisbane architect Clifford E. Plant. Suttons Beach Bathing Pavilion was opened in December 1937, replacing the previous 1906 kiosk and bathing house infrastructure. This new two-storey bathing pavilion featured a kiosk, dressing room, lockers, toilets and showers and café on level 1 (refer to plans in Appendix 1). Its design included a range of elements consistent with a late Art Deco Streamline Moderne (Art Moderne) style, including the extensive use of concrete and glass, a symmetrical and relatively austere façade and the minimal use of Art Deco elements (Figure 6).³

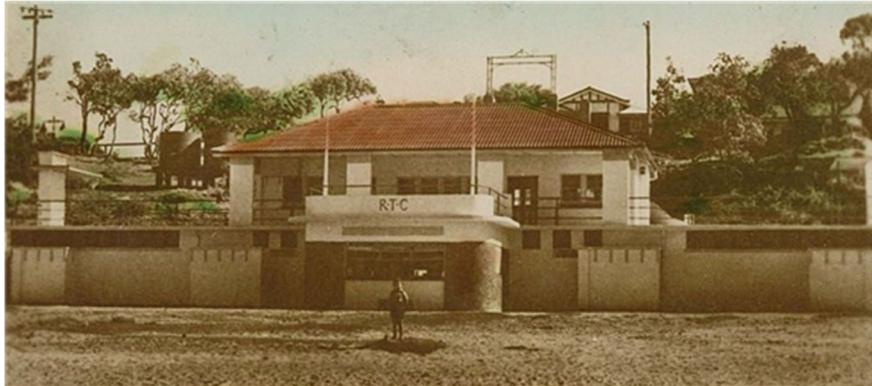
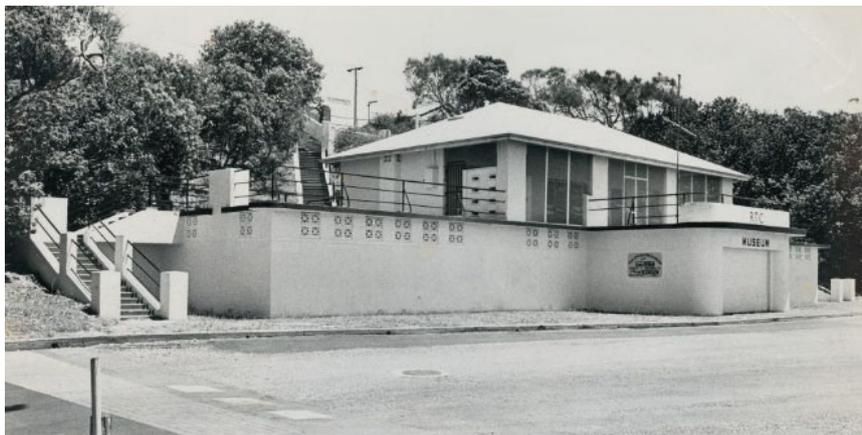
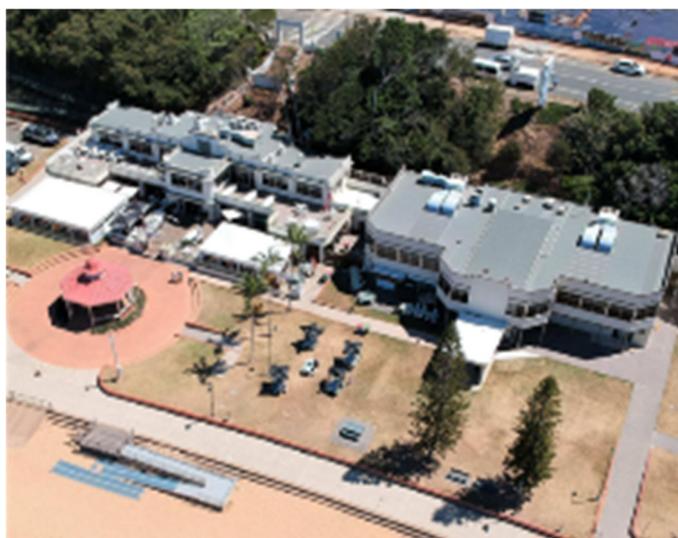
Figure 7. Suttons Beach Pavilion c.1975 to c.2022

The first significant alteration to SBP occurred c.1975 to accommodate the Redcliffe Museum. Alterations included enclosure of dressing room entrances, partial demolition of ventilation chimneys, demolition of the individual entrances and demolition of the kiosk counter. Despite this, the fabric of the 1930's pavilion remained largely intact and recognisable as the original structure.

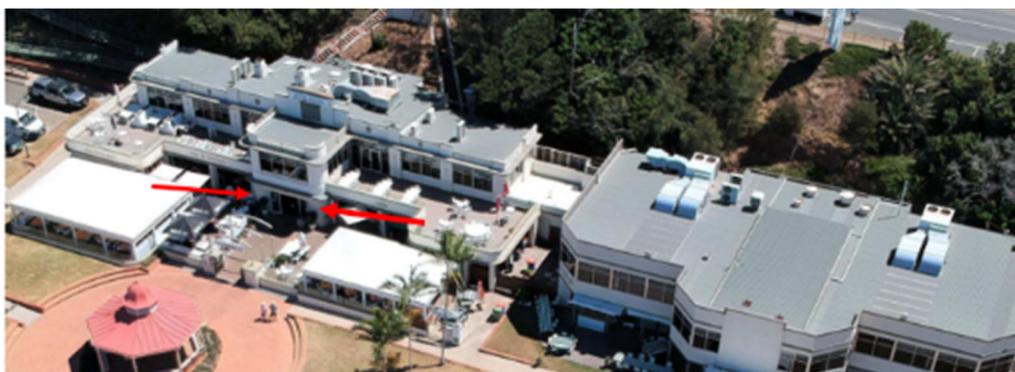
Figure 11. Location of curved walls

Currently, the full exterior of the P1 is the result of post 2000 alterations and additions, except for a portion of the curved walls either side of the of the former kiosk entrance at the ground floor of P1 (Figure 11). A detailed analysis of the known changes to P1 between 1937 and c.2006 is presented in Appendix 2.

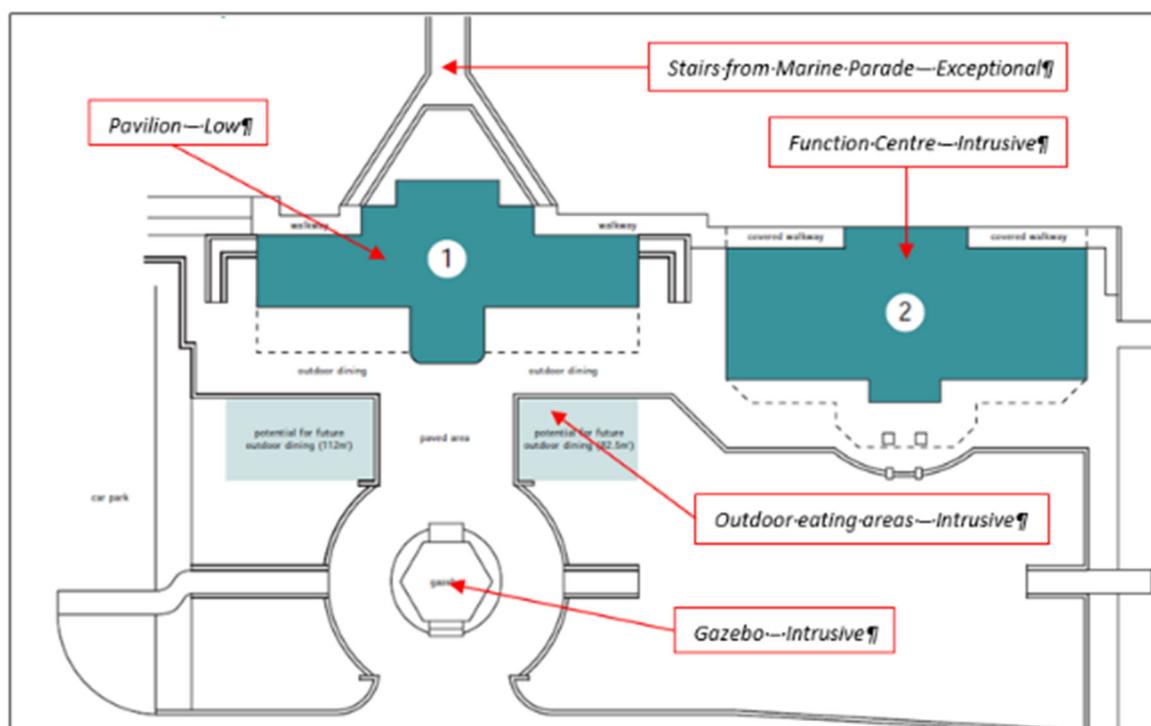
Figure 12. Location of significant elements around the settings of the pavilions (Converge heritage + community, 2020 (MBRC2006:8))

Figure 12 details an assessment of significant elements for each floor in P1 and is drawn from Report 1. In terms of the setting, P1 is rated Low, reflecting the significant change in appearance from the 1937 design. The stairs from Marine parade, largely original fabric, are classified as Exceptional. P2 and the outdoor eating areas are described as Intrusive due to impacts on the symmetry, dominance and integrity of the original P1 and other factors. The rotunda is also described as Intrusive as it interrupts the view to the pavilion from the beach. The term “faux heritage” is also used in reference to the Rotunda for depicting the wrong year of its construction (Victorian era ending in 1901 in contrast to its 1998 construction date).

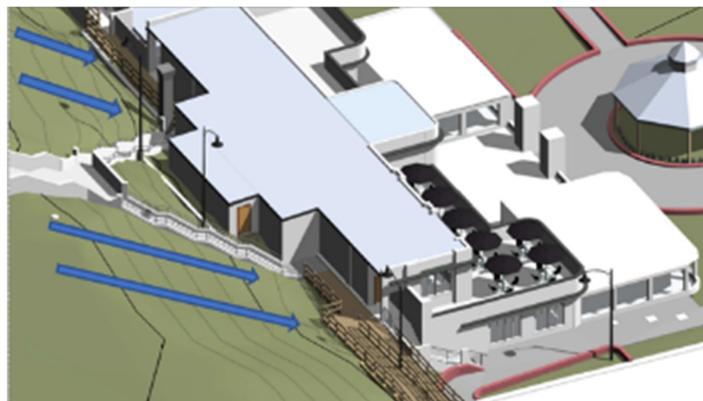
Figure 14. Direction of water flow during rain events (surface and subsurface)

Creating a void behind P1 was identified as high cost, and potentially impacting the heritage stairs and the portion of level 1 that overhangs the ground floor rear wall. At the time of this report, no effective methodology has been proposed to create this void, mitigate water ingress, and provide a guarantee that the issue can be rectified.

The water ingress through the rear western wall of P1 has been a pervasive issue for several years causing serious defects inside the building. Due to building design, location and potential heritage impacts, engineering investigations to date have not provided a feasible and guaranteed option to waterproof the rear wall.

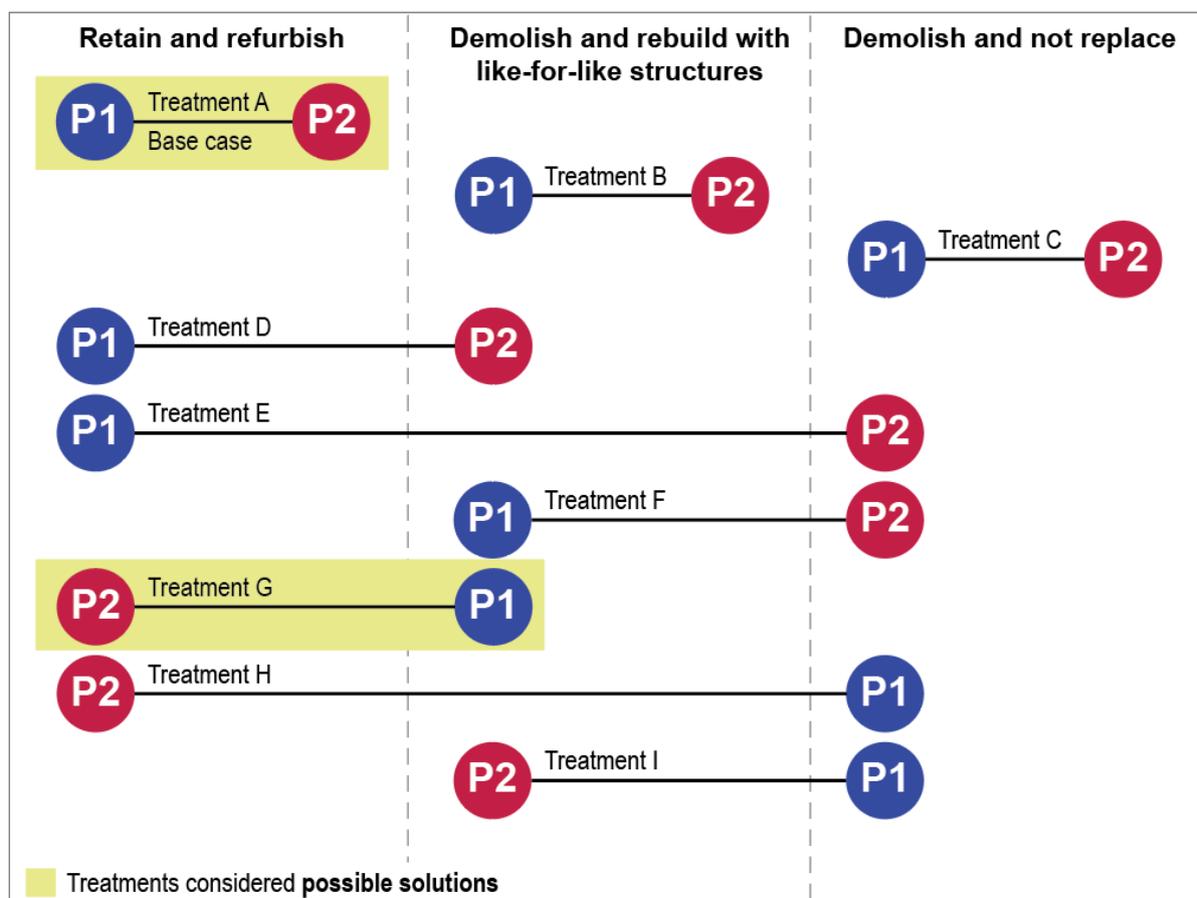
Figure 19. Different treatments that could be applied to the existing buildings

Figure 19 shows how these treatments could be applied in nine different combinations to the existing buildings.

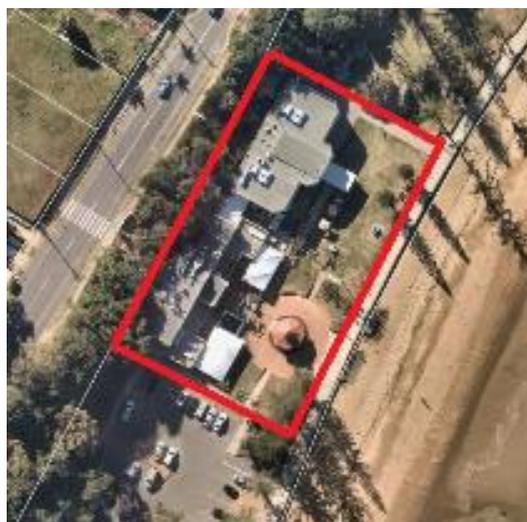
Figure 23. Area of interest

b) The 'area of interest', Figure 23, is included within the balance flood planning area (Flood Hazard Overlay) and within the balance coastal planning area and within the erosion prone area (Coastal Hazard Overlay). The following considerations are noted:

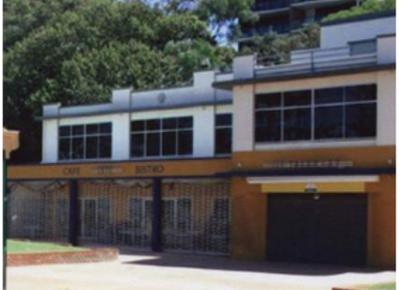
Figure 30: The pavilion in c.2002 (MBRC, image# 002\002180).

Date	Description of Changes	Image
Early 2000s	<ul style="list-style-type: none"> • The second storey of the building was enlarged with new building work that covered the length of the wings and the area above the former kiosk, completely enclosing the terraces. • The original hipped roof was replaced with a flat roof. An art deco style façade with parapet was added to the second storey of the building. • The RTC lettering was removed. • The gardens/grassed areas or pavements were installed in front the building. • New doorways were cut into the concrete walls of the former dressing rooms in the ground floor for the bistro area and a covered outdoor dining area was added as an extension to either side of the kiosk. • Minor changes included repainting and the addition of red awnings to the windows and covers over the stairs. • The adjacent function centre was built. • See also Figure 35 which shows an aerial image of the pavilion and adjacent function centre in 2004.

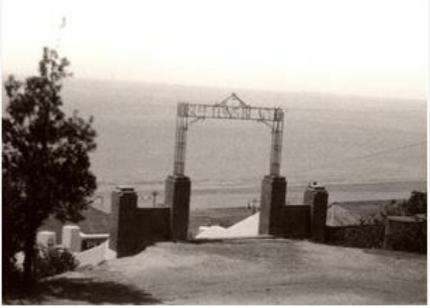
<p>Figure 37: Entrance to the stairs, late 1930s (Fryer Library).</p>

Description of changes	Early image	Comparative image in 2020
<p>The brick pillars at the entrance have been rendered and the fence has been extended at the left (north).</p>

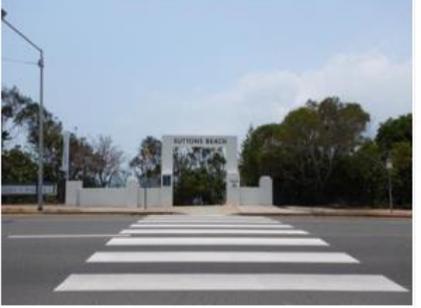
<p>Figure 38: Entrance to the stairs in 2020.</p>
<p>The original metal sign and <u>archway</u> at Marine Parade has been replaced with a simple square entrance with 'Sutton's Beach' in lettering at the top. The new entrance (replacing the old <u>archway</u>) is fixed to the back of the brick pillars.</p>	<p>See above</p>	<p>See above</p>
<p>Low <u>hand rails</u> have been added to the top of the concrete walls at the stairs from the upper terrace to Marine Parade.</p> <p>Handrails are evident on the original plans at the upper section of the stairs but are not shown in early photos – it is unclear when the handrails were attached to the walls from the upper terrace to Marine Parade.</p>

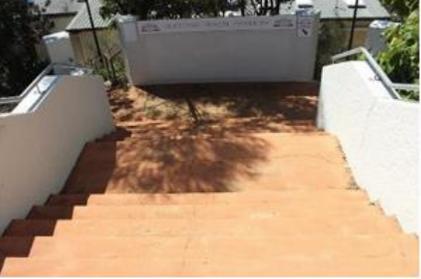
<p>Figure 40: Stairs from marine Parade to the upper terrace, now with rails at the top of the concrete walls.</p>

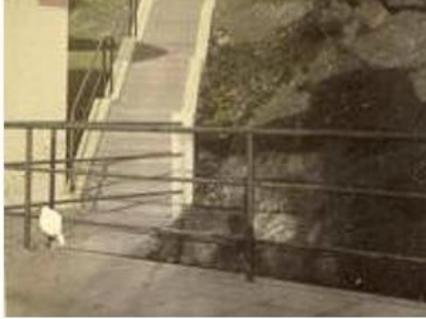
Description of changes	Early image	Comparative image in 2020
<p>The balustrades at the end of the stairs, where they formerly joined the balustrades at the rear of the pavilion (at upper verandahs) have been altered/replaced to construct a new timber walkway on either side – as the verandah was fully enclosed and the pavilion balustrades were removed.</p>

<p>Figure 45: Original layout of the balustrade at the end of the stairs to the pavilion (MBRC, file# 101\101569).</p>

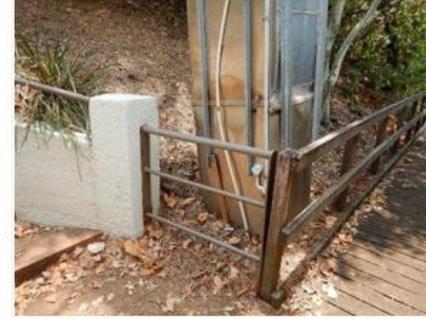
<p>Figure 46: Shorter balustrades from the end of the stairs, formerly leading directly to the upper verandah at the pavilion, now leading to the timber walkway.</p>

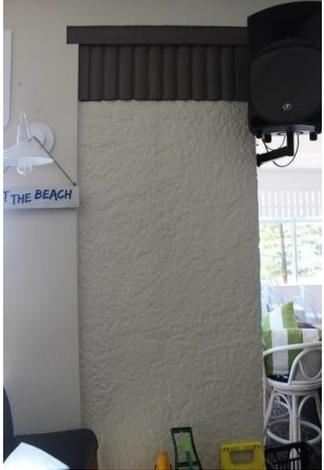
Two verandah columns	High	<p>Aside from the walls noted below, the two remaining verandah columns are all that remains from the original construction at the upper level. They retain the render and terracotta tile detailing.</p> <p>Their original context as verandah columns has been removed with the enclosure of the original verandah. The original hipped roof they supported has been completely removed and replaced with a flat roof.</p>

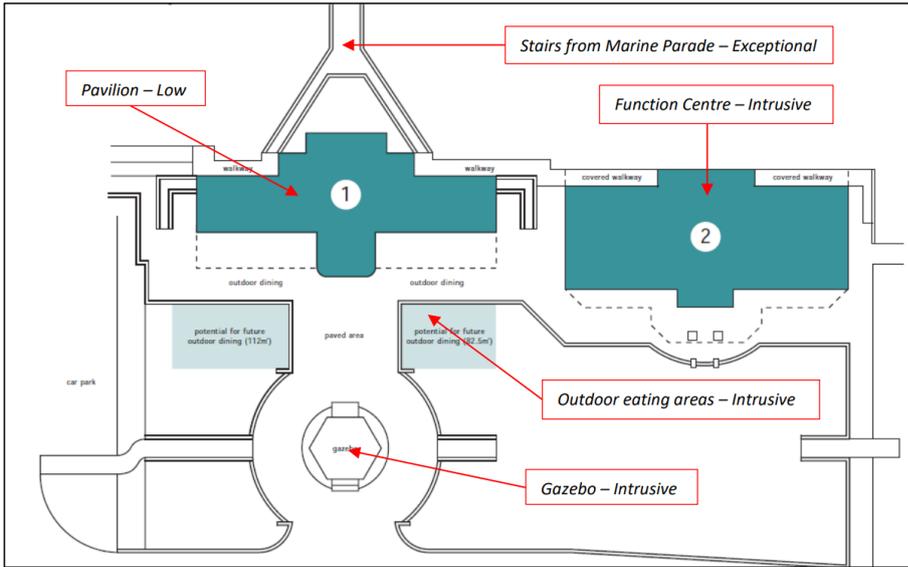
Figure 116: Location significant elements around the setting of the pavilion (MBRC 2006: 8).

NOTE: The following plans denote the place prior to the c.2006 extensive renovations. New additions and extensions have been constructed since these plans were produced. Up to date plans have not been provided for this CMP. For example, the northern pavilion stairs have since been demolished, the pavilion has been widened and extended at both levels, new outdoor dining areas have been constructed and a new verandah has been added at the upper level – some of these are shown as potential items on the plans. Updated plans should be added to the CMP as part of any review and update, alternatively they should be appended to this report when available.

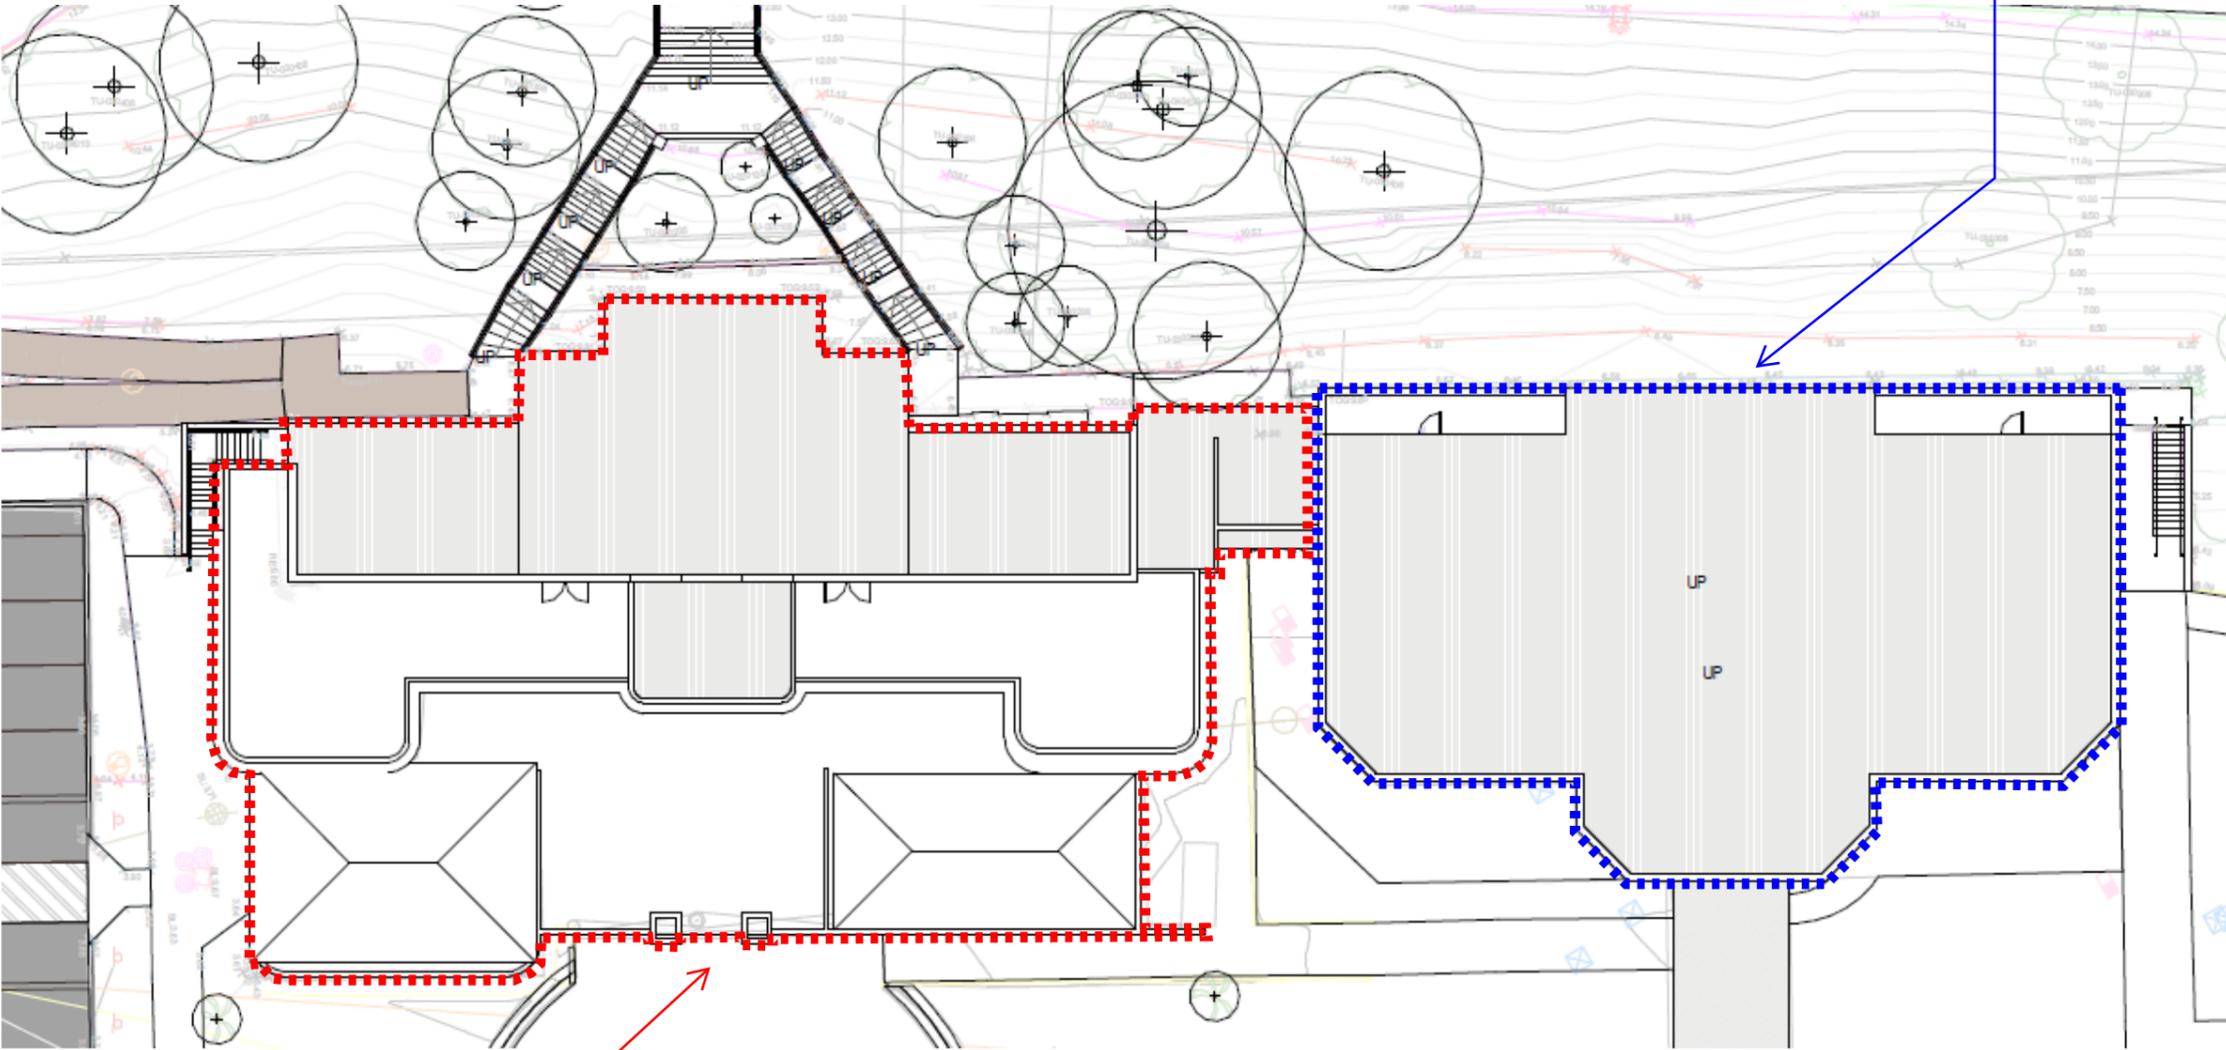
PAVILION 2 TO BE REFURBISHED WITH SAME FUNCTIONALITY AS CURRENT.

PAVILION 1 AND LINK STRUCTURE TO BE DEMOLISHED AND REBUILT IN SAME STYLE.
