Former Suttons Beach Bathing Pavilion Heritage Assessment

Moreton Bay Regional Council

November 2018

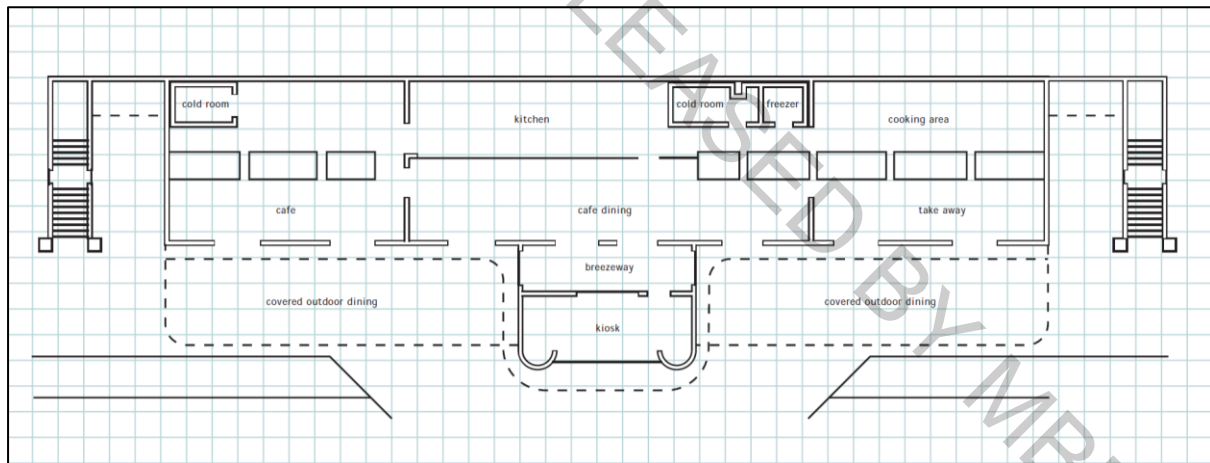
Figure 21: Floor plan of ground level in 2006 (MBRC 2006: 9).

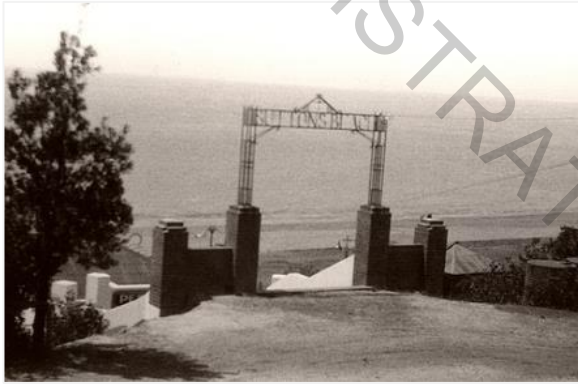
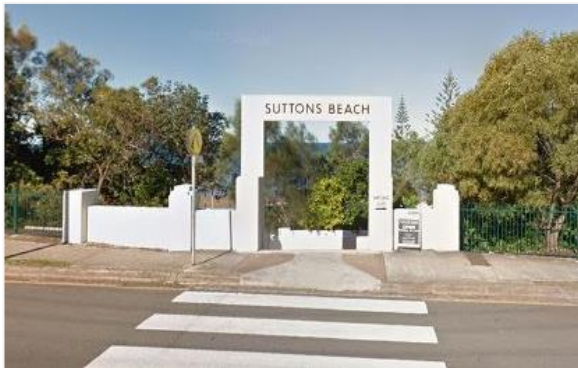
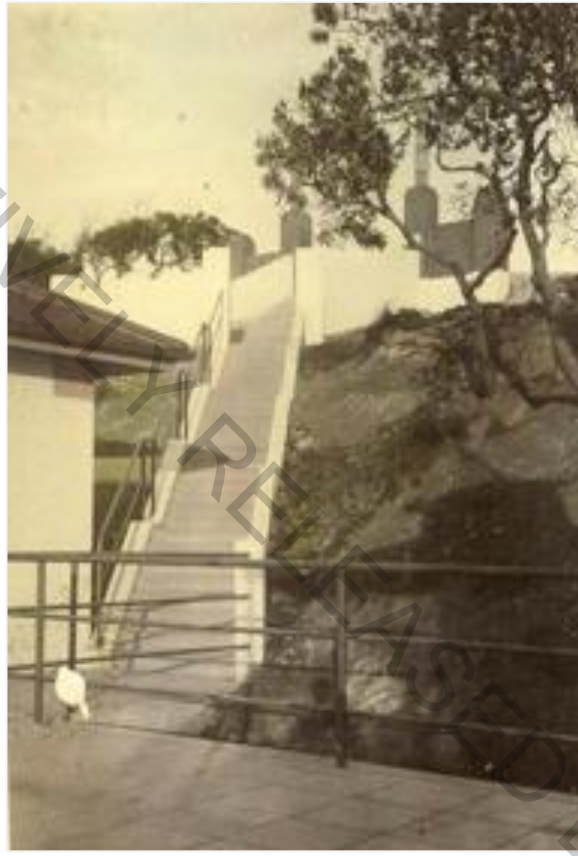
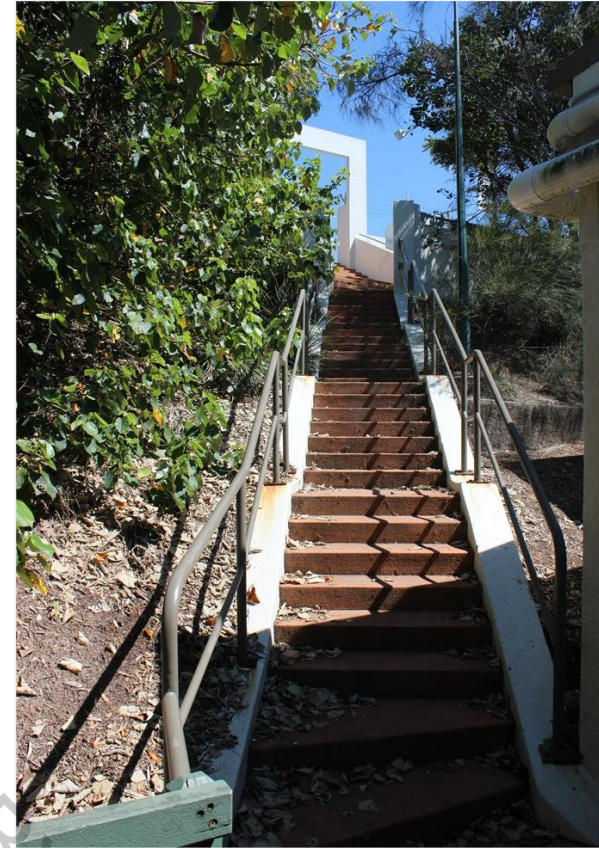
Figure 26: Entrance to the stairs, late 1930s (Fryer Library).

Figure 29: Entrance to the stairs in 2017 (Google Street View).

Figure 27: The stairs at the pavilion in late 1930s (MBRC, file# 101\101569).

Figure 28: The stairs at the pavilion in 2018.

- The original metal sign and arbour has been replaced.
- The brick posts at the entrance have been rendered and the fence has been extended at the left.
- Balustrades have been added to the sides of the concrete steps from the upper terrace to the road. The balustrades from the upper terrace to the pavilion are original.

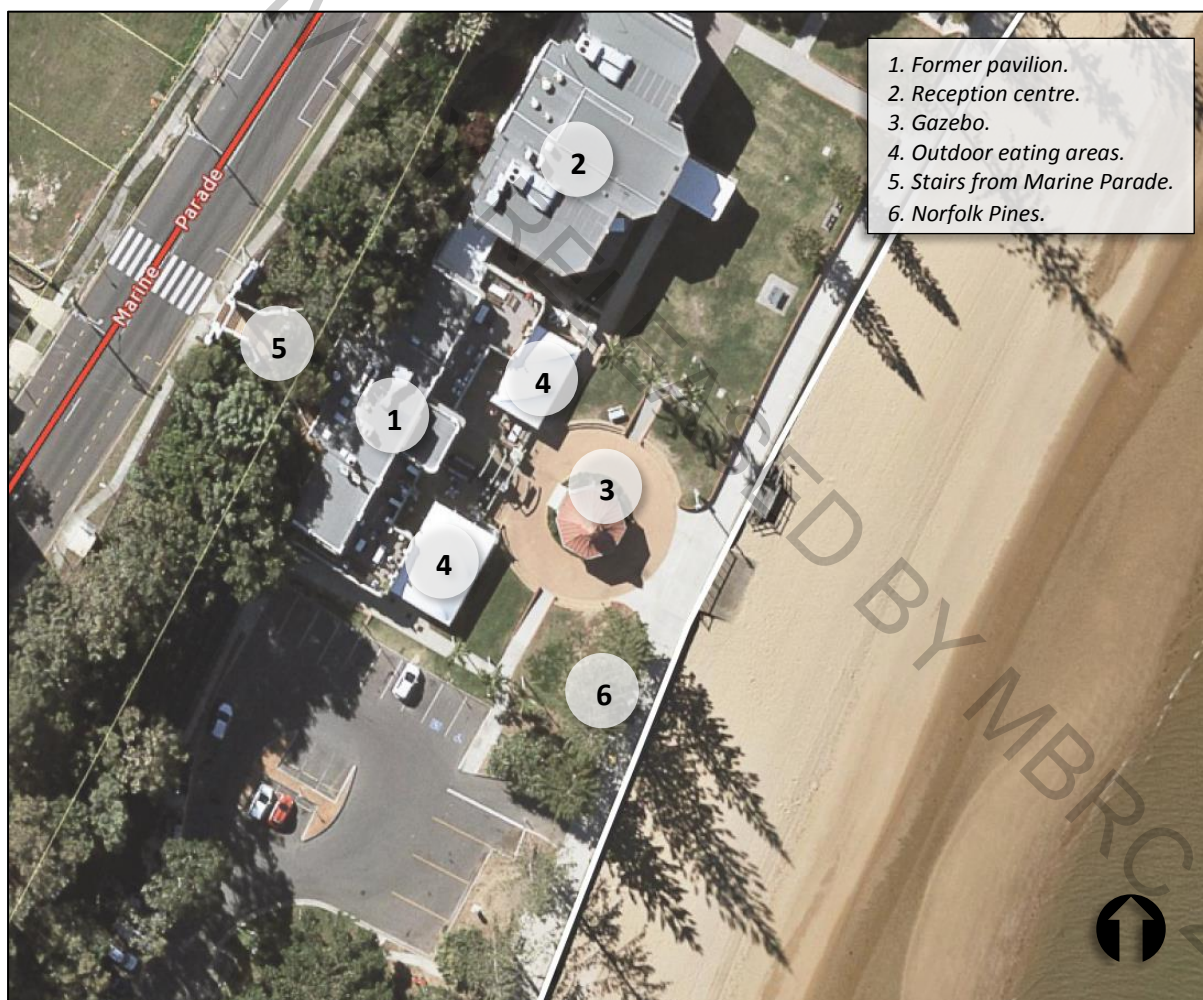
The original concrete stairs from Marine Parade still provide access to the western side of the building and to the beach (Figures 34 – 36). See Figure 30 for location of key features.

Figure 30: Setting and key features of the Former Suttons Beach Bathing Pavilion (base image Queensland Globe 2018).

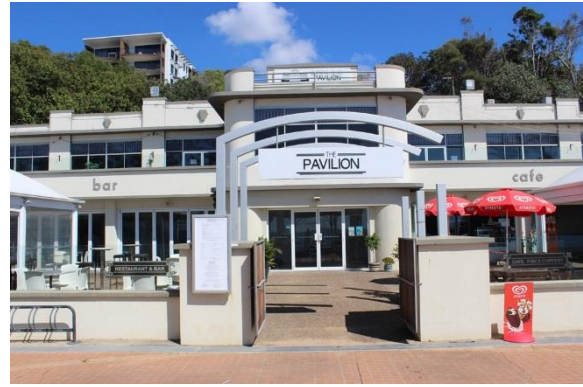
The Former Suttons Beach Bathing Pavilion consists of a two-storey, rendered brick and concrete structure with a flat modern roof and incorporating a main entrance on the ground floor facing the beach. The structure was originally designed in a modernist style with strong art deco influences, however, the current art deco style façade and parapets were added in the early 2000s as part of its redevelopment for use as a restaurant (Figures 31 and 32).

Figure 32: Beach elevation of the pavilion.

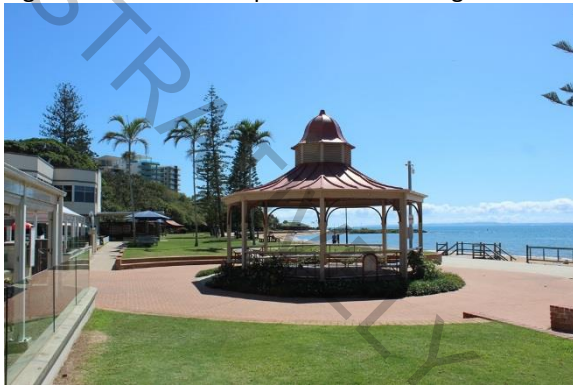
Views to the façade of the building are partially obscured by a gazebo that was built in an historic style in 1998 (Figure 33). The footpath at the water's edge in front of the pavilion is lined with Norfolk Pines. A large two storeyed reception centre (built c.2002) is located to the north of the pavilion (Figure 31). The reception is connected at ground level to the pavilion and at the upper level access is provided between a timber walkway at the rear of the buildings (Figure 37).

Figure 33: The gazebo, looking north.

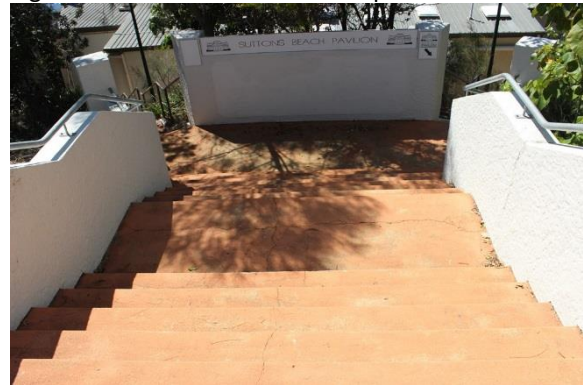
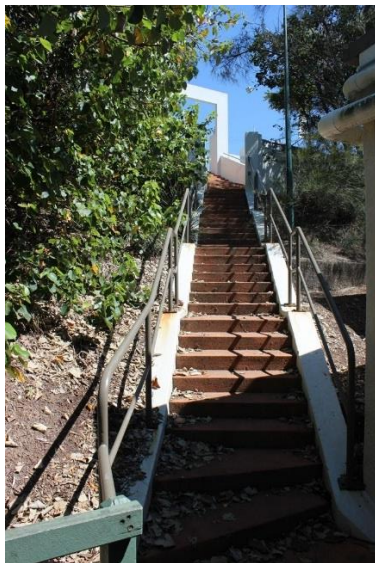
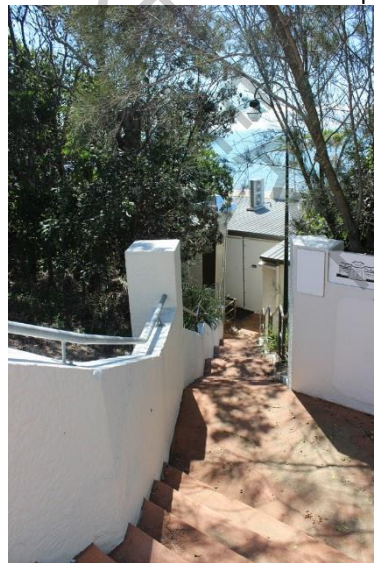
Figure 34: Original stairs from Marine Parade, looking down to the upper terrace where the stairs divide.

Figure 35: Original stairs from Marine Parade, view up.

Figure 36: Original stairs from Marine Parade, view down.

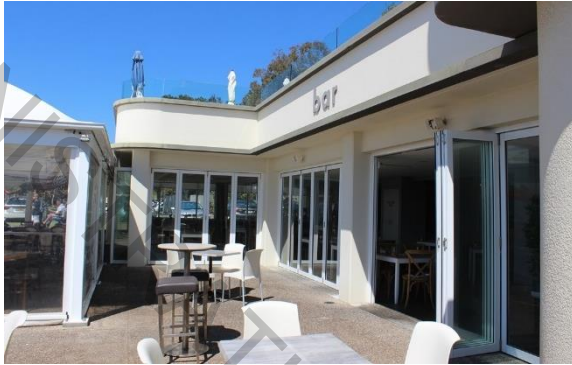
The beach elevation is lined with full height windows and glass doors (Figures 38 and 39) – all modern. There are no original doors or windows remaining on the building. The roof, which is also modern, is flat and lined with Trimdek sheeting (Figure 43). The southern concrete stairs are original but have been modified to suit the 2006 extension of the building – which infilled the previous space between the stairs and south wall of the pavilion. The metal balustrade is not original and nor is the brick retaining wall built up to the stairs (Figure 40). The verandah was added in c.2006.

Figure 38: Ground floor extension.

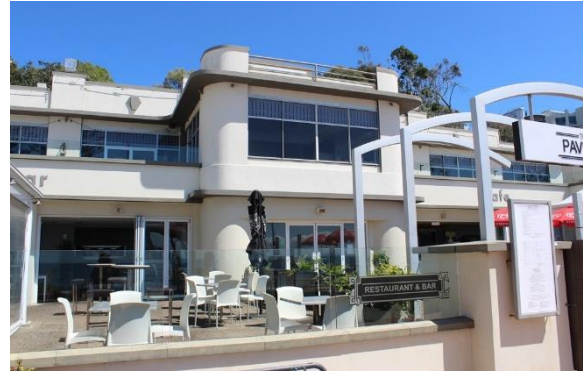
Most of the exterior of the building is modern fabric but has been designed to mimic an art deco period building. Extant original exterior walls are located at the western side of the building and are rendered brick (Figure 44). The adjacent modern walls are comprised of a rendered polystyrene cladding (Figure 45). The trims at the façade, which are painted grey, are also rendered polystyrene. The curved walls either side of the former kiosk entrance at the ground floor are also part of the original building – note the difference in appearance between the upper level and lower level part of curved wall – the upper level, which is modern, appears smoother (Figure 39).

Figure 39: View to façade.

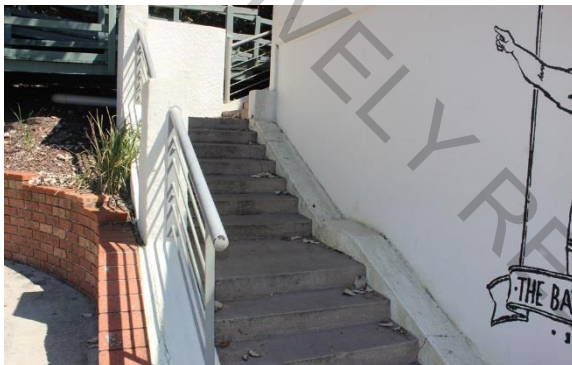
Figure 40: Stairs at the south, leading to upper level.

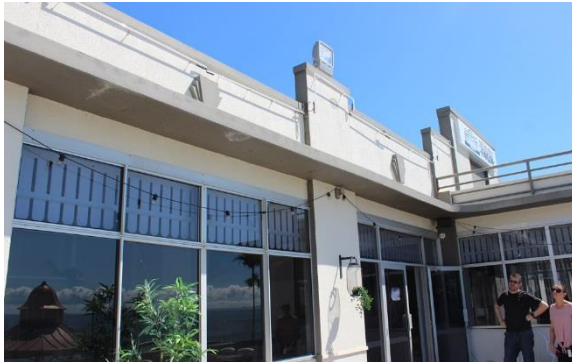
Figure 42: Modern 'art deco' façade at upper level.

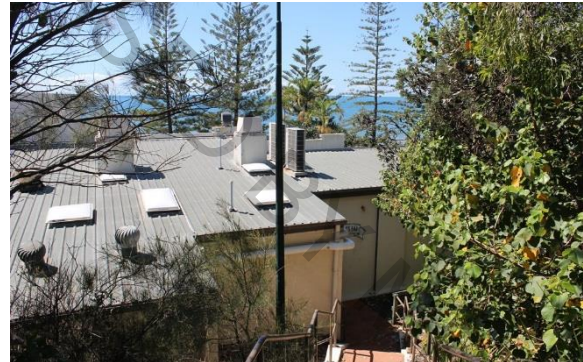
Figure 43: View to the modern roof.

Works to modern fabric and areas already heavily modified should be permitted by Council under a 'general exemption certificate'. For example, the replacement of the roof – which is modern – could be undertaken without applying for heritage approval.

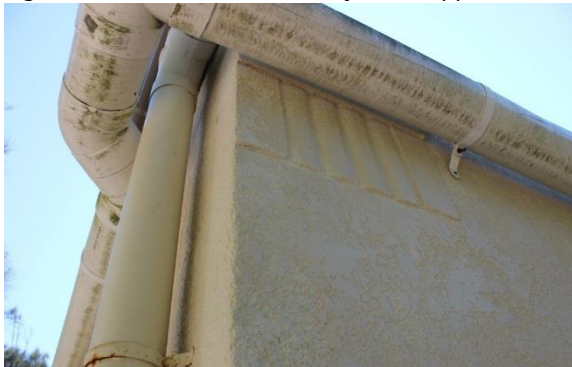
Figure 44: Original wall at the west, upper level.

• Western wall and corners of north and south wall	High	The original sections of the walls are visible from the stairs – they retain original detailing. The adjacent modern walls are built to look the same, but are made from polystyrene blocks, rendered to match the original building. Despite this attempt, the difference between the new and old is obvious.

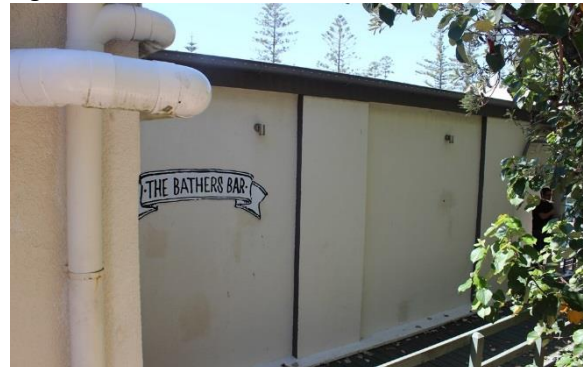
Figure 45: View to modern wall.

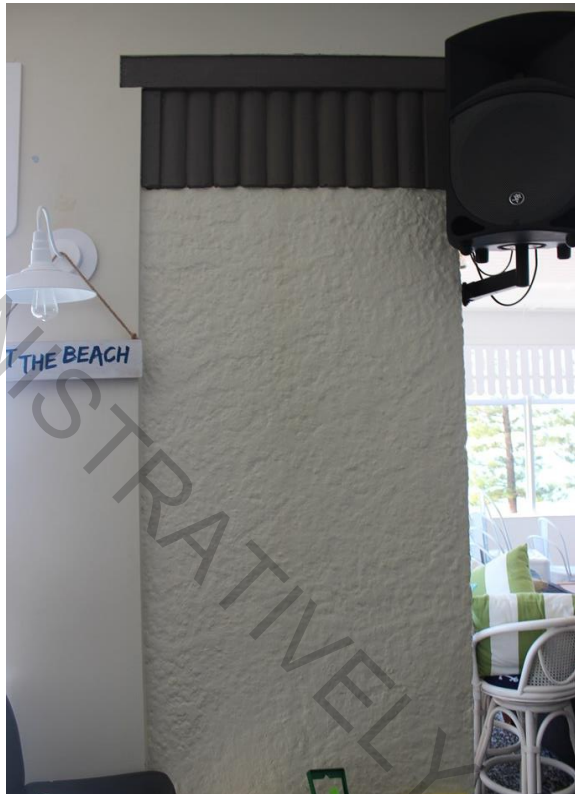
Figure 51: Original verandah column.

• Two verandah columns	Moderate	Aside from the walls noted below, the two remaining verandah columns are all that remains from the original construction at the upper level. They retain the render and terracotta tile detailing. Their original context as verandah columns has been removed with the enclosure of the verandah. The original hipped roof they supported has been completely removed and replaced with a flat roof.

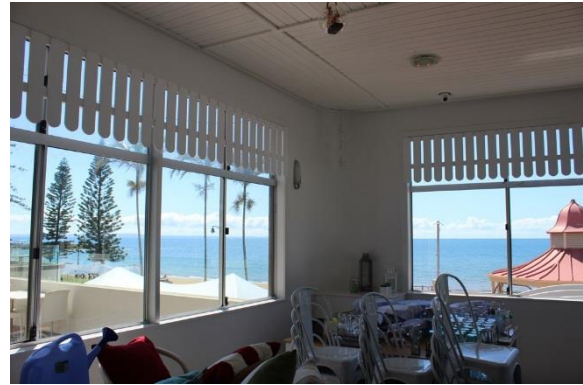
Figure 52: Enclosed terrace over former kiosk.

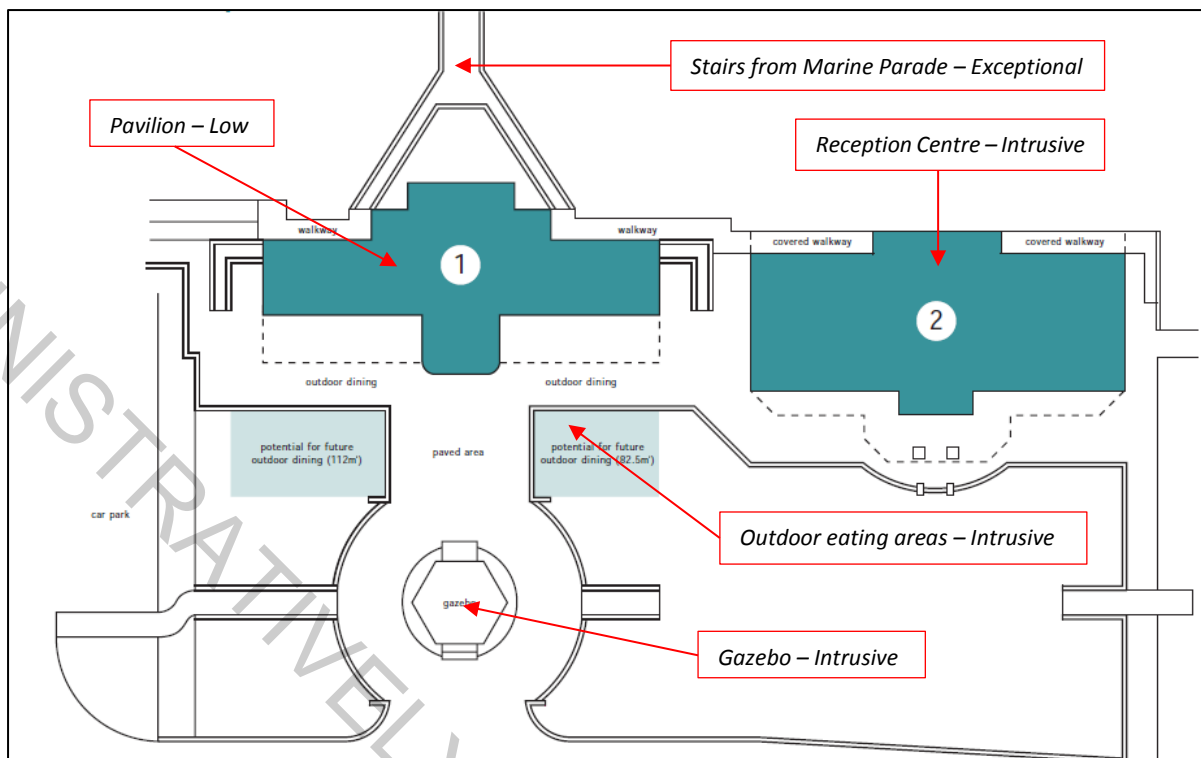
Figure 54: Location significant elements around the setting of the pavilion (MBRC 2006: 8).
