JOINT REPORT
GROUND FLOOR BRICK WALLS AND COLUMNS

PAVILION 1, 50 MARINE PARADE, REDCLIFFE

COVEY ASSOCIATES & ACOR CONSULTANTS

PROJECT NO: 223164
REF: RG/RG/102205RPT – A
22 DECEMBER 2022

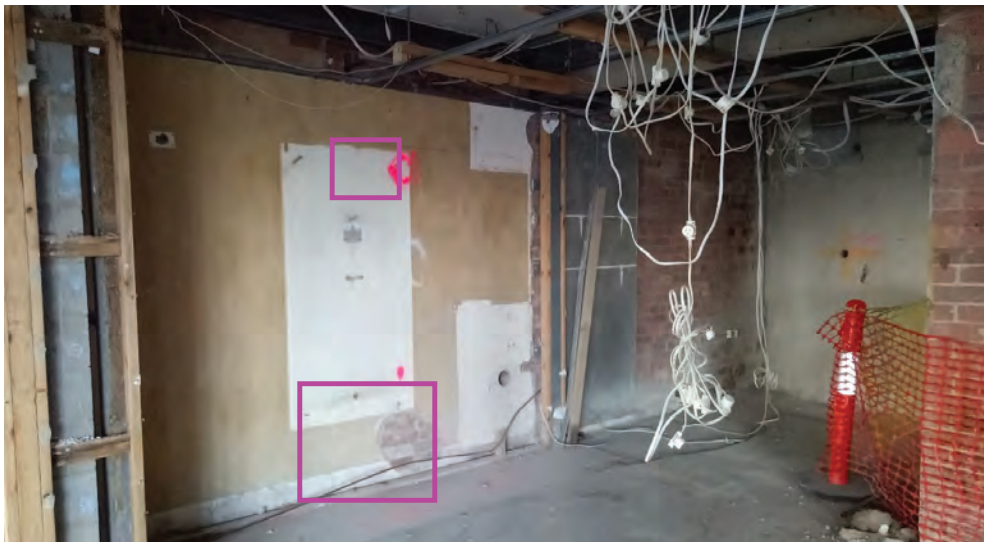
This section of wall was originally the end wall and exposed on the southern side for over half it's life. It has water ingress at the top closest to grid 5 and 4.

Photo 16: Wall section C:4/3 Inside view. Call out close up pics below.

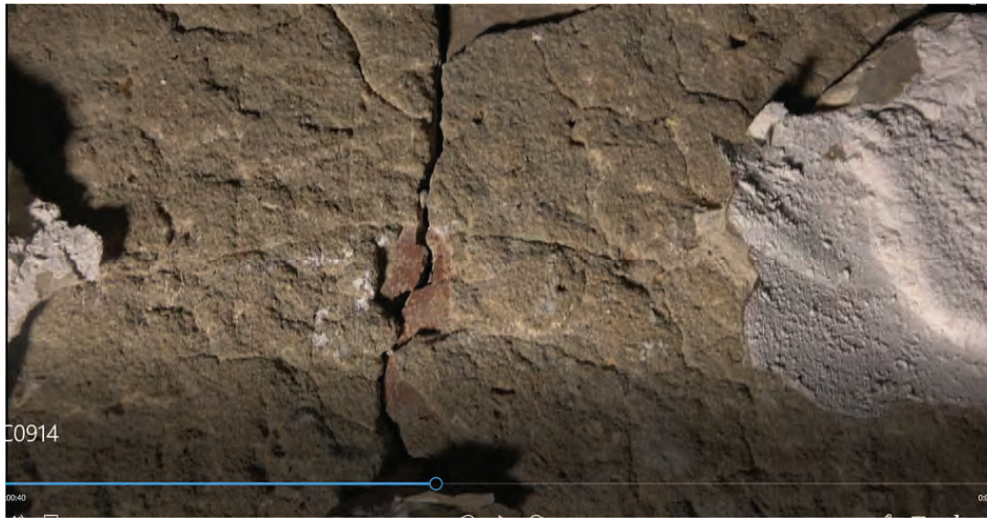
Photo 20: Close up of above

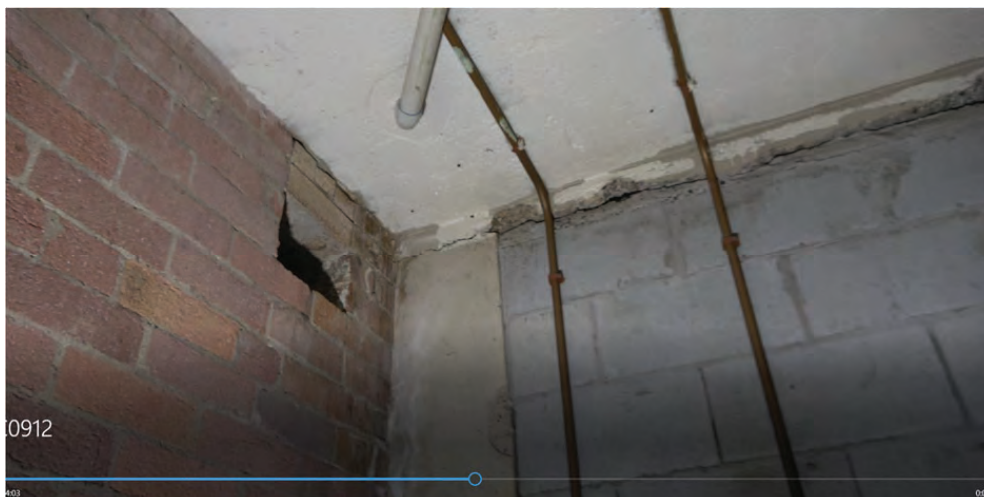
Double skin brick, with a small opening made in the top corner. The original lintel has been cut at grid 4 and the reinforcement is exposed.

Photo 22: Section H-3/4 at join to rear retaining wall

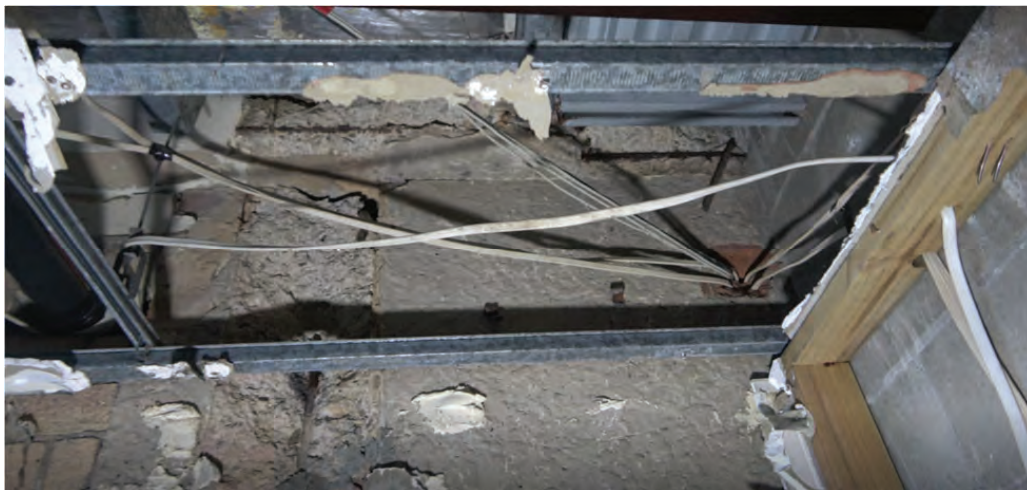
Photo 31: Of the opposite side of W-3/4 at the top where the stairs were cut off. Note stair beam on the left and landing/stair reo exposed at the top right.

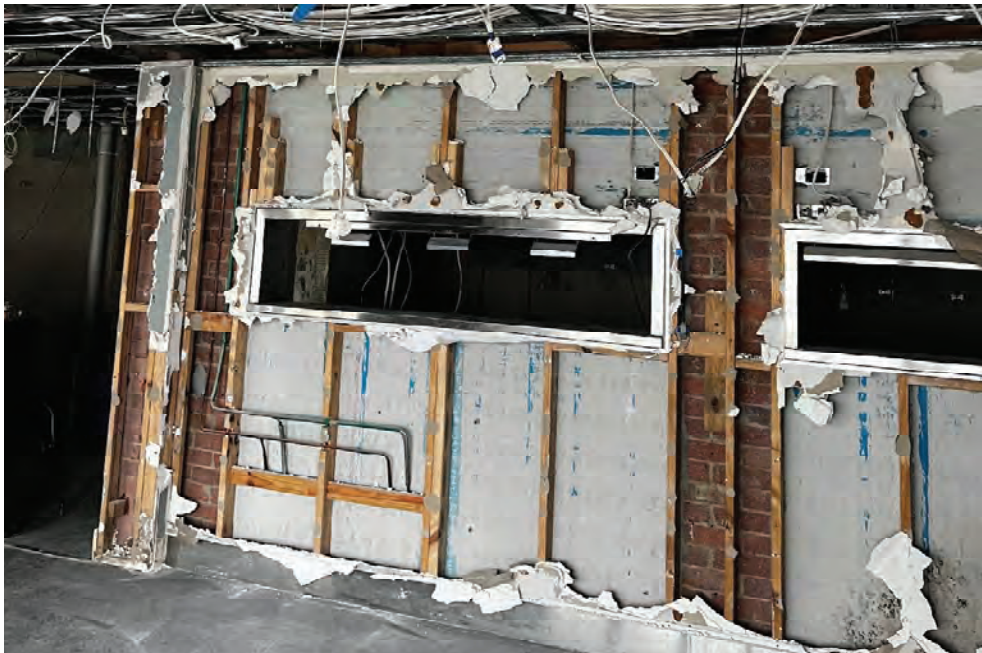
Photo 40: Brick columns on grids 4:H and 4:J

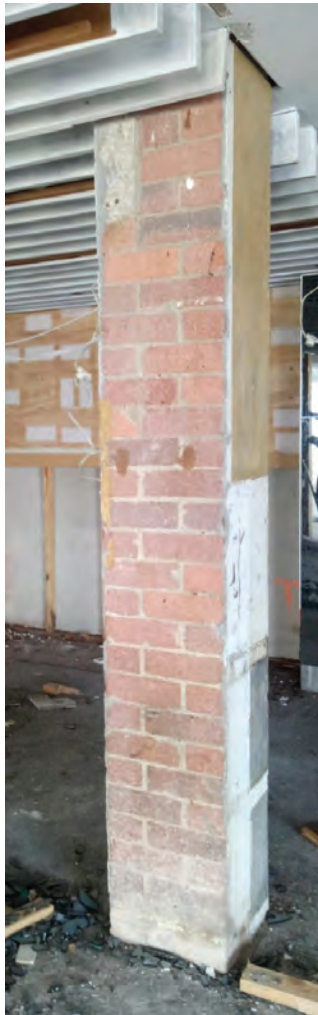
Photo 42: Brick column at D-4

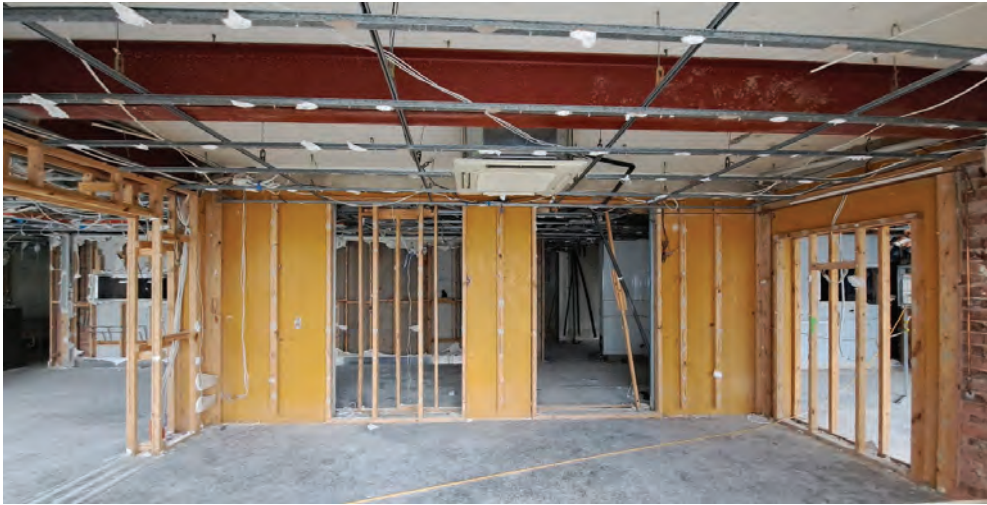
Photo 46: View of B1-1 at top of photo

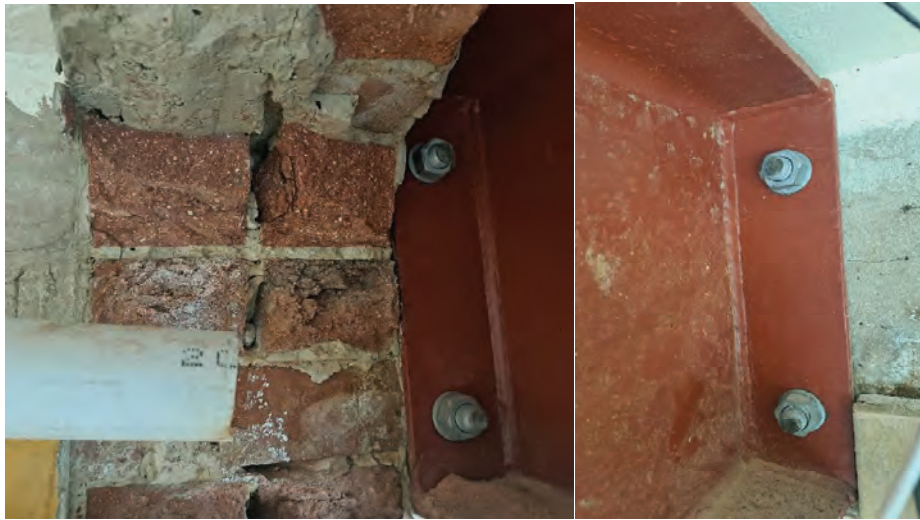
Photo 48: Close up of above at Grid P:6
Bolts to remaining brick wall on grid P

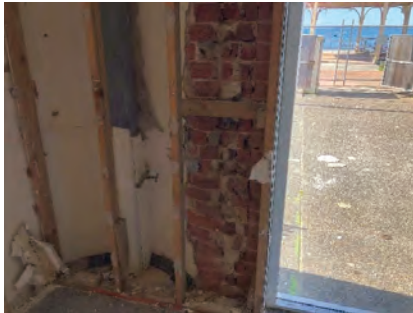
Photo 10 – Masonry wall panel

Without recourse to structural calculations, we can see that area of brickwork forming the wall, especially as evident in photo 11, is substantially less than was originally constructed.

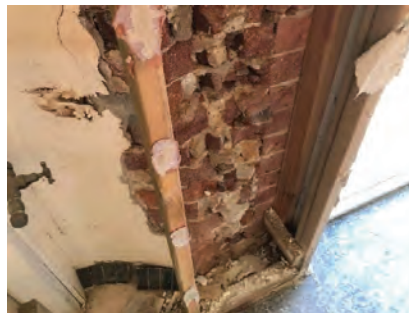
Photo 11 – Close up, batts & demolished ends

Further the batts (that is, the ends of the bricks) and demolished ends (again, visible in photo 11) suggest a tenuous (at best) connection between the curved section and the abutting nib.

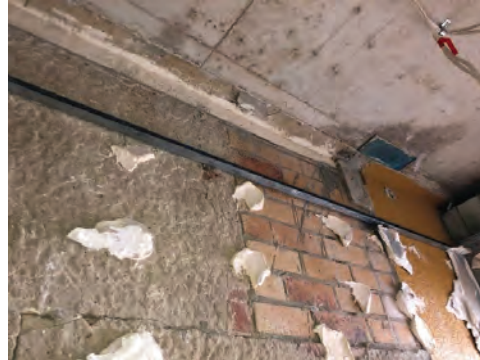
Photo 13 – Close up, batts & demolished ends

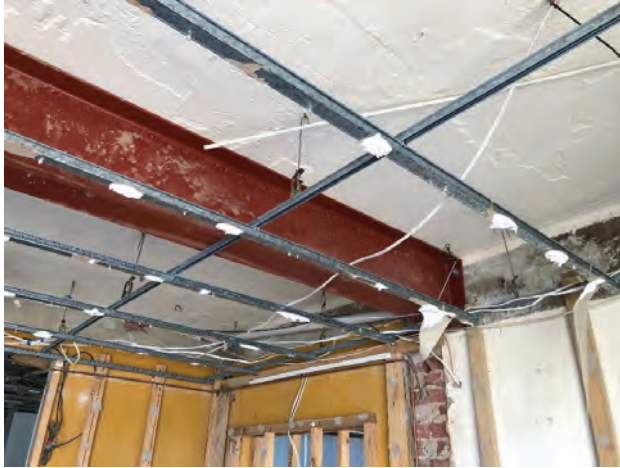
Photo 14 – Load point A

Additionally, review of figure 3 (above) suggests that there used to be a brick nib at this location. Photo 14 shows that this has since been removed

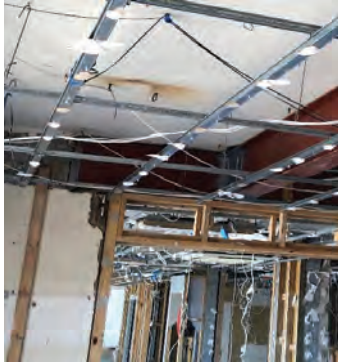
Photo 16 – Load Point C

At load point C, the steel beam is seated on the nib of the wall.

However, we note (refer to photo 16) that there is a large portion of the brick nib is missing (broken off).

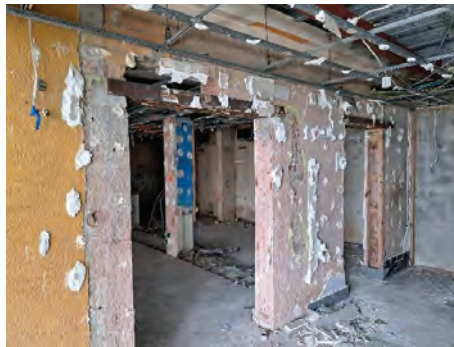
Also, there are (what appears to be) a duct penetration over the steel lintel (see photo 20).

Review of the lintel depicted in photo 20 (approximately at the intersection of grids W & 4) suggests that there has already been significant shear failure of the brickwork immediately supporting the right-hand side of the lintel. This is visible under the removed render.

Photo 20 – Grid W wall, from north

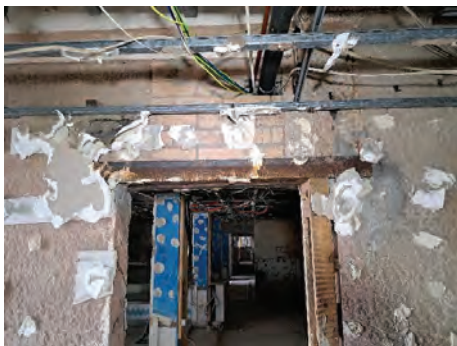
Photo 21 – Grid W wall, existing steel lintel

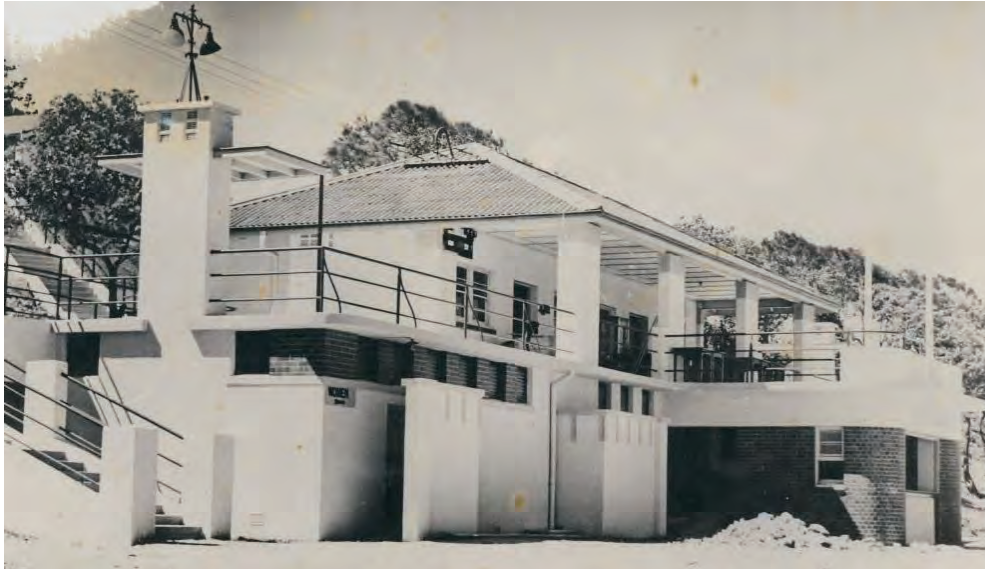
Photo1: from 1937 shows most of the upper floor brick walls and columns were originally rendered and some were not. Original parapet at front terrace was also rendered. Note many upper floor columns and walls have been removed.

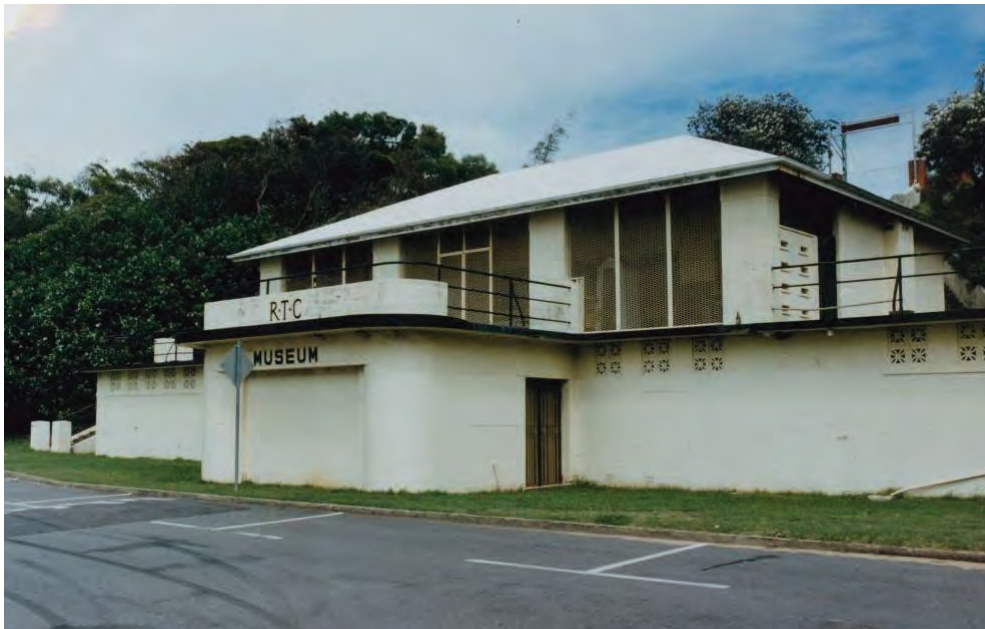
Photo 2: Photo of building fully rendered and enclosed in 1975 – photo here from 1991. Original rendered parapet at front terrace still exposed.

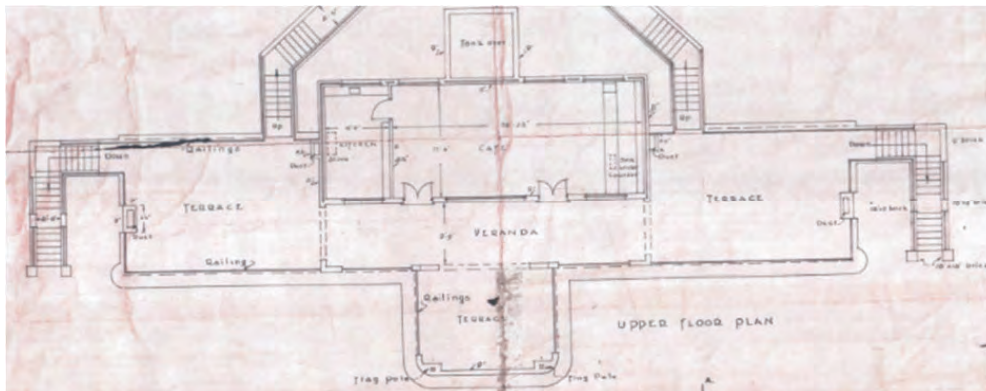
Figure 4: Scan of original blueprints showing upper floor use.

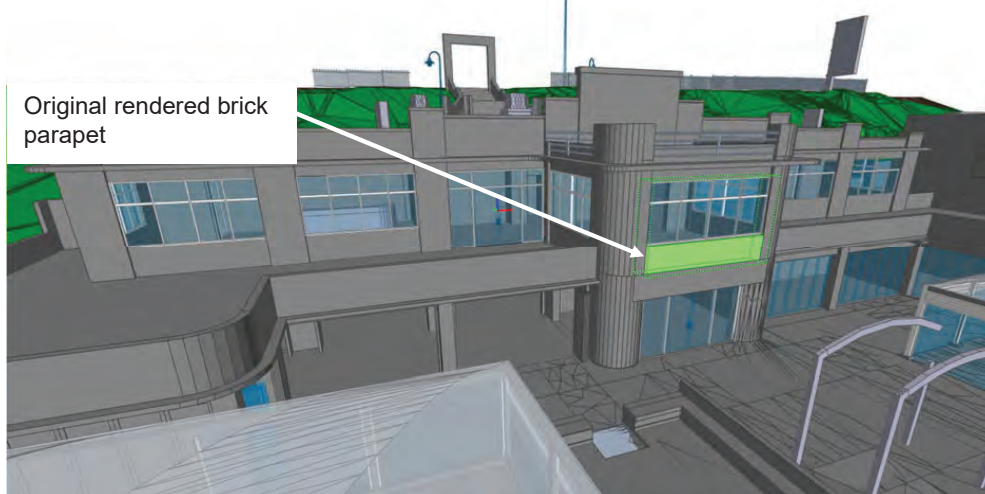
Figure 5: of brick parapet highlighted green, although it does extend to the curved section of the front wall either side.

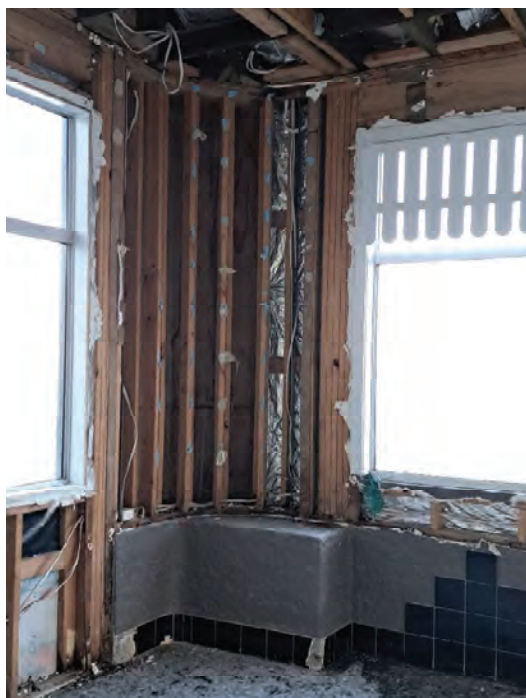
Photo 6: At U-8-N

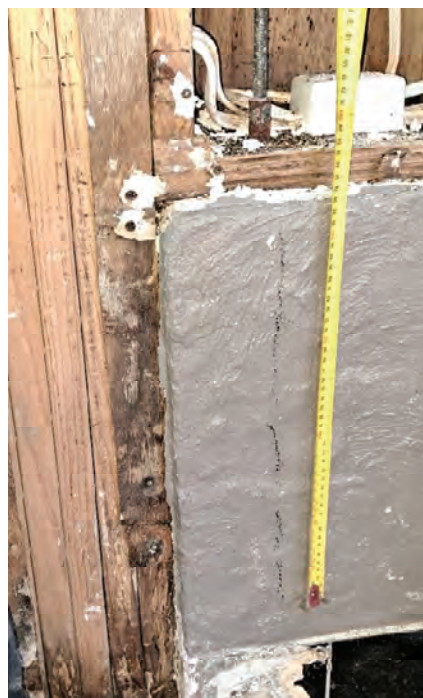
Photo 7: Depth of tiedown rod approx. 440mm

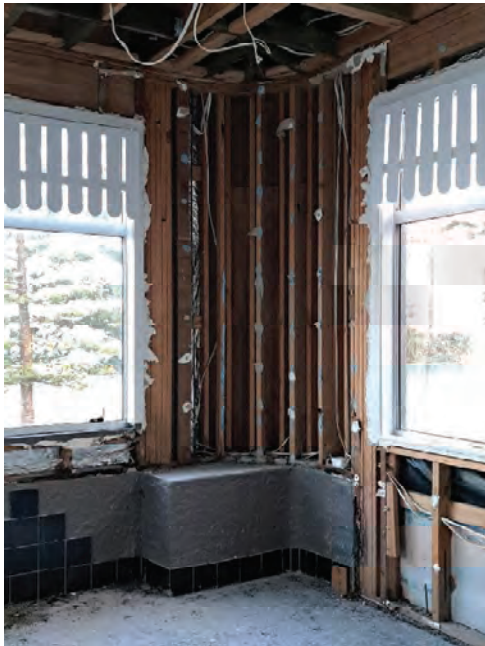
Photo 8: At U-8-L

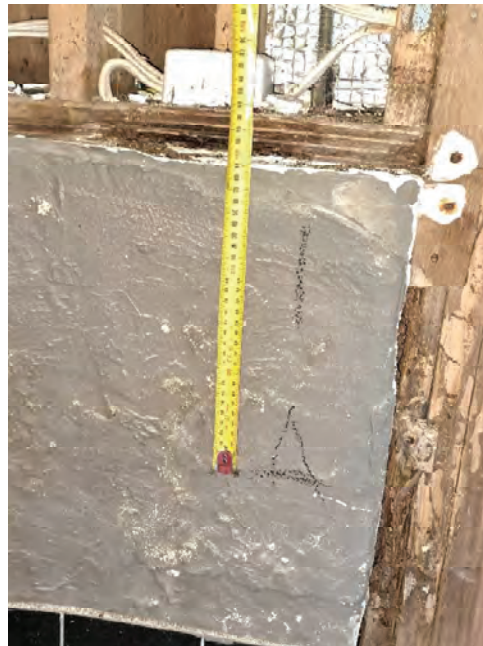
Photo 9: Depth of tiedown rod approx. 300mm

Note: The tiedown rod is drilled directly into the inner skin brick. It is not in the cavity.

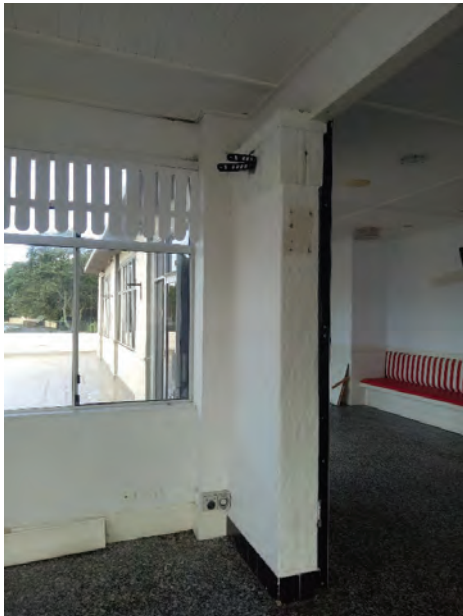
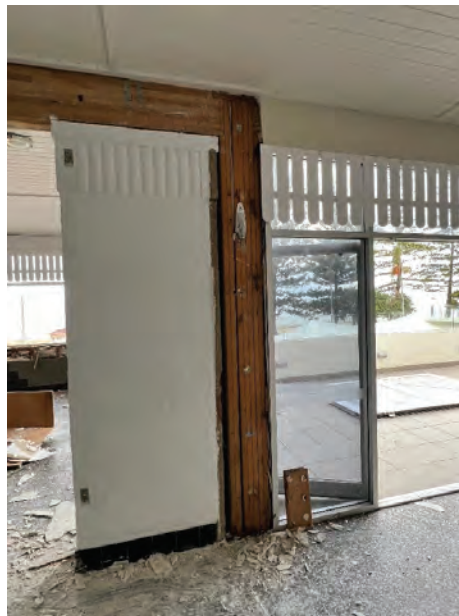
Photo 15: Original brick columns with Original tiles Photo 16: Other side of column during strip out.

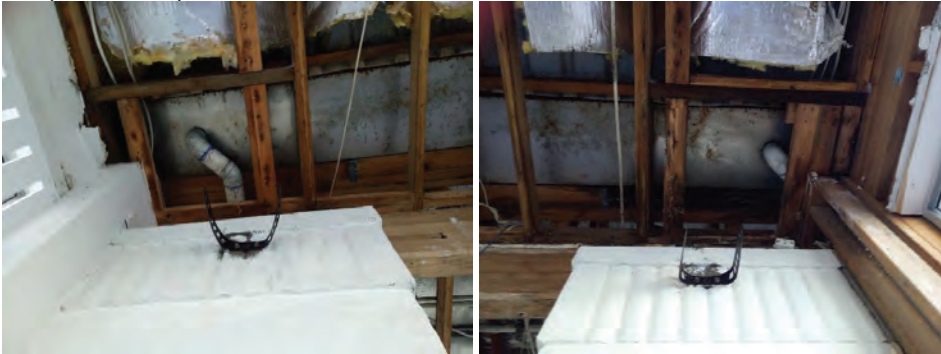
Photo 17: Top of Col. U-5-L Water ingress at box gutter

Photo 18: Top of Col. U-5-N Water ingress at box gutter

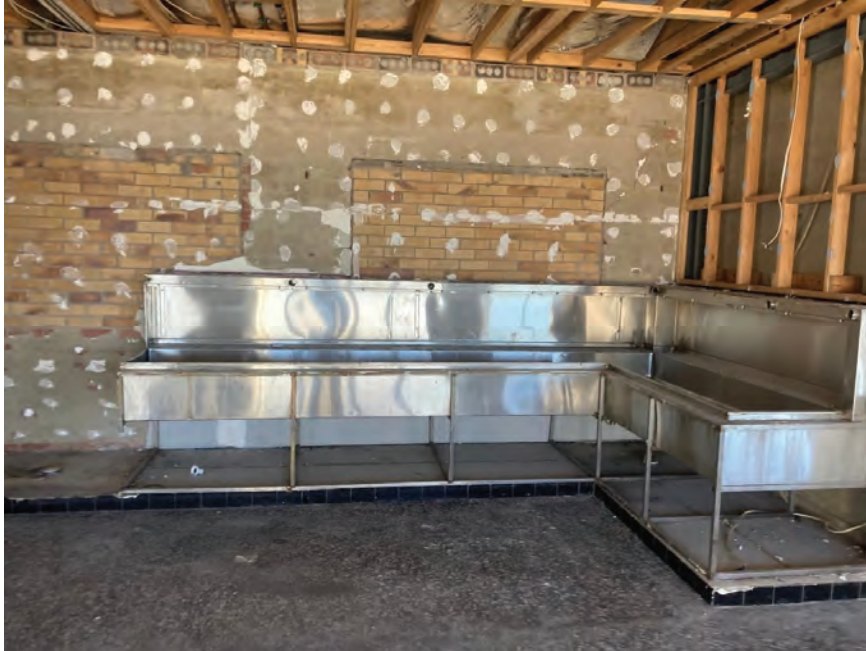
Photo 22: Section of wall at Grid 2:P-R Note the original bricks and lintel rendered with the openings filled with newer bricks. Outline of the concrete lintel is just visible beneath the render. See close ups below. Also note new bricks along top to increase the wall height. Behind these bricks is the original hardwood top plate with a double pine top plate over (strapped to the HWD). See photo at end of observations section.

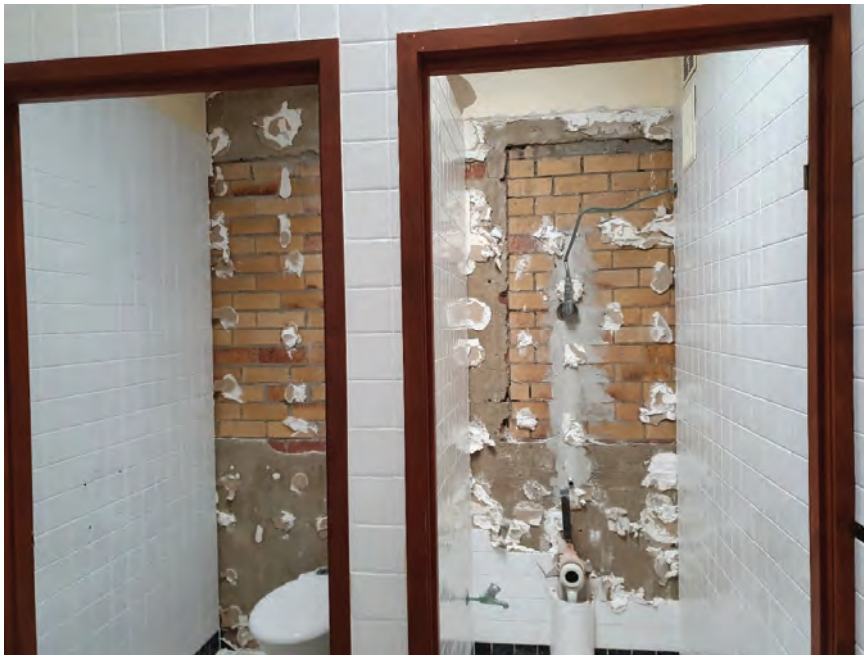
Photo 27: Brick walls in other toilets at grid 2:J-K

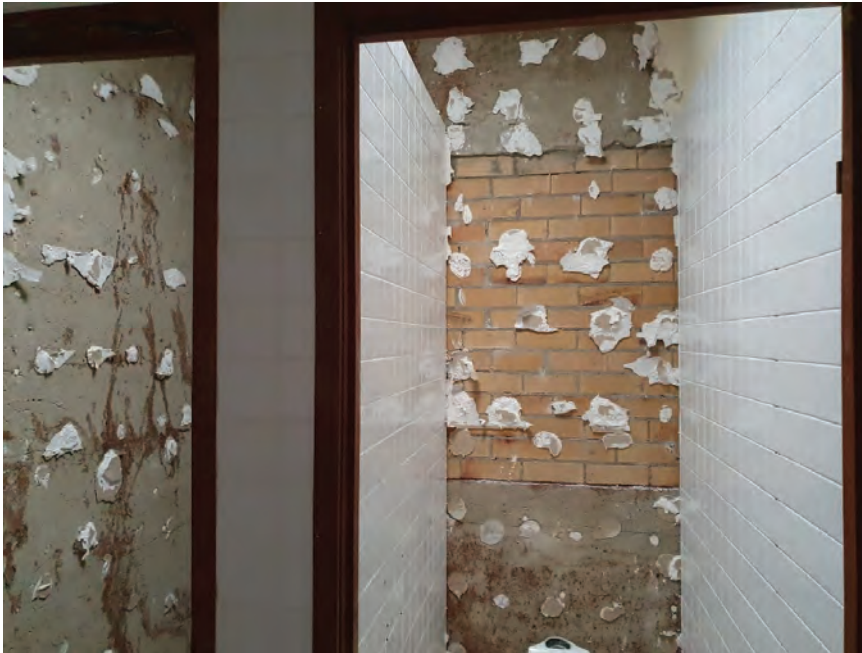
Photo 29: Brick walls in toilets on grid 2:H-J Note original walls still have original render. The opening is infilled with newer bricks.

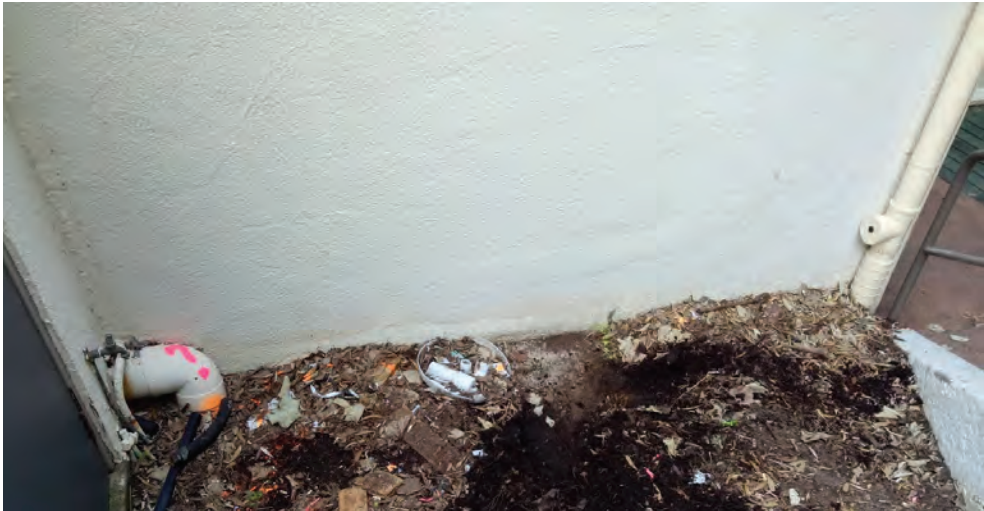
Photo 30: Outside wall U-2-H/J Note concrete spoon drain against wall covered in dirt and debris. Other side of wall along Grid 2 is inside the Plant room. But the infill appears to be block.

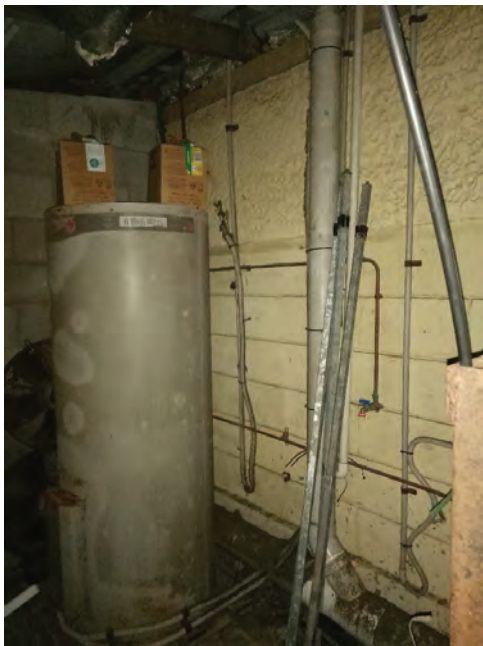
Photo 31: U-2-Q/N

Tiedown along grid 2 is unknown – removal of a top brick exposed the original hardwood top plate with a double pine top plate over (strapped to the HWD). But no tiedown of the original HWD plate could be seen.

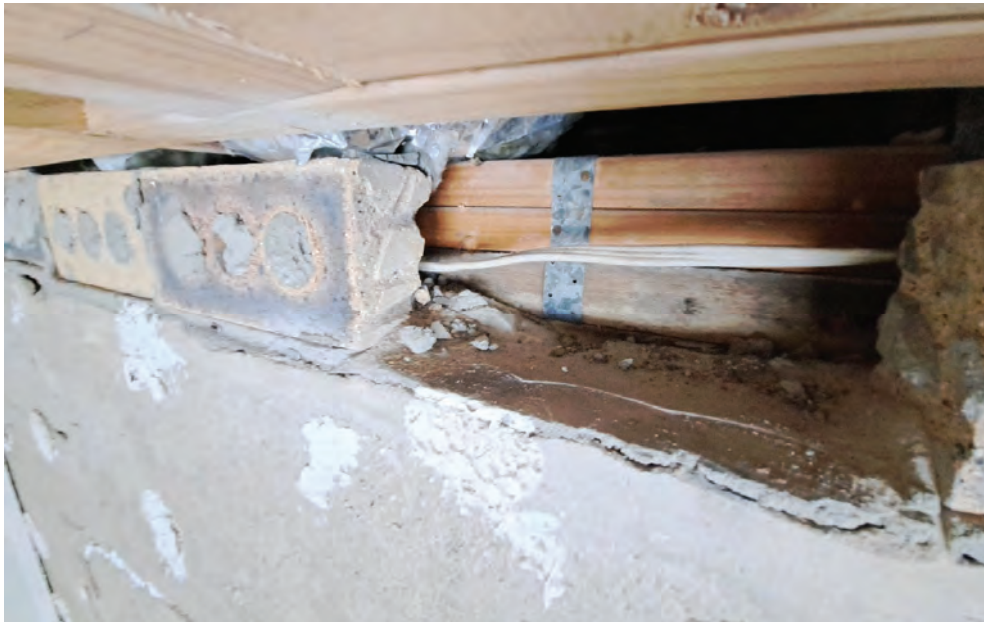
Photo 33: Approx location Grid 2:N removed brick shows top plates.
Note double 90x35 strapped to original HWD top plate.

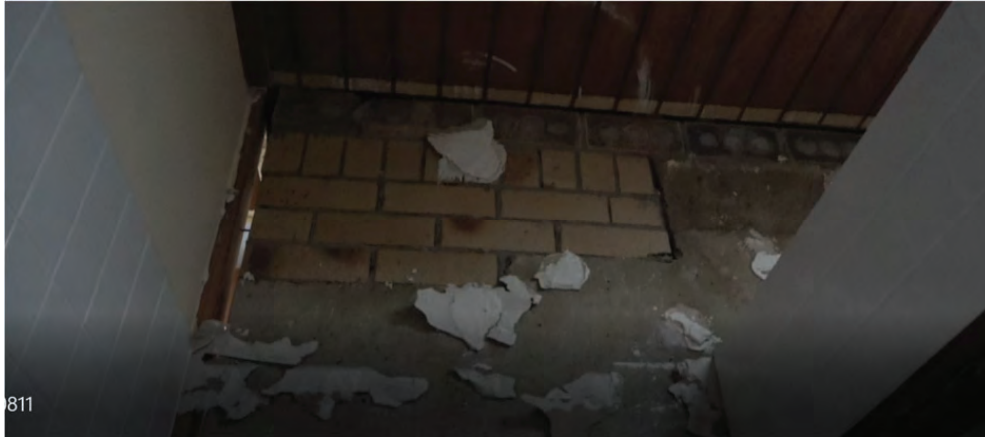
Photo 34: Top of wall U-C-3/4 taken from inside the amenities. Note original double skin brick wall cut. Also new brick infill above original rendered bricks.

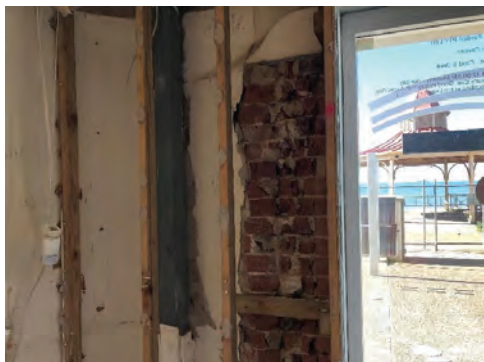
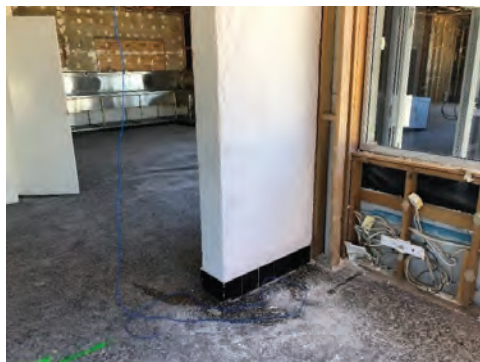
Photo 40 – Typical masonry wall - ground level Photo 41 – Typical masonry wall - upper level

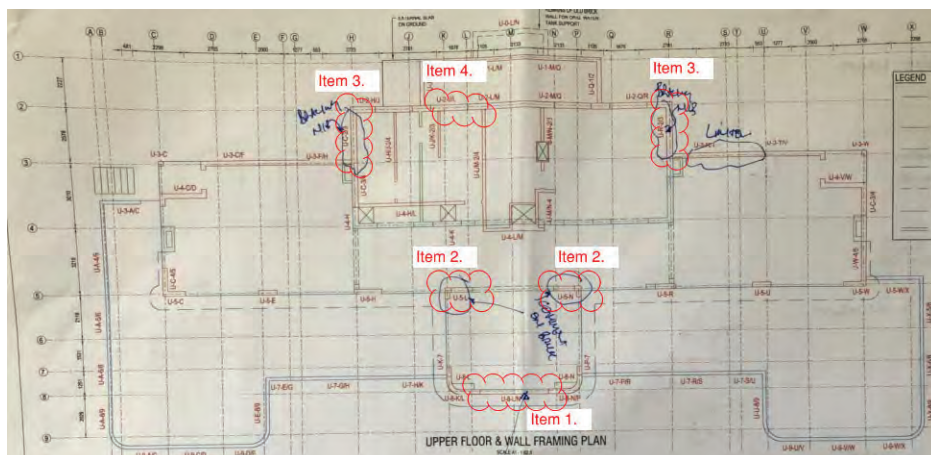
Figure 1 – site notes and references – upper-level brickwork

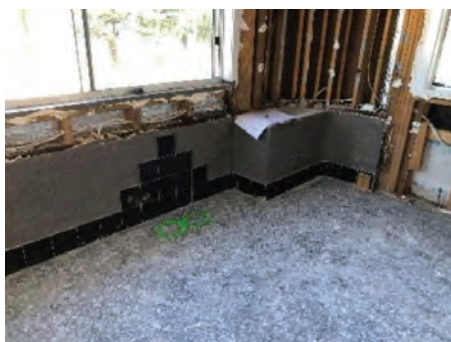
Photo 42: Dwarf wall, south end

Our review suggests that in its current configuration, the dwarf wall is not adequate to accommodate these loads.

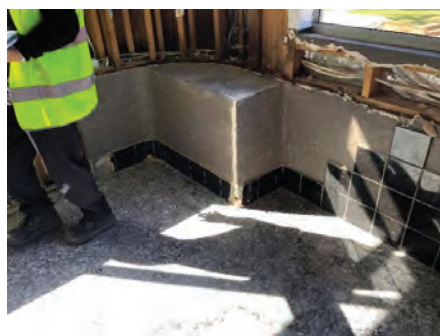
Photo 43: Dwarf wall, north end

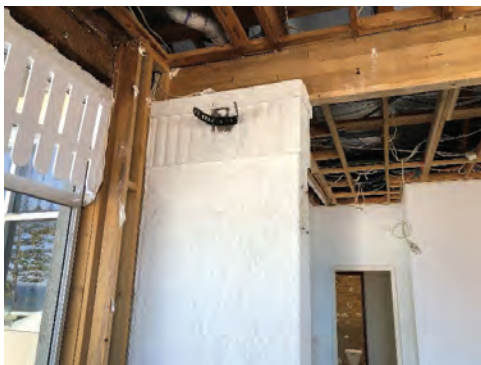
Condition - Brick work remains in serviceable condition.

Photo 44: Item 2 south end

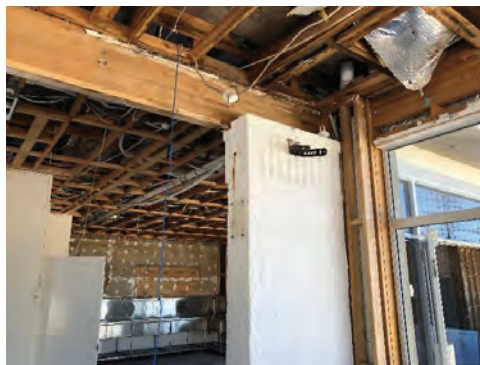
Photo 45: Item 2 north end

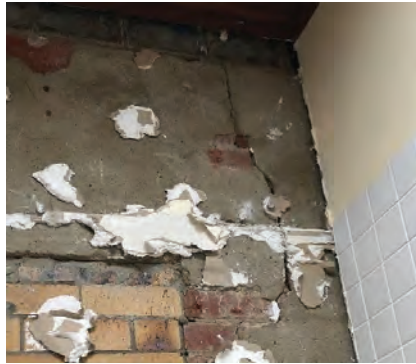
Photo 48: back wall at former lintel support

In addition, refer to photo 9, we note that the brickwork abutment that used to support the lintel is noticeably cracked. Crack width is up to 4 – 5mm. Such cracking (in this location) is typically due to shear failure.
