## CONSULTANCY STRUCTURAL ENGINEERING REVIEW

SUTTONS BEACH PAVILION 1

MARINE PARADE, SUTTONS BEACH, REDCLIFFE 4020

REPORT No: 62015RPT

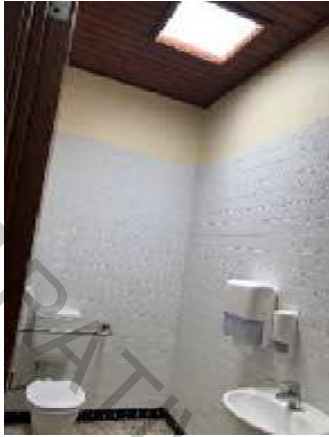
<p>Figure 17 – Upper level bar reception area</p>	Typically, the dining and bar areas are served by split system cassettes. It is unlikely that these provide sufficient outside air to these areas.	Outside air supply quantities should be checked for compliance with code.
MI.6		Toilets to the upstairs function room above the restaurant are naturally ventilated via skylight vents.	While this may be code compliant it is less than desirable for a space of this quality as generally smells are not adequately removed. It is recommended that mechanical exhaust be considered.

<p>Figure 18 – upper-level toilets</p>		
MI.7
