JOINT REPORT ORIGINAL SUSPENDED SLAB

PAVILION 1, 50 MARINE PARADE, REDCLIFFE

COVEY ASSOCIATES AND ACOR CONSULTANTS

PROJECT NO: 223164
REF: RG/RG/37300RPT – ISSUE A
22 DECEMBER 2022

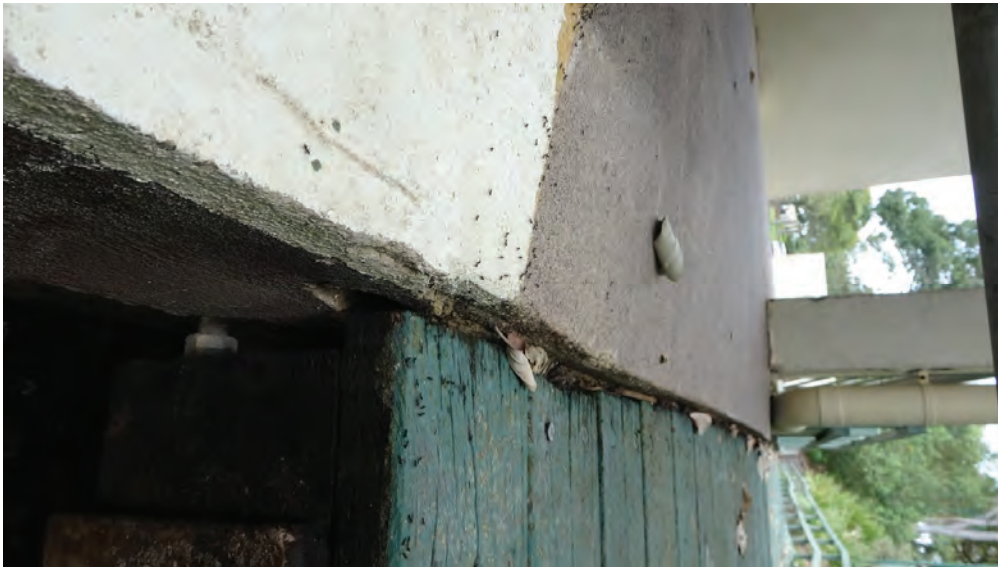
Photo 4 – Suspended slab overhang at southern rear walkway. Note the timber decking has no gap in some areas and/or is full of debris.

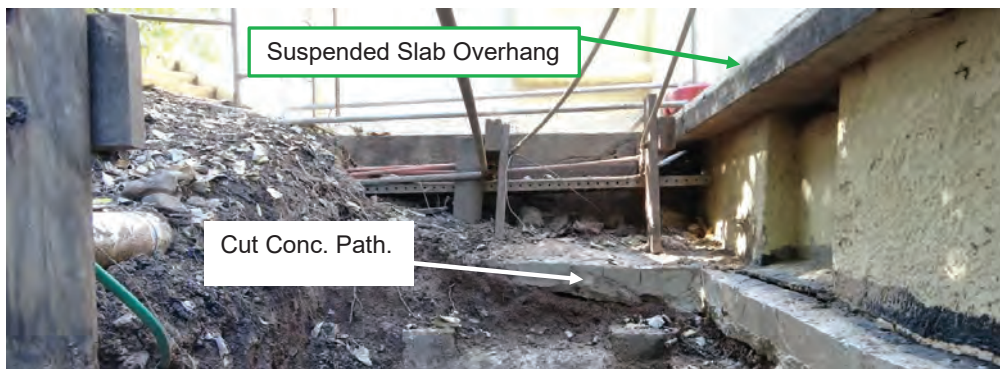
Photo 13 - Excavation behind retaining wall near grid 3:D/G

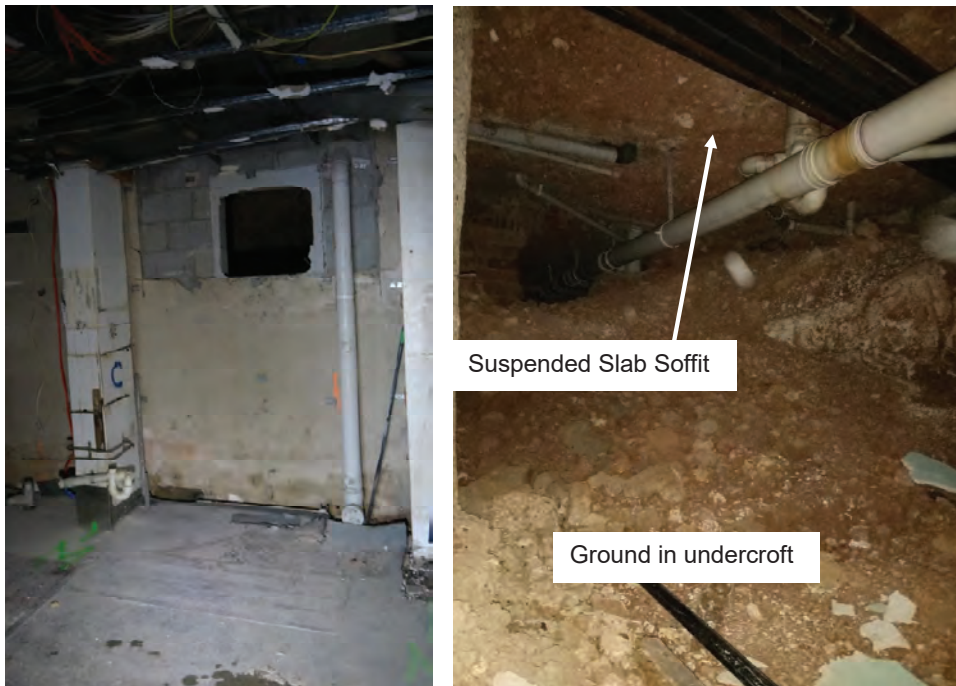
Photo 14 - Rear retaining wall between grids.
Note suspended Slab M and N. Note the hole in the block infill to the undercroft.

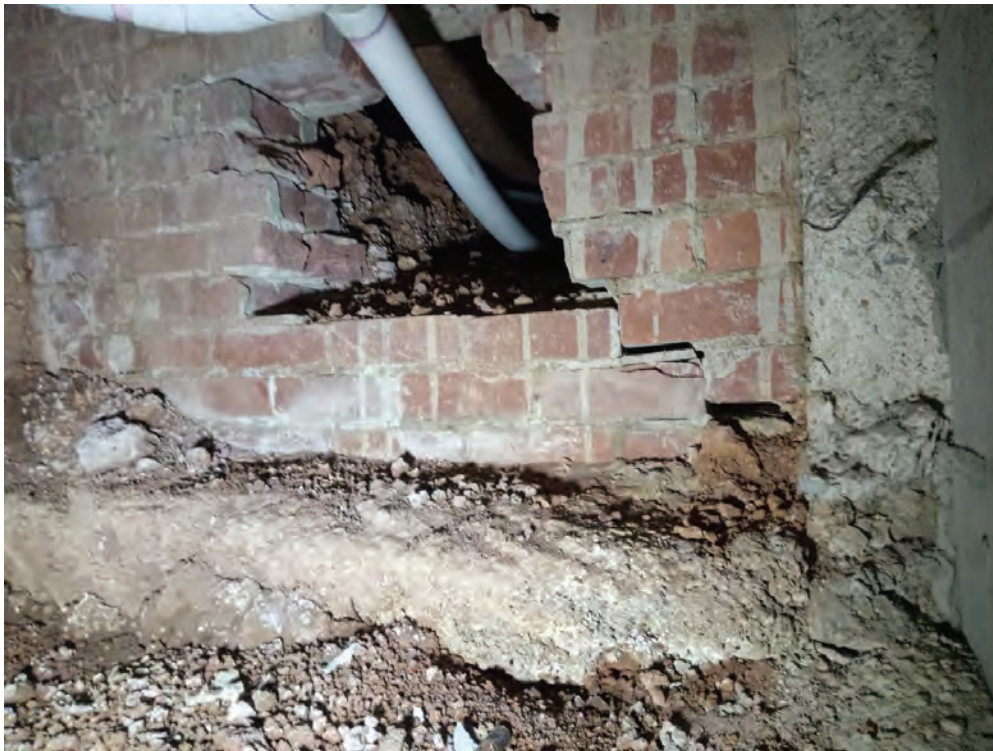
Photo 15 - Photo of wall along grid N:2/3 in undercroft.

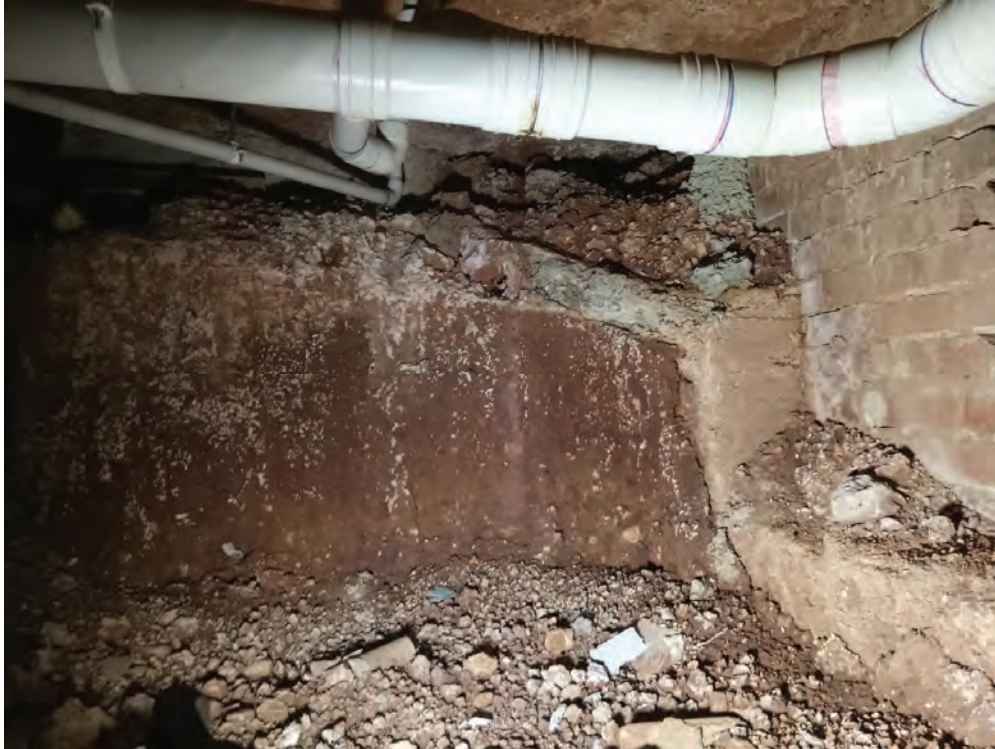
Photo 16 - Photo looking at corner between grids 2 and N, shows high level footings.

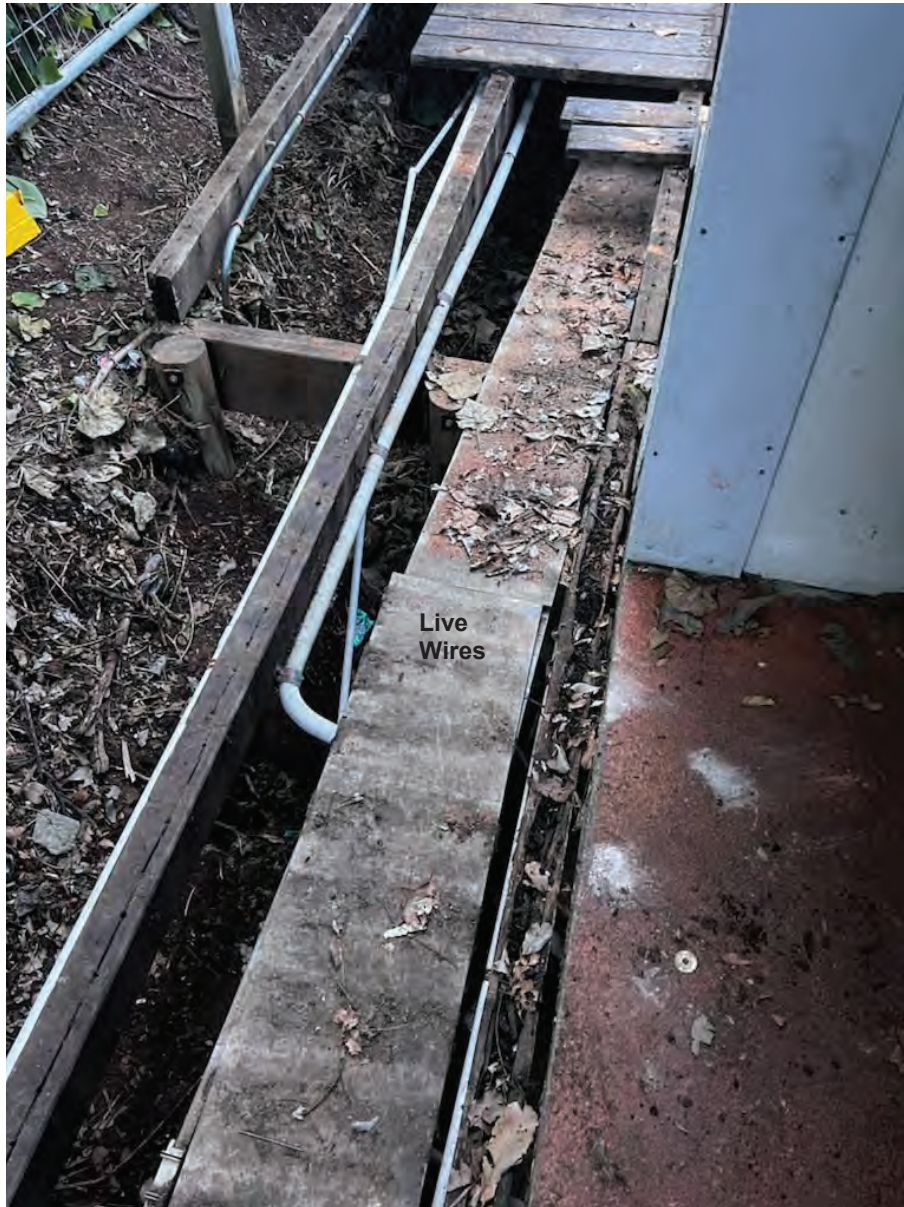
This section of the suspended slab at the edge has had the overhang cut off and steel exposed. This was seen once the rear deck was removed. Note live wires tray at back.

Photo 17 - Originally a mirror image to the other end of the building (i.e.similar to 3-A/H)

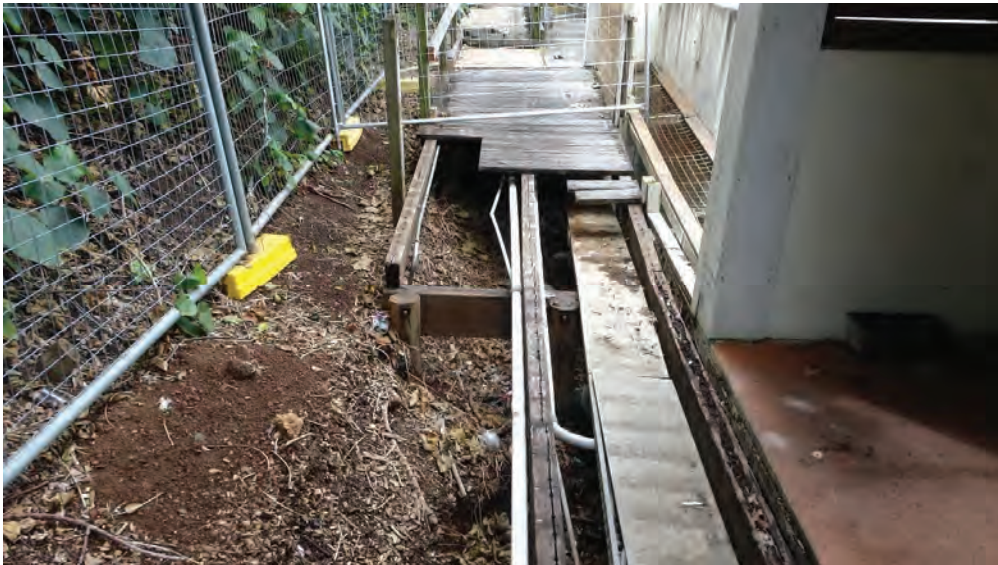
Photo 23 - View of above from other direction.

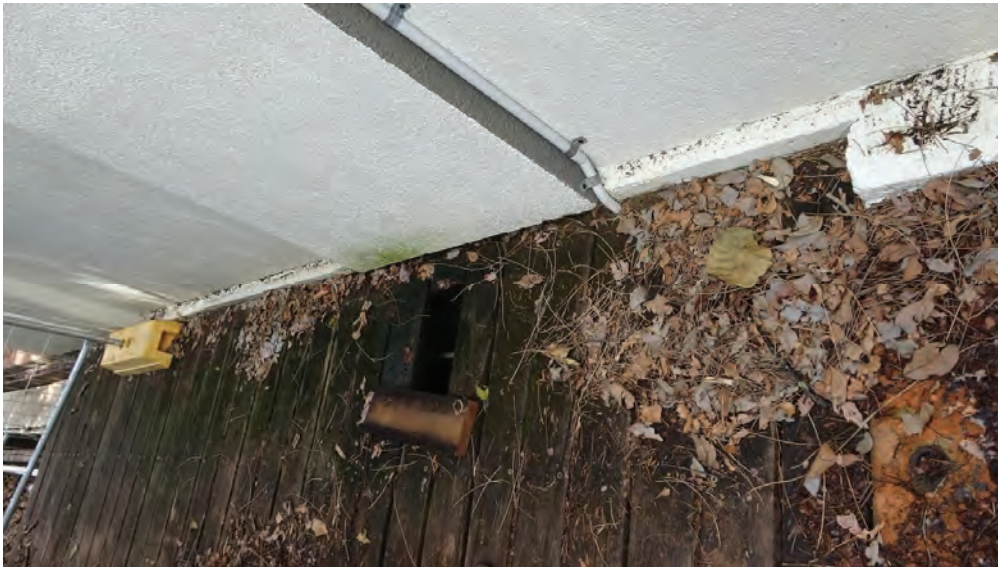
Photo 24 – View of cut concrete overhang with timber decking against cut section.

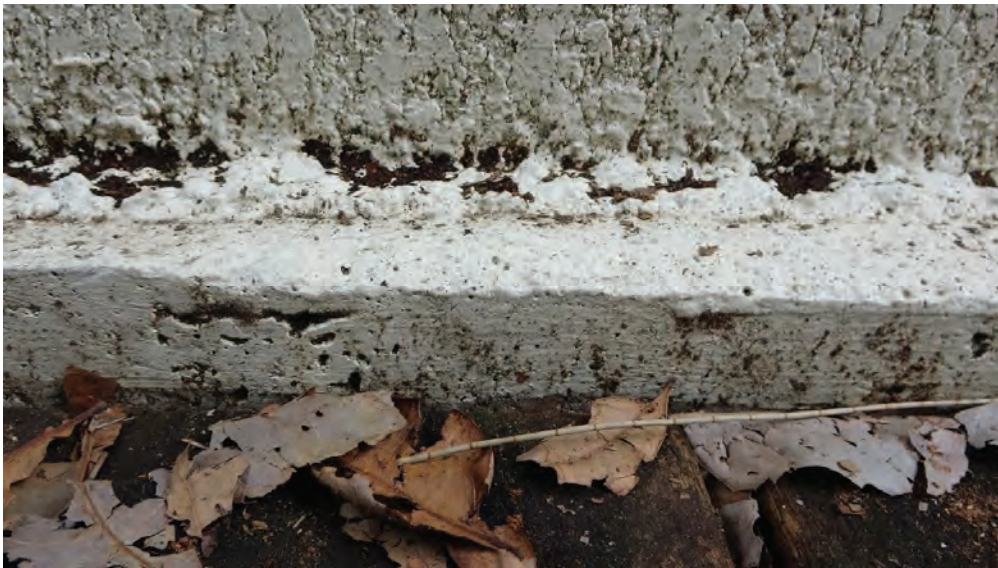
Photo 25 - Close up of edge of cut concrete. Note that only the top part above the deck is painted and the timber decking is touching the concrete in most areas or the gap is full of leaf matter and debris.

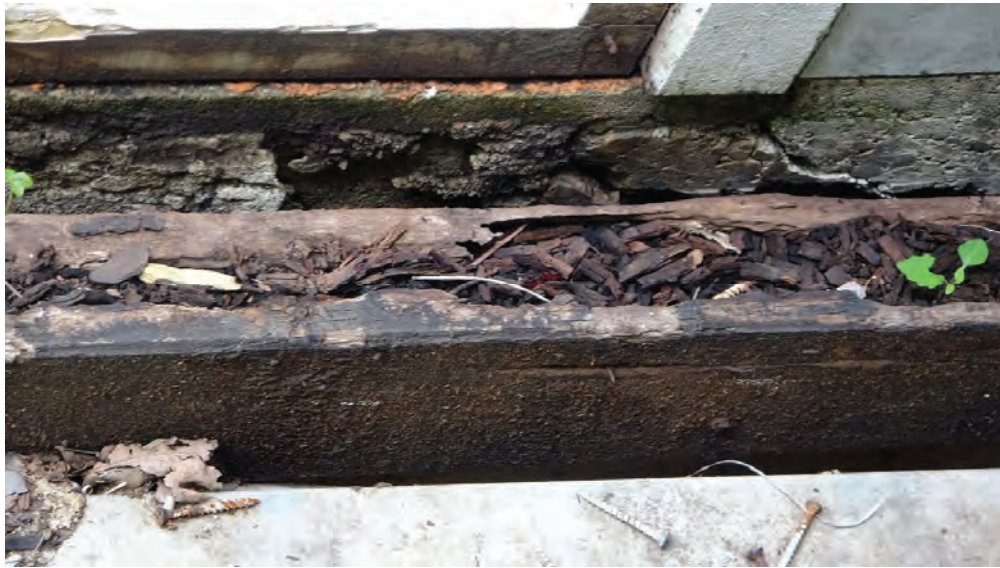
Photo 28 – Top of timber joist along rear deck near 3:U/W

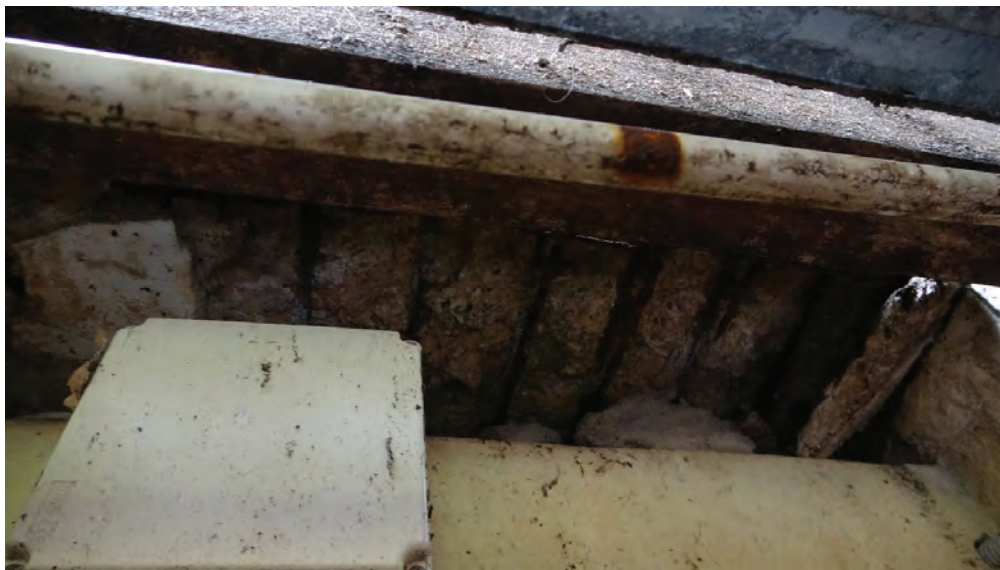
Photo 29 – The underside of the suspended slab overhang along grid 3:T/W has completely delaminated to the depth of reinforcement.

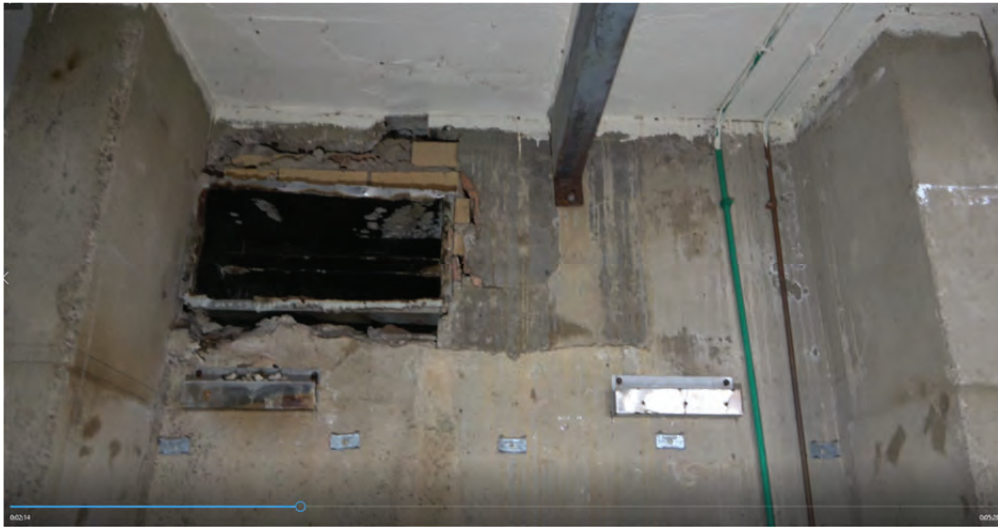
Photo 30: Rear retaining wall between grids S and T. Note the steel beam is connected to a brick infill section of the wall. Also, the opening for the vent has gaps and is not sealed.

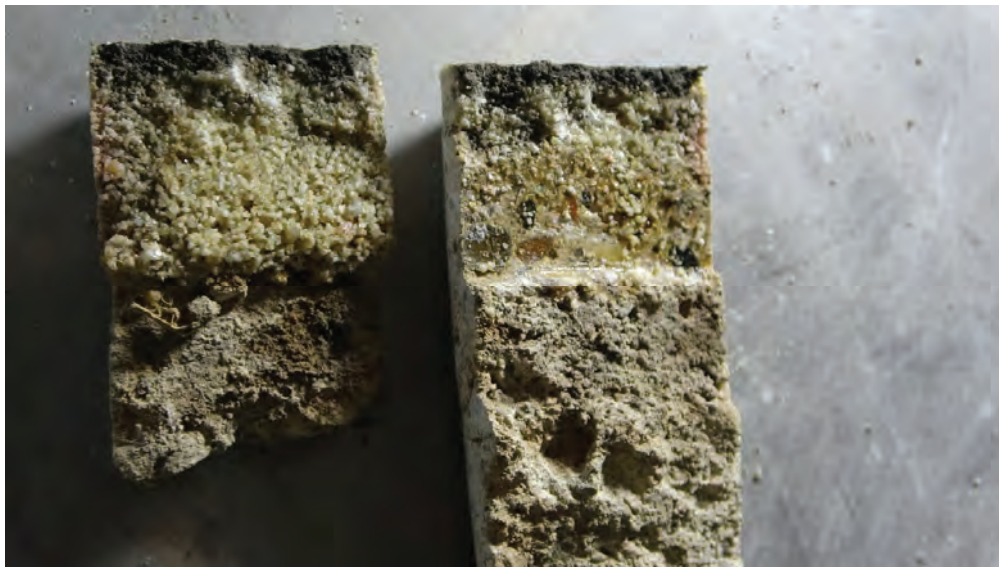
Photo 40 – Close up of above also shows sandy top section.

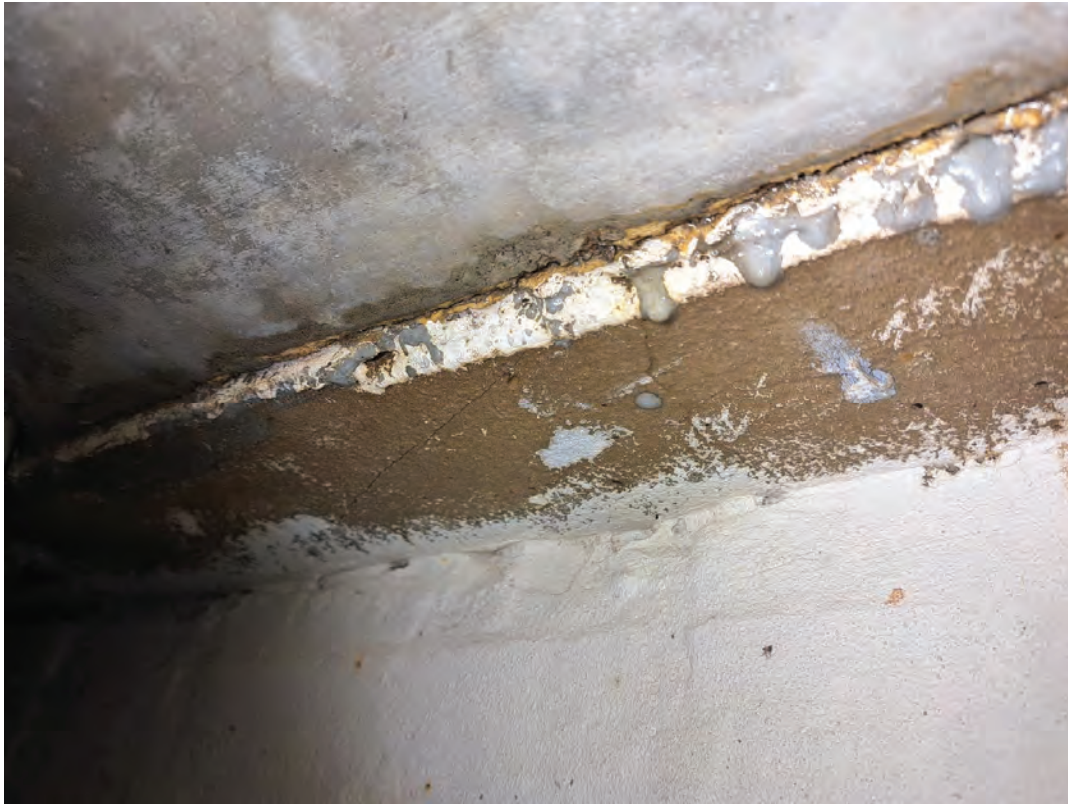
Photo 46 – Shows water ingress at slab joint old to extension coming down wall.

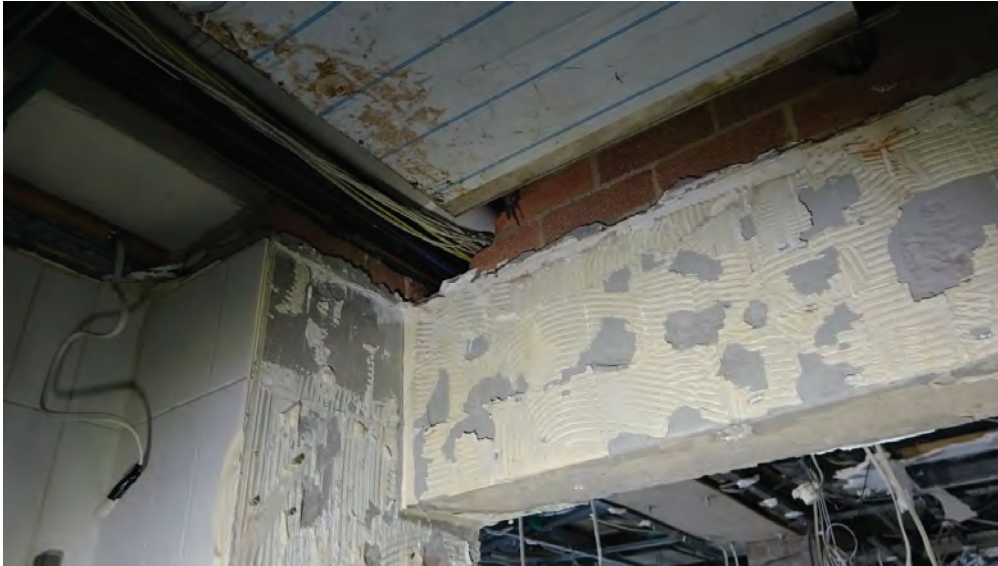
P9: Beam CB2 at column 4:H with perpendicular beam/lintel with tiles removed.

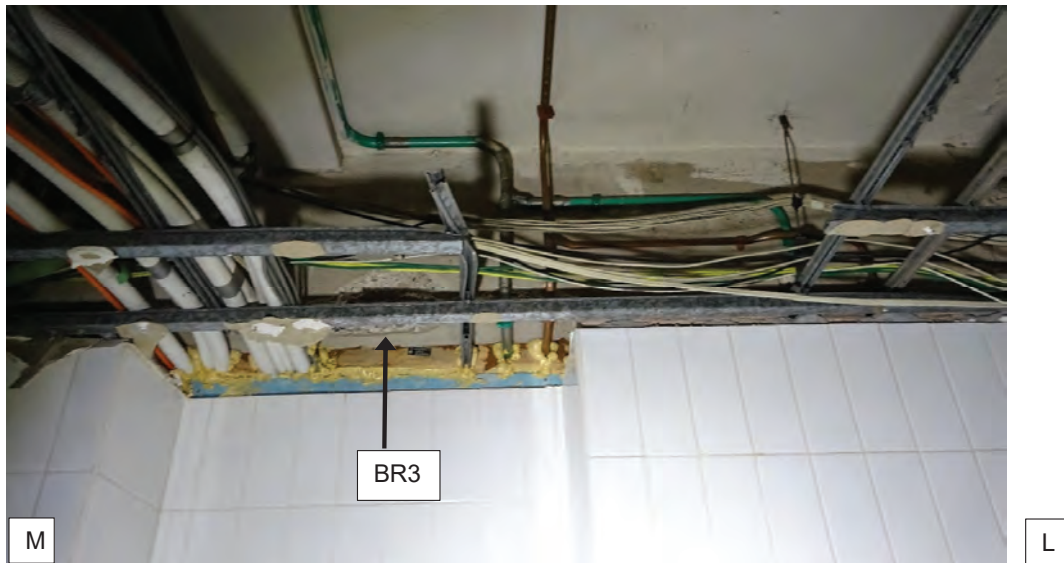
P13: Beam CB2 along grid 4 from halfway between grid M to half way between L and M. Note the breakout 3 at this location.
