APPENDIX I
JOINT REPORT: SLAB TESTING

JOINT REPORT
CARBONATION TESTING - SUSPENDED SLAB

PAVILION 1, 50 MARINE PARADE, REDCLIFFE

PROJECT NO: 223164
REF: 27735RPT - A
DATE: 22 DECEMBER 2022

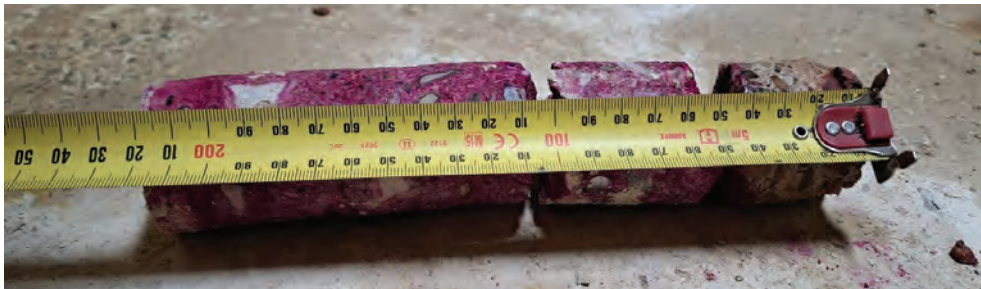
Image 3: Core at C1 with tape measure from soffit to top.

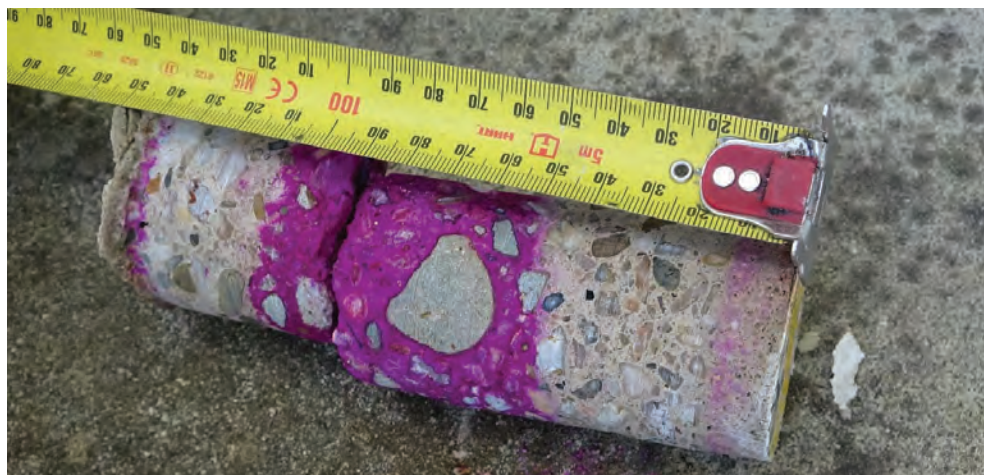
Image 5: Core at C2 with tape measure starting at 0 at the top of the slab. Note another 10-15mm topping/grout above original slab. This topping/grout appears to be and is assumed to be pre 1975. Note the carbonation from top and bottom of the slab.

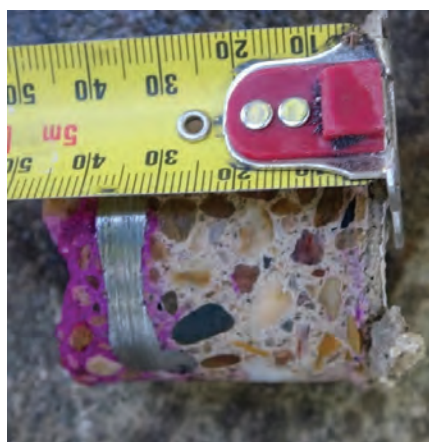
Image 6: C2 Core with bottom Transverse steel bar at 31 cover

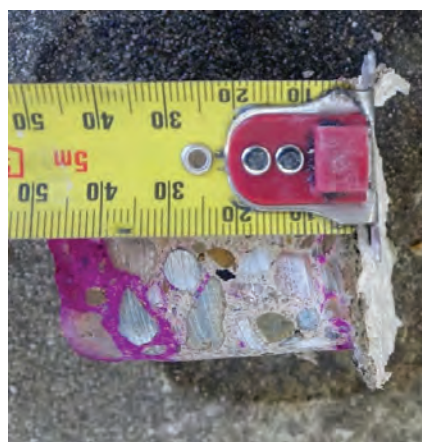
Image 7: C2 Core with Bottom Steel at 25 cover

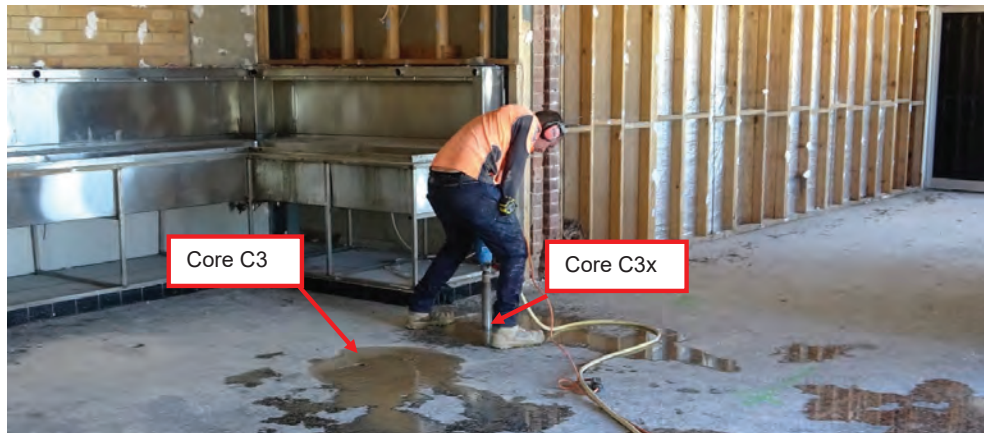
Image 8: Location of C3 and C3x

This core was also taken in the area of slab that was originally enclosed upstairs above the mens bathrooms. This Core was fully carbonated so another core was taken approximately one metre away (labelled 3x).

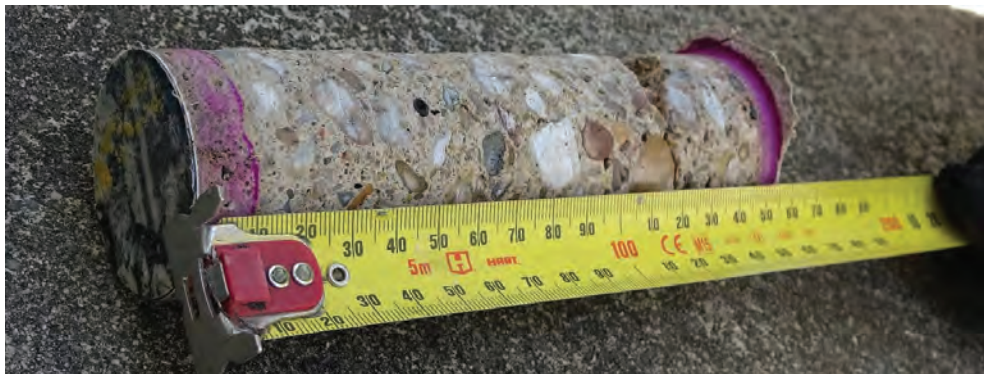
Image 9: Core C3 with tape measuring from top of slab to soffit – Fully Carbonated

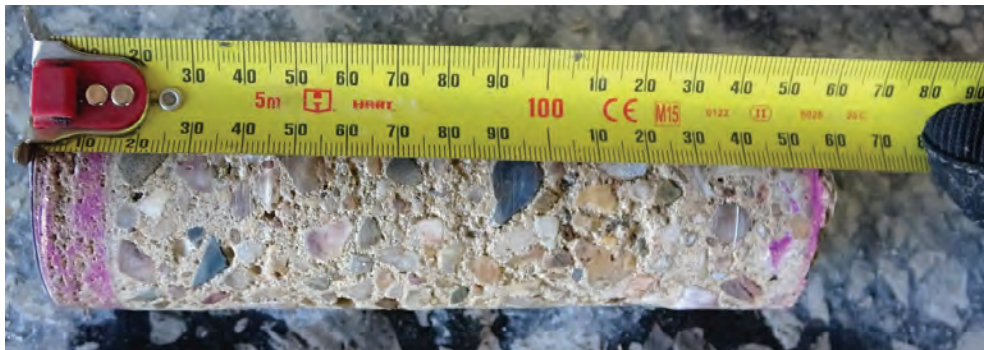
This core was taken approximately 1m away from the previous core towards grid R. But it also showed a fully carbonated result.

Image 10: Core C3x with tape measuring from top of slab to soffit – Also fully Carbonated. Note poor compaction and boney concrete.

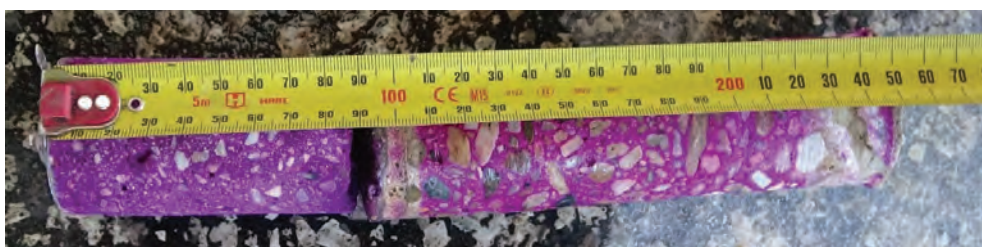
Image 12: Core C4 with tape measuring from top of slab to soffit

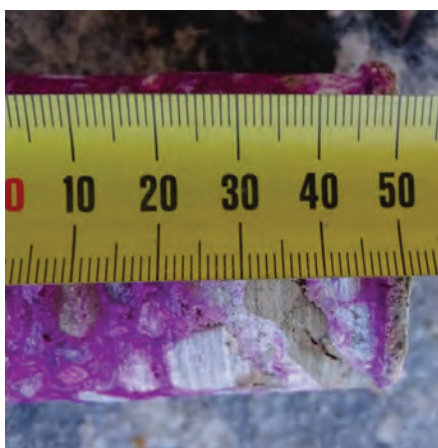
Image 13: C4 Core with
20 to 30mm carbonation

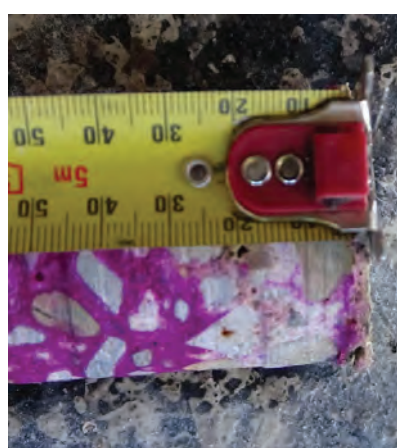
Image 14: C4 Core with
20-30mm Carbonation

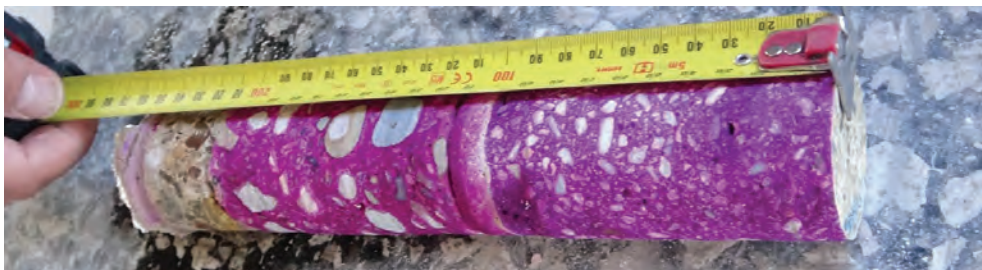
Image 23: Core C6 with tape measuring from the top of the slab to the soffit

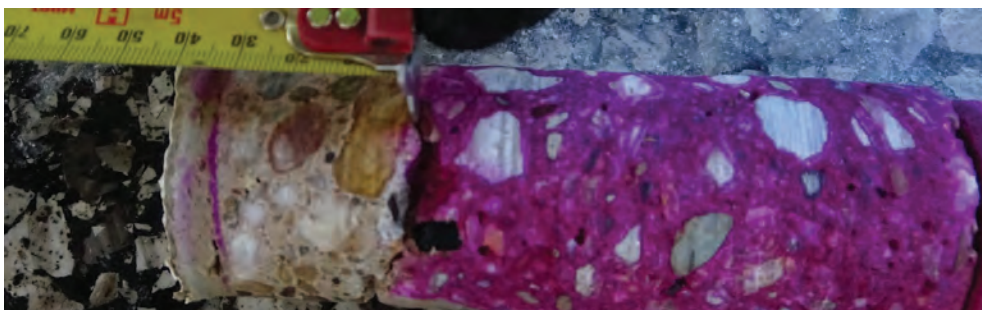
Image 24: Core C6 with tape measuring 40mm of carbonation from the soffit of the slab

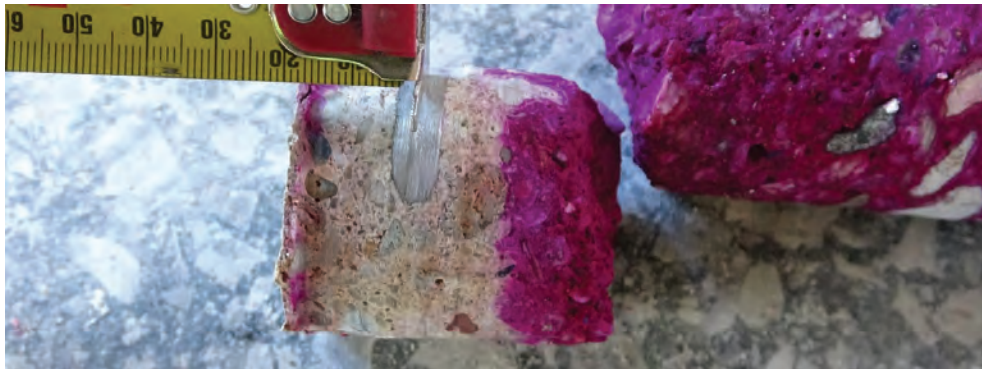
Image 27: Core C8 with tape measuring from the slab soffit to the centreline of the bottom steel reinforcement

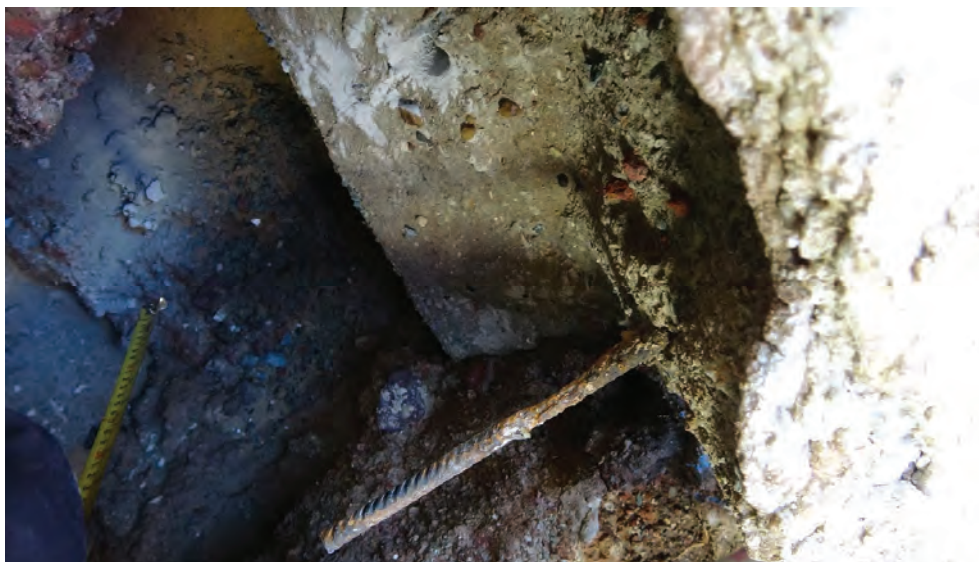
The external slab was cut and vacuum excavated to expose the concrete footing under the new column from the 2007 extension. The external slab was approximately 250mm deep over a concrete footing that was 450mm deep. A random exposed reinforcement bar was found in contact with the dirt with visible corrosion and sectional loss of steel.

Photo 5: Exposed reinforcement bar and concrete footing at 9-X (built in 2007).

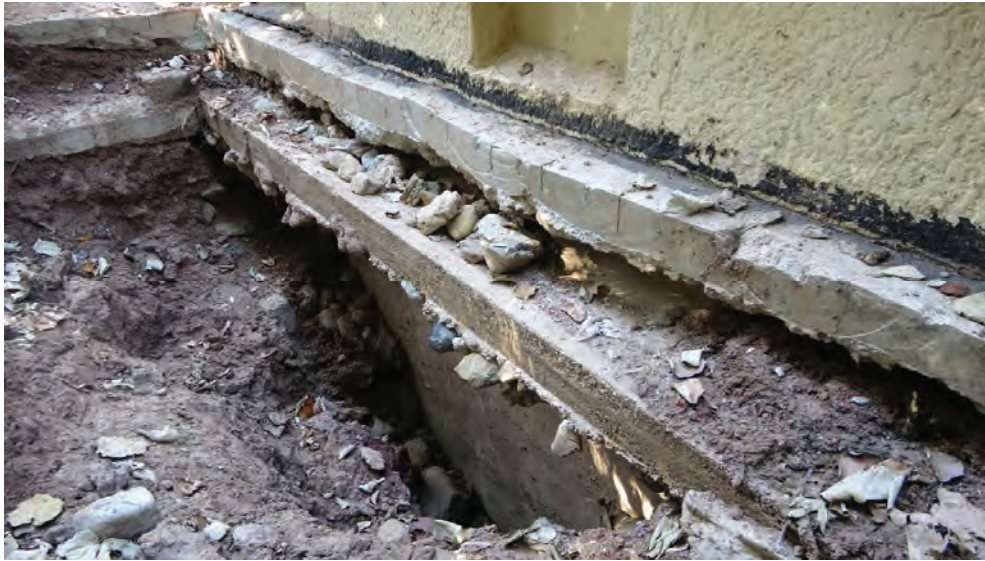
Photo 7: Excavation of rear retaining wall at 3:C-E.

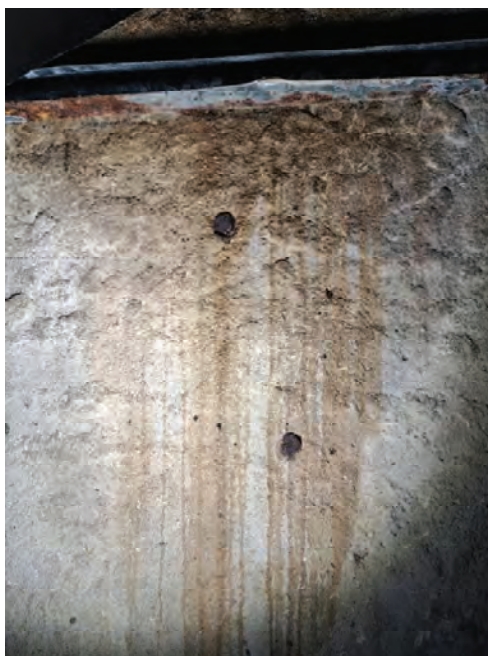
Photo 5: Water ingress at top of wall 3:A/C

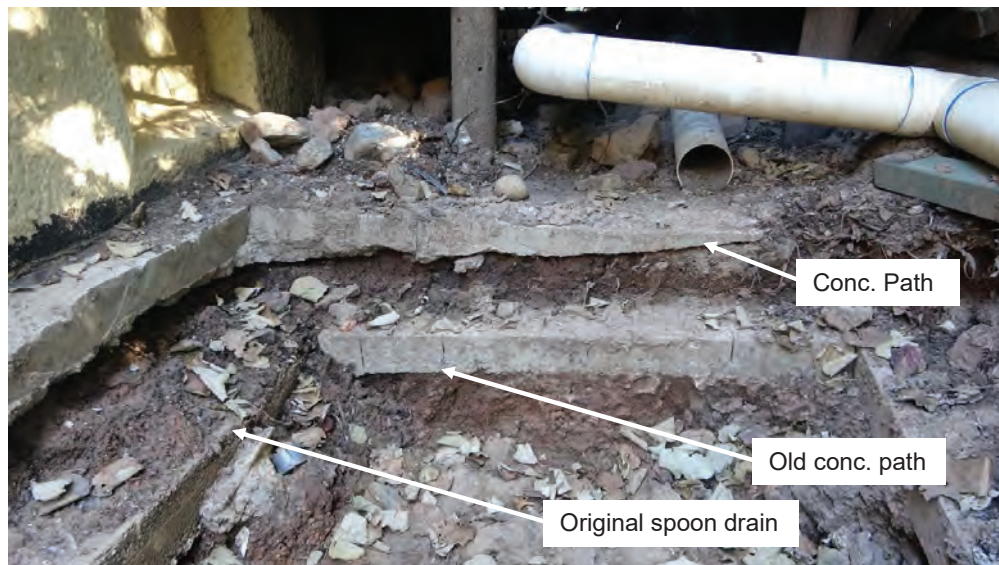
Photo 8: Rear retaining wall section 3-D/C/B.

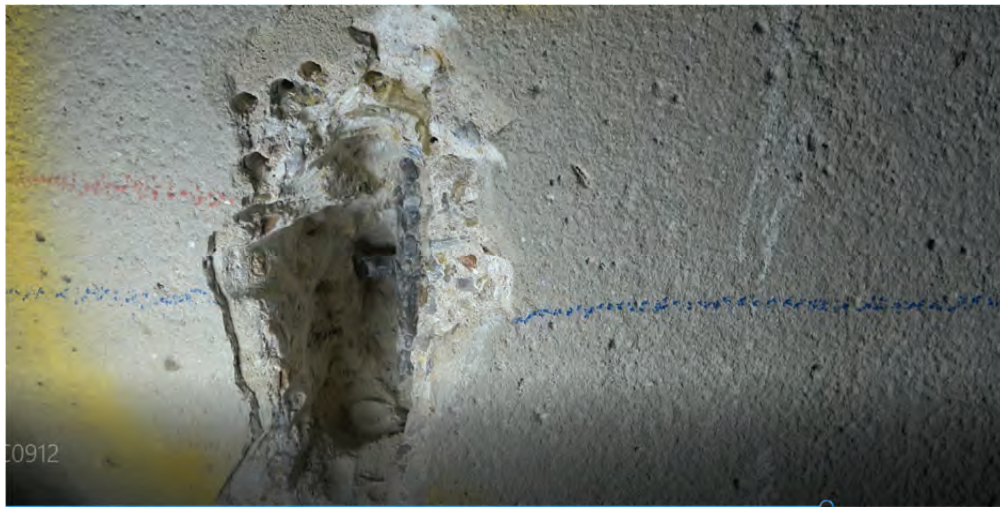
Photo 12: Shows breakout from internal face to steel reinforcement at 3:C-D.

The bars at breakout 3 (between grids C & D) were also exposed. We note that front vertical bar was approximately ⅜ inch bar (see photo 2) This doesn't affect the strength calculations, as the observations suggest that the wall is spanning horizontally. The horizontal bars are definitely ½ inch (ie; ~12mm).

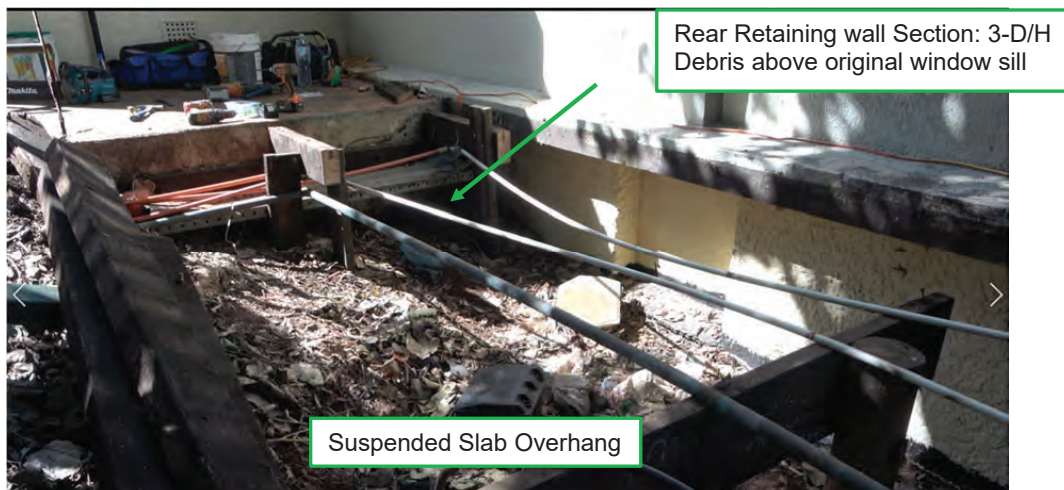
Externally the wall retains around 2m. A timber deck/path runs along this area. There was a lot of debris – soil/leaf matter/rubbish/build up under this deck, to the extent that it was above the original window sills and concrete path/apron.

Photo 15: Rear retaining wall section 3-D to H.

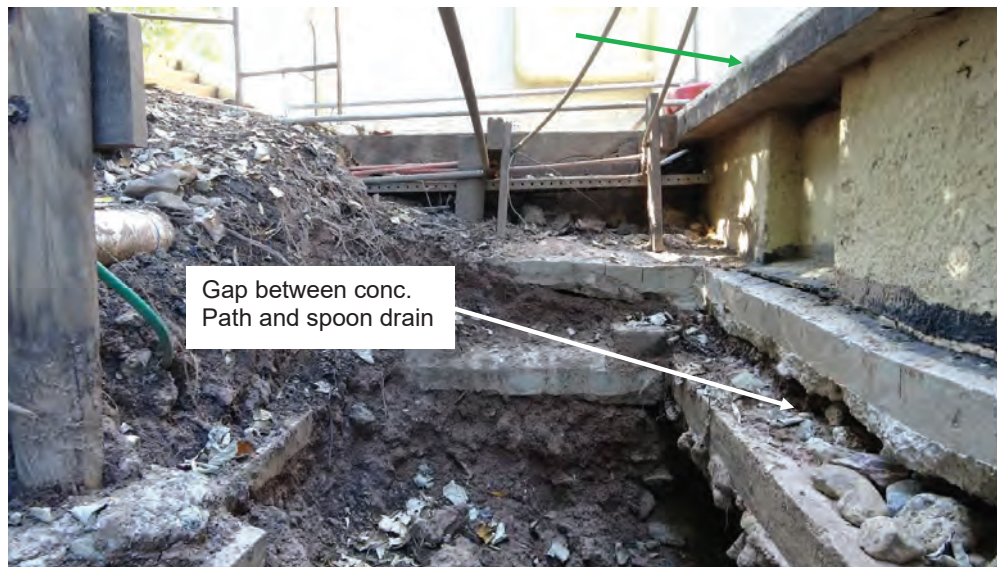
Photo 16: Excavation behind retaining wall near grid 3:D/G.

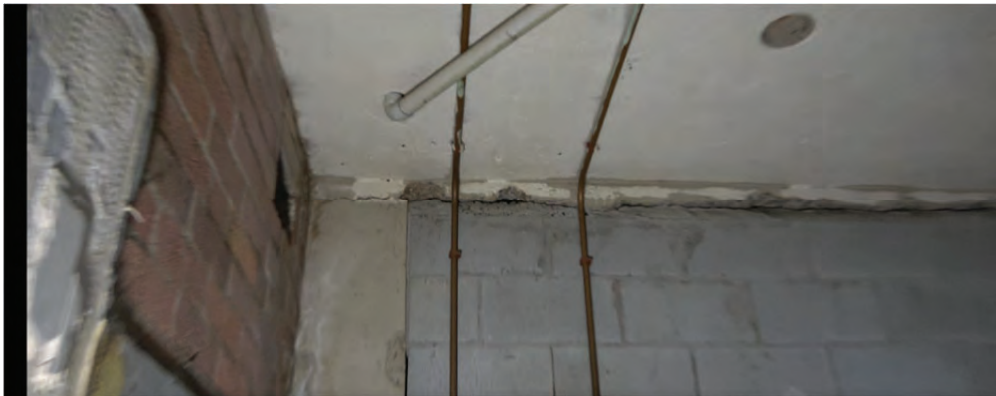
Photo 19: Top of wall 3:H-J.

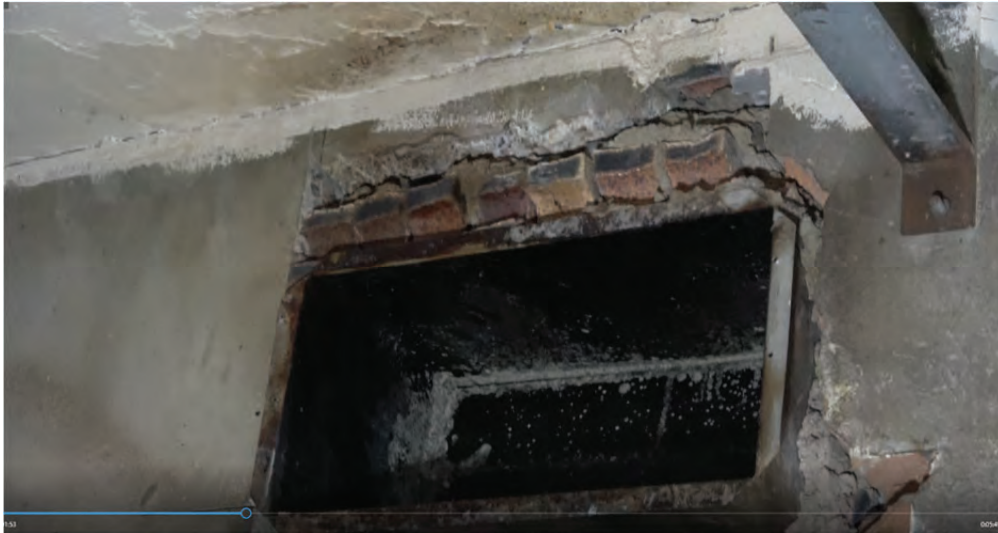
This section of wall originally had windows that have been filled in and grouted, but later the vents were installed and newer bricks grouted in around the penetration. However, this penetration was not sealed or water proofed and when the ground level outside beneath the timber decking was not maintained, it built up with leaf matter and debris over time so that the ventilation shafts were buried or half buried.

Photo 24: Vent penetration in rear retaining wall between grids R and S.

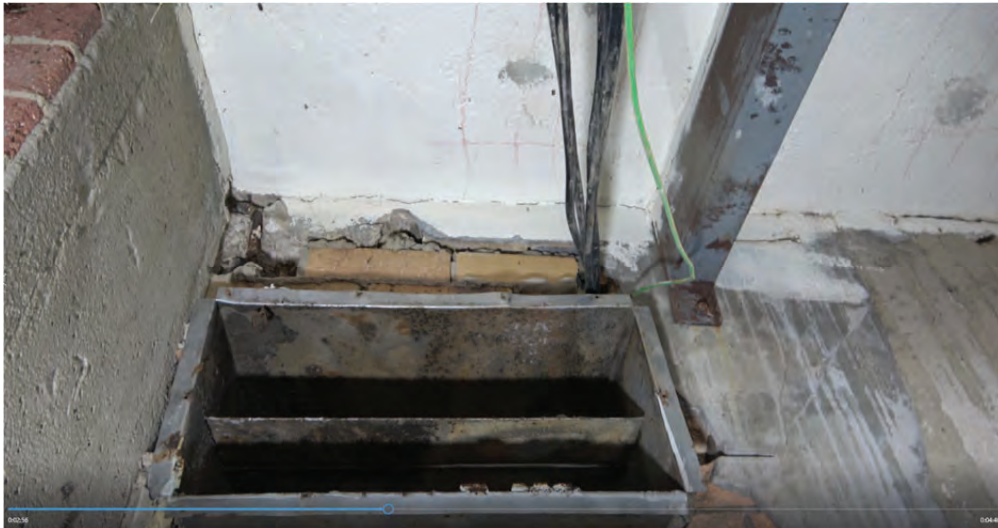
Photo 29: Close up of the above vent penetration in rear retaining wall between grids V and W. Note the vertical bar at buttress column corner is hooked and does not extend into the slab.

Also note the steel PFC support the slab is bolted to the brick window infill immediately adjacent to the vent penetration. These bricks have also been cut to fit the vent.

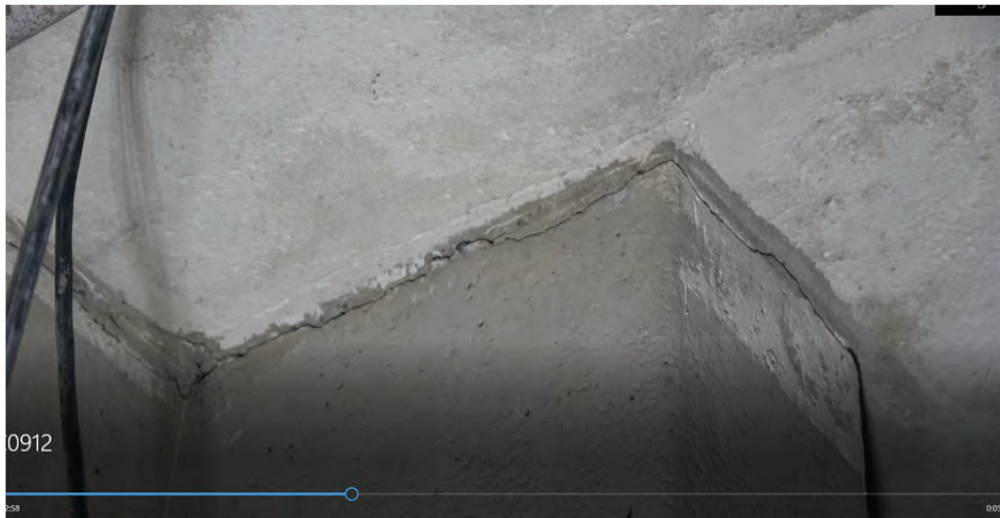
Photo 34: Butress at 3:Q Southern side.

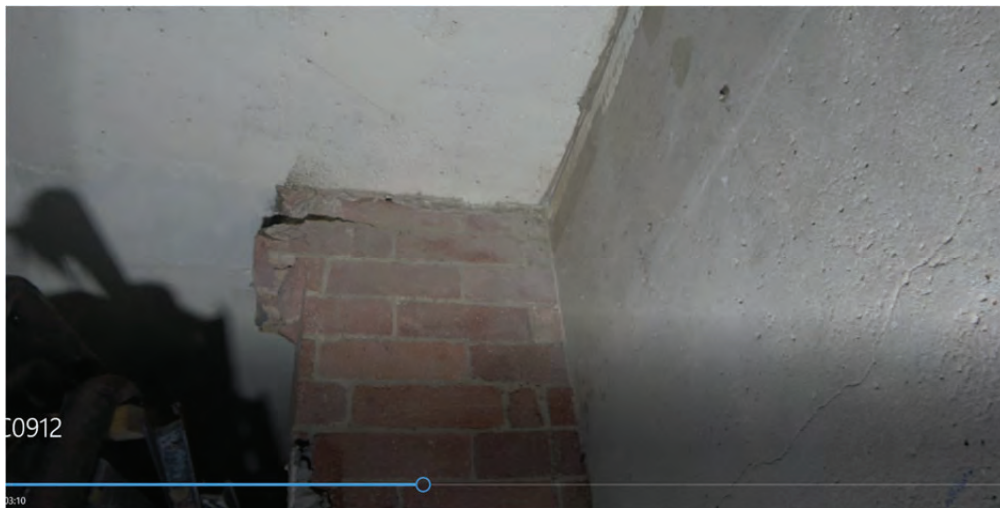
Photo 35: Removed brick wall at N-3/4

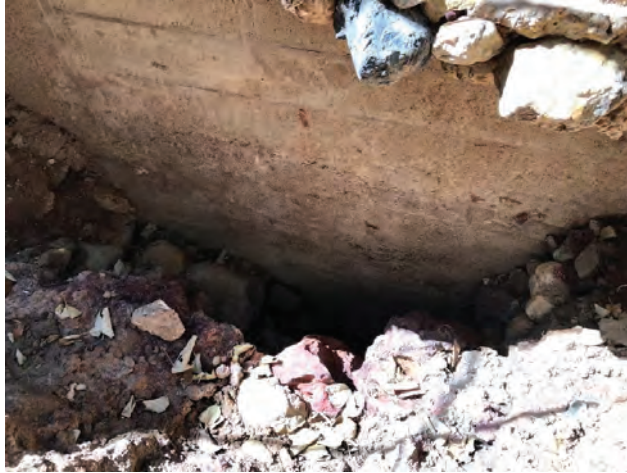
Given the site conditions, there is currently little (or no) opportunity for relief of hydrostatic build up in times of high intensity (or any) rainfall. As a consequence, when stormwater accumulates behind the wall, the resultant hydrostatic pressures act, in addition, to the normally retained earth pressures.

Photo 1 – level of retention at rear wall.

Note, the concrete element visible against the wall in photo 1 are actually the remainder of the cut path and spoon drain.

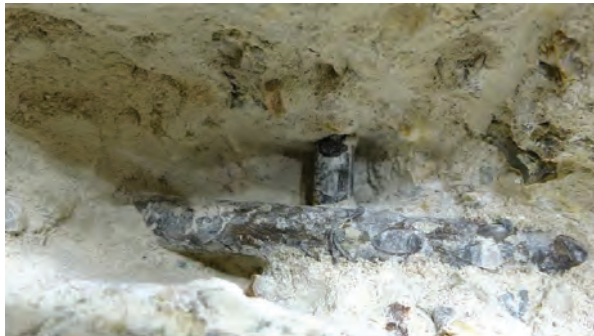
Photo 2 – reinforcement at breakout 3 between grids C & D.

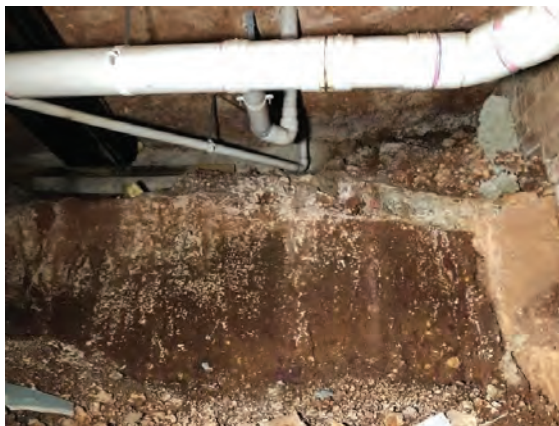
Photo 4 – Under croft of amenities room over between grids H & R

The significance of this is that any proximate excavation (to the retaining wall) would need to be done in such a manner that didn't undermine this part of the structure. Again, this would require specialists' advice.

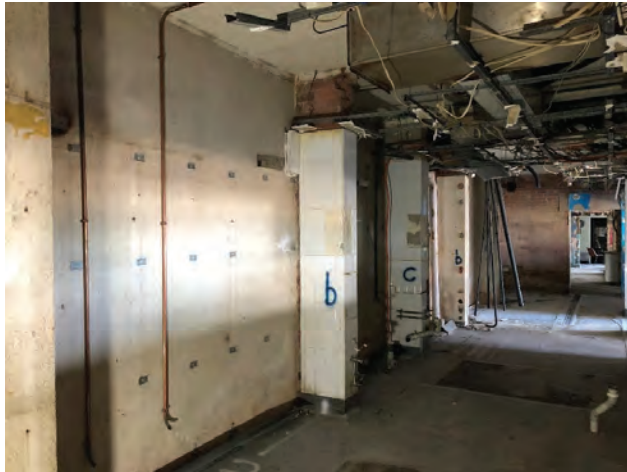
Our review suggests that these nib walls, as they currently exist (see Figs. 4 & 5) **are not** adequate to accommodate the lateral forces generated by the earth retaining pressures.

Photo 5 – existing nib walls
