Sutton Beach Pavilion, Redcliffe

Structural Condition Audit Peer Review

Moreton Bay Regional Council

Project no. 7366

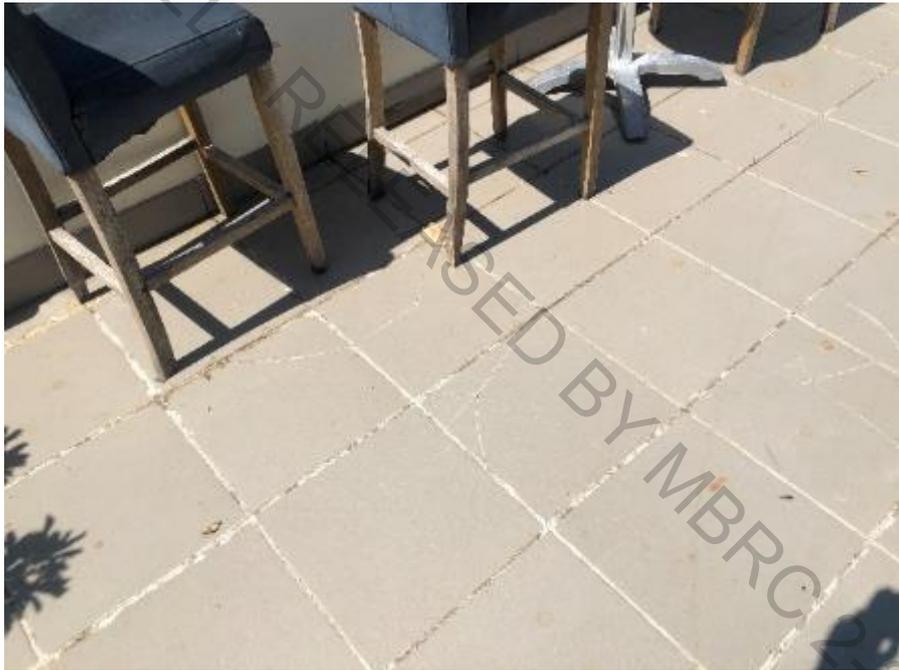
Figure 4: IMG_8600

Level 1 Balcony – general tile cracking

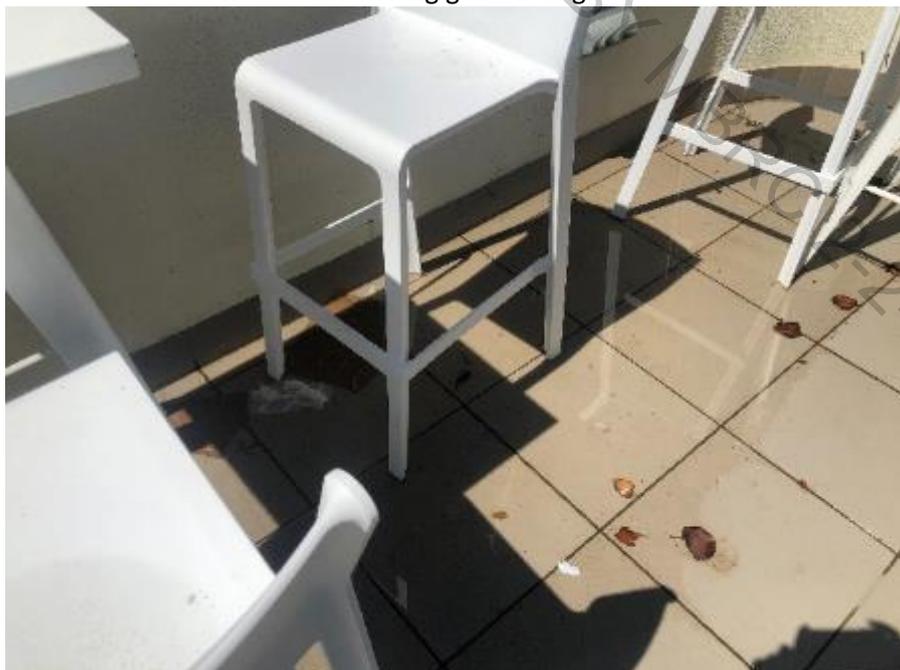
Figure 8: IMG_8613

Level 1 balcony water ponding

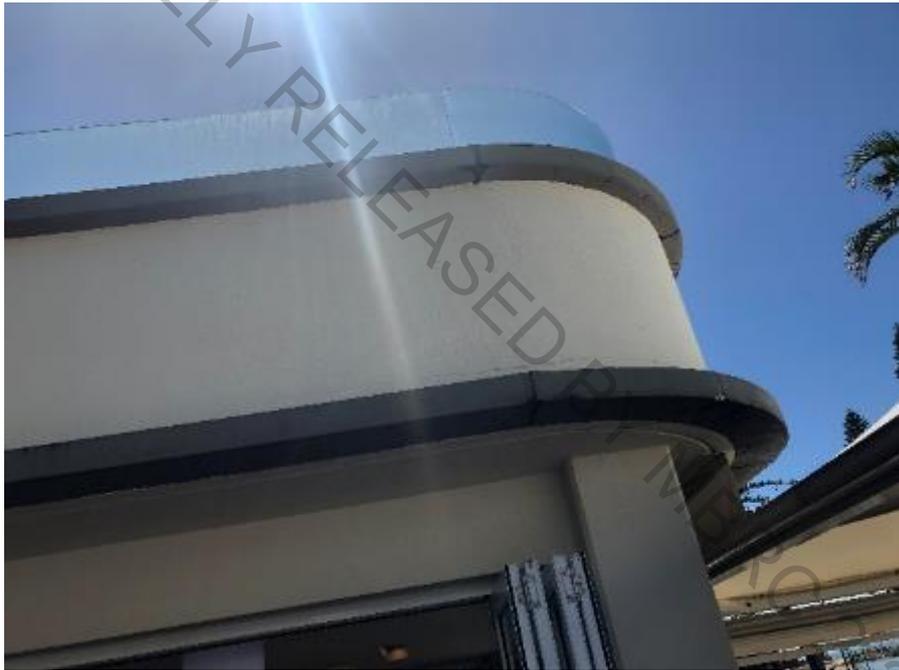
Figure 14: IMG_8645

Awning Level 1	Defect D19 Foam awnings (fiberglass lined) are degraded. Delaminating may contribute to water ingress to structural frame.	Removal and/or repair all foam awnings.	<i>All rendered foam awnings appear to be degraded/delaminating. Recommend to remove and replace all.</i>

General foam awning degradation

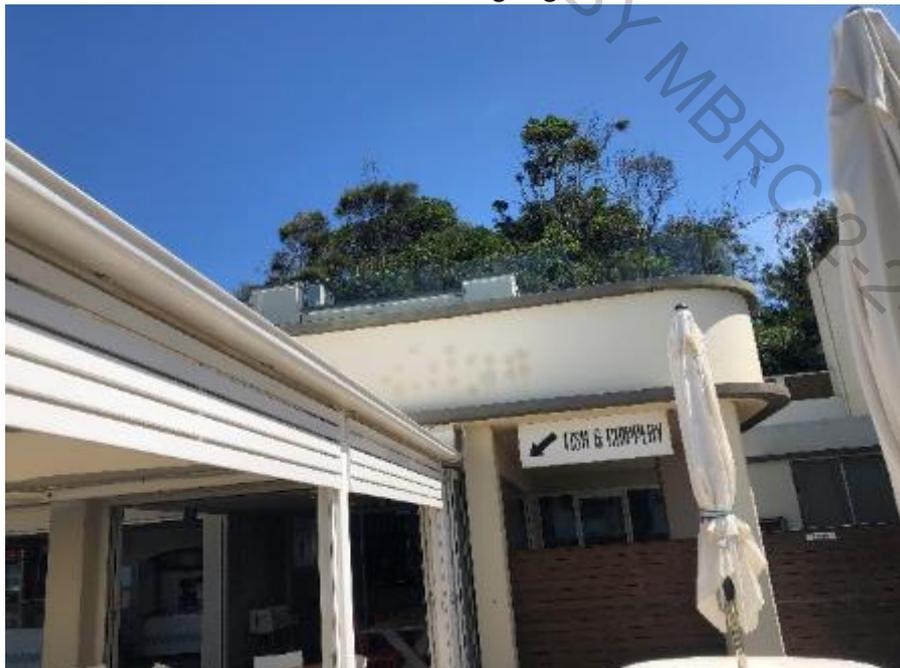
Figure 20: IMG_8654

General Eastern Façade

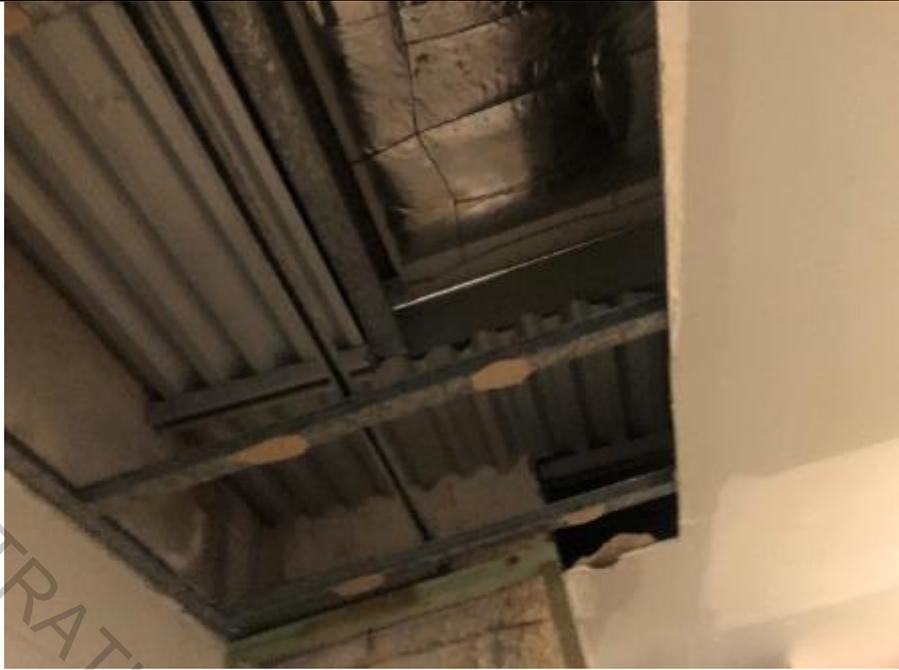
Figure 32: IMG_8545

G6 – Box gutter over – leaking

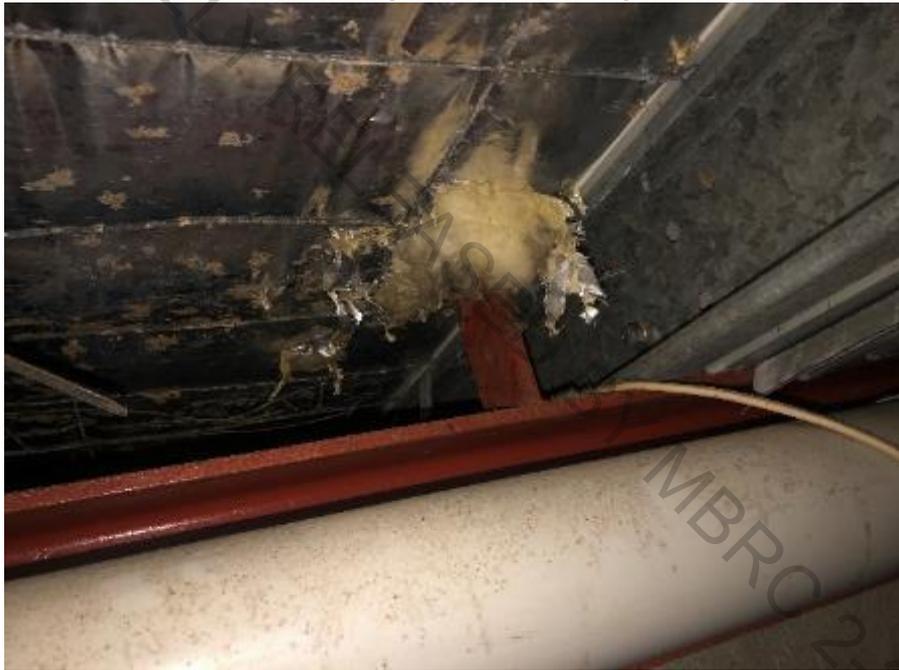
Figure 33: IMG_8546

G6 – Box gutter over – leaking

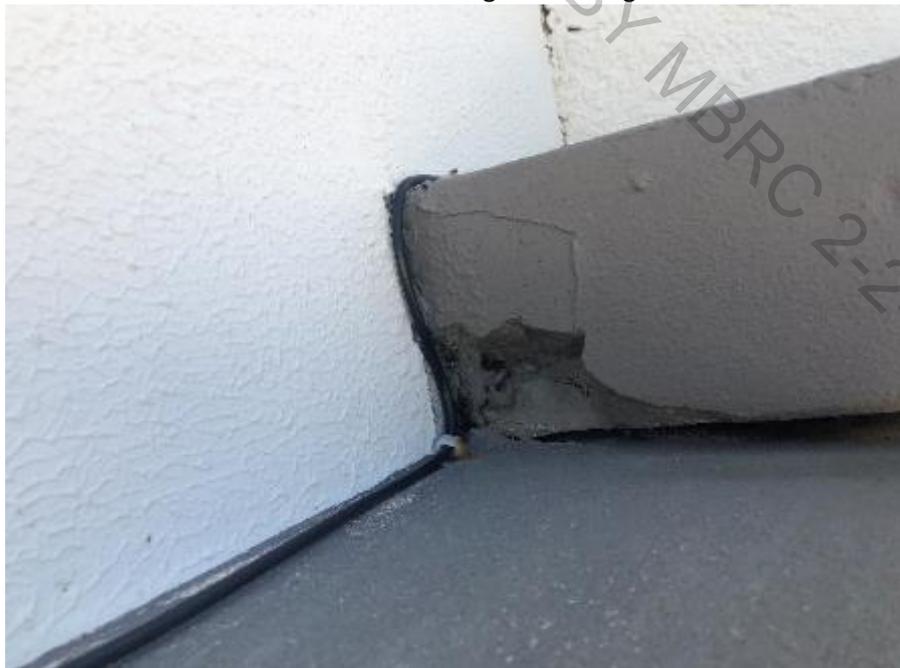
Figure 48: IMG_8555

G9 – Water damage to awning

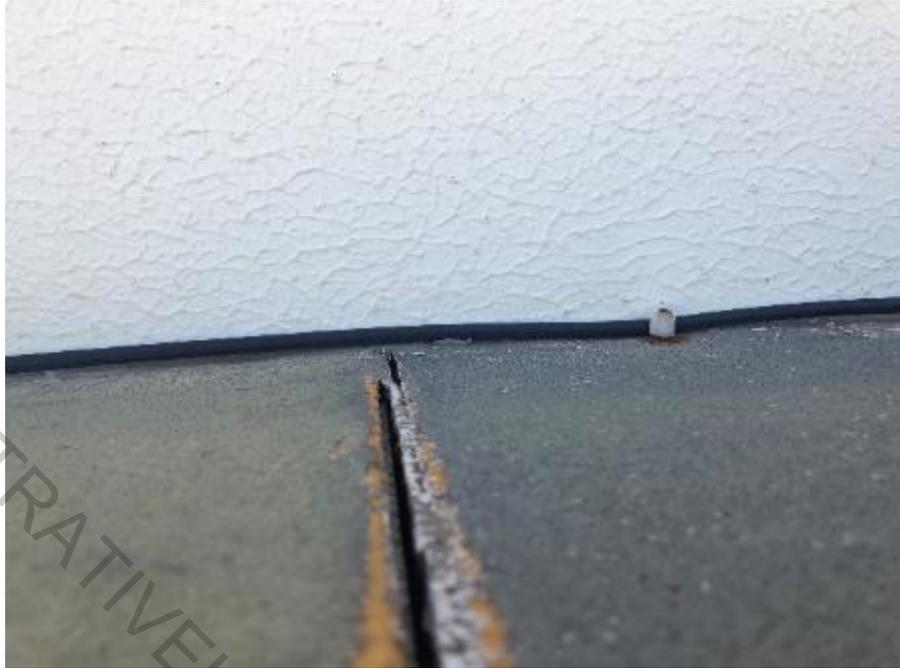
Figure 49: IMG_8556

G9 – Water damage to awning

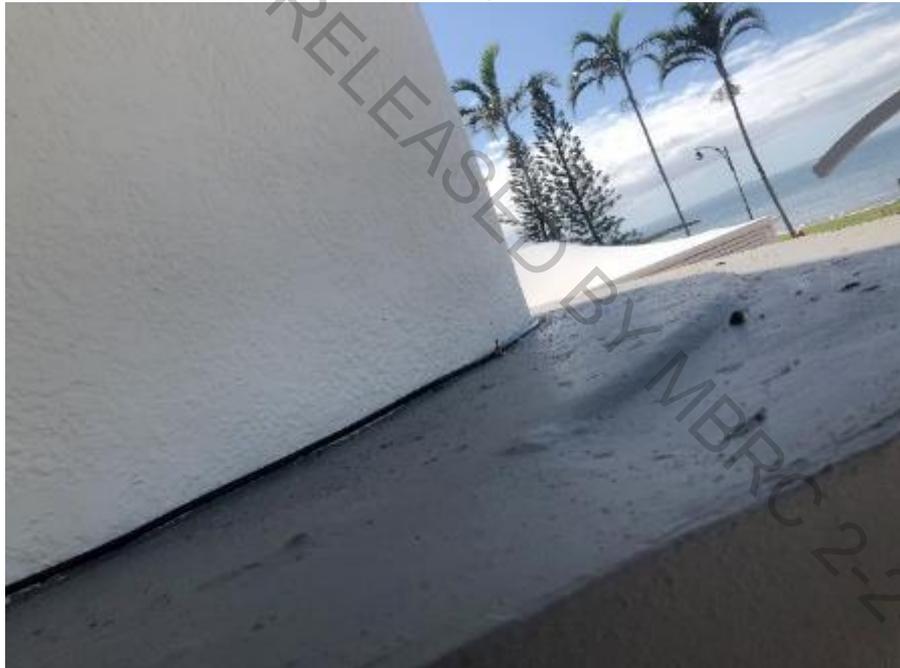
Figure 50: IMG_8557

G9 – Water damage to awning

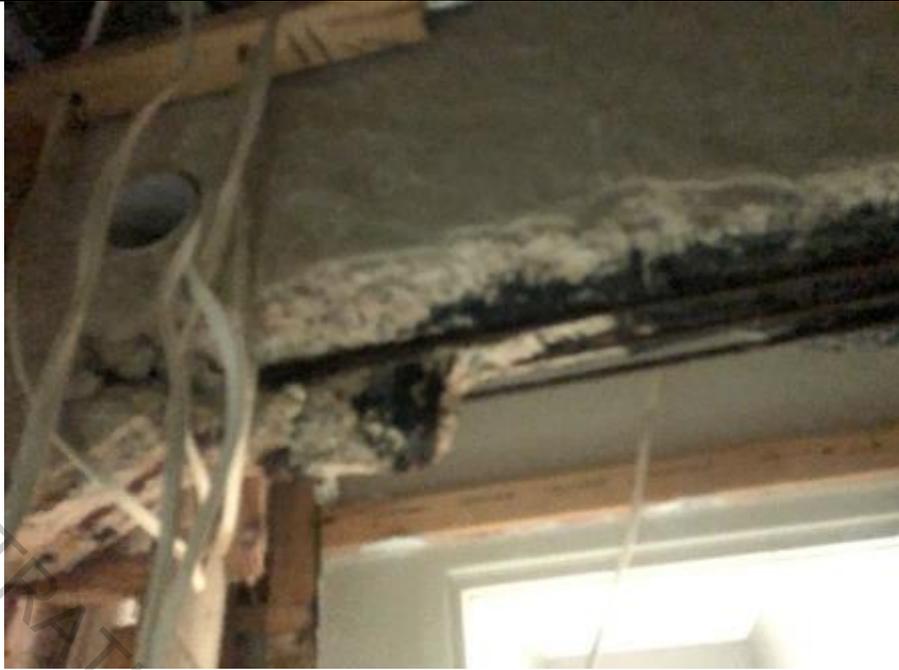
Figure 57: IMG_8494

G20 - PWD Bathroom – RC beam over

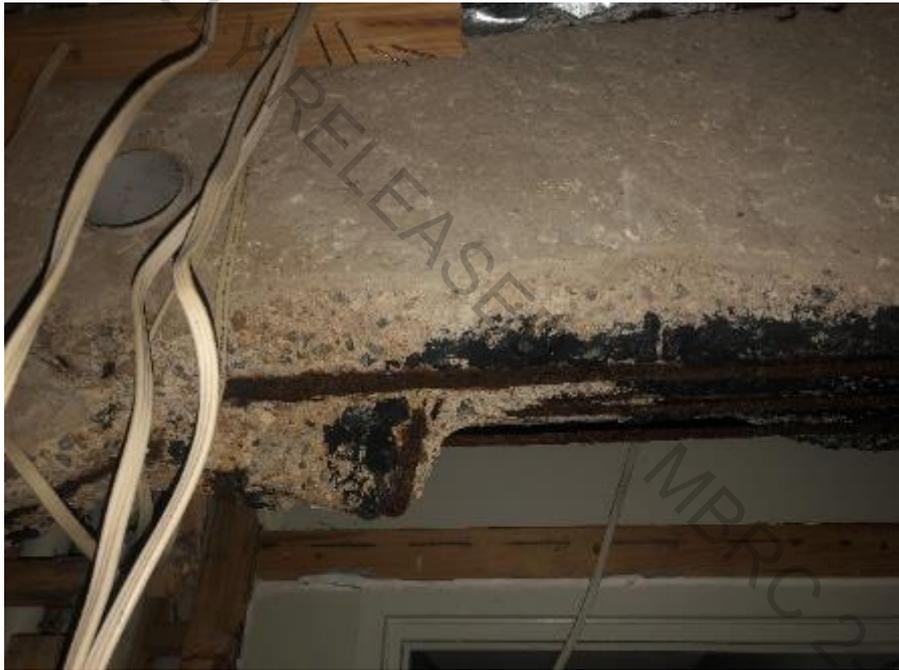
Figure 58: IMG_8495

G20 - PWD Bathroom – RC beam over

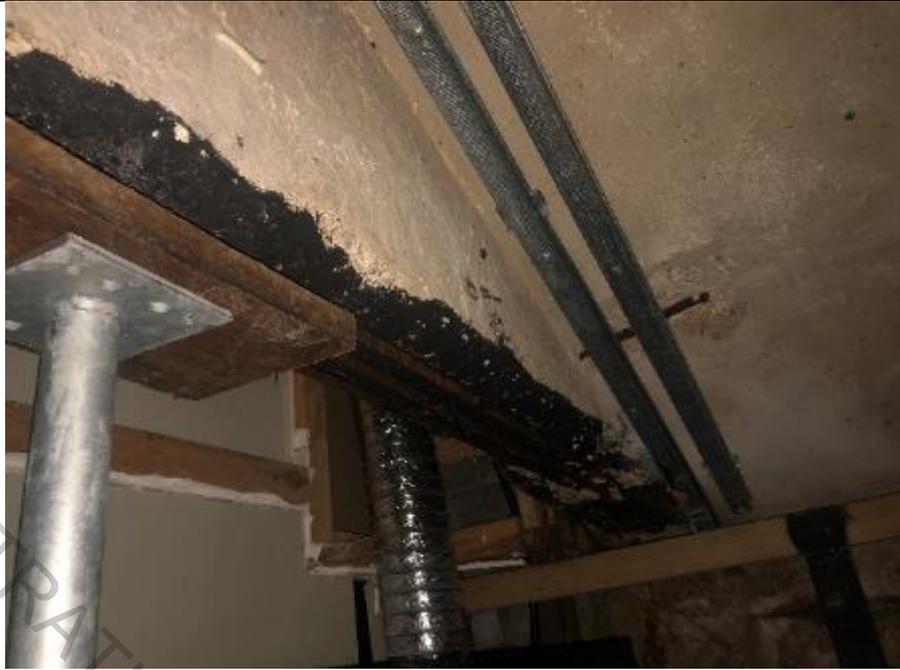
Figure 59: IMG_8496

G20 - PWD Bathroom – RC beam over

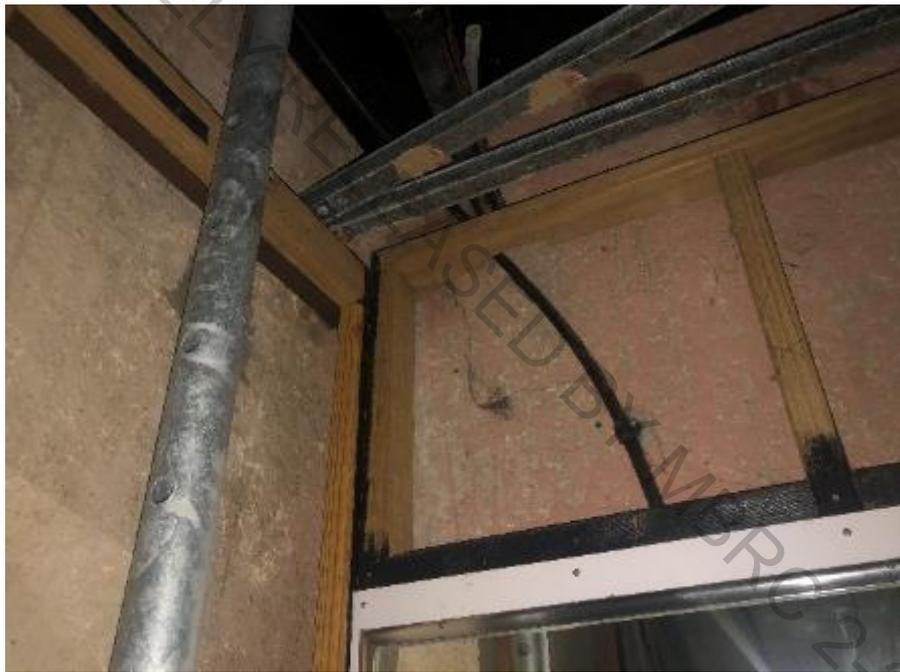
Figure 60: IMG_8497

G20 - PWD Bathroom – RC beam over

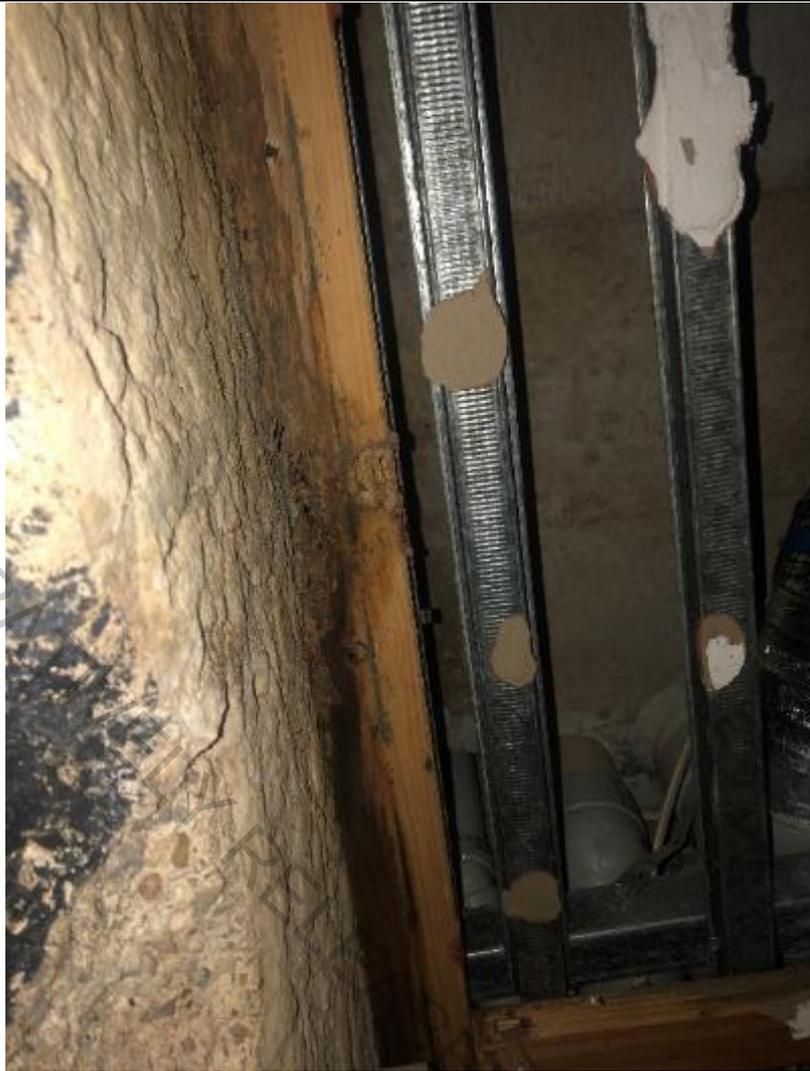
Figure 61: IMG_8498

G20 - PWD Bathroom – RC beam over

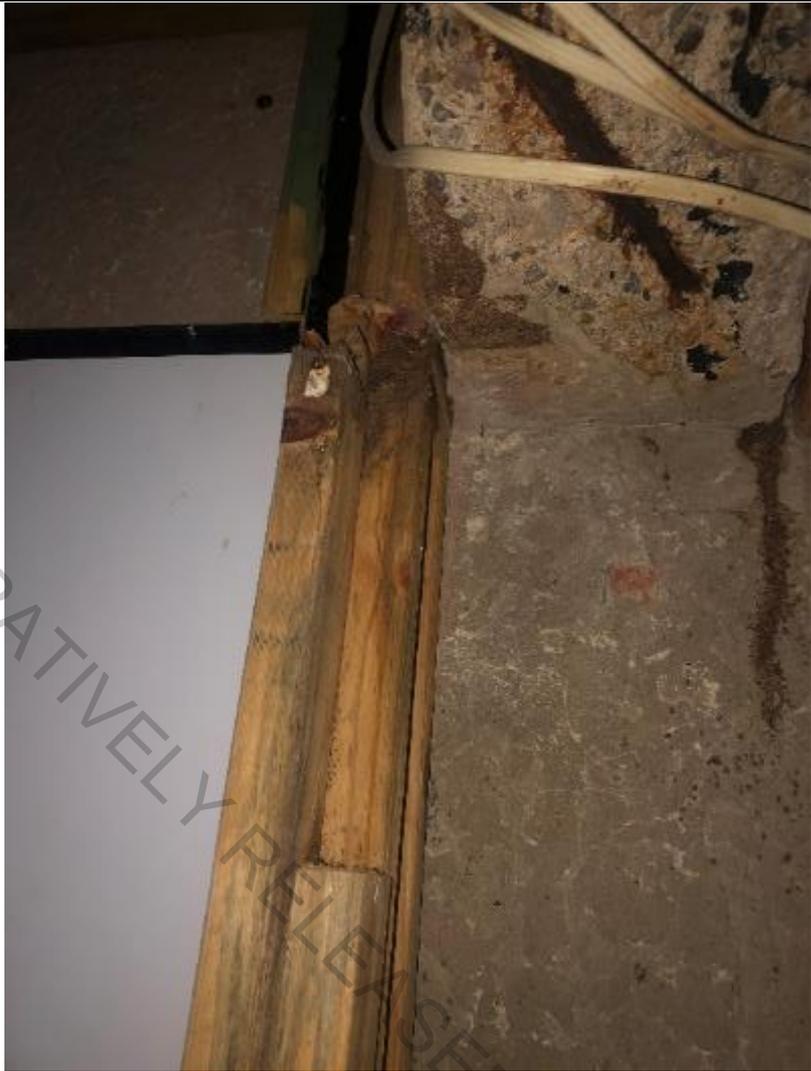
Figure 63: IMG_8500

G20 - PWD Bathroom – RC beam over

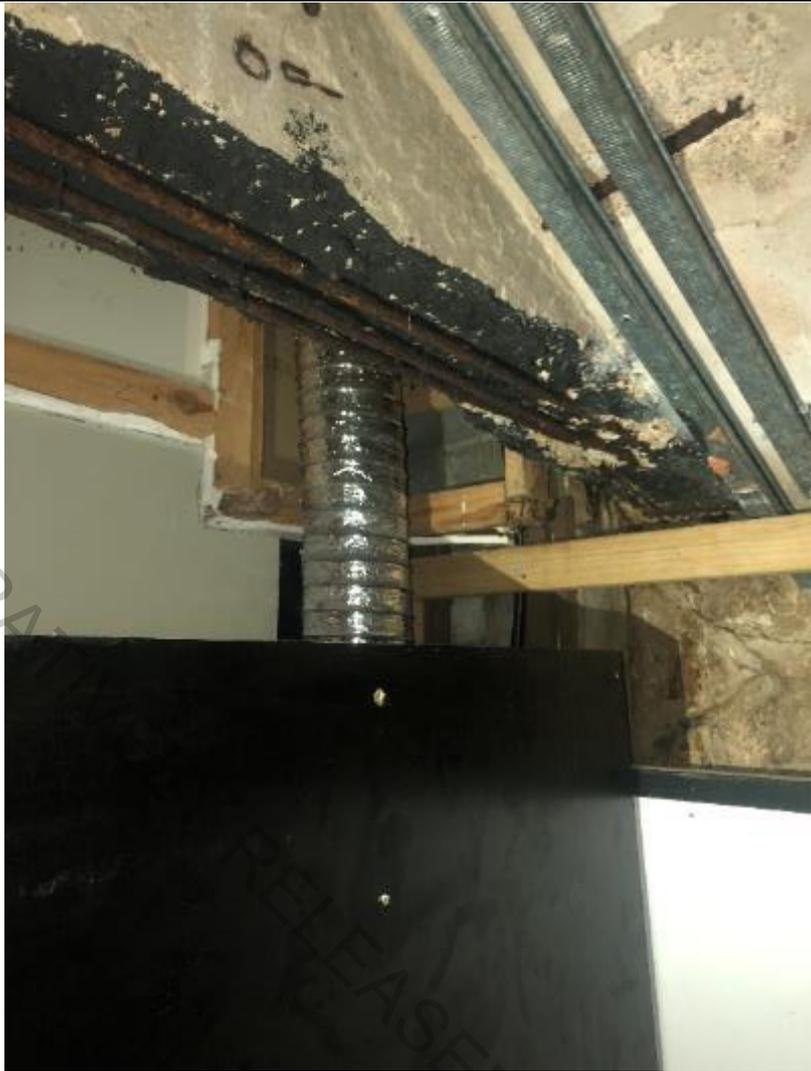
Figure 64: IMG_8501

G20 - PWD Bathroom – RC beam over

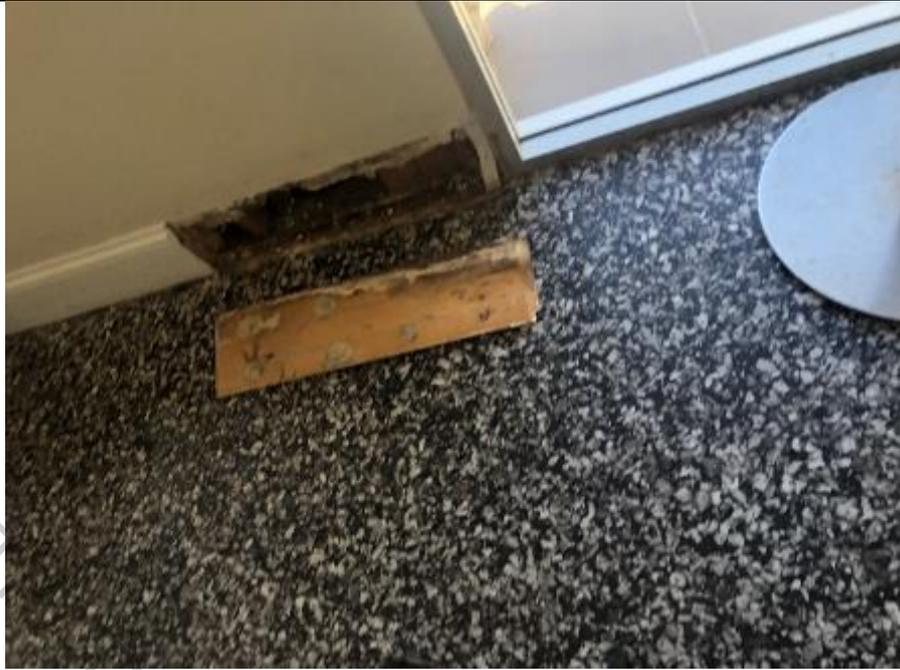
Figure 84: IMG_8577

F7 – Water damage to frame

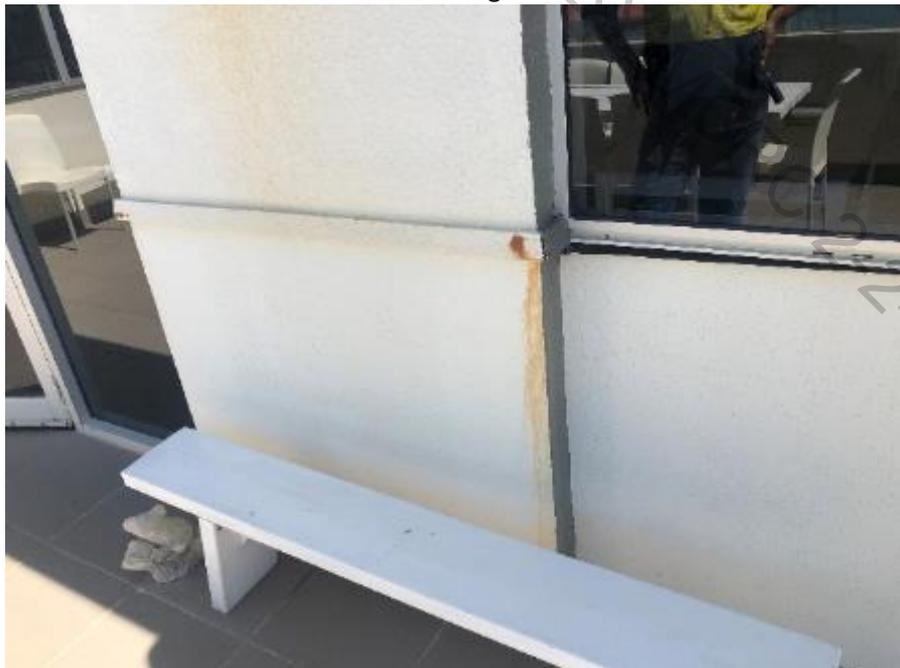
Figure 87: IMG_8595

F7 – External side – water damage

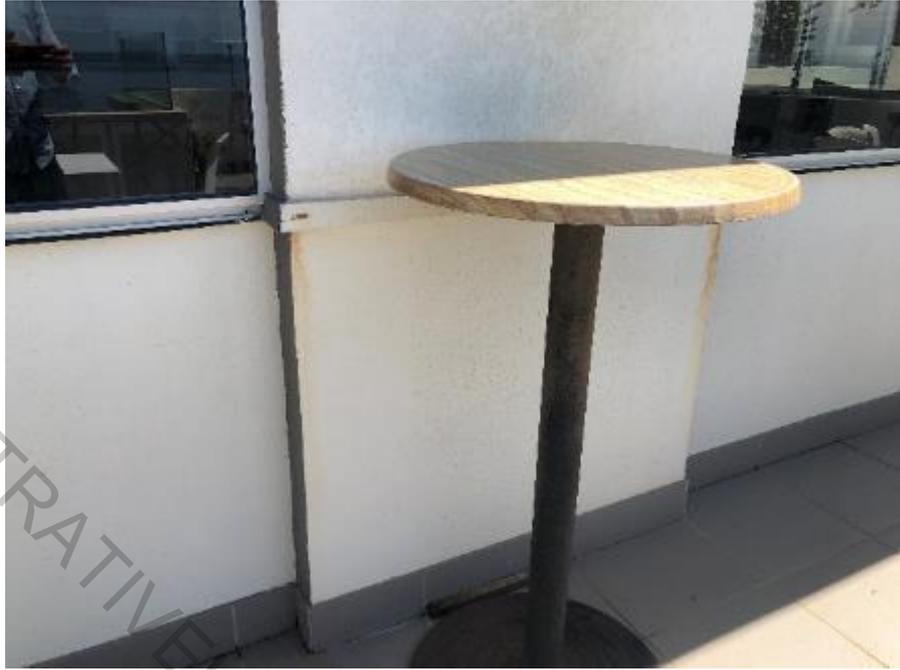
Figure 88: IMG_8596

F7 – External side – water damage

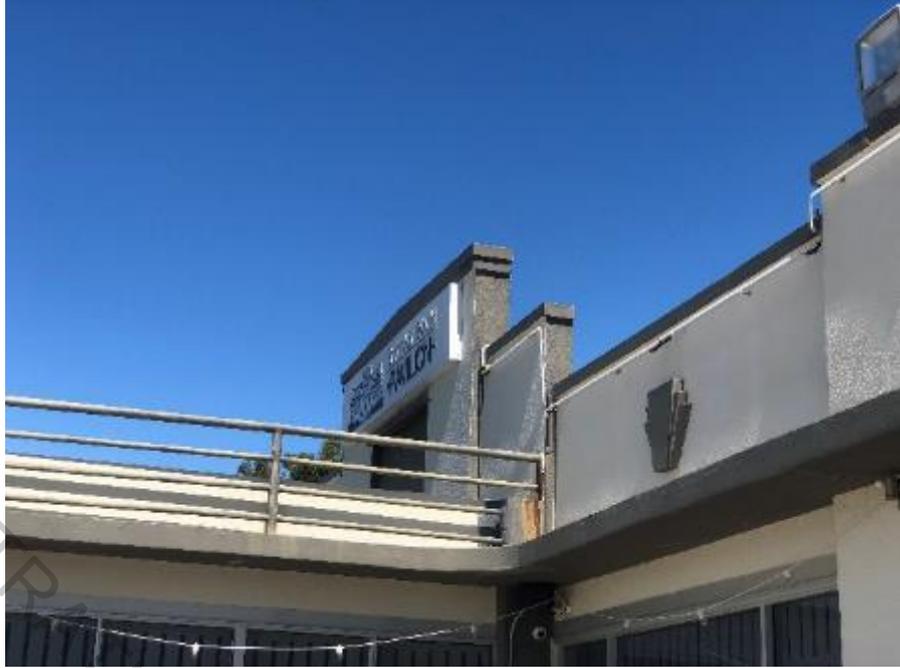
Figure 94: IMG_8603

F10 – Roof balustrade fixings corroding

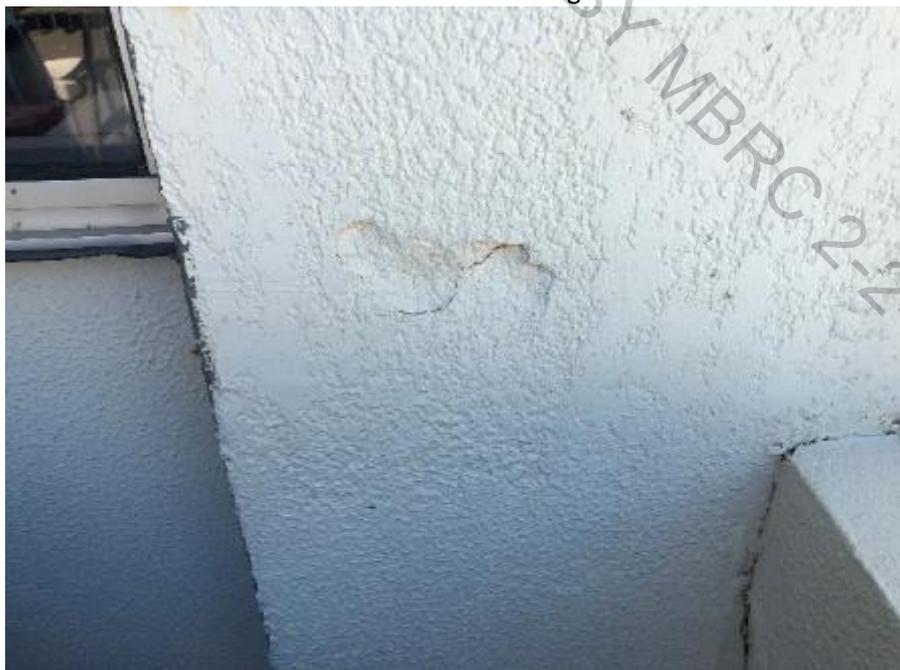
Figure 97: IMG_8608

F10– Wall water damaged

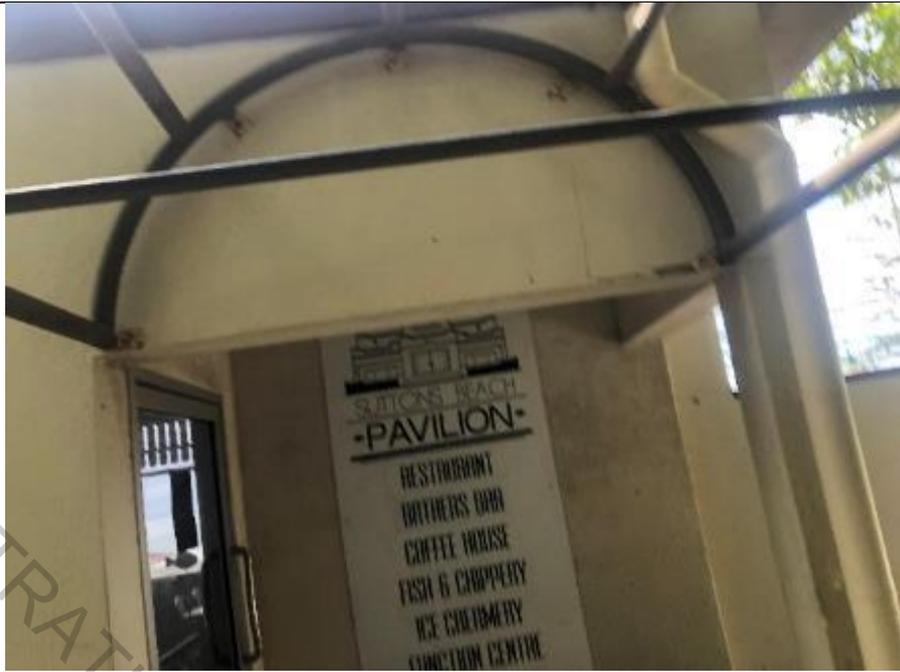
Figure 99: IMG_8505

F20 - Steel frame awning – level 1 entrance

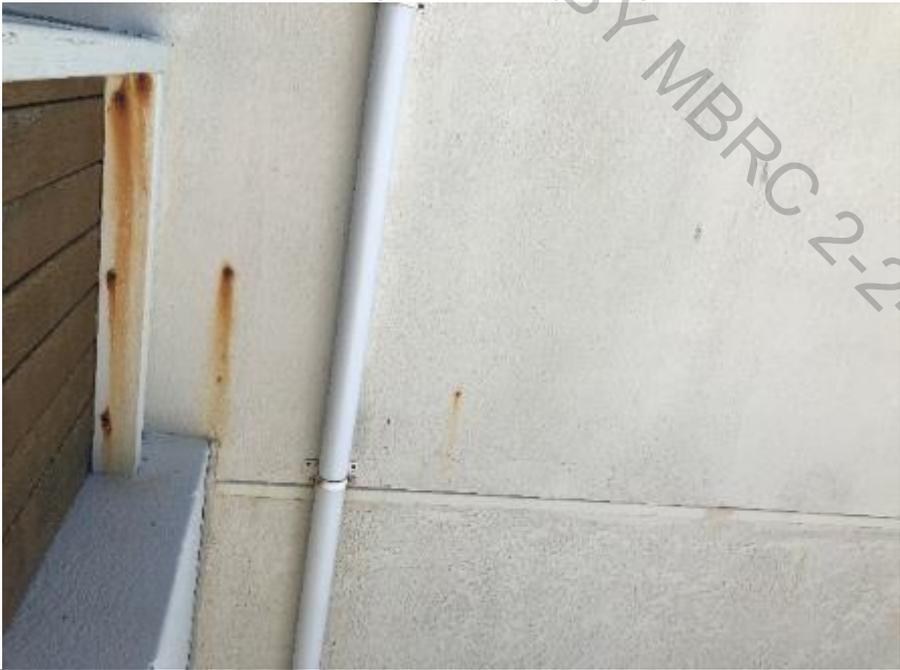
Figure 104: IMG_8590

F20 – General pavilion 2, minor corrosion spots on wall and screen fixings

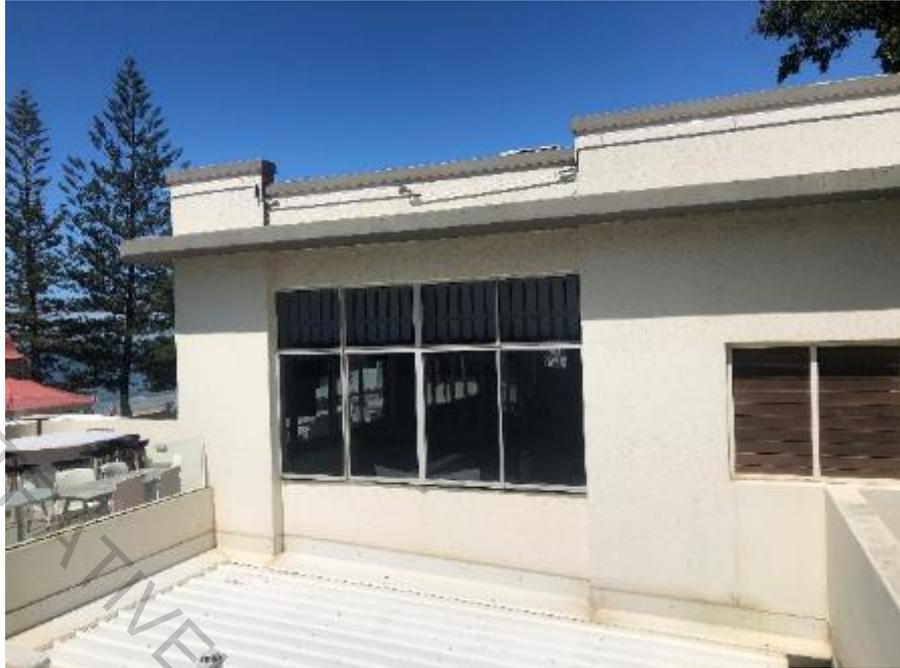
Figure 105: IMG_8591

F20 – Level 1 wall and lower roof

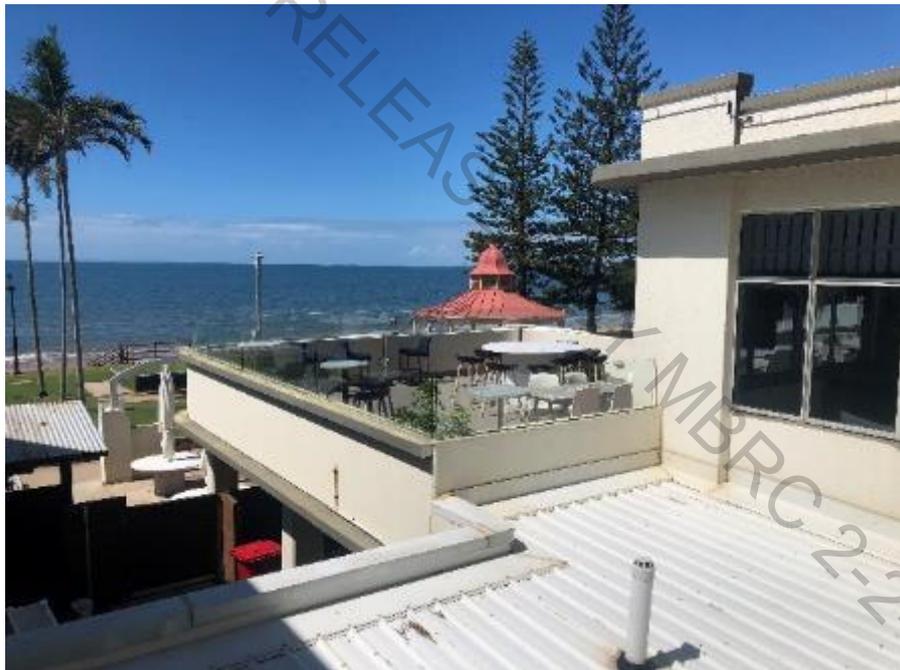
Figure 106: IMG_8592

F20 – Level 1 wall and lower roof

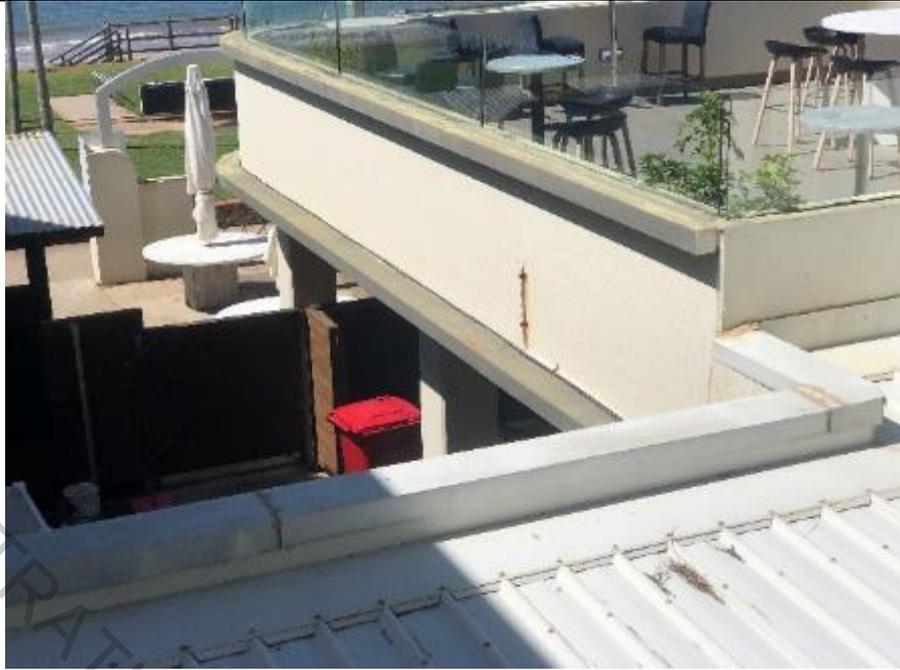
Figure 107: IMG_8593

F20 – Level 1 wall and lower roof

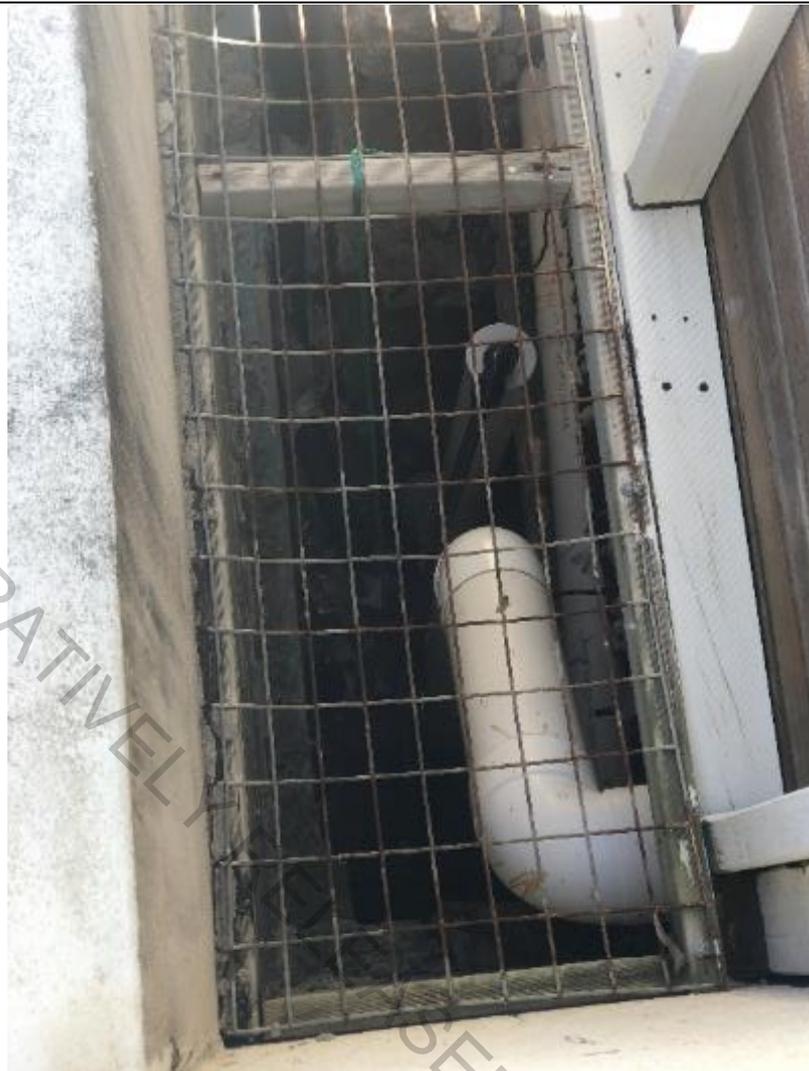
Figure 108: IMG_8583

F21 – Rear drainage channel

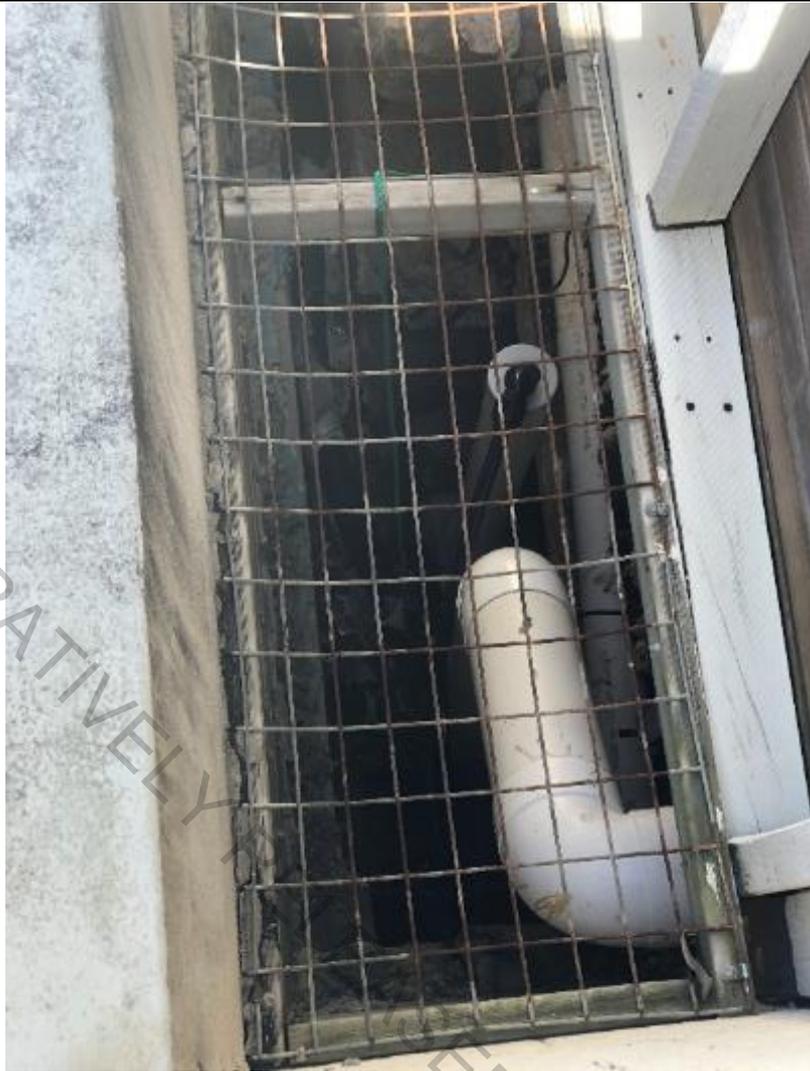
Figure 109: IMG_8584

F21 – Rear drainage channel

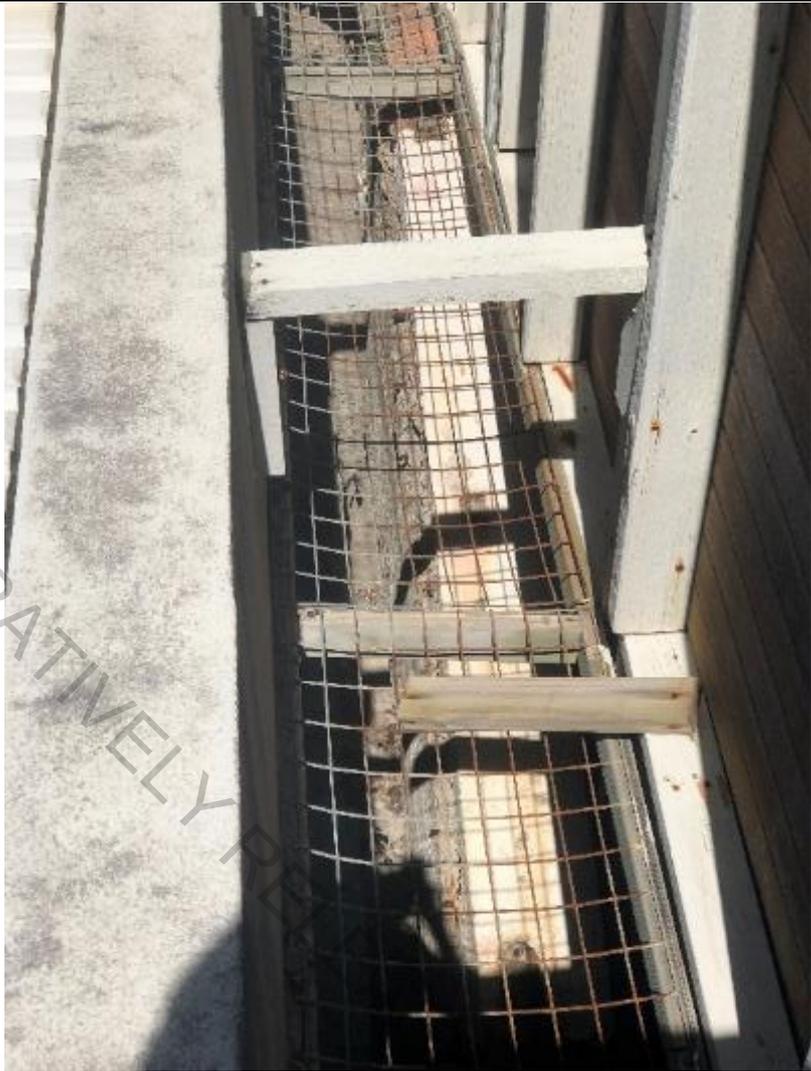
Figure 110: IMG_8585

F21 – Rear drainage channel

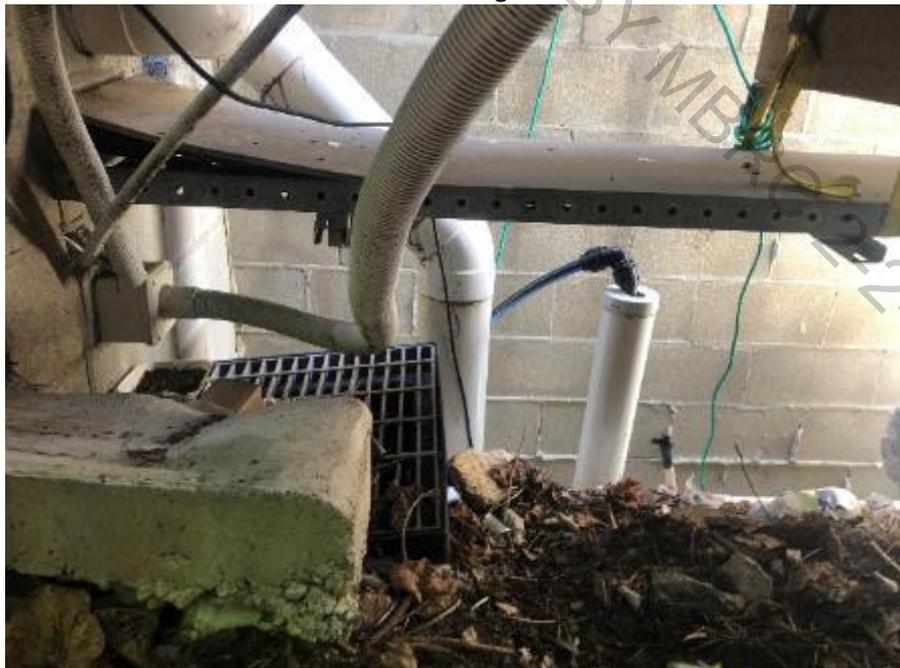
Figure 111: IMG_8620

F21 – Added drainage sump/pump. No water proofing to block wall. Undermining old structure

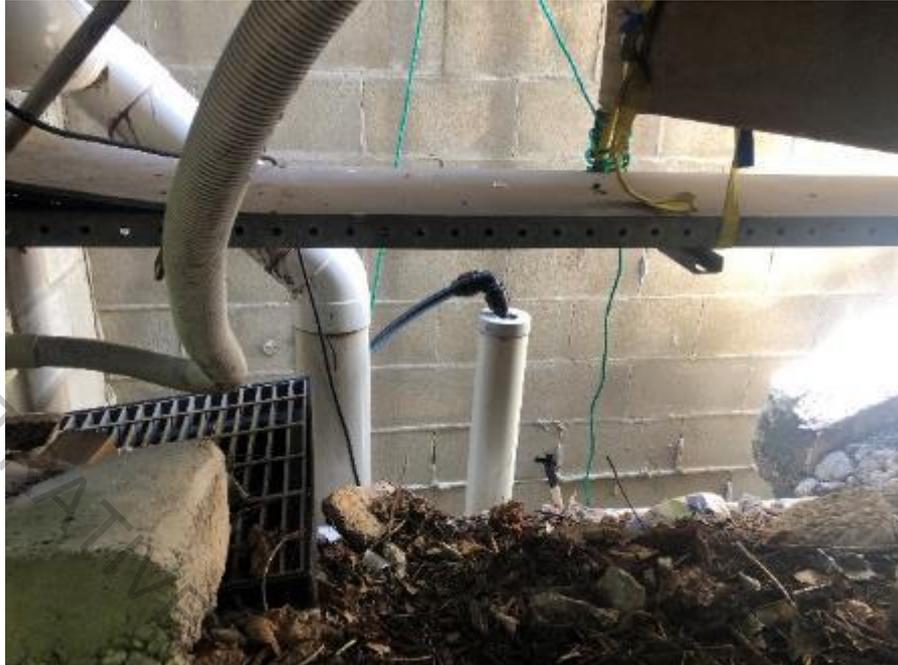
Figure 112: IMG_8622

F21- Cable try and deck support temporary propped/strapped

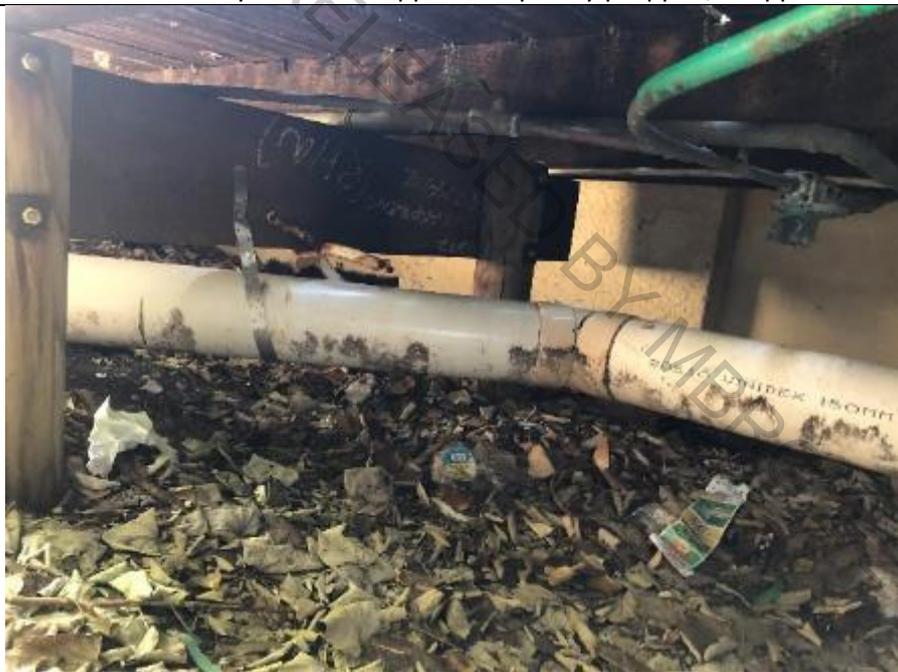
Figure 113: IMG_8637

F30 – under boardwalk – okay

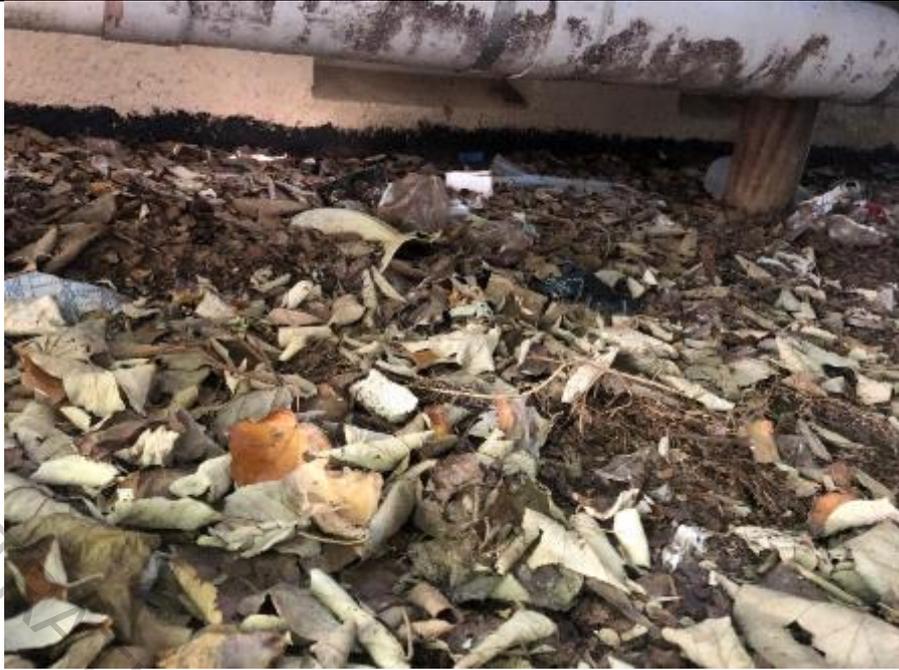
Figure 114: IMG_8641

F30 – under boardwalk visible water proofing

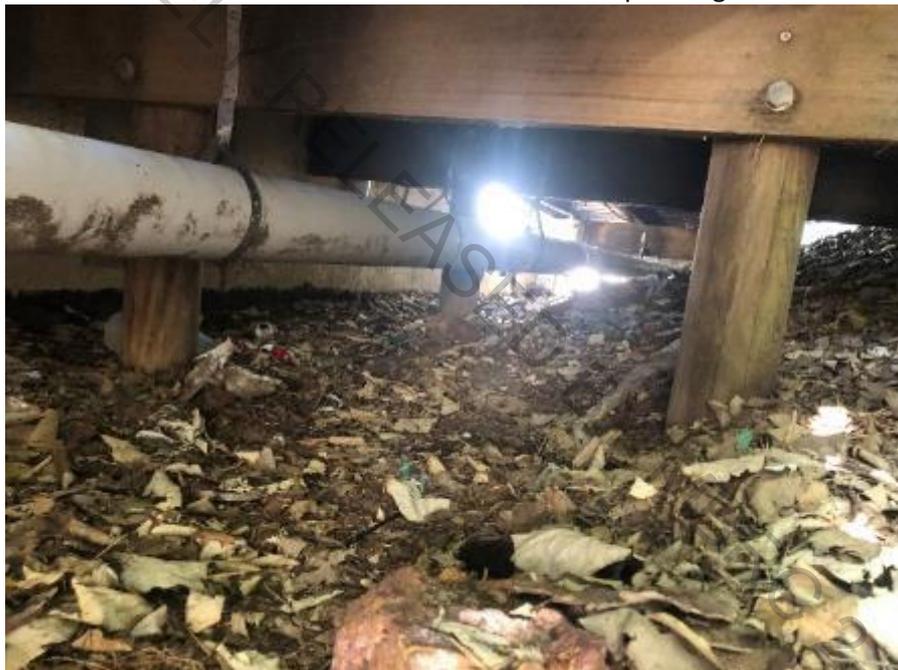
Figure 115: IMG_8642

F30 – under boardwalk visible water proofing

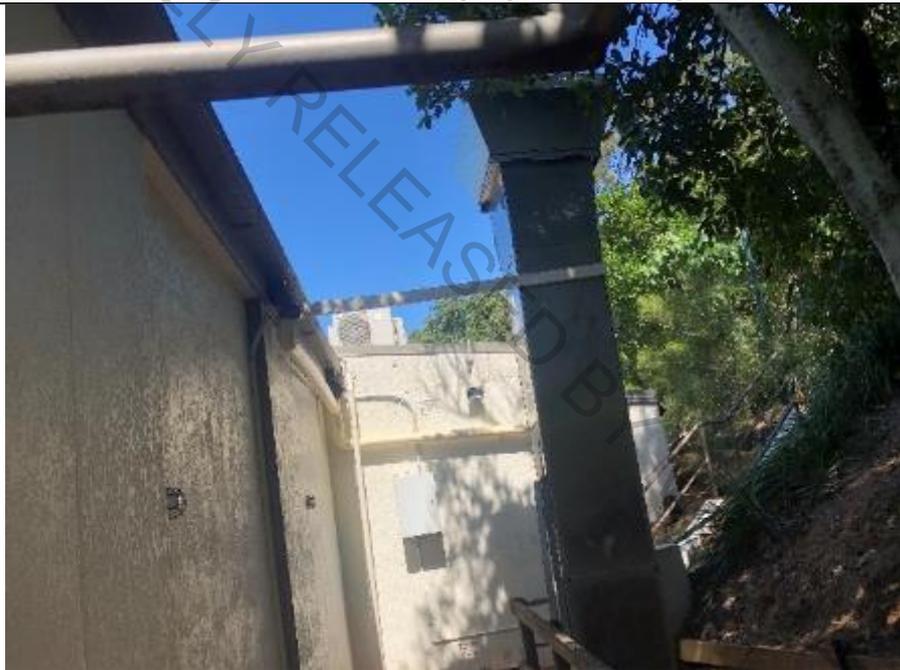
Figure 118: IMG_8617

F32 - Damaged exhaust duct with temporary propping
